MINES BRANCH INVESTIGATION REPORT IR 61-100

**INVESTIGATION INTO THE CAUSE OF FAILURE
OF A BACK BOLT FOR STEEL SHEET PILING**

SEPTEMBER 13, 1961

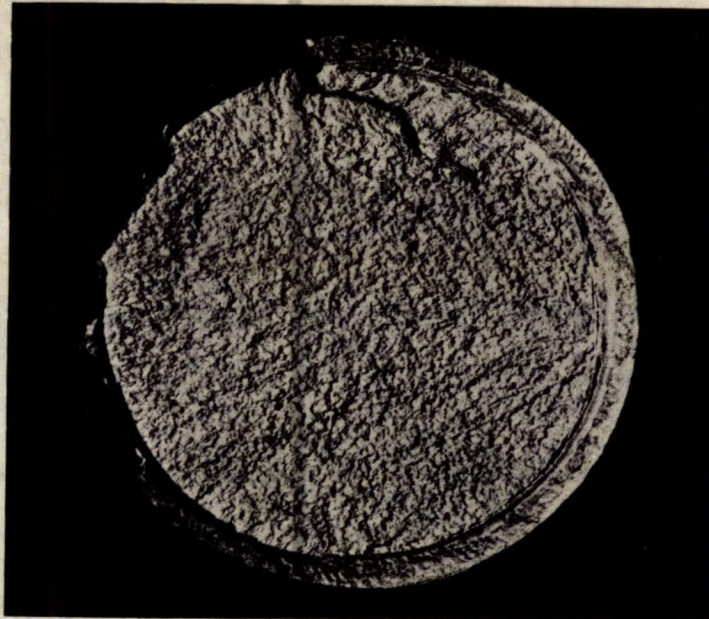
Figure 1. Surface of Fracture in a Bolt from Steel Sheet Piling.

The investigation has shown that the bolt fractured in a brittle manner at the root of the thread. No material defects were evident and it was concluded that failure resulted primarily from a suddenly applied overload. Such failures would be abetted by a stress concentration at the root of the thread, and possibly by some increase in notch sensitivity caused by a thin layer of cold worked metal in that region.

A photograph of the surface of the fracture is shown in Figure 1. It is a brittle type of fracture, having its origin at the root of the thread.

Brittle fracture with origin at the three o'clock position.

Cold work evident at the root of the thread would tend to increase the notch sensitivity of the material. It is concluded that, initially, high torquing loads have been chiefly responsible for the failures when combined with the additional suddenly applied loads during back filling. In the presence of a severe notch and some cold work, brittle fracture could be anticipated.

Failures of this type should be greatly reduced if initial torquing stresses are held to a minimum.

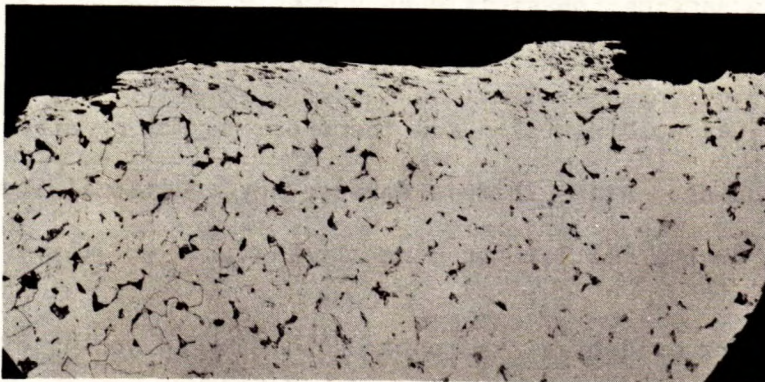
Figure 2. Cold Work on Surface of Thread

A microscopic examination of threads adjacent to the origin of the fracture revealed areas of cold worked metal up to 0.002 in. thick on thread surfaces, (Figures 2 and 3). These areas were not continuous, apparently as a result of corrosion and scaling. The depth of scaling, or corrosion attack, in many areas appeared limited to the depth of the worked metal. However, the corrosion appeared to be general with no severe pitting.

The microstructure was typical of a normalized steel or a hot rolled steel which had been finished at a low temperature. It appeared likely that some of the cold work occurred during threading and some due to heavy torquing during installation of the bolts.

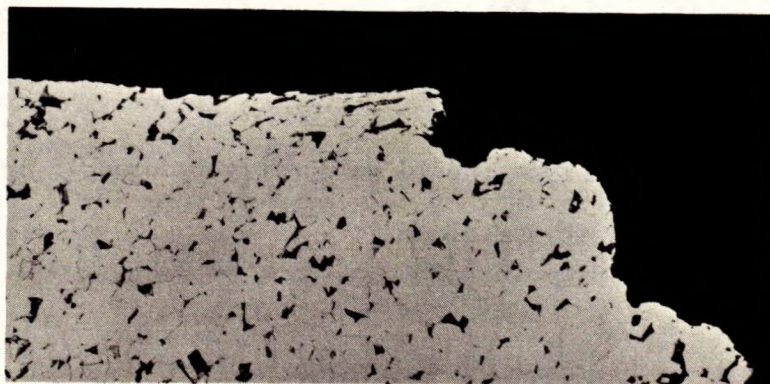
Figure 3. Cold Work on the Same Thread as in Figure 2 but Located at the Origin of the Fracture.

A cold worked area was observed at the root of the thread at the location where the fracture originated.
