MINES BRANCH INVESTIGATION REPORT IR 61-118

**EXAMINATION OF TWO PIECES OF A SPLIT
PILE FROM THE FERRY TERMINAL WHARF
AT CARIBOU, NOVA SCOTIA**

EXAMINATION OF TWO PIECES OF A SPLIT PILE
FROM THE FERRY TERMINAL WHARF AT
CARIBOU, NOVA SCOTIA

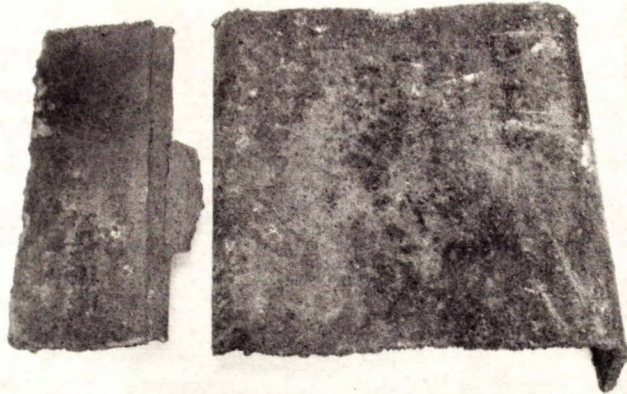
Visual examination showed that the pile had failed at the radius of the flange and web junction, tearing in a longitudinal direction (Figure 1). Although both surfaces of the fracture were severely corroded, it was quite evident that a fibrous type of fracture had occurred.

Figure 1. Samples as-received.
1/5 actual size.

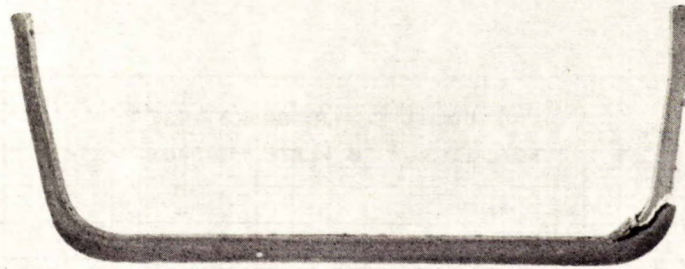
Transverse slices were etched in 1:1 HCl and water at 160° to 170°F (70°C to 75°C) for ten minutes. The samples were uniformly etched and showed no indication of segregation (Figure 2).

Figure 2. Etched in 1:1 HCl and water for
ten minutes.

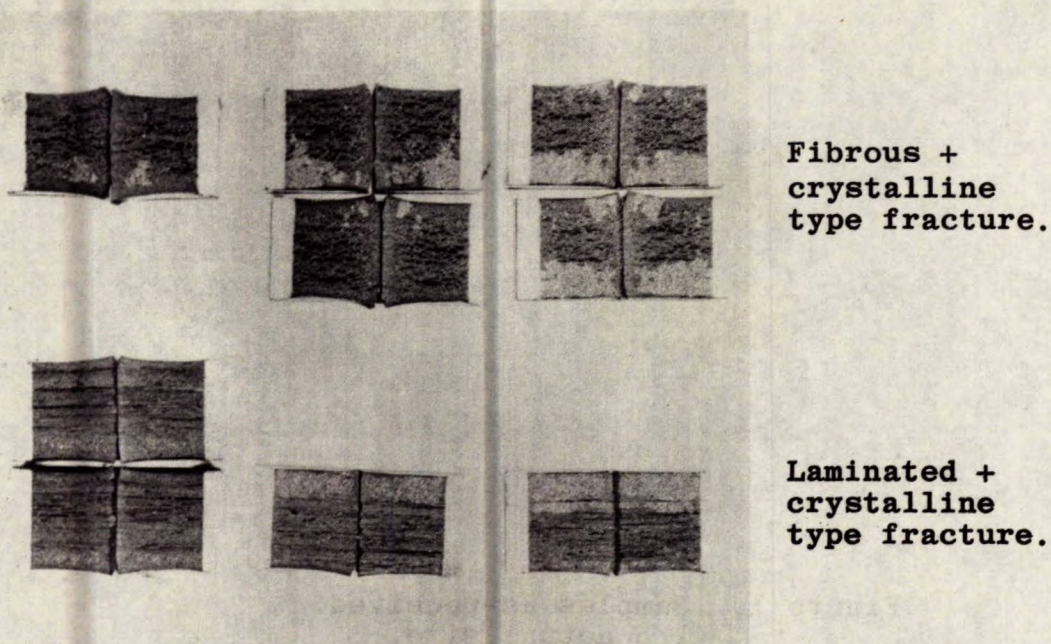
temperatures -18, 0, 20, 30, 65 and 100°C (0, 32, 72, 100, 150 and 212°F), three bars being tested at each temperature. The results of these tests were scattered. However, the samples could be separated into two groups by the appearance of the fractures, fibrous plus crystalline or laminated plus crystalline (Figure 4). The results were grouped according to the fracture appearance of the bars and a graph was prepared showing the difference in impact values at each testing temperature (Figure 5). Table 3 gives the results of the impact tests and the 15 ft-lb transition temperatures taken from the graph in Figure 5.

Figure 4. Impact test specimens grouped as to type of fracture.

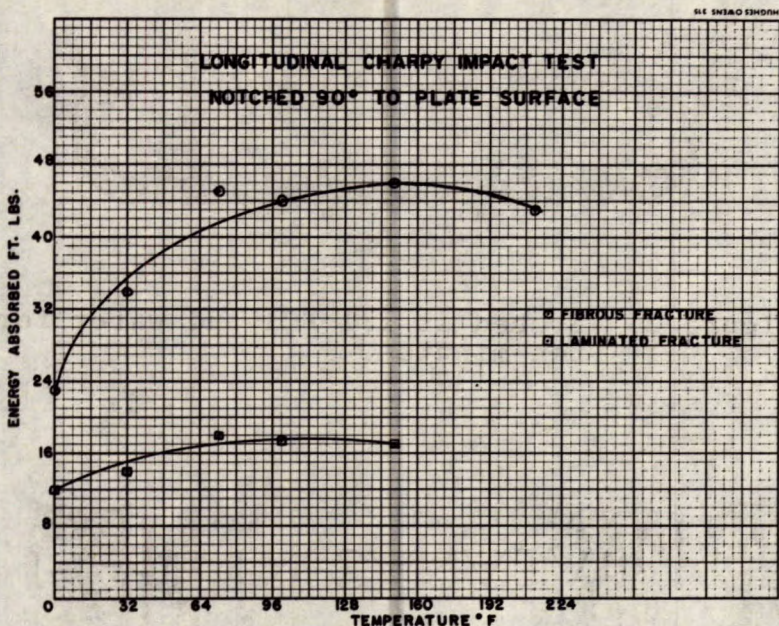
Figure 5. Impact test results grouped as to fracture appearance.

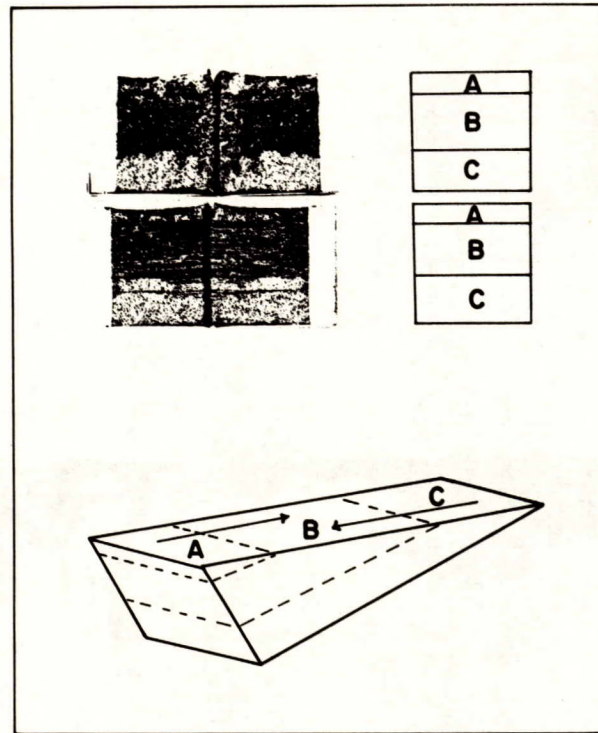
To determine if chemical segregation could account for the variation in impact results and fracture appearance, a half section of two Charpy impact bars was selected to represent fibrous and laminated type of fractures. These samples were diagonally sectioned and prepared for a spectrographic traverse. The samples were divided into 3 zones, A-fibrous and crystalline or laminated and crystalline, B-fibrous or laminated, C-crystalline. Two traverses were made on each sample from A to B and from C to B, starting at about 1 mm from each end and overlapping in the centre (Figure 6). The spectra were analyzed for nickel, chromium, aluminum, copper, silicon and manganese.

Aluminum was present in only very small amounts (trace) at ends A and C. There was a marked increase in the region B. The fall-off of the intensities of the

aluminum lines corresponded with the boundaries of the fracture regions marked on the specimens.

Figure 6. Zones of Spectrographic Traverse Samples.

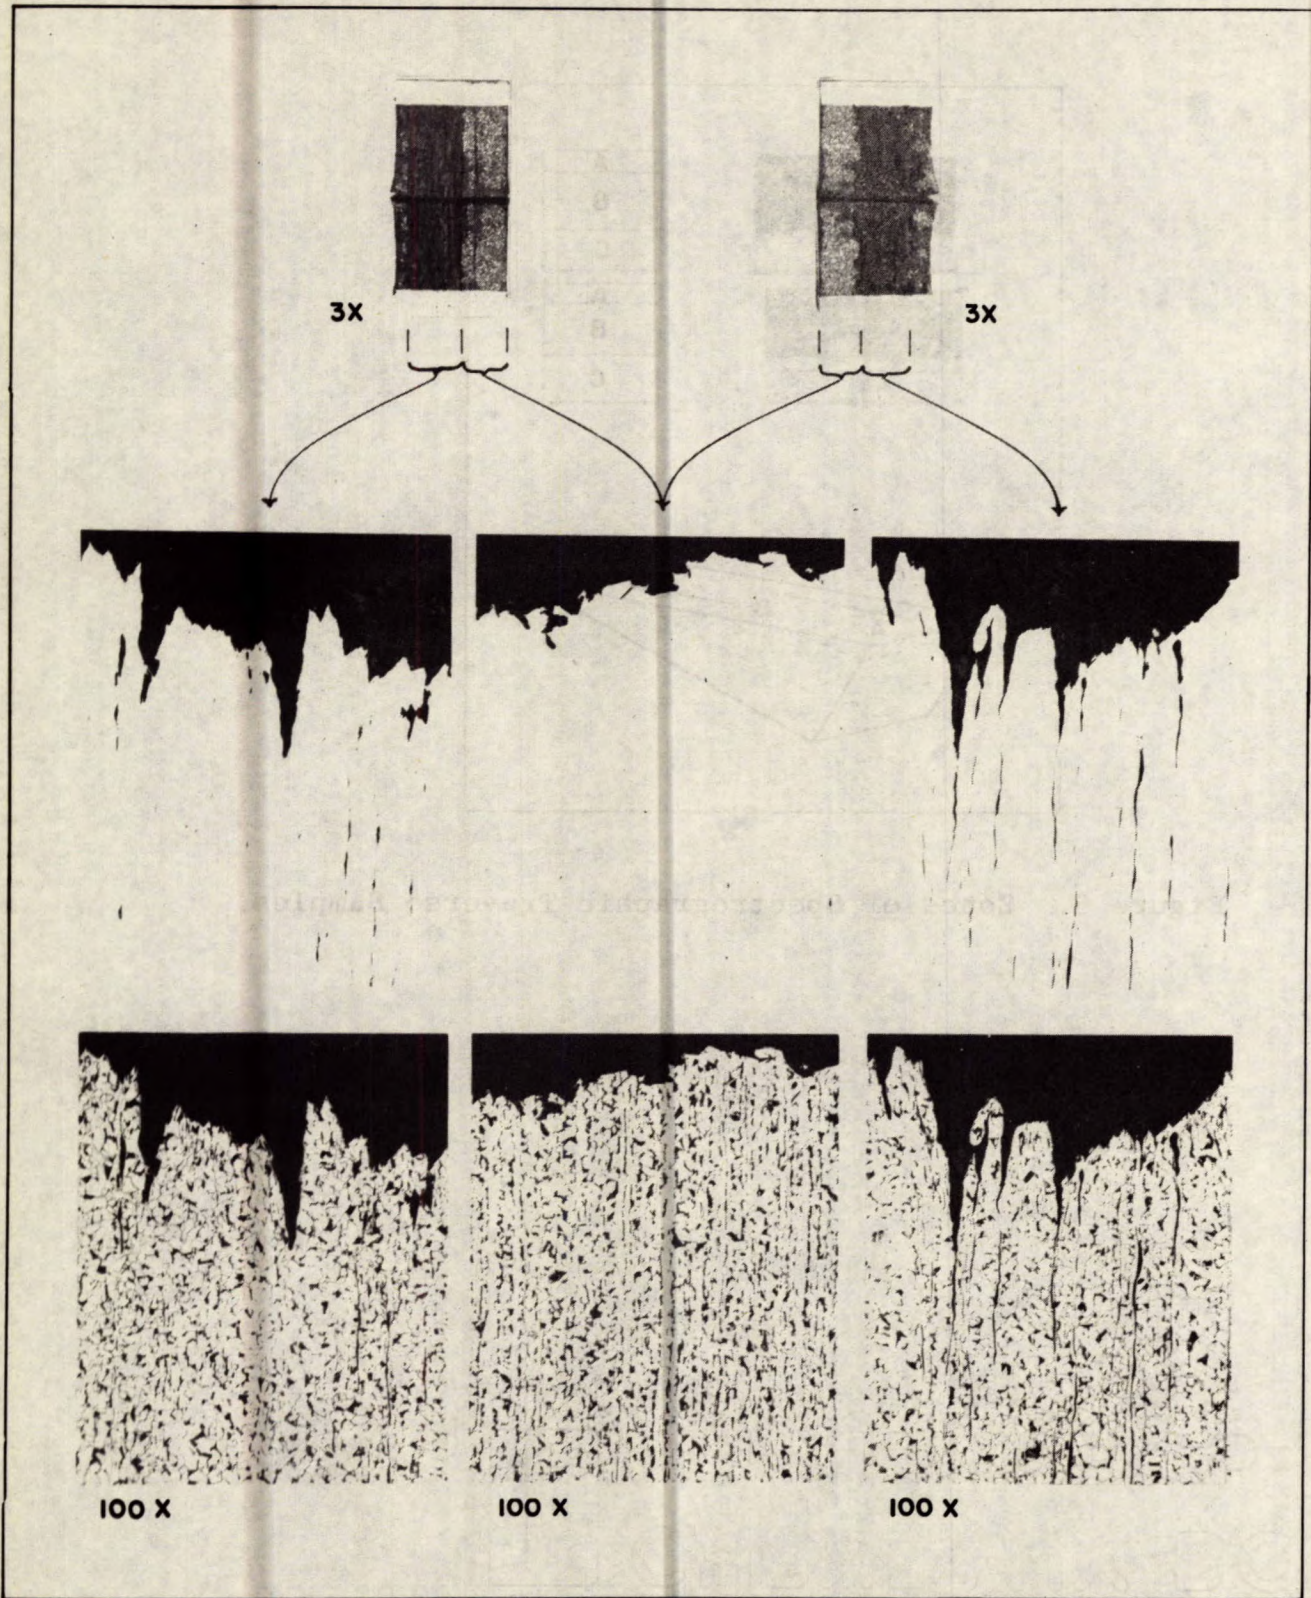
The opposite halves of the Charpy impact bars used for spectrographic traverse, were prepared for micro-examination of the fractured surface. In the as-polished condition both samples were dirty, the concentration of inclusions being heaviest in the areas of fibrous and laminated type fracture, and could account for a large part

of the chemical segregation. Etched in nital the samples revealed a normal ferrite-pearlite structure, with a uniform grain size in all areas. The only difference noted between the two samples was in the size and distribution of inclusions, the sample showing a fibrous type of fracture having the largest and heaviest concentration. Figure 7 shows the distribution of inclusions and the micro-structure found in the various regions.

Figure 7. Distribution of inclusions and micro-structure at the various regions of impact specimens. 1/2X actual size.
