MINES BRANCH INVESTIGATION REPORT IR 61-132

EXAMINATION OF CARBIDE-TIPPED BURS

Mines Branch Investigation Report IR 61-132

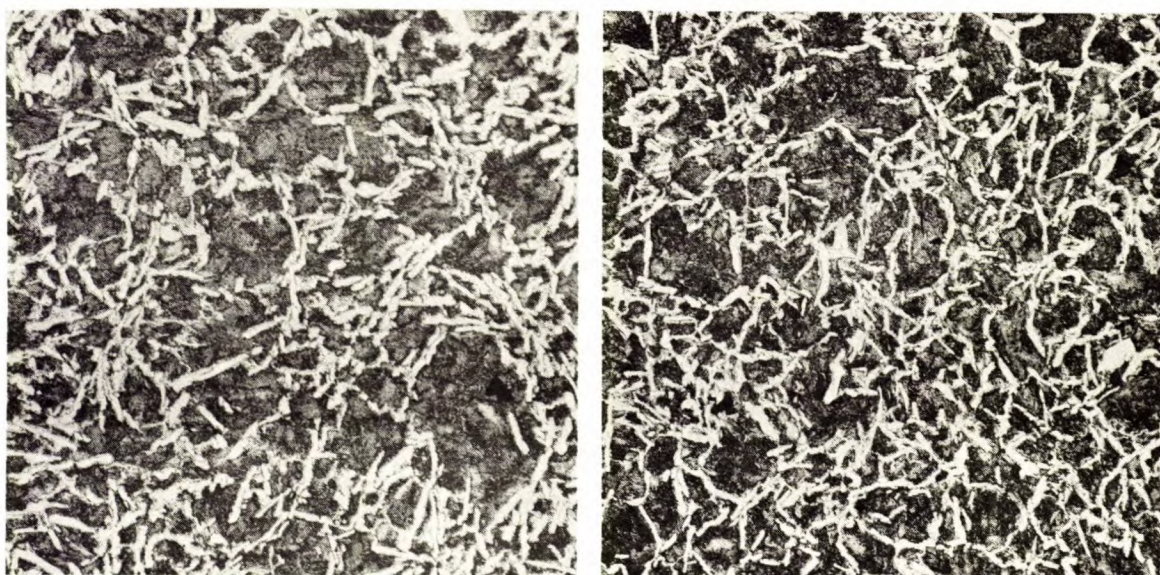
Figure 4. Transverse Section through Wire from Heat 59 after Grain-Coarsening at 2000°F and Carburizing for 2 hr (59-C-2000)

Transverse Section through Wire from Heat 60 after Grain-Coarsening at 2000°F and Carburizing for 2 hr (60-C-2000)

No significant difference was observed between heats 59 and 60 with respect to the initial spheroidized microstructure or to grain-coarsening tendency at 2000°F. For the particular sample examined, heat 60 appeared to be slightly dirtier than heat 59, but this difference was not believed to be significant.

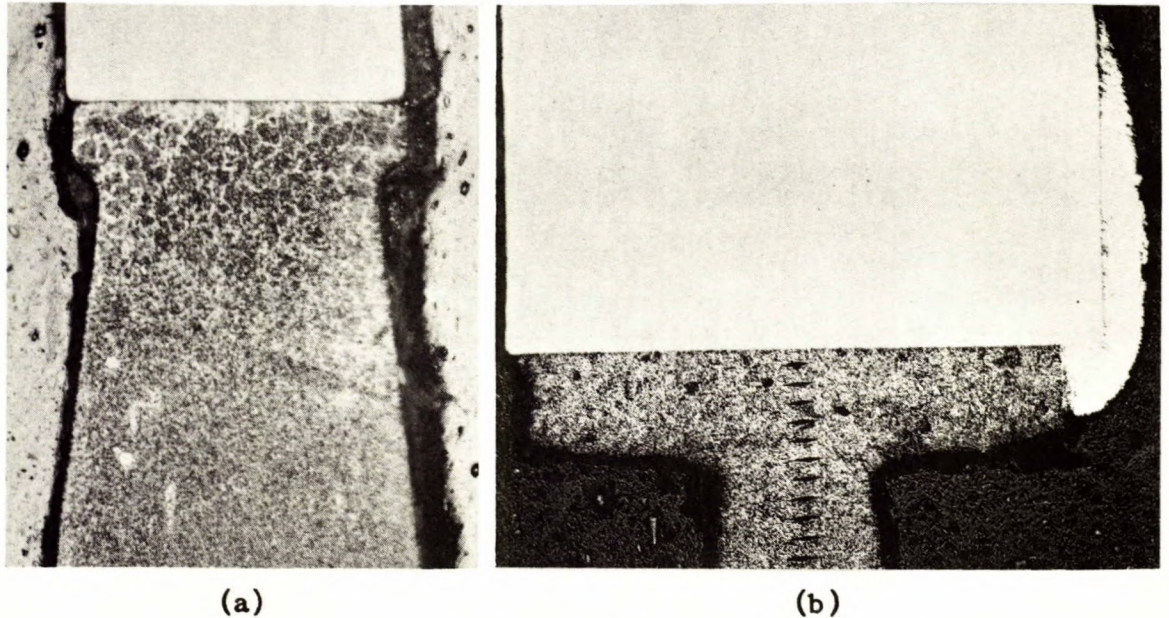
Examination of reject burs showed that welding temperatures were frequently so high that the steel in the neck and pedestal region was burned and grain boundaries were oxidized. At times, traces of metal which had been liquid at welding temperature were observed at the bottom and side surfaces of the carbide. Most of this metal was

removed by the finish-grinding operation and its presence may only be significant where the zone of liquid metal extends beneath the carbide, causing a poor bond and brittle condition at the metal-carbide interface.

The appearance of an as-welded bur exhibiting grain coarsening (incipient or actual burning) and of another bur where liquid metal has been present at the interface between the carbide and the steel are illustrated in Figure 5(a) and 5(b), respectively.

Figure 5. As-Welded Bur Showing Grain-Coarsening (Incipient Burning) at the Carbide Metal Interface. (W-T-400)

As-Welded Bur Showing the Presence of Metal which was Liquified at the Interface and Side Surface During Welding. (W-T-400)

It has been mentioned that the welding temperature is selected from the range 2200 to 2600°F. Overheating and burning is liable to occur with temperatures in the range 2500 to 2750°F, and it is apparent from the metallurgical evidence that these phenomena do occur. If the present system must be adhered to, an attempt should be made to control welding temperatures within the range 1900° to 2200°F, with the latter as a top limit, to avoid the possibility of serious defects appearing.

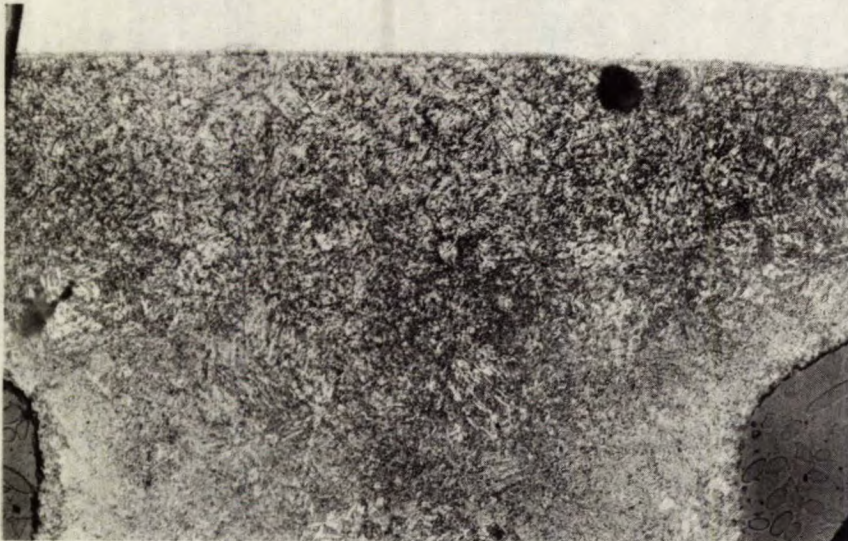
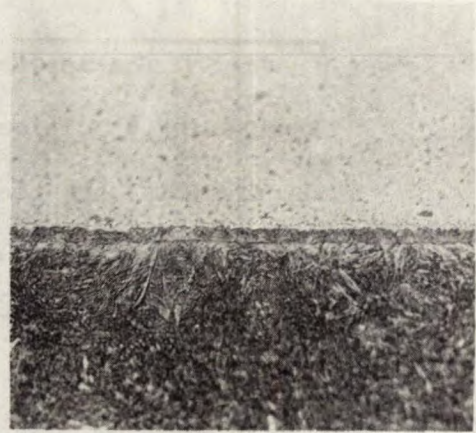
The appearance of an unburned bur in the as-welded condition is shown in Figure 6(a) with a portion of the weld zone illustrated at higher magnification in Figure 6(b).

Figure 6. Unburned, Welded Bur. Unburned weld zone consisting of martensite and transformation product. (W-T-400)

Weld Interface. The serrated interface of the weld zone and the presence of at least two compound layers between the carbide and the steel is visible. (W-T-400)

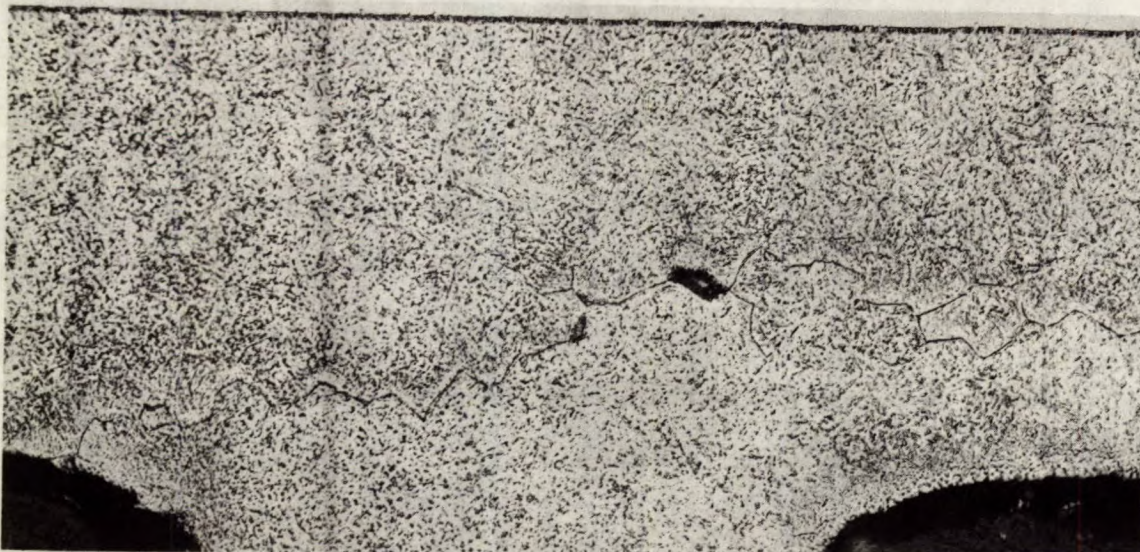
Another serious condition was observed when burning and formation of grain boundary oxides occurred, whereby oxidized intergranular cracks were left which extended inwards from the surface. The presence of a crack in a finished bur would have a serious notch effect and could cause brittle failure under relatively small loads. These cracks would be difficult to detect prior to service.

The appearance of an intergranular crack that was oxidized and open to the surface is illustrated in Figure 7.

Figure 7. Intergranular Surface Crack in Burned Bur.

This type of crack was probably caused by excessive welding temperature under oxidizing conditions and presents a dangerous notch that is difficult to detect during final inspection (W-T-400).

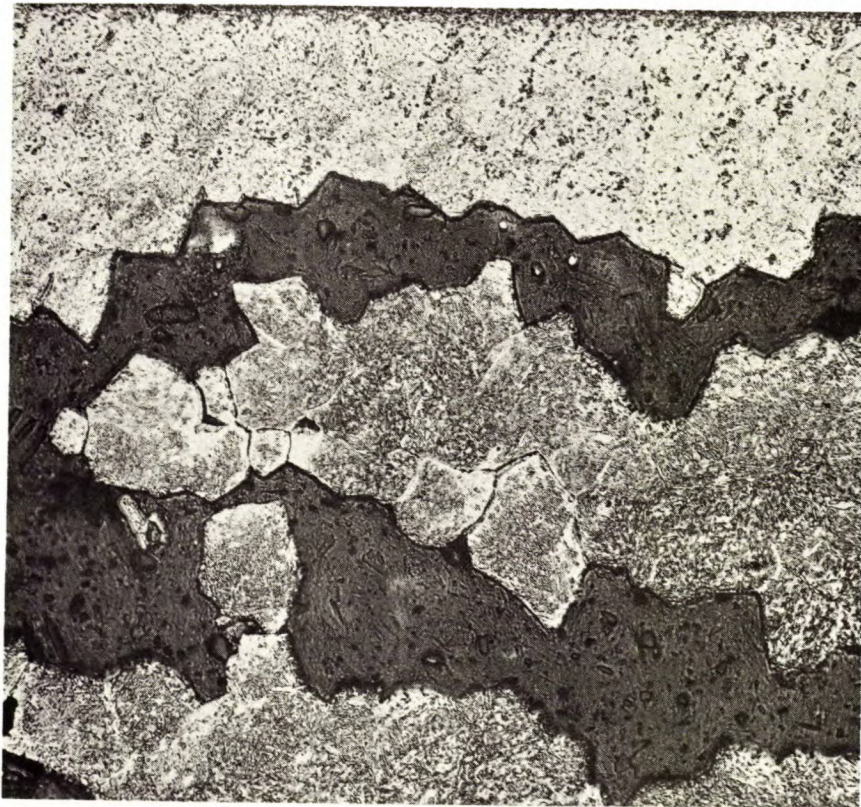
The intergranular separation present at the fractures of copper-plated burs after welding is illustrated in Figure 8. A low melting point, copper-rich, constituent is believed to be present in the grain boundaries. This constituent would have the effect of lowering the burning temperature of the steel and would constitute an extra hazard during the welding operation.

Figure 8. Intergranular Crack Present in Copper-Plated Bur after Welding. (W-Cu-OT 400).

The fracture resembles a "creep" failure with intergranular separation along oxidized grain boundaries.

The presence of copper plating on welded burs is believed to increase the likelihood of defects by lowering the burning temperature of the grain boundaries.

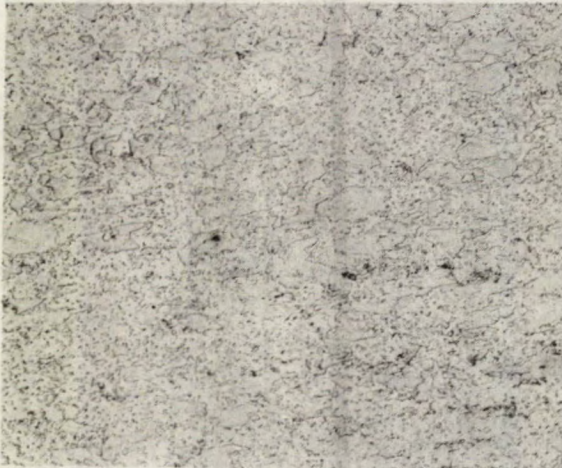
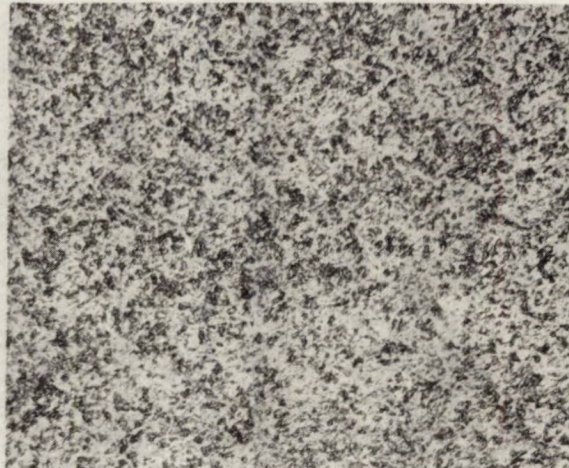
Figure 9. Transverse Section through the Shank of Sample W-1500-500. The microstructure consists of martensite, ferrite and undissolved carbide.

Transverse Section through Shank of Sample W-1700-515. The microstructure consists of martensite bainite and considerably less undissolved carbide than was observed in Figure 9(a)

A salt bath was used for the 1500° and 1700°F austenitizing treatments, and some decarburization may have been caused by this bath. The salt should be rectified and maintained in a non-oxidizing condition by insertion of a graphite electrode in accordance with recommendations made by the Salt Supplier.

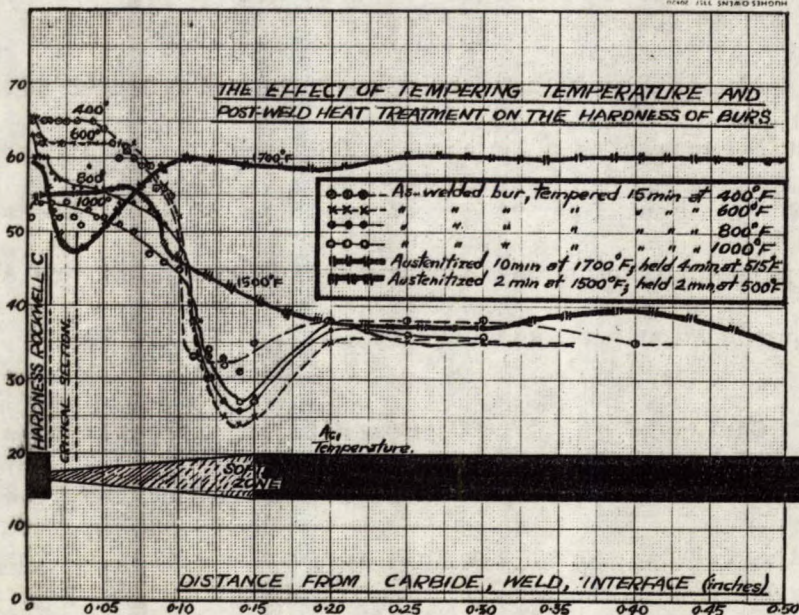
Tempering was successful in reducing this hardness so that the as-welded hardness, R_c 62 to 65, was reduced to R_c 48 in the pedestal region after tempering 15 min at 1000°F.

The hardness gradients obtained by tempering as-welded burs for 15 min at 400°F, 600°F, 800°F or 1000°F are shown in Figure 10. The hardness of the as-welded burs, prior to tempering, varied between R_C 54 and R_C 65 in regions adjacent to the weld and in the narrow, neck section of the burs. The hardness present after welding and the results of the tempering tests suggest that a tempering temperature in excess of 1000°F would be necessary (after welding) in the absence of other post-weld heat treatments.

The four tempering curves show that, during welding, the A_{C1} temperature (approximately 1330°F) is reached about 0.10 in. from the weld interface. At this point the hardness drops rapidly and between 0.10 and 0.20 in. the minimum hardness is obtained coinciding with the thick end of the tapered portion. The hardness values between the 0.20 in. and 0.60 in. positions represent the hardness of the as-received wire.

Figure 10. Hardness Gradient of Burs Tempered at 400°F, 600°F, 800°F or 1000°F and of Burs that Received 1500°F or 1700°F Post-Weld Austenitizing and Marquenching Heat Treatments.

These tests indicated that use of a tempering temperature up to 1200°F is probably possible without hazard of soft shafts, and that, by this means, the brittle region adjacent to the weld can be stress-relieved and toughened if burning does not occur during welding. (Deflection tests would be required to prove this).
