MINES BRANCH INVESTIGATION REPORT IR 61-149
REVISED FROM IR 61-58

INVESTIGATION OF PIPELINE FAILURE

K. WINTERTON

PHYSICAL METALLURGY DIVISION

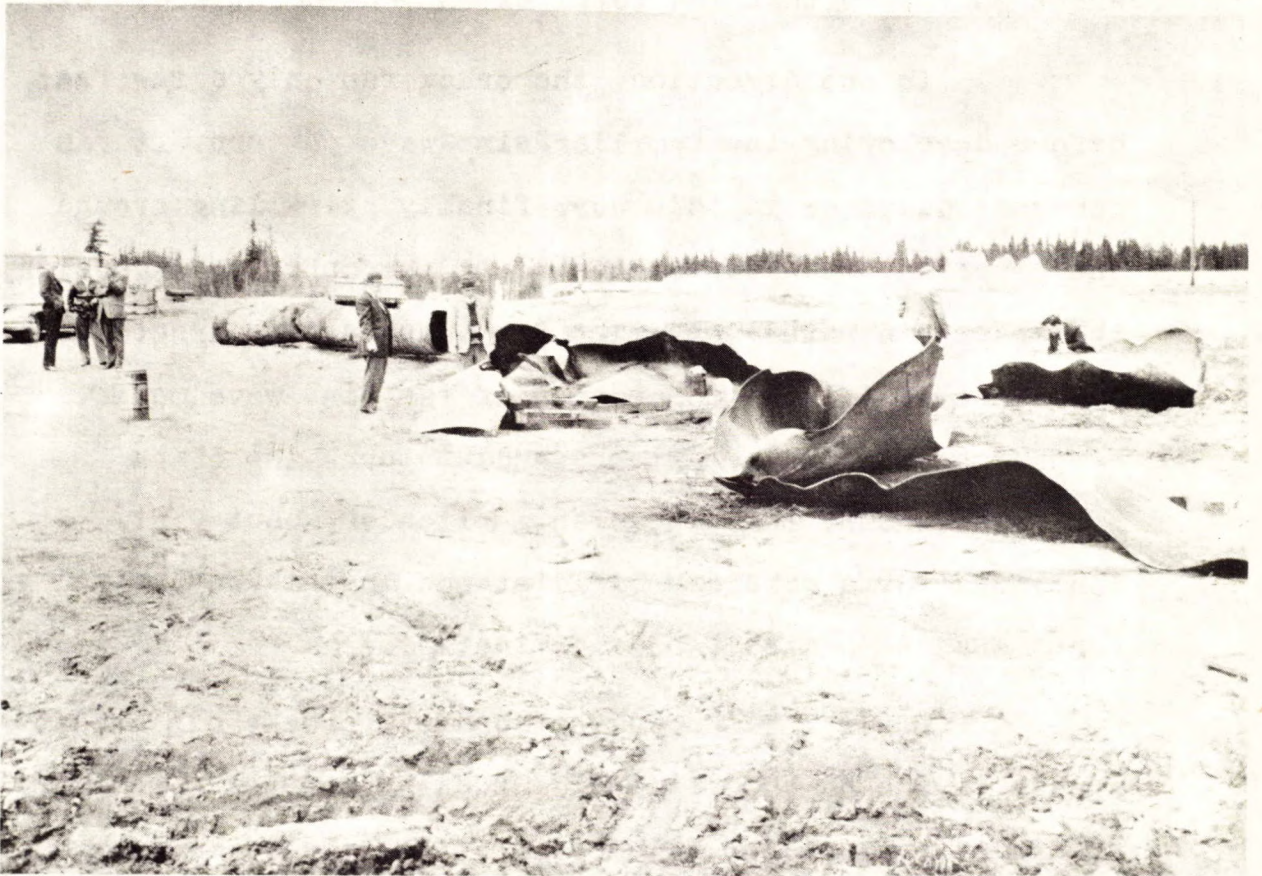
Figure 1 - General view of damaged pipe

It was not difficult to perceive the main course of the fracture. The break had evidently originated close to a circular patch plate of 1/2 in. thickness which had been welded over the leaking location to effect a repair. The crack* had spread in both directions to a distance of about 30 ft, so that the total extent was about 60-70 ft.

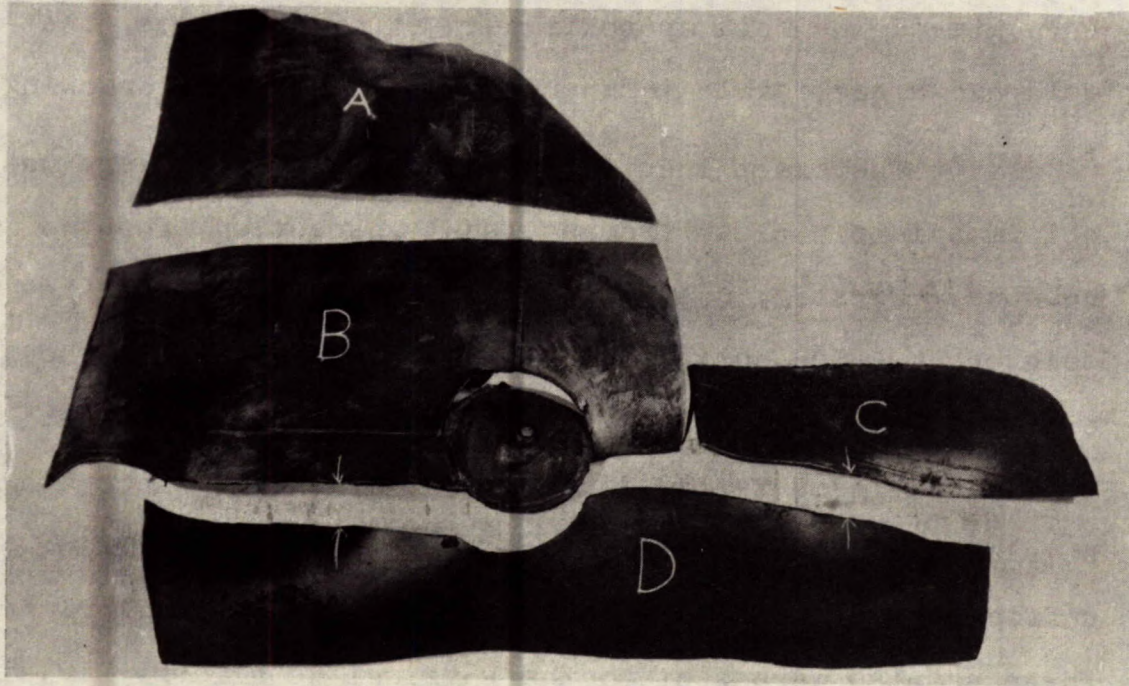
Figure 2 - Samples of pipe near the fracture origin.

The approximately straight border between samples B and C on the one hand and D on the other shows the main path of fracture. On the left-hand side, may be seen the beginning of the development of the sine-wave mode of fracture.

A subsidiary crack apparently had started from a point about 12 in. to the right of the patch, thus providing a natural separation between Samples B and C. This crack is represented further by the right-hand edge of Sample B and the top edge of Sample A. It was roughly semi-circular in form and intersected the main crack at a point, not shown in the photograph, about 12 ft to the left of the patch. It is the combination of the subsidiary crack and part of the main crack that provided the outline of the half-disc that was blown clear of the fire area.

At the two positions marked by the small arrows, the fracture showed chevron markings typical of brittle fracture in which cleavage is predominant. At these positions, it is known that the main fracture was proceeding in opposite directions away from the patch. The origin may be sought between these two points. No unusual damage or defects could be seen in this region except at the patch itself, and it was concluded that the fracture originated at some point on the periphery of the patch.

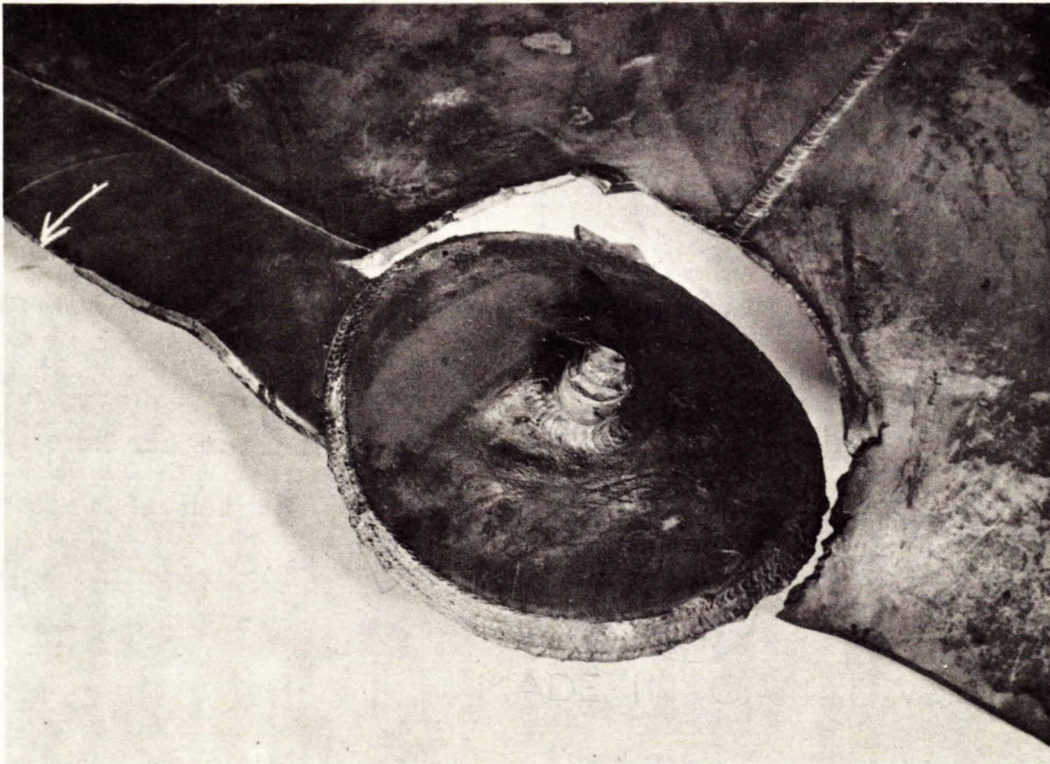
Figure 3 - Circular patch used for pipeline repair.

patch has retained its original curvature, in contrast to the flattened pipe metal surrounding it. This emphasizes in a graphic way the stress field that is introduced at the periphery of such a patch. The appearance of the fillet weld around the patch was consistent with the reported "cold" welding technique, that is the stringer beads had a convex contour. In other respects, the fillet weld appeared externally to be of reasonable quality.

On the assumption that the main crack initiated on the periphery of the patch, it is clear that the fracture is forked, a minor branch following up and around the circumference of the patch, almost completely separating it from the original pipe metal. This illustrates the fact that the fracture has occurred at tremendous speeds, so that the patch was almost completely removed before there was time for relief of the stresses by escape of gas. It is also worth noting that at several points there is a tendency for the fracture to deviate tangentially from the circular path, but was held to its course by the stress field introduced by the patch.

Referring to Figure 3, the flat cleavage surfaces noted above appear first at a point roughly vertically below the patch centre, and become larger as the fracture is followed in an anti-clockwise direction.

The use of a welded circular patch to repair a leak in a pipeline must be condemned. This system provides severe stress concentration not only for the longitudinal

stress but also for the hoop stress. The use of a patch (1/2 in. thick) of thickness greater than that of the pipe wall (3/8 in. thick) would increase the stress-raising effect. Even if no welding cracks had been present, the presence of the patch alone might well have been sufficient to originate a catastrophic failure. If the fillet welds around the patch had been ground to a smooth contour, the stress-raising effect would have been reduced, though not necessarily to a safe value.

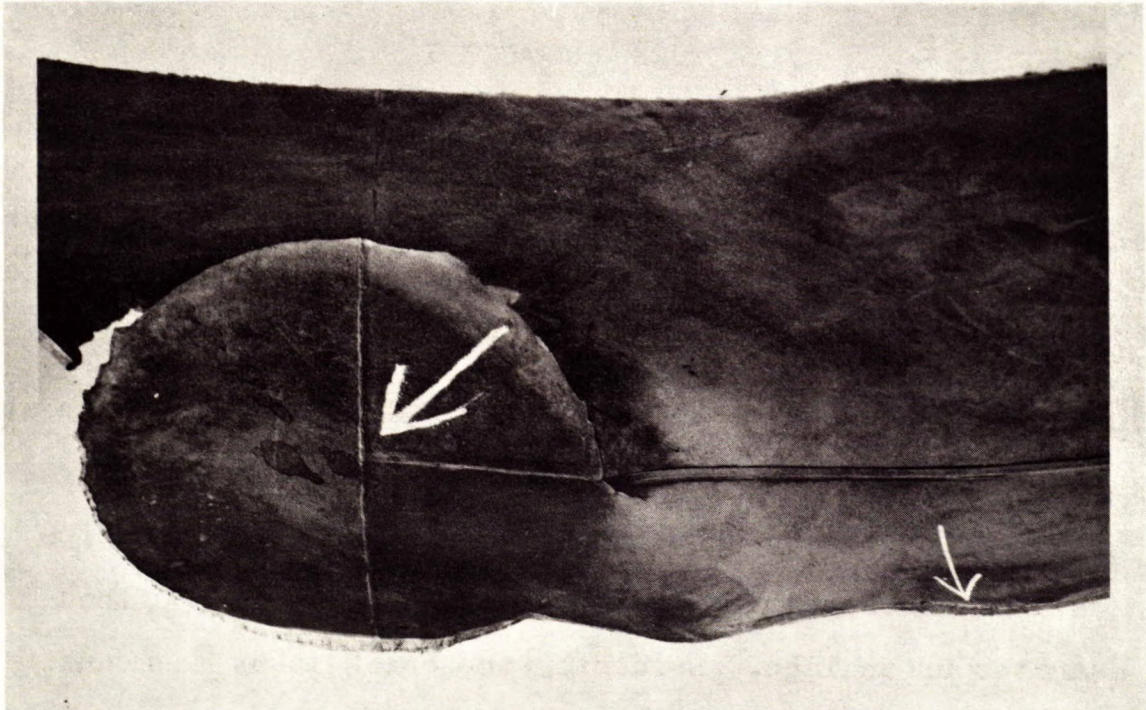
Figure 4 - Interior surface of pipe underneath patch showing location of original leak (large arrow).

patch was applied to repair a leak occurring at the junction of a longitudinal seam and a girth weld. Close inspection showed a short crack or line of separation in the longitudinal seam close to the girth weld, with an apparent extent of about $3/4$ in. This was later examined by magnetic-powder and microscopical methods.

Some attention was also given to the fault in the longitudinal seam which had been responsible for the original leak (See Figure 4 - large arrow). A section was cut through the seam weld at a point about $3/4$ in. from the edge of the girth weld. However, this fell into two parts and the seam weld had evidently failed to join at this point. Successive transverse specimens were taken

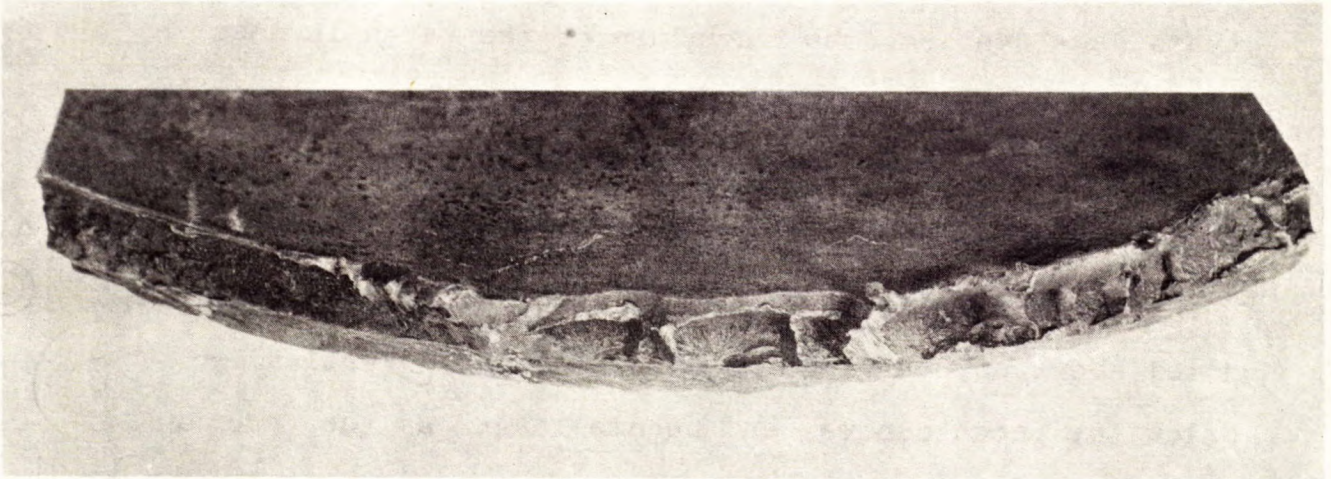
Figure 5 - Large cavities in fracture around circular patch.

The bases of the cavities were flat cleavage surfaces and showed no distortion, in contradistinction to the shear areas of the main fracture surrounding them. This phenomenon is believed to be due to the presence of pre-existing, heat-affected zone cracks from which small cleavages occurred to form the bases of the cavities. Figure 6 shows an adjacent sector of the fracture around the patch.

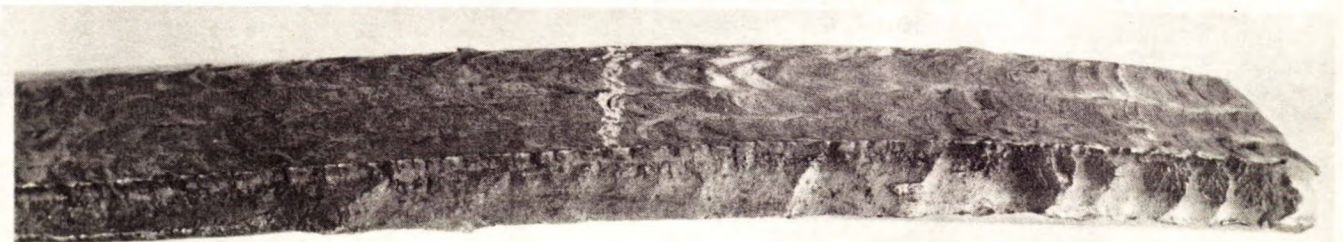
Figure 6 - Small cavities and other markings in fracture around circular patch.

Because of the depth of focus and the use of the side elevation, the curvature of the patch is lost in this photograph. The cavities become smaller and finally disappear. However, at the top edge, adjacent to the weld, smaller disturbances are present.

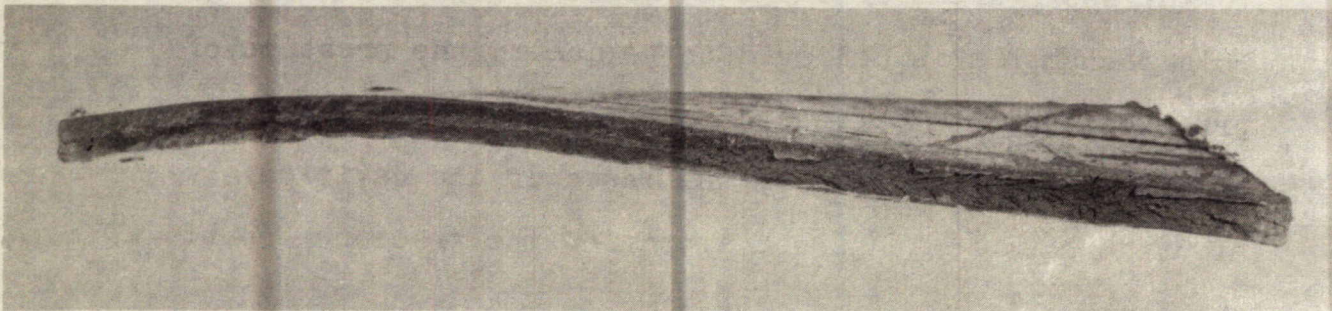
Figure 7 - Cleavage area with chevrons and tapering cleavage area.

The region of the fracture shown in Figure 7 includes the location marked with an arrow to the right of the patch in Figure 2. The cleavage area tapers down to a narrow band on the left-hand side of Figure 7. This

is no doubt associated with the presence of a high-carbon band at this location, as noted later on.

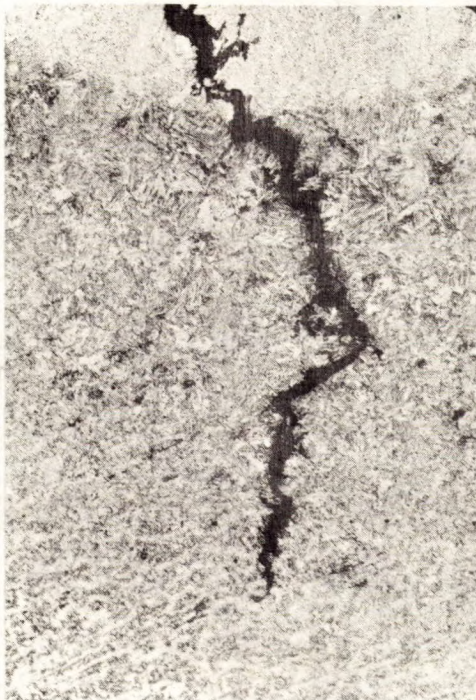
Figure 8 - Extremities of brittle crack in relatively sound section of fillet weld around patch.

These represent extensions of the main fracture, and were present only in the outer layers of the pipe wall close to the toe of the fillet weld. In Figure 8, the crack runs through weld metal (top), heat-affected zone (centre) into unaffected pipe metal (bottom). At other locations, the nature of the crack was characterized by distortion in the ferrite-pearlite structure of the unaffected pipe metal.

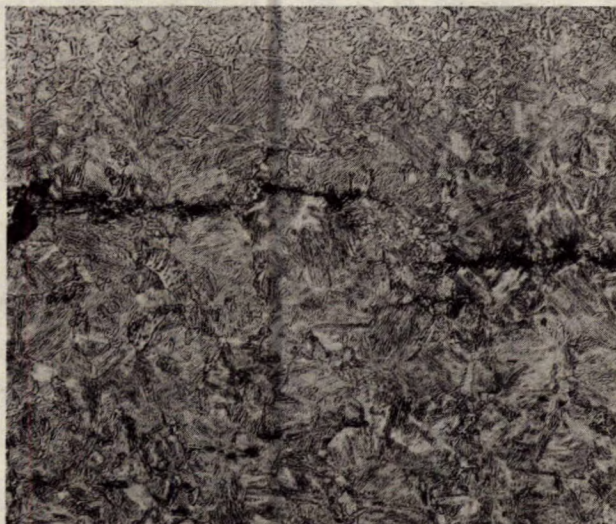
Figure 9 - Heat-affected zone parallel to the weld junction of the fillet weld around the patch.

These two illustrations (Figures 9 and 10) were taken from the central region of the undisturbed weld of the patch, as remote as possible from the main fracture. These cracks were rather fine, typical of heat-affected zone cracking, and quite distinct from the various brittle cracks associated with the main fracture (Compare for example Figure 8).

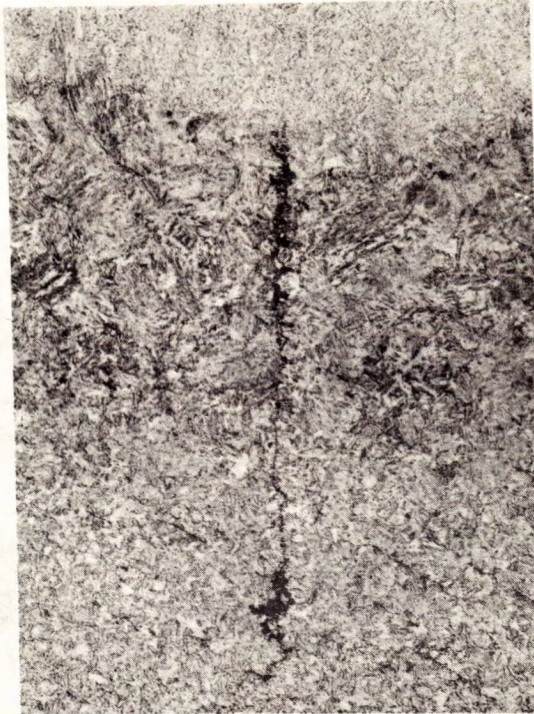
Figure 10 - Heat-affected zone cracking perpendicular to the weld junction of the fillet weld around the patch.
Etched nital (2%) Mag. X100

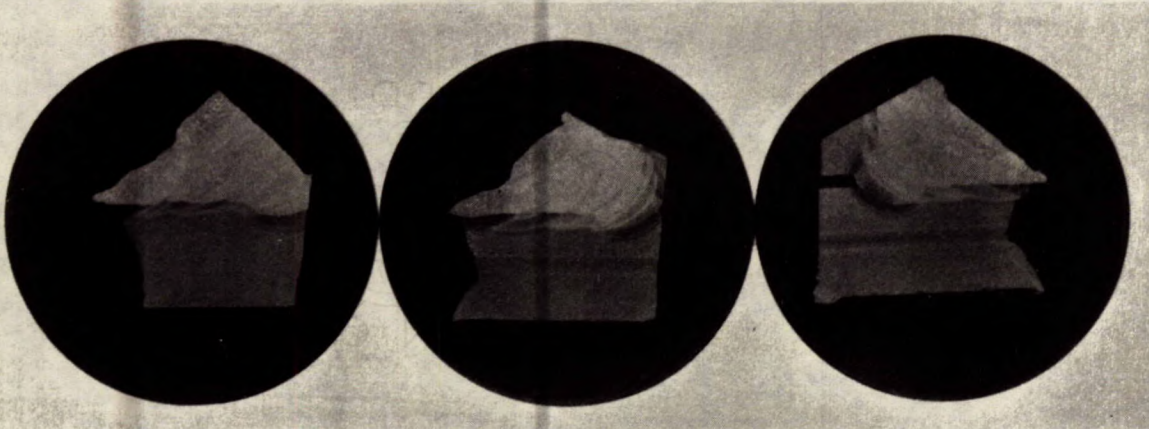
Figure 11 - Cross-sections through the fillet weld around the patch.

In all cases, the fracture lies just underneath the toe of the weld, and there is a suggestion from the changes in direction of the fracture of pre-existent horizontal and vertical cracking. The specimens in the centre and on the right were taken through fracture cavities such as those shown in Figures 5 and 6, and it seems most likely that the bases of these cavities are small cleavages separately initiated from pre-existent cracks. In the same specimens (Pipe II) may be seen a dark band about $\frac{1}{32}$ in. in thickness at the centre of the wall. By microscopical examination, this was found to be a high-carbon band. The specimen on the left (Pipe I) in Figure 11 does not show this feature.

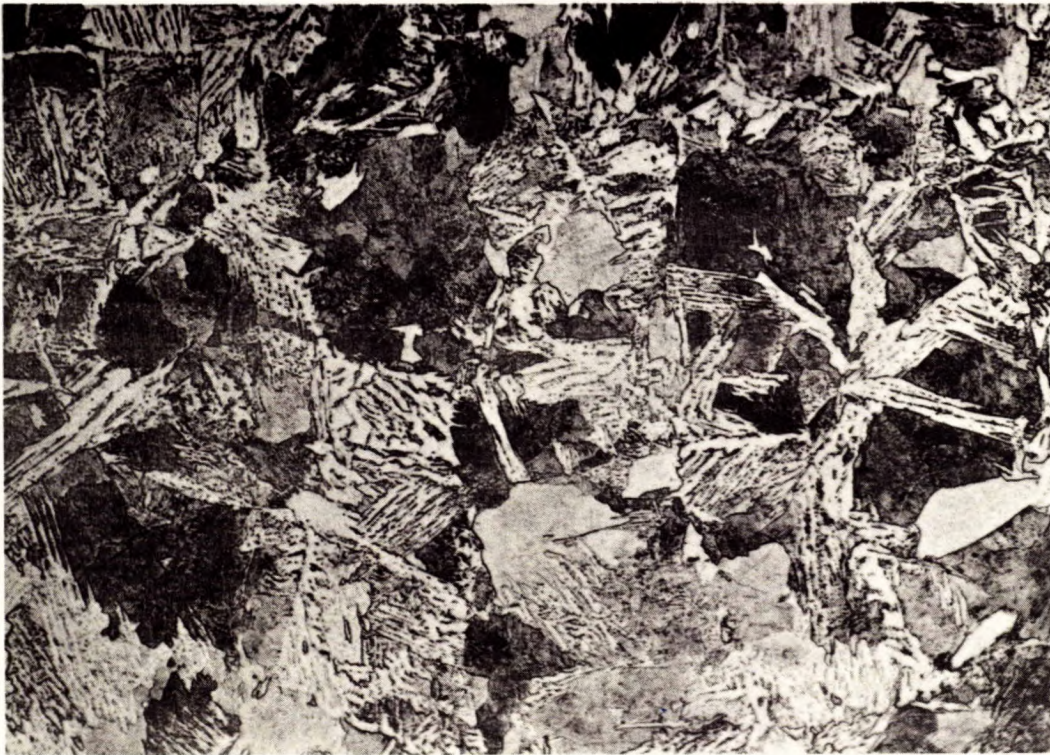
Figure 12 - Structure of typical untempered heat-affected zone adjacent to a girth weld.

Cracking would not be expected with this type of structure (Figure 12). However, the presence of the high-carbon band, previously noted in Figure 11, was associated with an anomalous structure as shown in Figure 13.

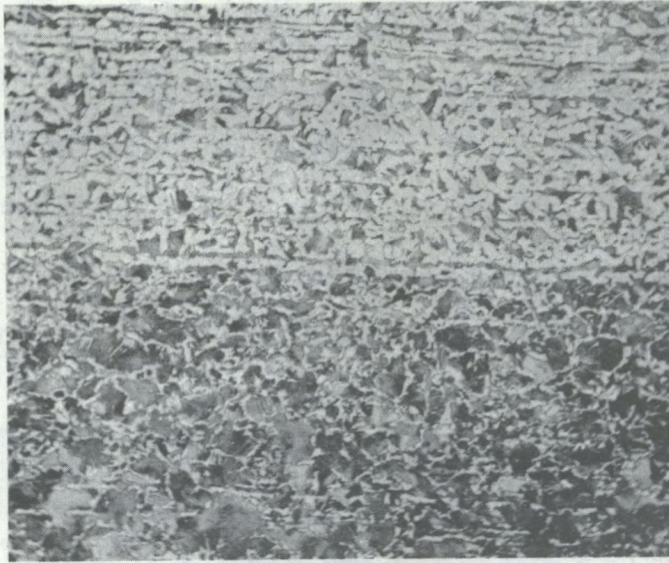
Figure 13 - Normal structure and high-carbon structure in Pipe II.

The normal low-carbon, ferrite-and-pearlite structure is at the top in Figure 13, and may be compared with the almost-entirely pearlitic structure of the high-carbon band at the bottom of the photograph. Some minor cracking occurred in the high-carbon band adjacent to the girth weld, as shown at high magnification in Figure 14.

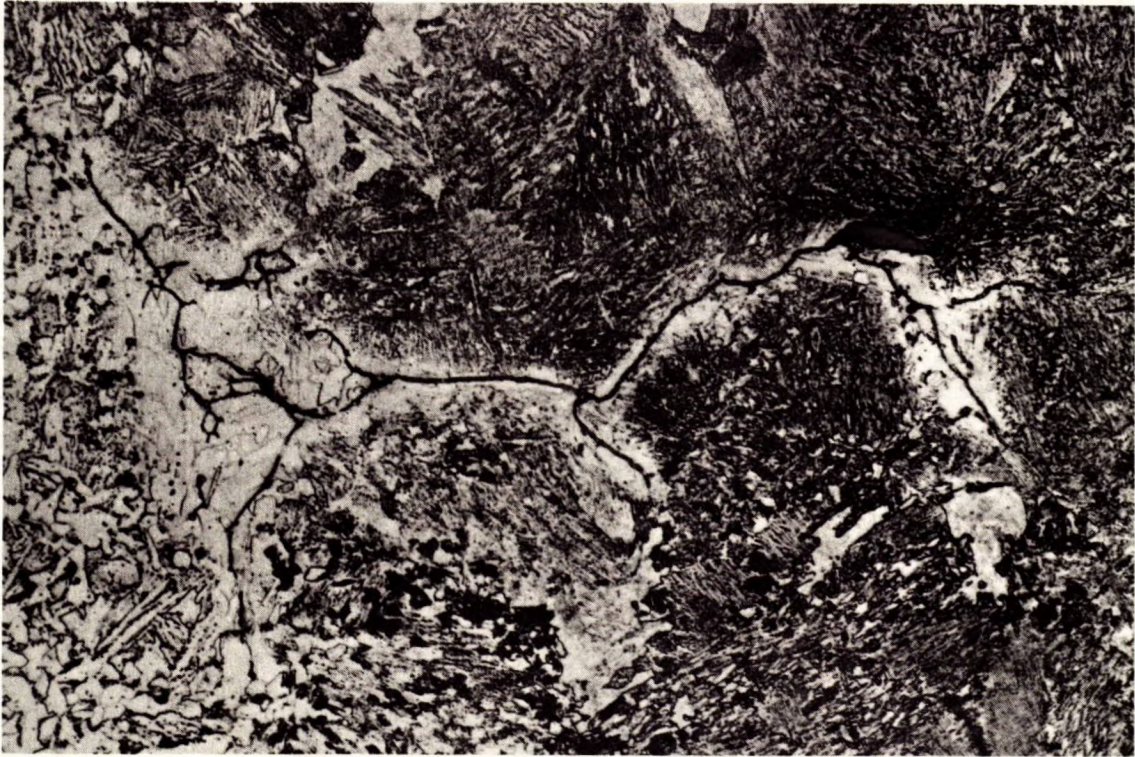
Figure 14 - Fine cracking in high-carbon band adjacent to girth weld.

As might be expected, a martensitic structure was produced in the high-carbon band by the weld thermal cycle in the heat-affected zone.

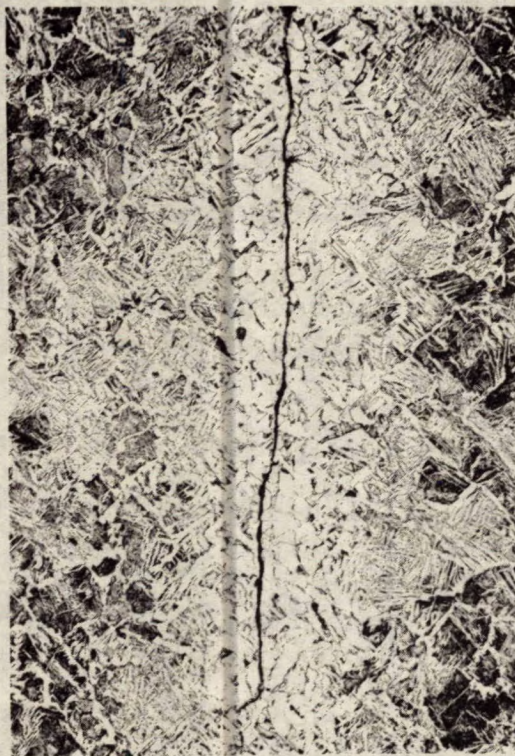
Figure 15 - Mid-section of longitudinal seam at a point near the end of the pipe.

It may be seen that some decarburization had occurred at the butting surfaces. Cracking has presumably extended from a lack of join in the seam-weld.
