DEPARTMENT OF MINES AND TECHNICAL SURVEYS

**MINES BRANCH INVESTIGATION REPORT IR 61-150
REVISED FROM IR 61-85**

**AN INVESTIGATION INTO THE CAUSE OF FAILURE
OF A SECTION OF A GAS TRANSMISSION PIPE LINE**

AN INVESTIGATION INTO THE CAUSE OF FAILURE
OF A SECTION OF A GAS TRANSMISSION PIPE LINE

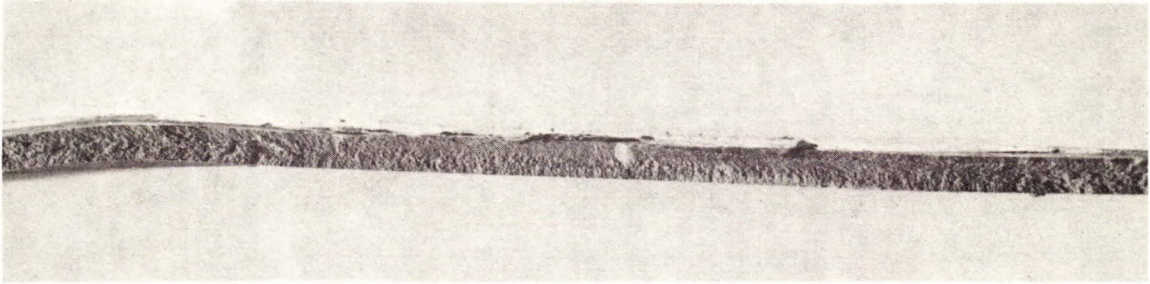
The fractured surface of the pipe at the point of origin is shown in Figure 1 and clearly shows two sets of chevron patterns pointing in opposite directions. No defects were visible to the naked eye on the inside or outside surface of the pipe.

Figure 1. Chevron pattern pointing to origin of failure.

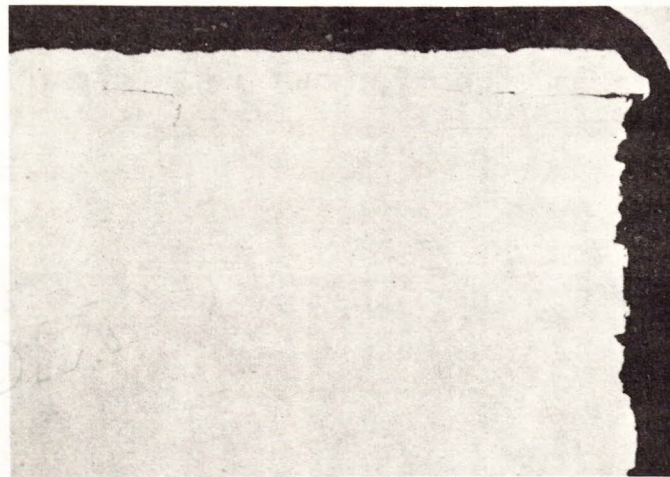
A transverse section was taken across the fractured surface at the origin of failure. In the unetched condition, the steel was not excessively dirty but did possess several large inclusions near the outside surface. Figure 2 shows two large inclusions near the outer surface, one starting at the fractured surface, the other starting further from the fracture and having a crack propagating from one end. Figure 3 shows the inclusions and cracks at higher magnification. Examination of the specimen in the etched condition shows tempered martensite at the outer surface, the structure gradually changing to a mixed structure of tempered martensite and transformation product, the amount of tempered martensite decreasing towards the inside surface (Figures 4 and 5). A hardness survey across the

Figure 2. Crack propagating from end of large inclusion.

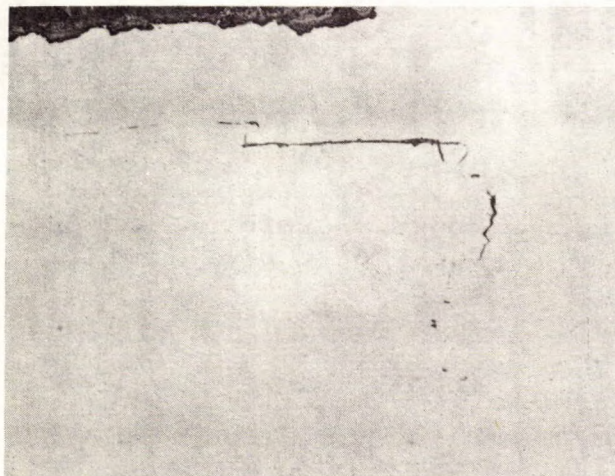
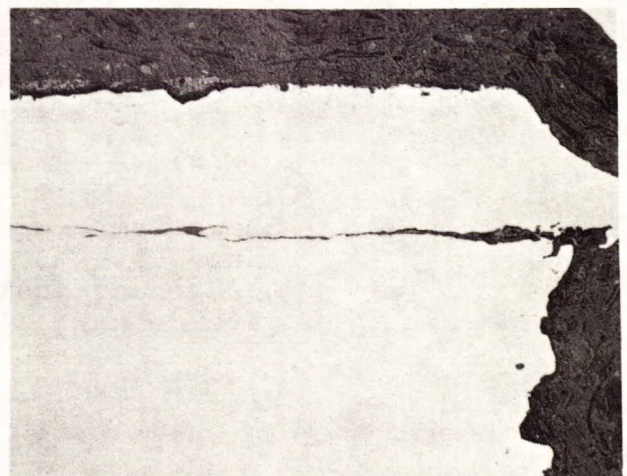
known at this time. Micro examination revealed some large inclusions near the outer surface of the pipe, and quench cracks started at these locations. The failure of the pipe was due to quench cracks, which have propagated through the wall thickness to a critical size, and initiated brittle failure. The etched structure shows the material in the failed area to be in a quenched and tempered condition. Hardness surveys confirm this and indicate that an area of 10 in. in diameter has been affected.

Figure 3. Cracks propagating from the end of an inclusion.

Large inclusions from which failure could have started.

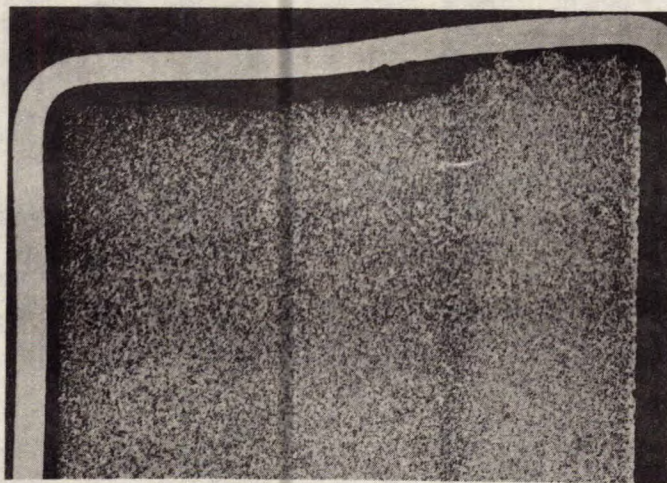
Figure 4. Darker etching structure at outside edge.
(left side)

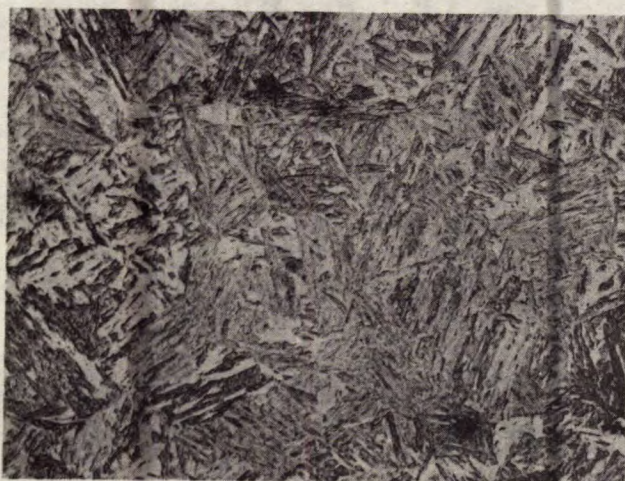
(a) X500

Figure 5. Shows tempered martensite structure found near outside edge.

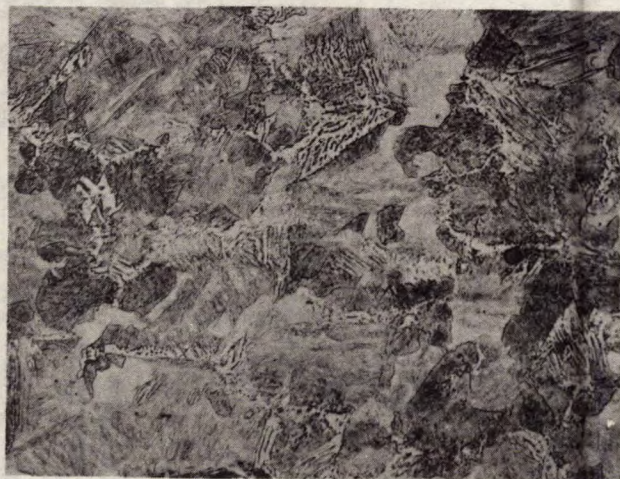
(b) X500

Shows transformation product found near inside edge.

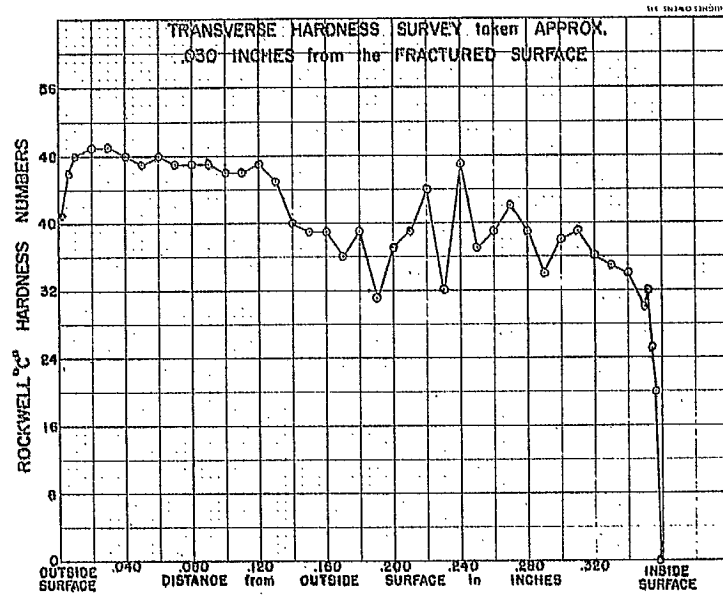
section (Figure 6) confirms this.

A hardness survey was carried out to determine the extent of the hard area. Starting at the origin of failure, hardness readings were taken at 1 in. intervals in all directions. It was found that the hardness of a region of approximately 10 in. in diameter was above normal for this material. The hardness varied from Rockwell "B" 95-100 at the outer edge of the zone to a high of Rockwell "C" 44 at, and adjacent to the origin of failure. The higher hardness (Rockwell "C" scale) zone was approximately 5 in. in diameter.

Figure 6. Hardness survey graph. Note the variations in hardness from the centre to the inside surface.
