MINES BRANCH INVESTIGATION REPORT IR 62-5

# INVESTIGATION OF FAILURE OF STUB AXLES ON ROAD GRADERS

FEBRUARY 5, 1962

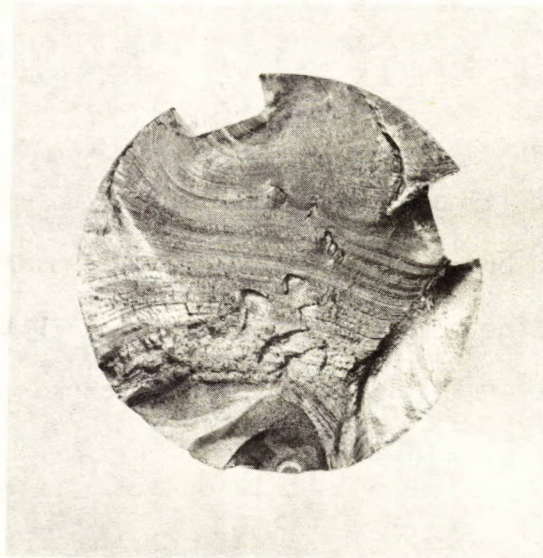
Figure 1. Surface of the fracture of one of the failed axles, showing fatigue markings originating at the keyway at the top of the photograph.

The examination revealed that both fractures resulted from fatigue originating at a keyway, progressing to the second keyway, and then to final failure. Although it is likely that the failures originated at the bottom fillets in the keyways, there is some indication that a crack might initiate at the edge of a keyway at a junction with the surface of an axle. The fractures progressed through approximately two-thirds of the cross-section prior to final failure.

There was visual evidence of poor machining in the keyways, frequently resulting in a slight groove or step at the junction of a fillet and the side wall. The fractures show indications of adequate ductility.

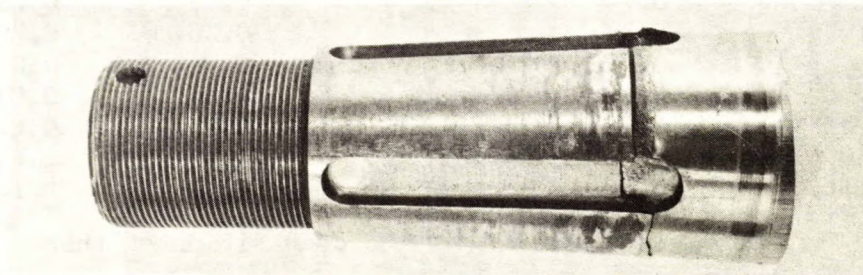
Figure 2. Longitudinal view of the incompletely broken axle showing a well opened crack.

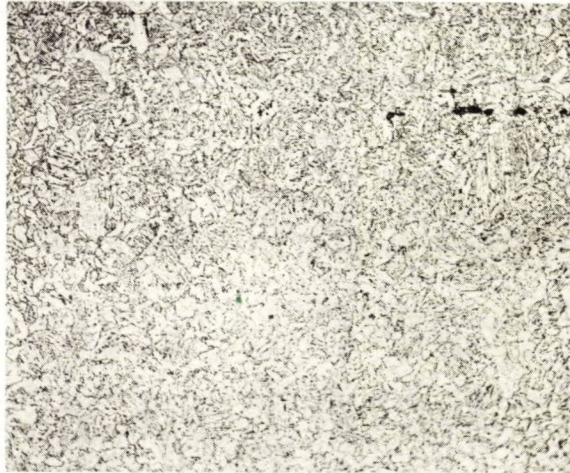
The examinations of both axles show microstructures typical of a low alloy steel that has received a normalizing and spheroidizing heat treatment. Each of the microstructures consists of spheroidized carbides in a ferritic matrix. The microstructure is shown in Figure 3.

Figure 3. Microstructure of a section taken near the fracture of the completely broken axle. This microstructure could be developed by a normalizing and spheroidizing heat treatment.

1. A reassessment of the strength and hardness requirements should be made, and when this has been done, the correct heat treatment can be established to provide the required properties, eg, a section of Ultimo-4 steel of 4 in.

diameter, oil quenched and tempered at 650°C (1200°F) provides a tensile strength of 136,000 psi and a hardness of 277 Brinell. These values will be lower for Atlas SPS-245 steel.
