MINES BRANCH INVESTIGATION REPORT IR 62-54

**AN EXAMINATION OF STAINLESS STEEL  
MICROSTRAINER FABRICS SHOWING  
"PINHOLING" WHEN USED TO FILTER  
LAKE ERIE WATER**

**R. D. McDONALD & G. J. BIEFER**

JULY 30, 1962

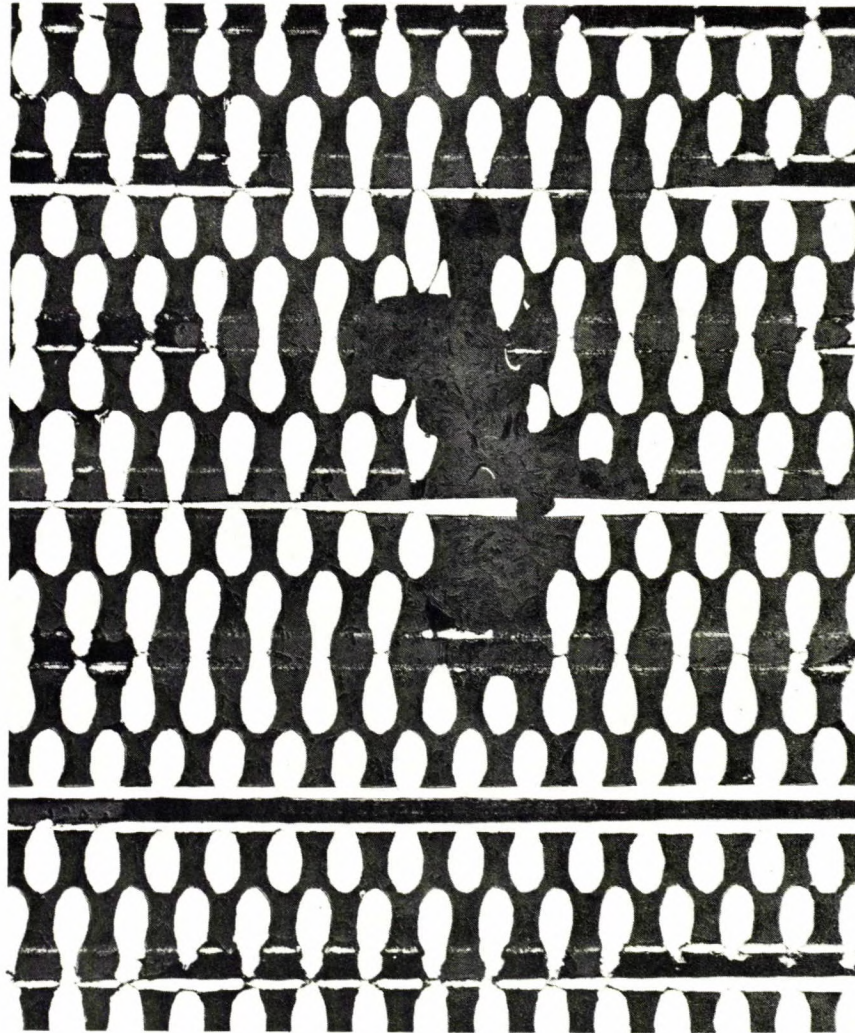
Figure 1 shows a typical pinhole of the type attributed to corrosion. It will be observed that the fabric weave is essentially undisturbed near the pinhole, despite the extent of attack which has occurred. It is also notable that many of the weft wires showed corrosion attack at points where they crossed

Figure 1. Section in plane of microstrainer fabric (Unit #2, Dunnville, Ontario), showing a pinhole. The pairs of wires lying horizontally represent the warp, while the "dogbone" shapes represent weft wires, which loop over and under pairs of warp wires. X100

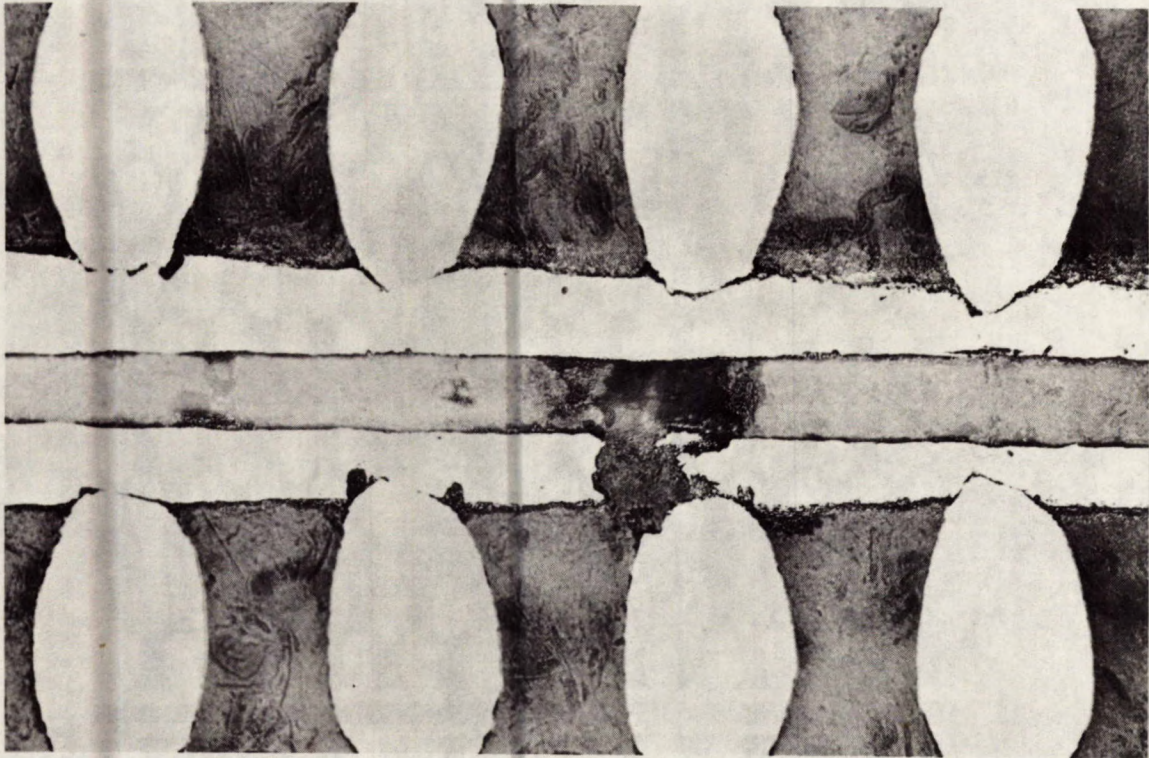
over the warp wires (at the waist of the "dogbone" shapes). Figure 2 shows an example of this type of attack at a higher magnification.

Figure 2. Section in plane of microstrainer fabric (Unit #4, Dunnville, Ontario), showing corrosion attack at cross-over points of warp and weft wires. One of the warp wires has been severed by the corrosion attack, which appears to be proceeding along the severed ends.

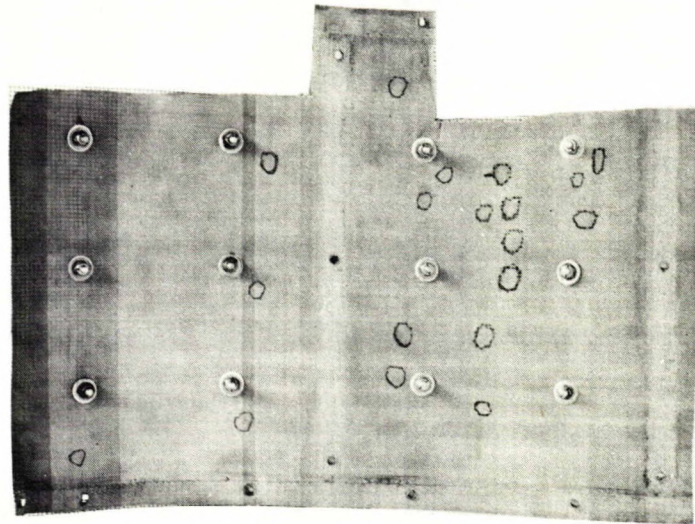
A sample of a used microstrainer fabric taken from the Dunnville installation is shown in Figure 3. It is attached to its coarse backing screen by nut, bolt and washer assemblies. In Figure 4 an enlarged view of one of these assemblies is shown.

It was observed that some of the pinholes were at cross-over points of the coarse backing screen and thus might have been initiated at this particular crevice, or by abrasion, due to relative motion of the two fabrics. However, other pinholes appeared at locations other than the cross-over points, and appeared to be due completely to corrosion.

Figure 3. Microstrainer fabric, bolted to coarse backing screen. Some of the pinholes have been circled.

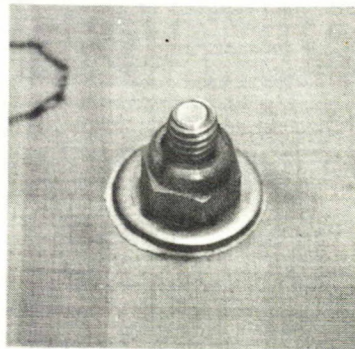
It was observed that the threads of many of the bolts were rusty. When the nuts were removed it was evident that this was due to crevice corrosion, occurring between the nut and a metal washer, and also in the crevice between the washers and the bolt heads.

The units (nuts, bolts and washers) used to bolt the microstrainers to the backing screen were not given detailed metallographic examinations. However, a brief examination of a polished section of the thread from a corroded nut revealed that it was a free machining (i.e. high sulphur) type of stainless steel, probably similar to AISI Type 303. Corrosion attack had progressed actively along the sulphide inclusions normally found in this type of steel. The corrosion resistance of free machining stainless steel is much less than that of non-sulphurized types.

Figure 4. Nut and bolt assembly fastening microstrainer fabric to backing screen, showing rust on threads and in the crevice between metal washer and nut.

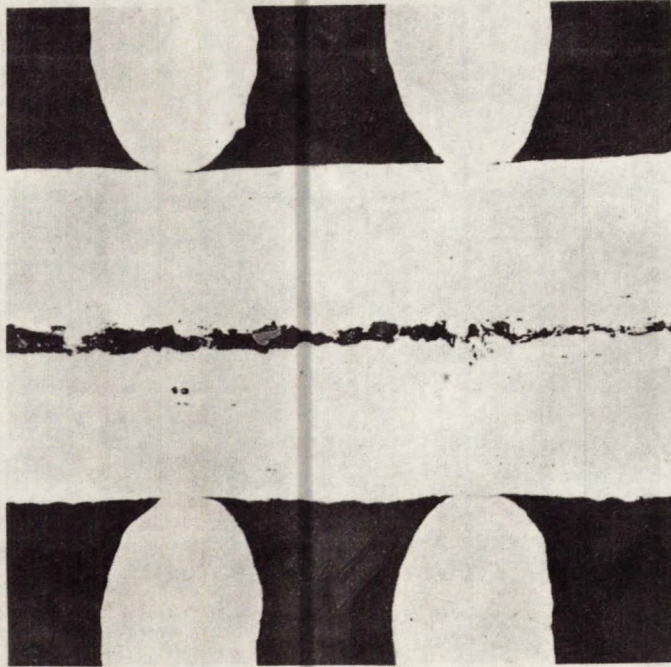
Two small samples of Mark O fabric, purportedly unused, were sectioned and examined. It was observed that corrosion appeared to be proceeding at some points where parallel weft wires were in contact (Figure 5).

The observation of crevice attack on an unused microstrainer fabric cannot be considered conclusive, as the history of this fabric is not definitely established. However, it does suggest that greater attention could be paid to the condition of the microstrainer fabrics at the time of installation. Sectioning techniques such as those used in the present work would show whether or not corrosion had already begun.

Figure 5. Section in plane of unused Mark 0 microstrainer, showing corrosion attack at contact point of two warp wires. X500

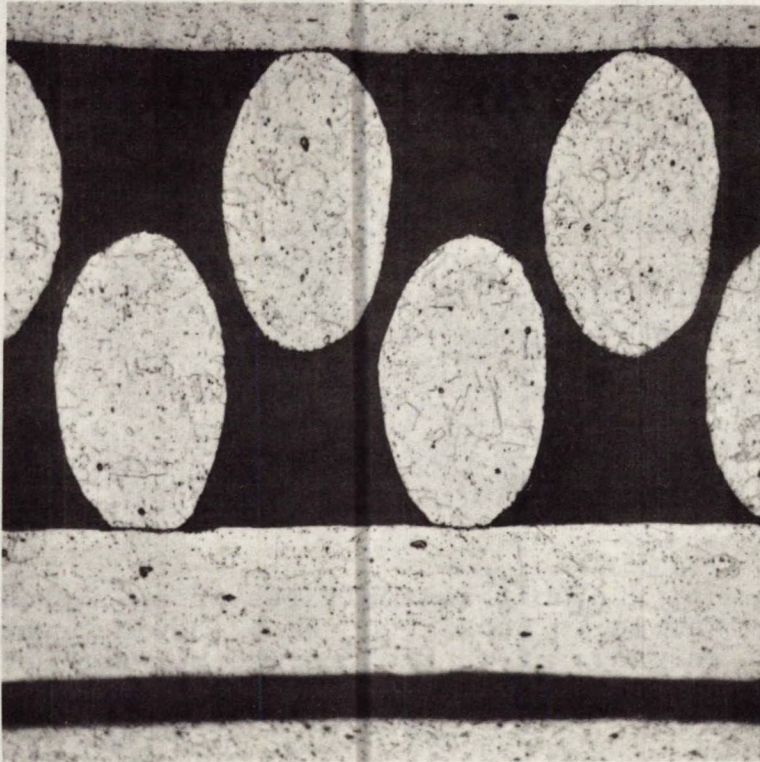
In general, the examinations showed an austenitic matrix with evidence of work hardening (presumably from manual polishing of such small wires), and numerous small carbides in some specimens (for example, the warp wires of #2 microstrainer).

The metallurgical examination did not produce any positive evidence of the specific cause of the corrosion observed in the microstrainers. However, there was evidence that optimum annealing conditions were not attained at all times. Although residual cold work did not exist, according to X-ray diffraction measurements, the large number of carbide particles in some of the wires indicated that time, temperature and possibly cooling rates, were not best suited to take carbides into solution and retain them. It has been widely accepted that stainless steels of this type provide the best resistance to corrosive attack when fully quench-annealed with absence of cold work and with most of the carbides retained in solution. Microstrainer numbers 2 and 4 were selected for examination since, for the sections examined, number 2 appeared to be much more severely pinholed than number 4. It is possibly worth noting that more carbides are apparent in microstrainer number 2 than in number 4.

Figure 6. Microstructure of microstrainer fabric No. 2, showing austenite grain boundaries and large numbers of carbides in both warps and wefts. (Etched in Vilella's reagent, X500)

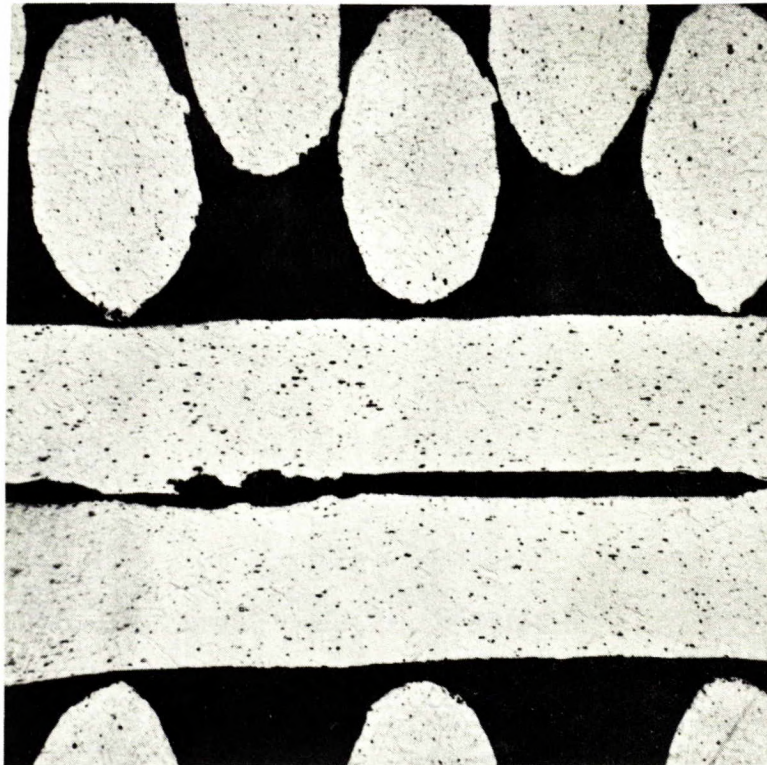
Figure 7. Microstructure of microstrainer fabric No. 4, showing austenite grains and carbides. The latter appear to be generally larger and fewer in number than those in No. 2 microstrainer. (Etched in Vilella's reagent, X500)

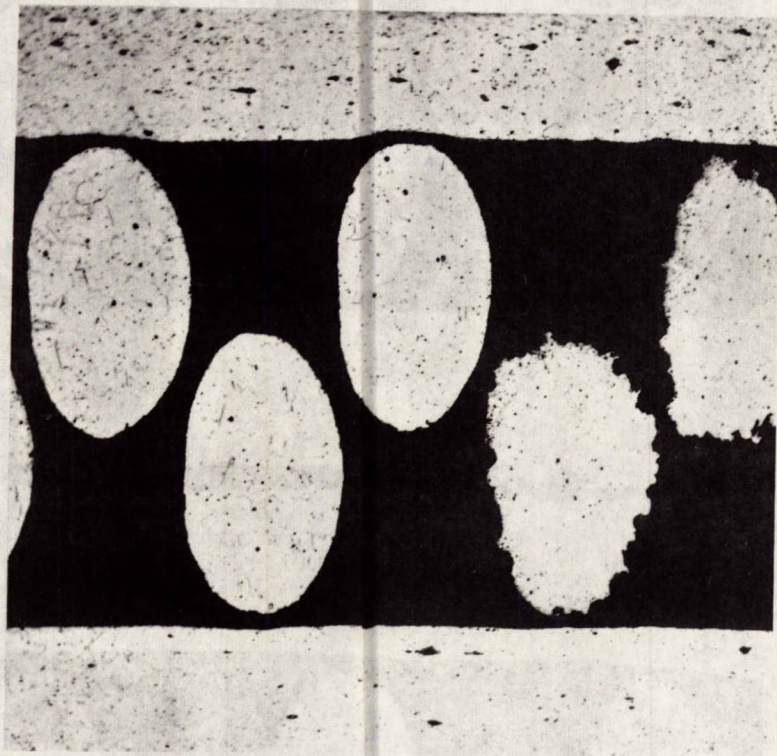
Sections through the fabric, taken during the studies of microstructure, showed that the outer contours of weft wires within the streak were irregular, compared to similar wires outside the streak (Figures 8 and 9). This reflected the greater severity of the corrosion attack within the streak. A study of these figures also shows a difference in weave geometry, such that there were many more contact points between weft wires within the streak than without. There were thus many more points vulnerable to crevice attack.

As noted previously, it was observed that the outer contours of the weft wires within the dark streak were less uniform than those outside that area (Figures 8 and 9).

Figure 8. The weft wires on the right are within the dark streak on microstrainer No. 1. Those on the left are outside of it.  
(Etched in Vilella's reagent, X500)

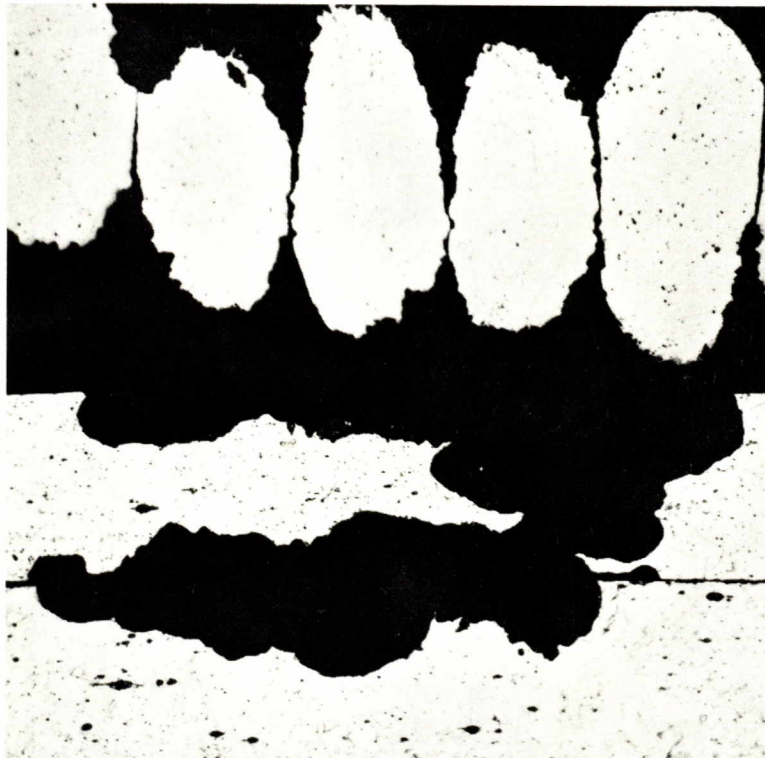
Figure 9. Corroded area within the dark streak (micro-strainer No. 1), showing crevice attack in warp wires and around the periphery of the weft wires. (Etched in Vilella's reagent, X500)
