MINES BRANCH INVESTIGATION REPORT IR 62-106

**EXAMINATION OF SAMPLES CUT FROM
CCGS JOHN A. MacDONALD SPARE
PROPELLER BLADES**

D. E. PARSONS

JANUARY 3, 1963

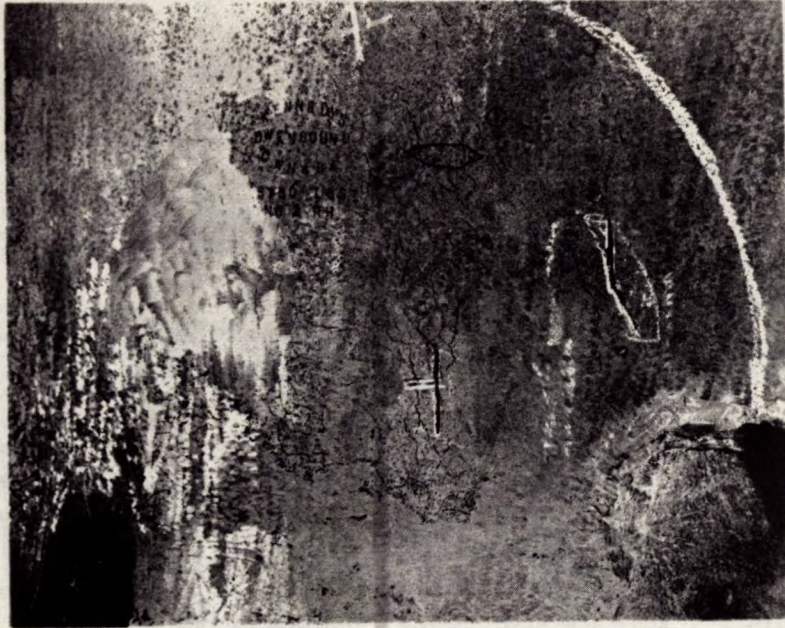
Figure 1. No. 2. R.H. Blade Surface. Working Side. Aft Surface. Contains numerous intergranular crevices having depths up to 3/8 in. The location of a boat sample is illustrated. This boat sample intersected one typical crevice.

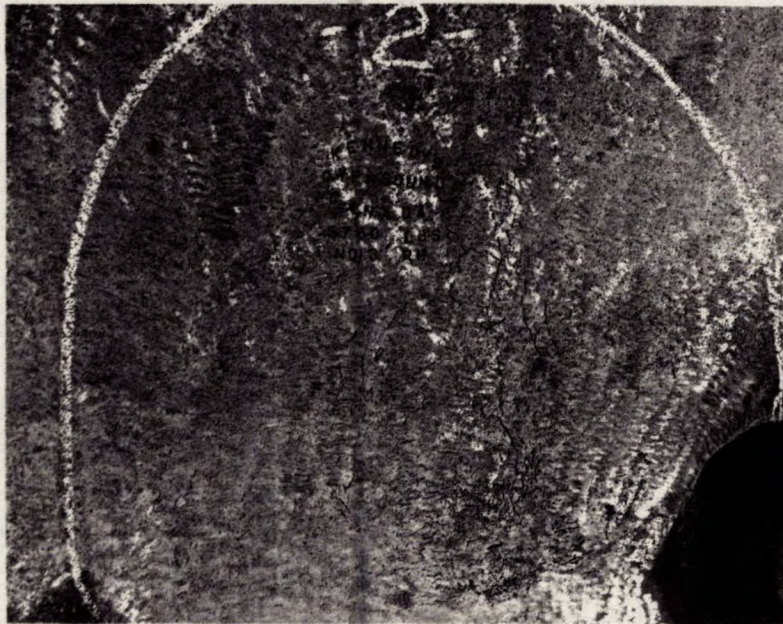
Figure 2. No. 3 R.H. Blade Surface. Working Side. Aft Surface. Numerous branching crevices are shown. The surface of the casting has a pitted and etched appearance caused by service in salt water.

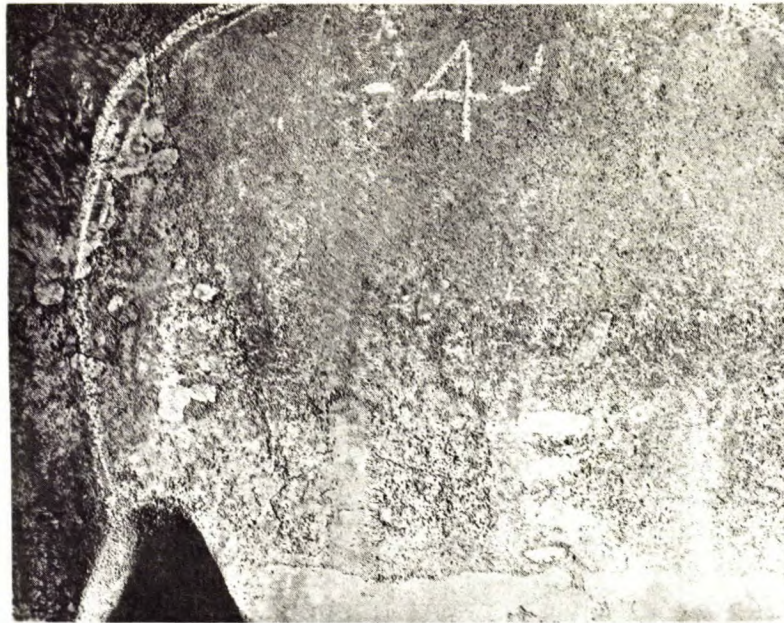
Figure 3. No. 3 R.H. Blade Surface. Forward Surface. Opposite to that shown in Figure 2. "Weld deposits" have not been attacked during service. Minor quantities of crevice defects are present on this surface.

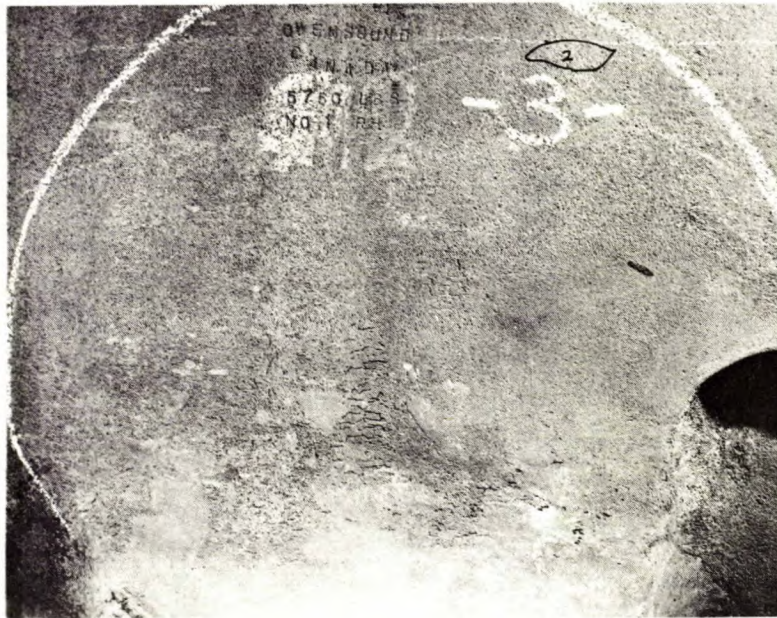
Figure 4. No. 1 R.H. Blade Surface. Working Side. Aft Surface. Except for one central area crevices were absent on this surface. Similarly, the forward surface (Fig. 5) contained only a few regions where chipping and weld repair were necessary. The location of a "boat" sample is illustrated. The surface of this boat sample contained pits but did not intersect any crevice cracks.

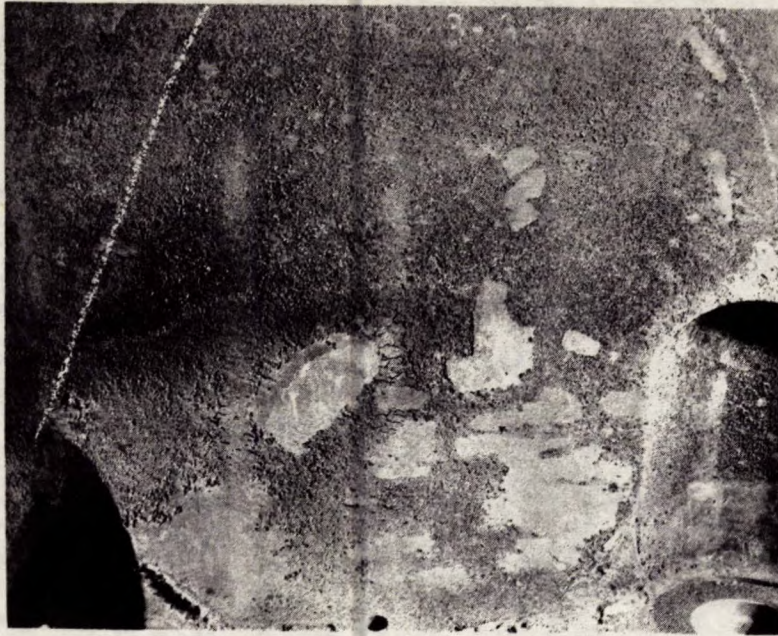
Figure 5. No. 1. R.H. Blade Surface. Forward Side. This surface contained a few crevices in one local area. The deep etched appearance of the steel surface is illustrated. The areas that have resisted pitting may be weld deposits.

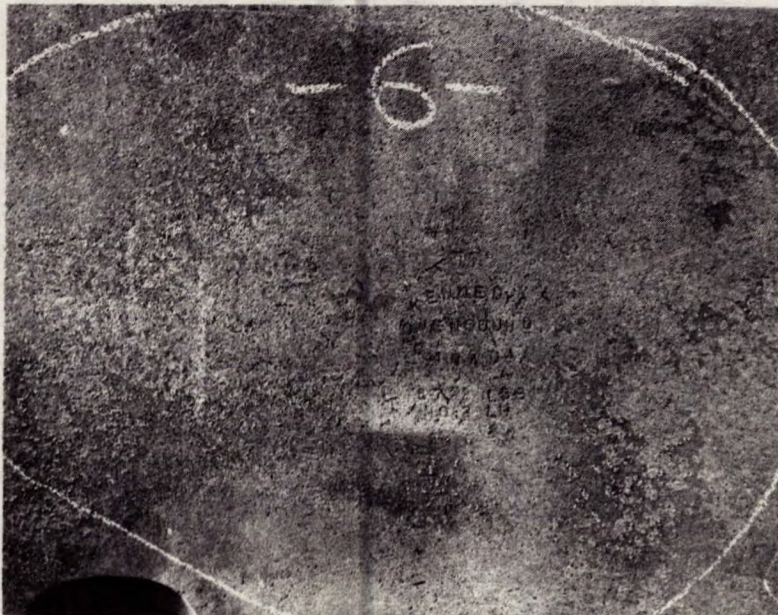
Figure 6. No. 2. L.H. Blade Surface. Working Side. Forward Surface. Relatively small crevices are randomly distributed on the face of this blade.

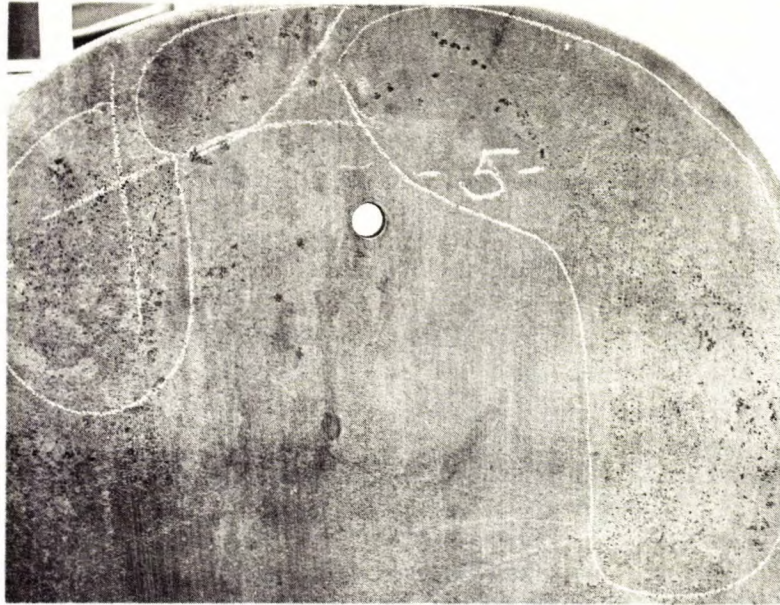
Figure 7. No. 3 L.H. Blade Surface. Non Working Side. Aft Surface. Cavitation is visible at the edge surfaces, but only minor pitting is present on the central surface.

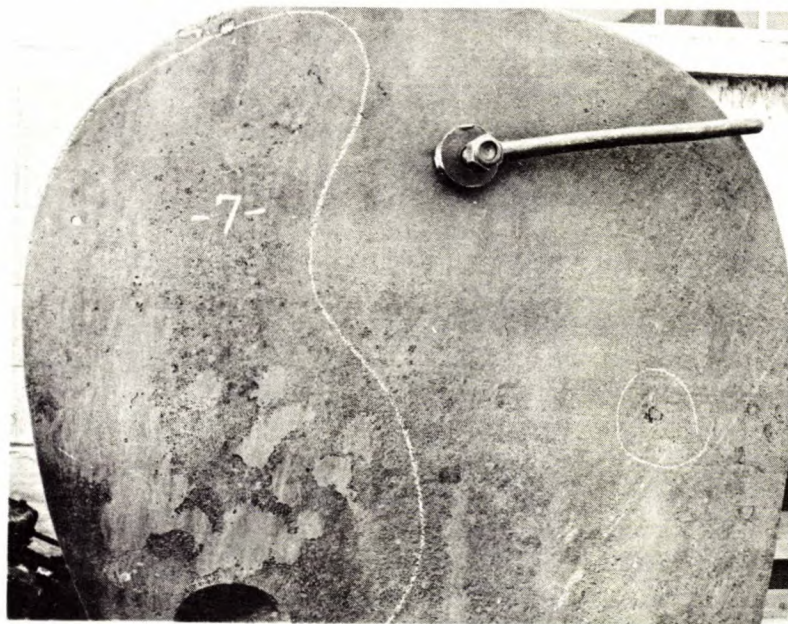
Figure 8. No. 4 L.H. Blade Surface. Non Working Side. Aft Surface. A minimum of pitting was observed in this blade.

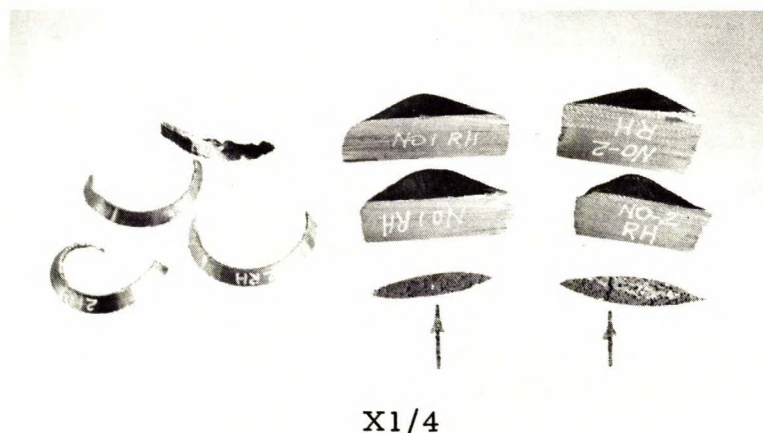
Figure 9. Samples from Blades No.1 R.H. and No.2 R.H. Metallographic examination was made on sections cut along the centre axis of the two boat samples, illustrated (arrows). One of the sections intersected the crevice visible in the boat sample at the right of the picture.

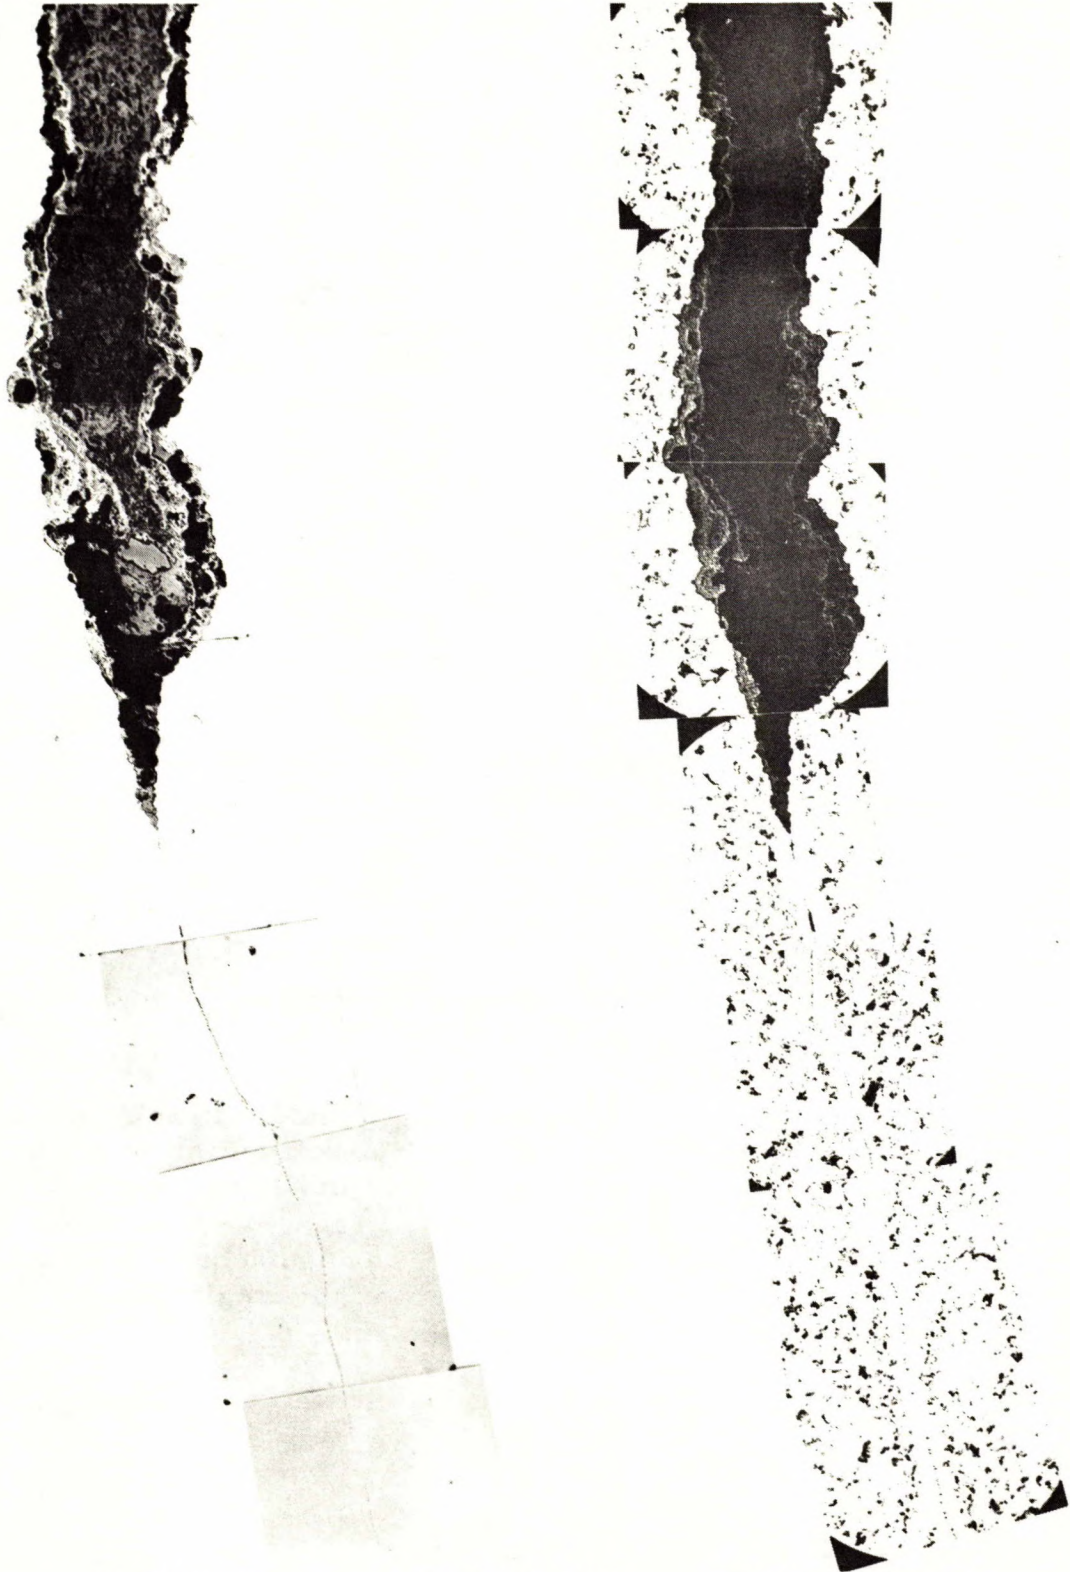
Figure 13 illustrates the appearance of the crevice shown in Fig. 12. The crevice is filled with corrosion product, has a sharp tip and is progressing along a sulphide film present in the primary austenite grain boundaries.

as polished X50 Approx Etched: 2% nital
Figure 13. Appearance of oxidized crevice with the tip of the crack following sulphides present in primary grain boundaries.

The crevices appear to be caused by preferential corrosion following chains of sulphides situated in primary grain boundaries. The presence of this type of sulphide is consistent with the low residual quantities of aluminum and titanium-zirconium as determined by analysis. Chain sulphides can result from low recovery of deoxidizing additions of aluminum and zirconium particularly in low carbon steels and even at low sulphur contents(1, 2). The effect of the section size on the tendency to formation of sulphide films is not known. However, in thin sections, silicon deoxidation or aluminum-calcium-silicon deoxidation tend to form spherical "birdseye" inclusions rather than sulphide films (2). Vanadium is stated not to contribute to formation of chain sulphides during solidification (1). Some published data indicate that, for low carbon steel, a residual aluminum content greater than 0.05% is required to avoid the formation of chain sulphides but at or above this level of residual aluminum, difficulty with conchoidal, aluminum nitride, fracture can occur as a consequence of slow cooling and segregation of sulphur in heavy sections.

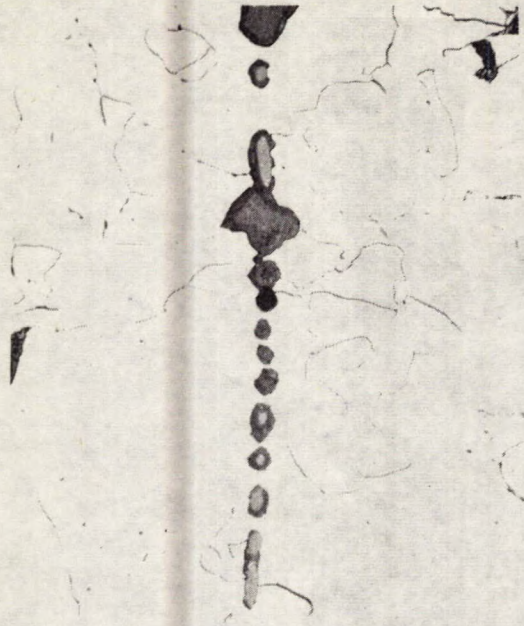
Figure 14 shows sulphides adjacent to the tip of the crack where corrosion has commenced and has oxidized the surface of the sulphide inclusions.

Figure 14. Sulphide particles adjacent to the tip of the crevice after corrosive attack. The surface of the sulphide inclusions is oxidized.

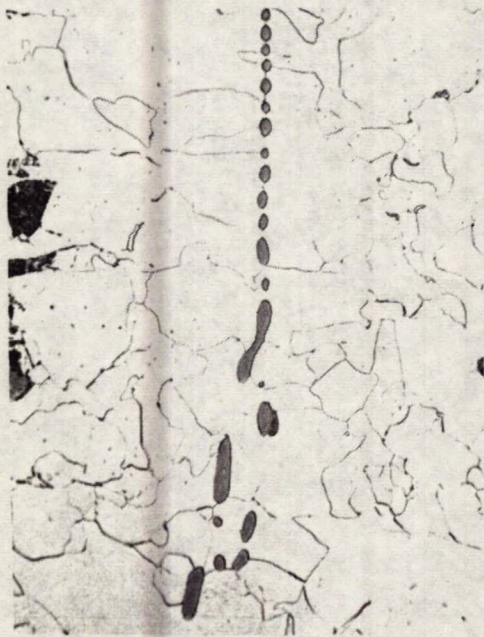
Figure 15 illustrates the appearance of part of the chain of sulphides in a region remote from the tip of the crevice.

Figure 15. Sulphides forming the grain boundary film in a region remote from the tip of the crack. Corrosion and oxidation have not started in this region.

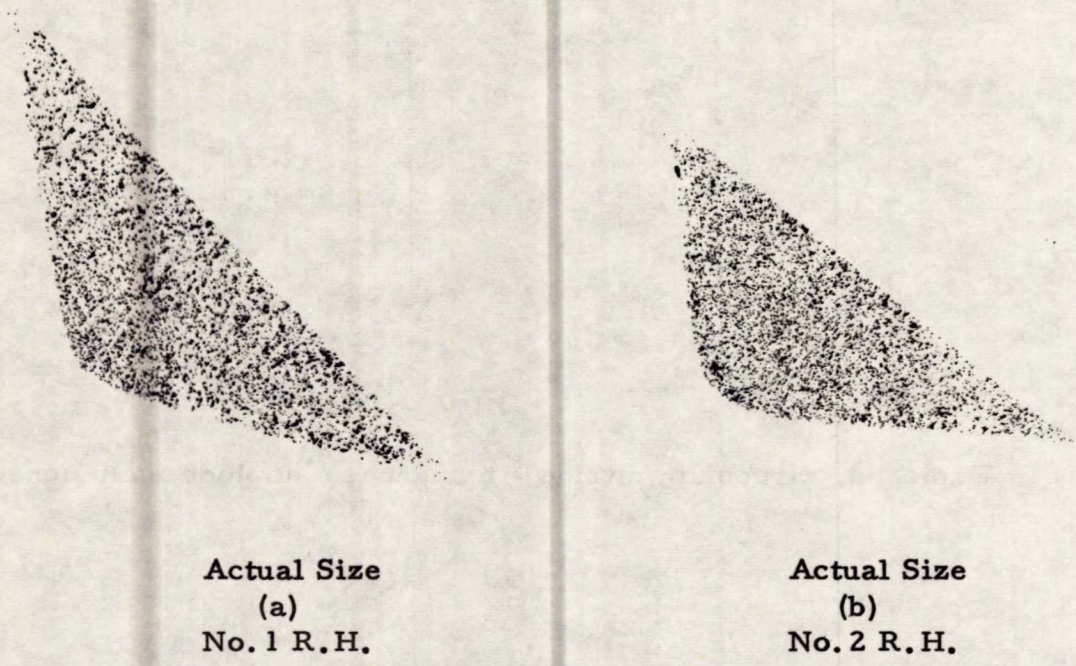
Figure 18. Sulphur distribution in triangular samples used for room temperature impact bars. Sulphides comparable to those illustrated in Figure 13 were not observed in this location.
