MINES BRANCH INVESTIGATION REPORT IR 62-112

EXAMINATION OF ARSENIC-INHIBITED ADMIRALTY BRASS CONDENSER TUBES

J. O. EDWARDS

DECEMBER 13, 1962

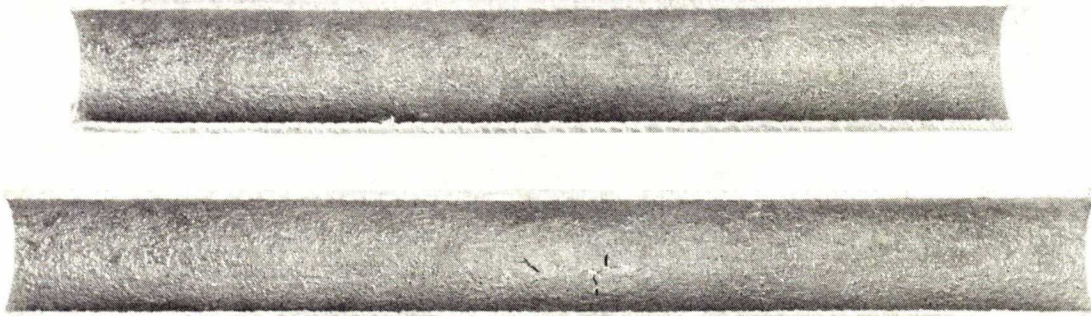
The surface of the tube had been cleaned, but in some areas, patches of a black film resembling graphite were still present on the outside of the tube. A thinner black deposit was also visible on the inside, and overall pitting of the inside surface of the tube was apparent. This is shown in Figure 1.

Figure 1. Inside surfaces of failed tube. Note pitting and perforation by branching crack in lower section. (approx. full size)

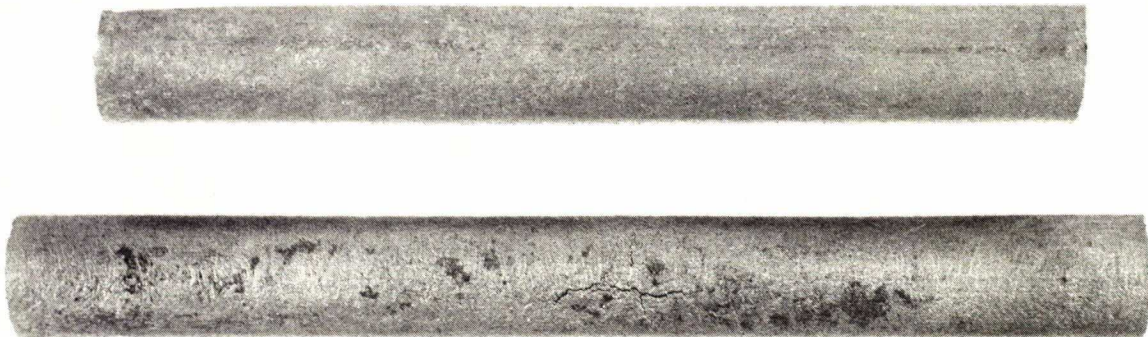
The most remarkable feature of the tube was the extensive cracking and veining on the outside as shown in Figures 2 and 3. This ranged in character from a straight crack on the longitudinal axis which completely perforated the tube to a widely branching crack which also perforated the tube. There were a large number of smaller cracks - particularly the widely branched ones - which had not completely perforated the wall.

Figure 2. Outside surfaces of failed tube showing overall branching cracks, particularly in lower section. (approx. full size)

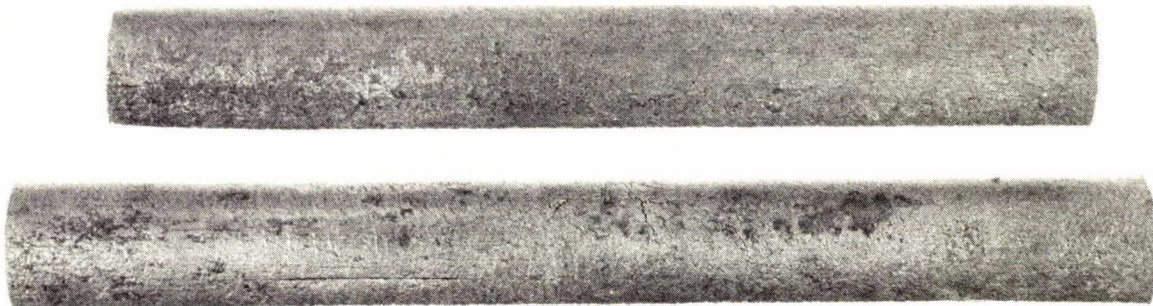
Figure 3. As in Figure 2 showing both branching cracks and straight cracks. (approx. full size)

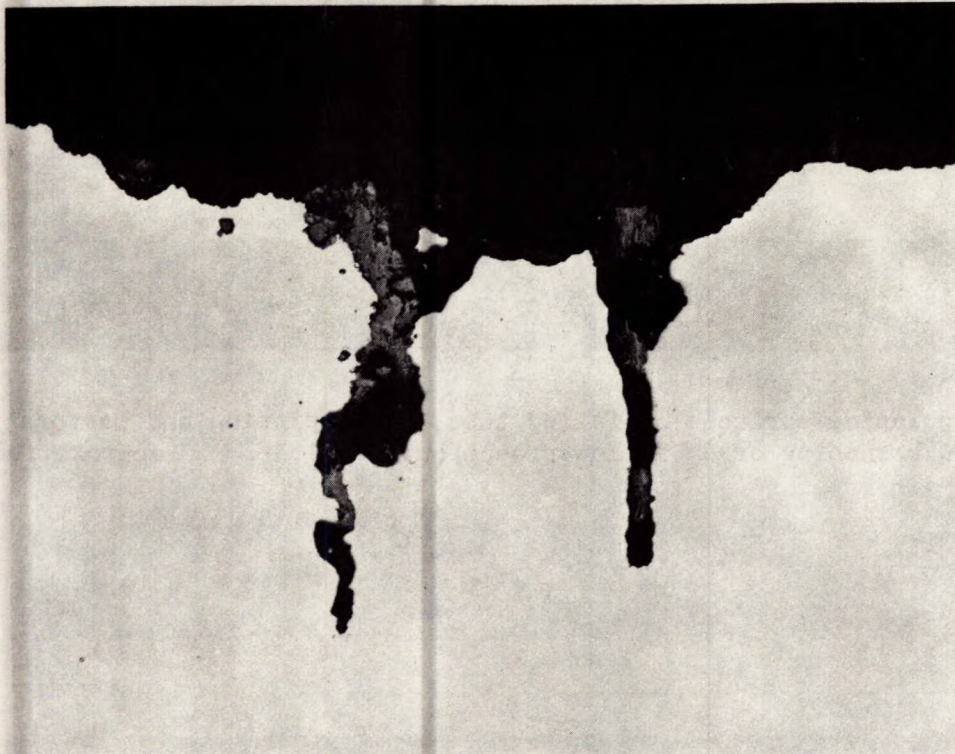
The cracks all originated in the outside surface of the tube and, in general, were blunt ended and filled with corrosion product. Figure 4 represents two typical cracks, although the majority of the cracks observed were relatively straight, as shown by the crack on the right. The cracks seemed to have the same general structure whether they appeared branched or straight on the surface, but this cannot be stated definitely as the nature of the crack was masked by the corrosion product.

Figure 4. Pitting and cracks full of corrosion product. Outside surface of tube. X150 Unetched.

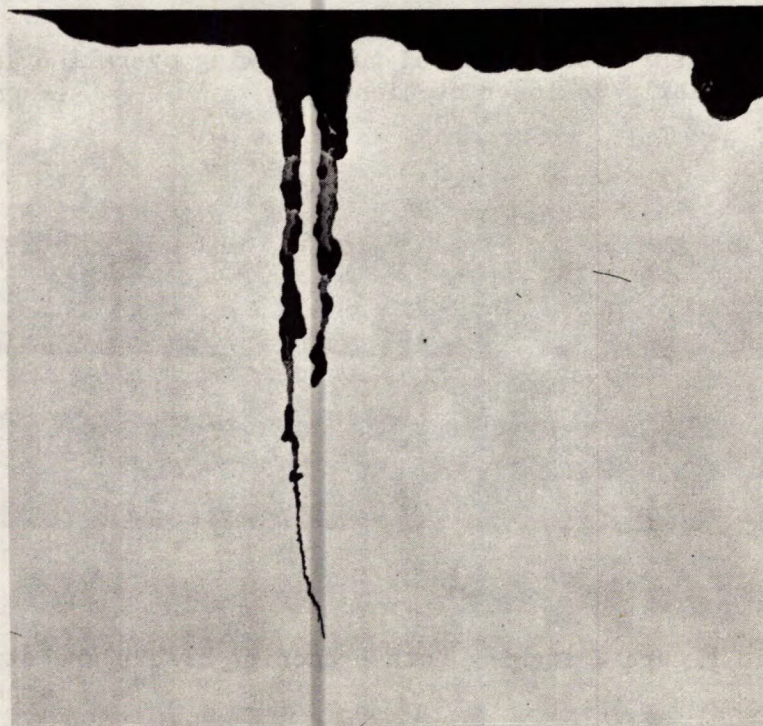
Occasional cracks were observed that had not been heavily corroded, presumably because they were of fairly recent origin. Figure 5 is representative of such a crack and Figure 6 shows an enlarged view of the tip of the crack in the etched condition from which it is apparent that the cracks are transcrystalline as well as intercrystalline.

Figure 5. Double crack, one of which shows well-defined tip, probably of recent origin. X75 Unetched.

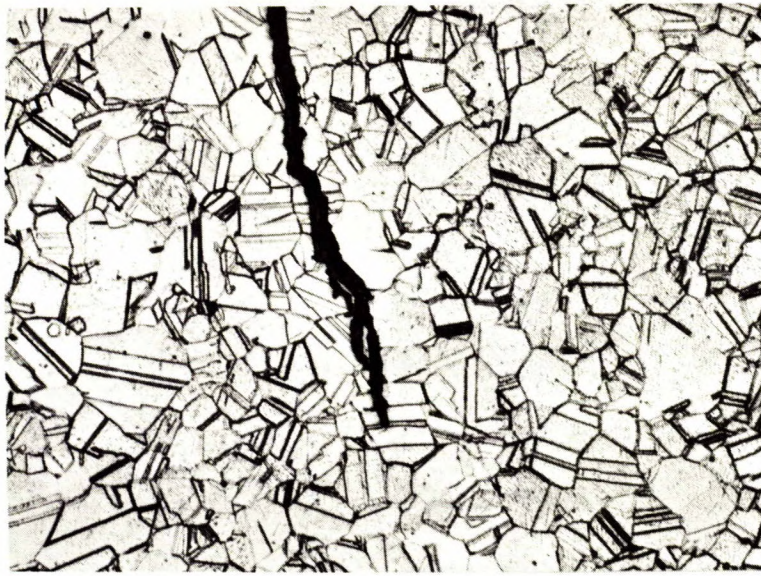
Figure 6. Tip of crack showing both transcrystalline and intercrystalline nature of crack propagation. X300
