MINES BRANCH INVESTIGATION REPORT IR 63-3

**METALLURGICAL EXAMINATION
OF GALVANIZED TRANSMISSION
TOWER SAMPLES**

J. J. SEBISTY

JANUARY 9, 1963

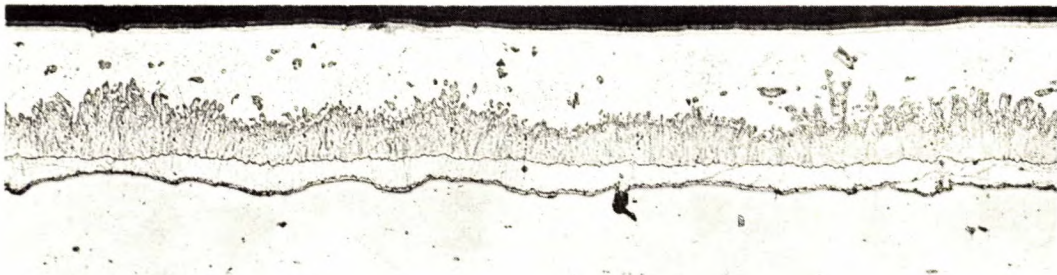
(a) Plate, Sample P₁

The microstructure of the coating on the plate material, Sample P₁, was found to be most representative of a so-called normal galvanized coating. The characteristic layer development of iron-zinc alloy phases was present as shown in Figure 1(a) and the coating was uniformly thick at about 0.004 in. (2.4 oz/sq ft) over the section examined. The coating on the rod material, Sample R₁, showed similar areas of uniform iron-zinc alloy growth which, however, were occasionally broken by zeta phase bursts extending outwards into the zinc layer as a loosened mass of crystals. Such formations as well as non-uniform iron-zinc alloy growth at notches and other steel surface irregularities apparently contributed to heavier zinc drag-out and a thicker coating averaging around 0.0055 in. (3.3 oz/sq ft). These features are illustrated in Figure 1(b).

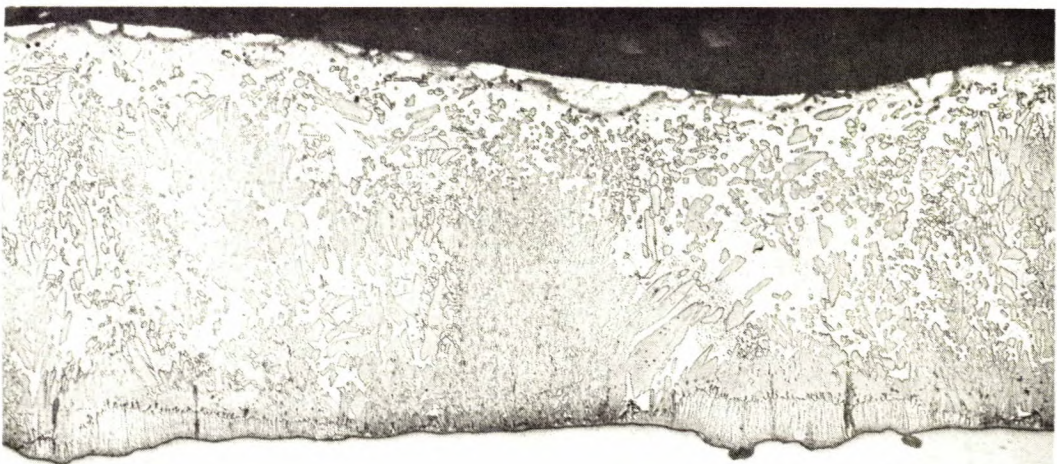
(c) Angle section, Sample S₁

A typical area showing the very heavy coating at about 0.011 in. (6.6 oz/sq ft) developed on the angle section, Sample S₁, is reproduced in Figure 1(c). It can be seen that extremely active localized reaction with the steel base has occurred leading to the formation of a highly exaggerated

outburst of fine zeta crystals, bounded on either side by much larger crystals of the same phase. In the affected area, the delta phase originally formed at the steel surface has disappeared, presumably having been transformed to zeta. An indication of the more active nature of this steel is also provided by the thickness of the delta phase patches which remained intact as in Figure 1 (c). In the section examined, numerous sites of aggressive attack such as illustrated were found and the resulting excessive dispersions of iron-zinc crystals embedded in a zinc matrix thus accounts for the very thick coating developed on the angle section.

The variable galvanizing behaviour of the samples submitted was found to be associated with very aggressive localized zinc attack of the angle section material, and of the rod material to a lesser extent. Observed variations in steel base microstructure appear to be of some significance in explaining this abnormal behaviour since it is known that a pearlitic structure is much more aggressively attacked than a decarburized surface by molten zinc. However, steel microstructure is not necessarily the only factor involved. Localized attack of the type encountered can occur in sporadic fashion on otherwise "normal" surfaces that would be expected to yield a uniform coating comparable to that in Figure 1 (a). The effects of such factors as local work hardening, surface roughness, steel composition and bath temperature on the initiation of heavy, general or localized steel attack by zinc are well established. Much less is known about sporadic local attack occurring for no obvious reason and this apparently involves a complex mechanism.

From the practical standpoint, it is suggested that acceptable coatings could be produced on the aggressive angle section material by application of closer control of the pretreatment and galvanizing operations. Minimum pickling, combined with a short dipping time and low bath temperature should be effective in reducing the incidence of excessively thick coatings. For this and related types of products, pregalvanizing annealing treatments to produce a less reactive surface would probably be uneconomic but could be expected to provide a more satisfactory solution.

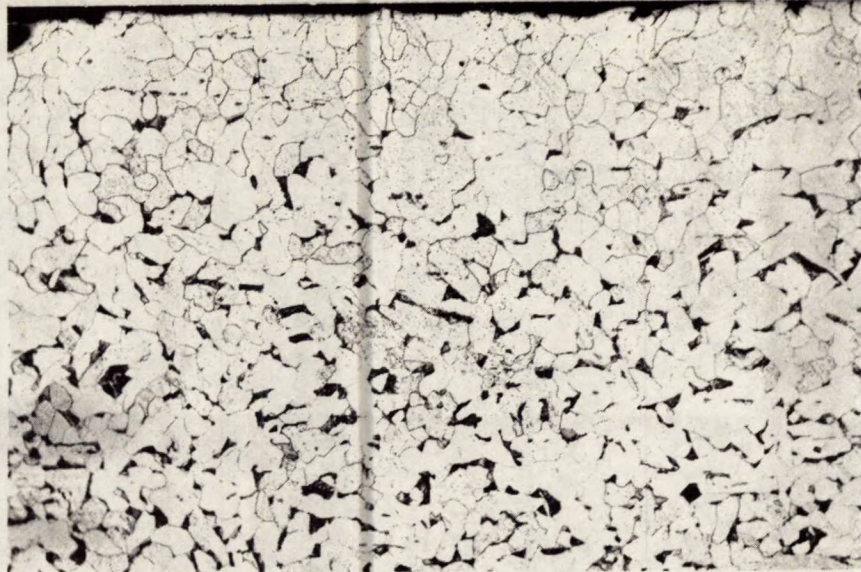
(a) Plate, Sample P₁

Interference by the galvanized coating prevented satisfactory etching of the steel microstructure adjacent to the coating and additional microsections were polished after removal of the coating. Microscopic examination revealed evidence of a decarburized surface rim on the plate material. The negligible amount of pearlite phase in this rim is shown in Figure 2 (a). In the angle section, a surface rim was absent and the pearlite distribution was essentially unaltered across the section as illustrated in Figure 2 (b). The microstructure at and near the surface of the rod represented an intermediate condition, but was more similar to that of the angle. These structure variations are apparently related to original processing of the steels and/or the working and finishing operations in fabrication of the end products.

Figure 2. Steel base microstructures of samples indicated showing surface decarburization of plate sample (a) and uniform pearlite distribution through to surface in angle section (b). Nital etch X150.
