MINES BRANCH INVESTIGATION REPORT IR 63-5

**DETECTION AND ANALYSIS OF
METALLURGICAL DEFECTS IN STEAM
TURBINE ROTORS**

R. D. McDONALD

JANUARY 25, 1963

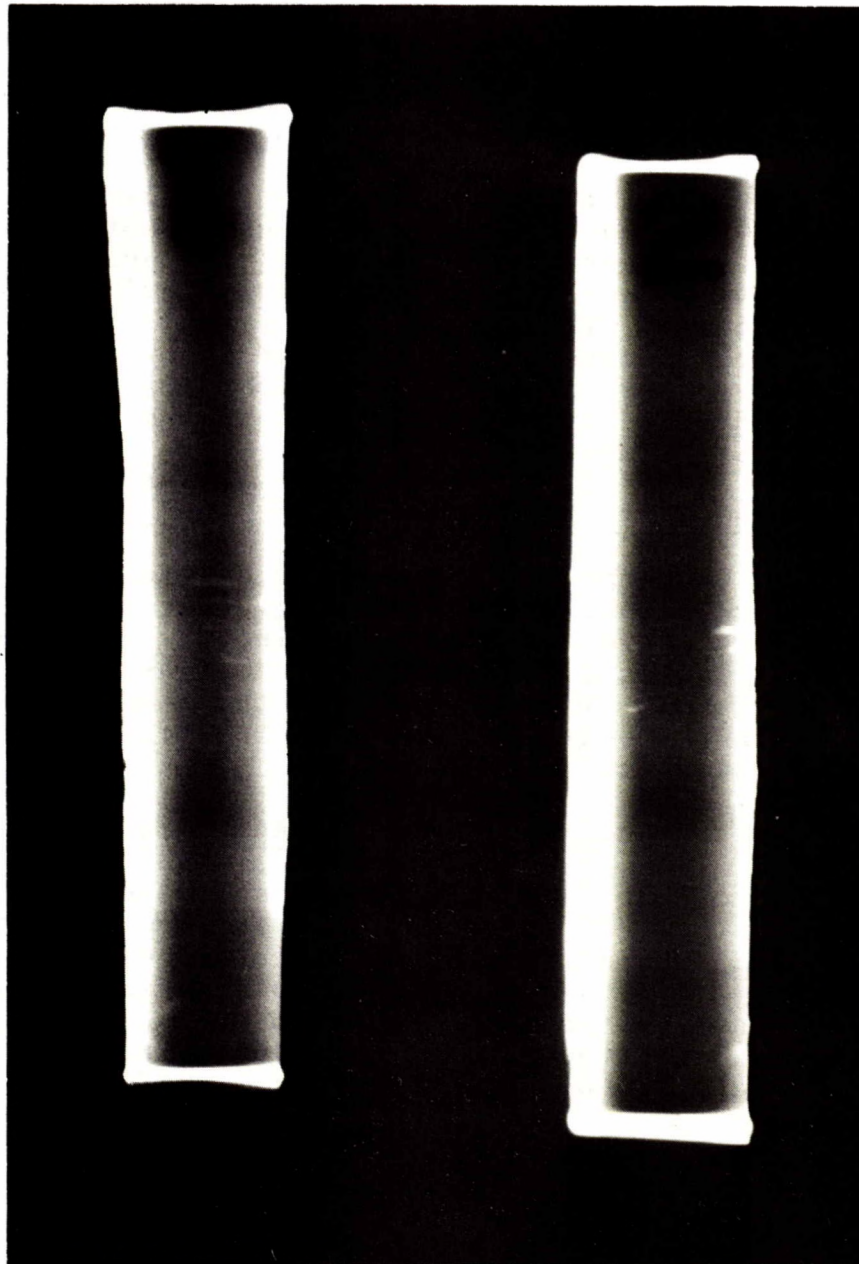
Figure 1. Prints of radiographs of core trepanned from main rotor M-1.

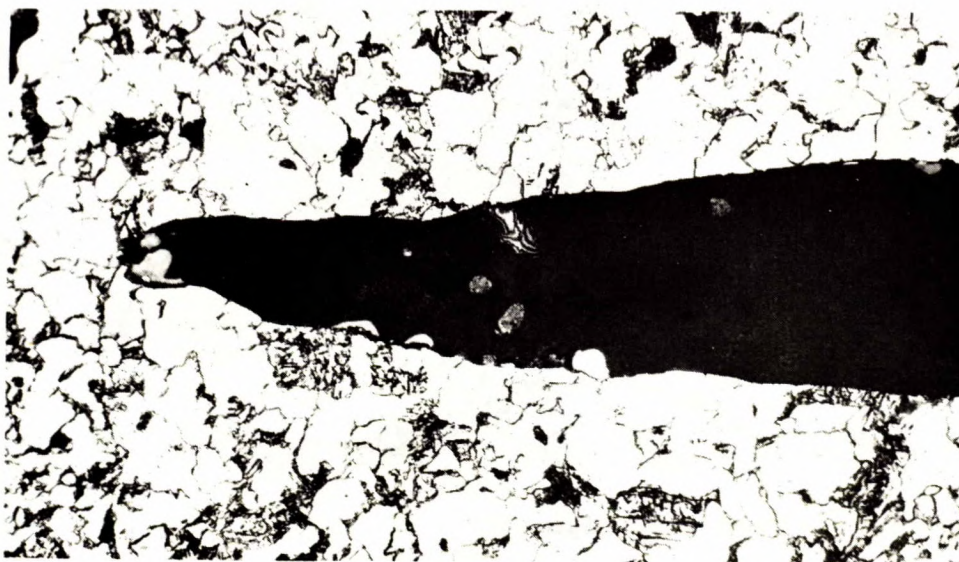
Figure 3. Same as Figure 2, after etching in 10% nital for 10 seconds.

There was a slight darkening of some globular inclusions within the matrix, indicating FeO with FeS or MnO in solution. The remainder of the inclusion was not attacked.

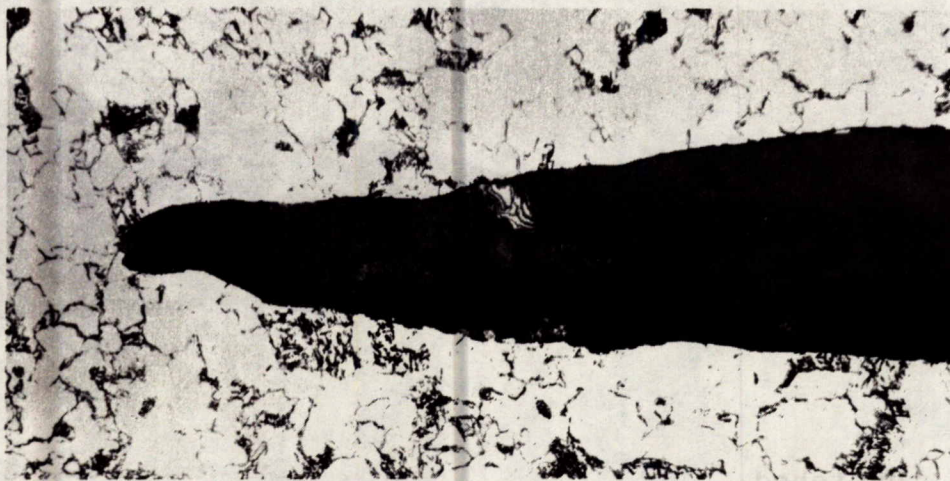
Figure 4. Same as Figure 3, after etching for 5 minutes in 5% chromic acid in water.

All of the globular inclusions were attacked, indicating FeS-MnS rich in MnS. Those within the matrix which were slightly attacked in nital probably contain FeO with FeS.

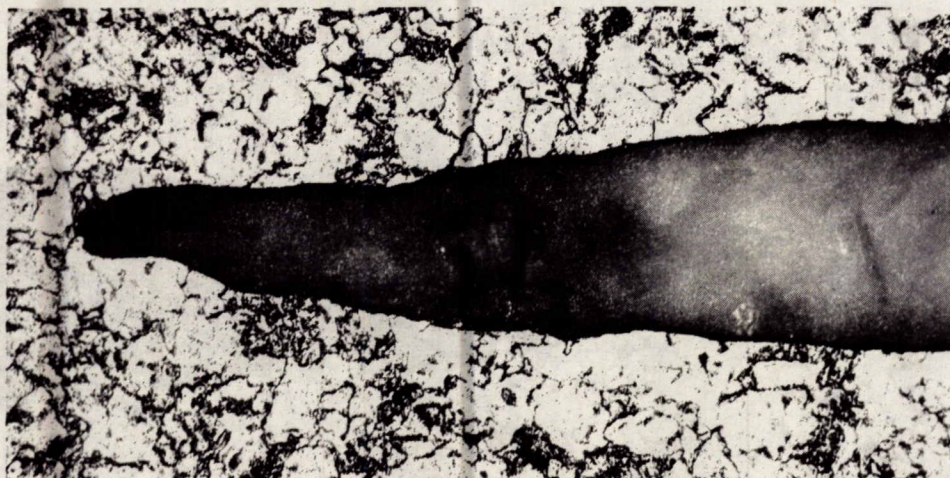
Figure 5. Same as Figure 4, after etching for 10 minutes in 20% aqueous solution of hydrofluoric acid.

The matrix has been attacked, showing that the inclusion consists mainly of siliceous material.

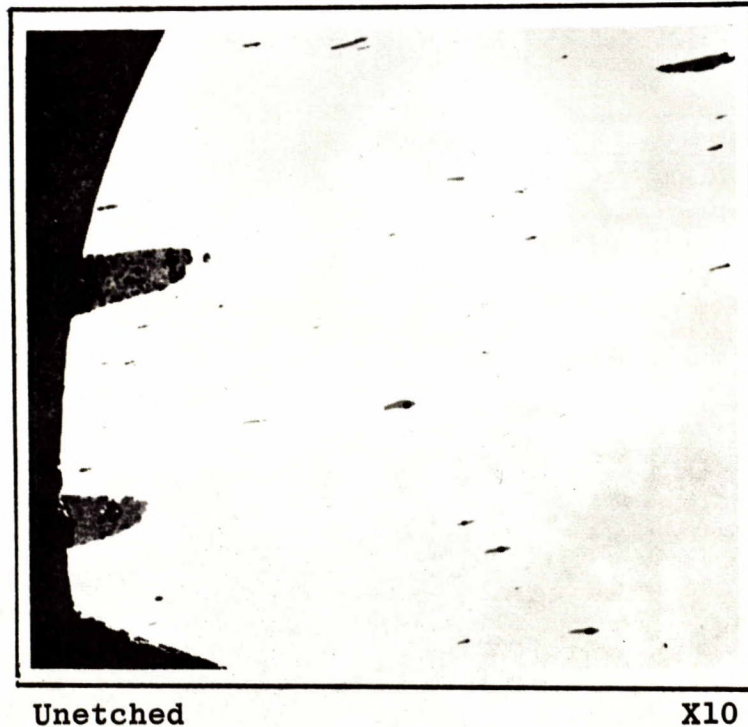
Figure 6. Two large inclusions located 2-7/8 in. from the end of the core from rotor M-1, shown in Figure 1.

This photomicrograph shows the difference in texture of the large inclusions as compared with the smaller inclusions nearby.

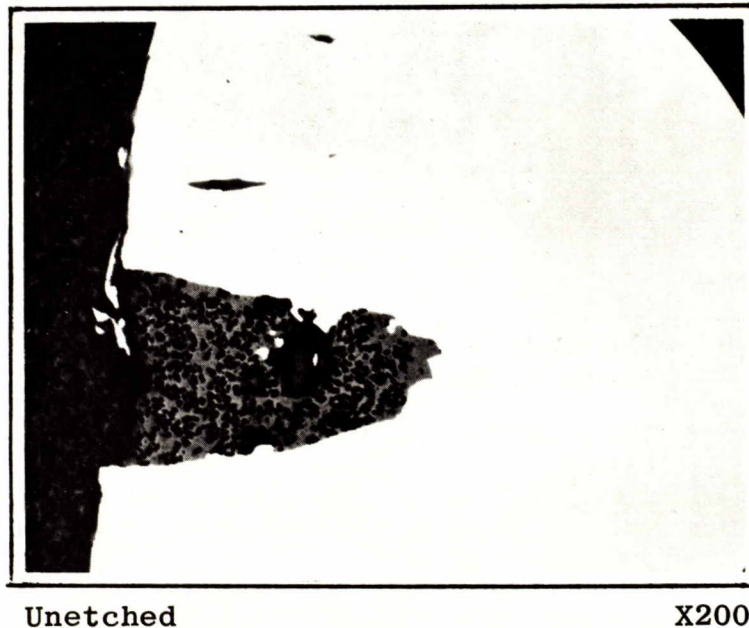
Figure 7. One of the large inclusions shown in Figure 6. This inclusion was selected for etching tests.

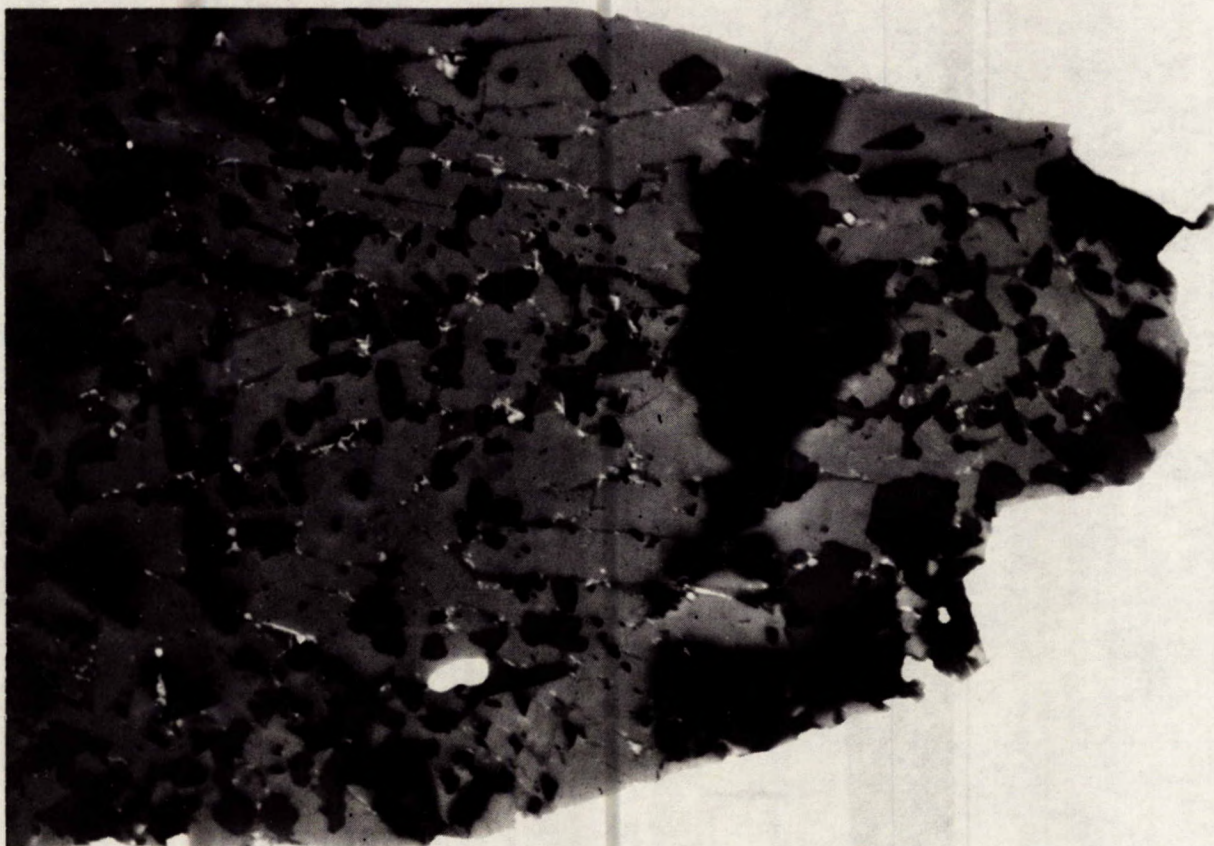
Figure 8. The second of the two large inclusions shown in Figure 6.

This inclusion was used for X-ray diffraction tests.

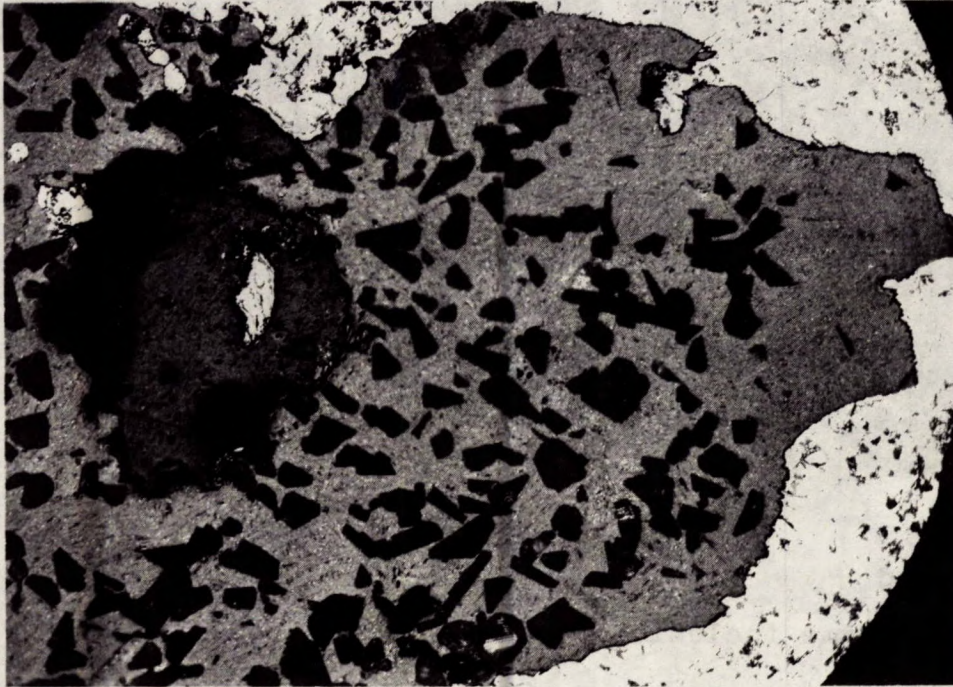
Figure 10. Same as Figure 9, after etching in 10% nital for 10 seconds.

This etchant caused no significant attack.

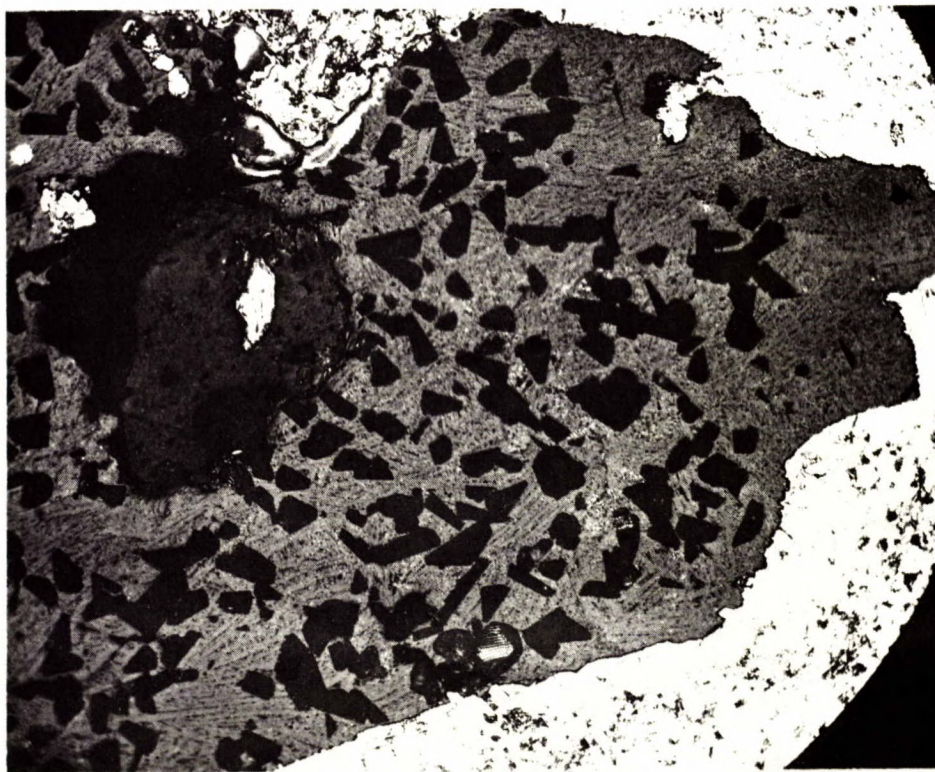
Figure 11. Same as Figure 10, after etching in 10% solution of chromic acid in water for 5 minutes.

Very slight attack, which is confined to some very tiny light particles in the matrix.

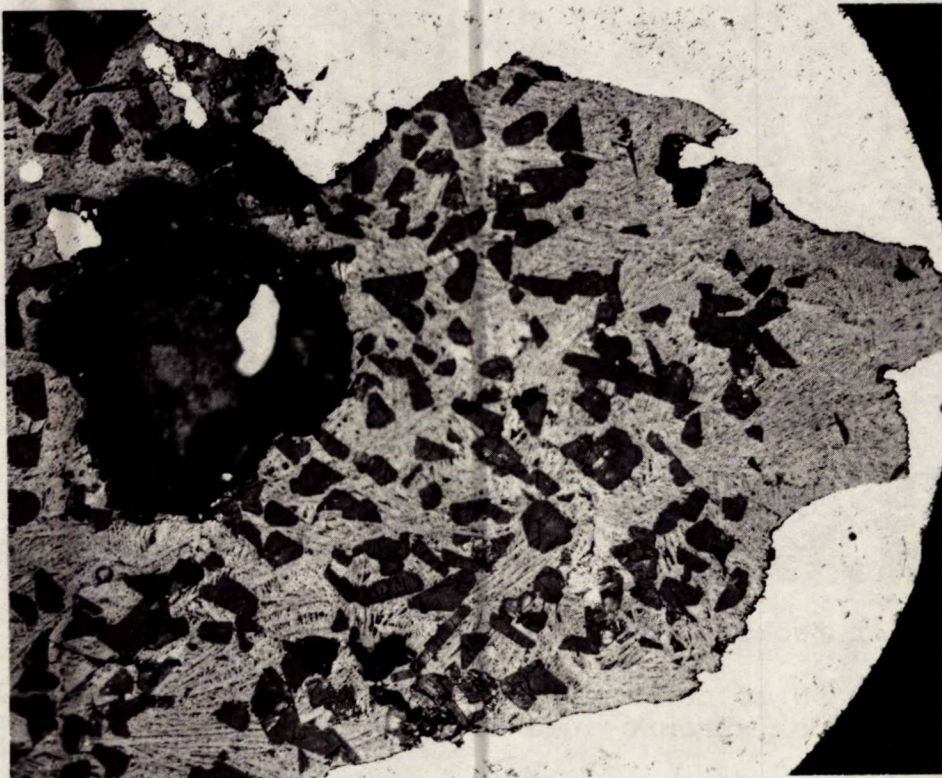
Figure 12. Same as Figure 11, after etching in boiling alkaline sodium picrate for 5 minutes.

The larger dark inclusion has been attacked, indicating an oxide rich in MnO . Slight attack in the grey crystals and the matrix may indicate the presence of oxides, such as the jacobsite revealed by petrographic techniques.

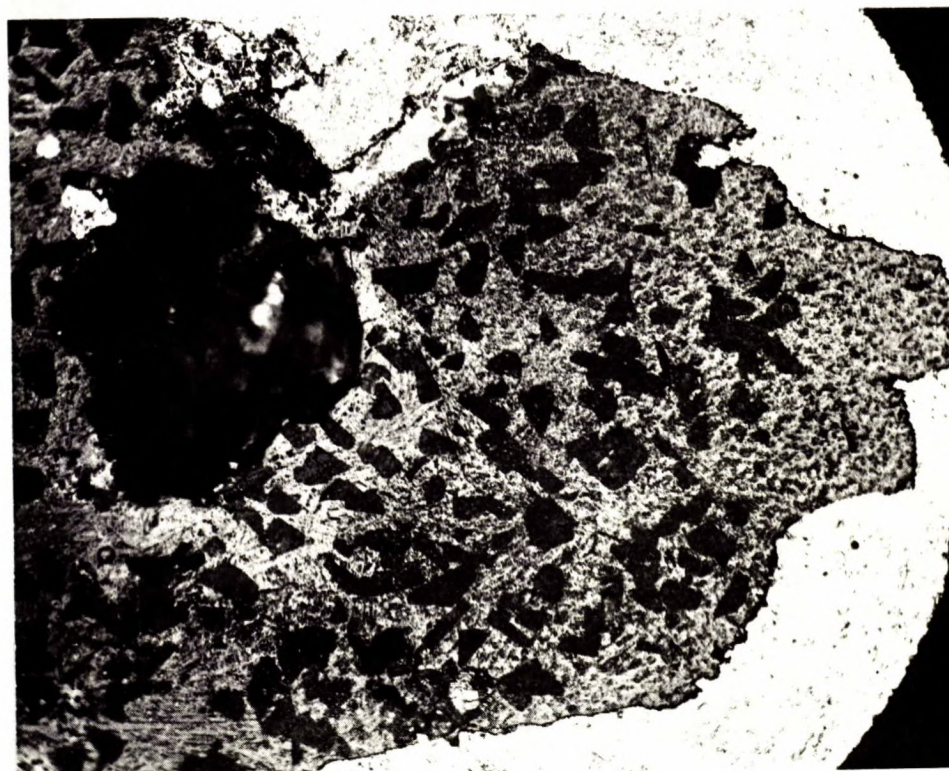
Figure 13. Same as Figure 12, after etching in a saturated solution of stannous chloride in alcohol for 10 minutes.

Additional pitting attack throughout indicates the presence of compound (FeMn) oxide. The dark-grey crystals and matrix show strong resistance to the etch.

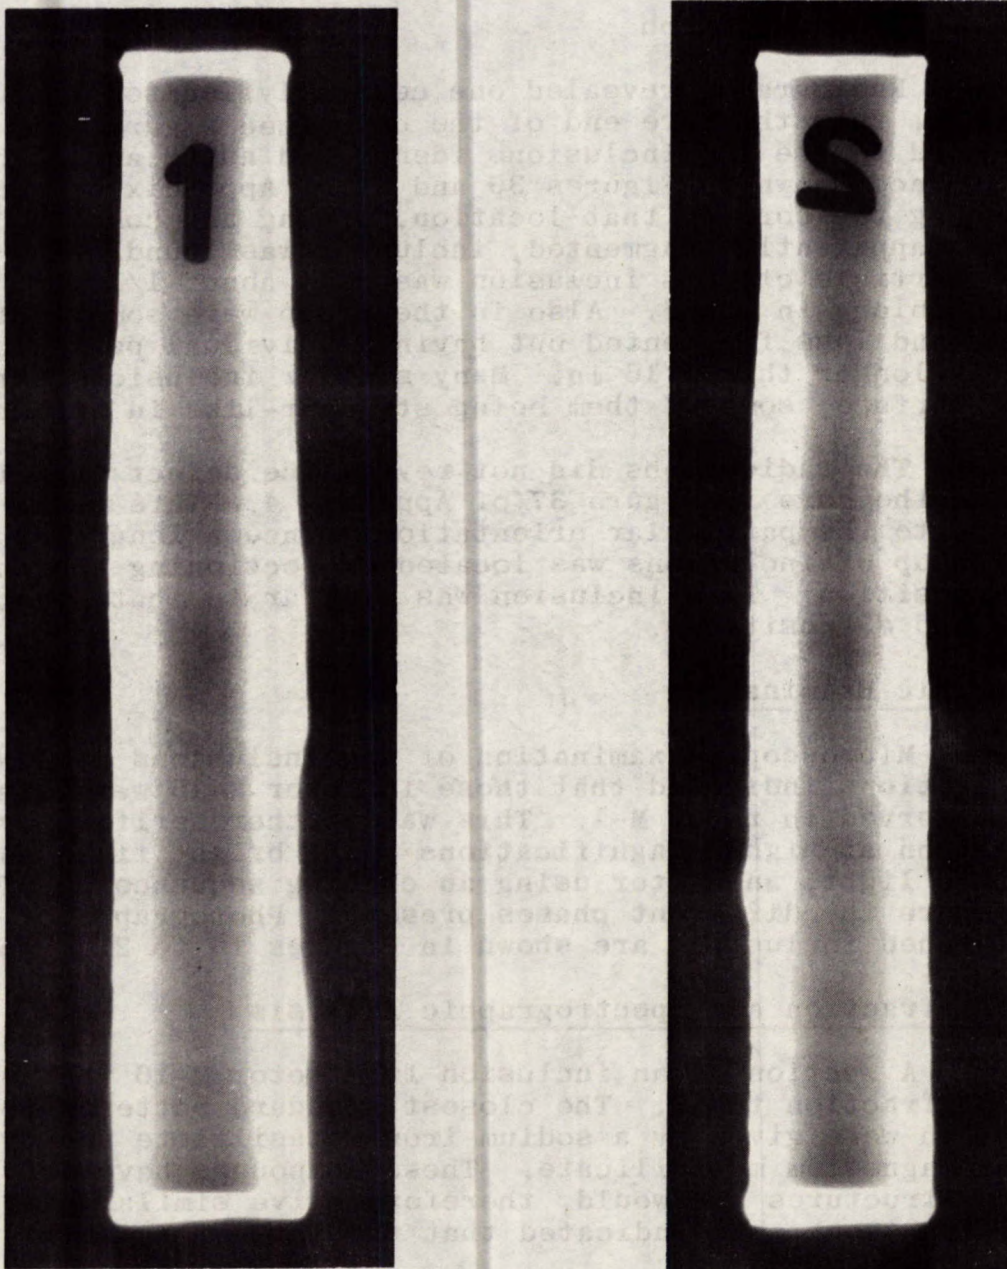
Radiographs revealed one centrally located inclusion at 2-5/16 in. from the bore end of the core (see Figure 15). It could correspond to the two inclusions identified as #2 and #3 on the core surface shown in Figures 36 and 37 of Appendix 4. On sectioning the core at that location, a long and continuous, although apparently fragmented, inclusion was found. The largest single particle of this inclusion was only about 1/16 in. long and was oblong in shape. Also in the group were some inclusions, smaller and less fragmented but having individual particles slightly longer than 1/16 in. Many similar inclusions extended to the surface, some of them being stringer-like in appearance.

Figure 15. Prints of radiographs of the core trepanned from main rotor M-16.

The core is radial, and the tops of the prints are adjacent to the bore of the rotor. The numbers were used on the core to orient the radiographs at 90° with respect to each other. The light streak in the dark area of the print is evidence of the group of inclusions located 2-5/16 in. from the bore (shown as defect area No. 2 in Figure 36 of Appendix 4). The other group one inch from the core cannot be detected on these prints.

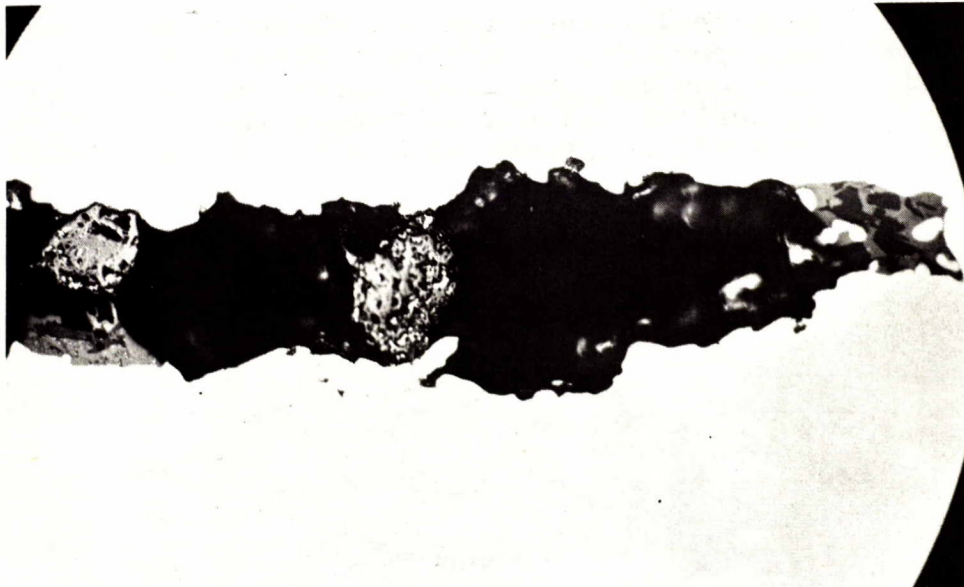
Figure 17. Same as in Figure 16, at higher magnification. This inclusion has been partly removed for diffraction tests. Note dark grey crystals within lighter matrix at end. Note, also, some spherical or hemispherical globules of pearly-grey material.

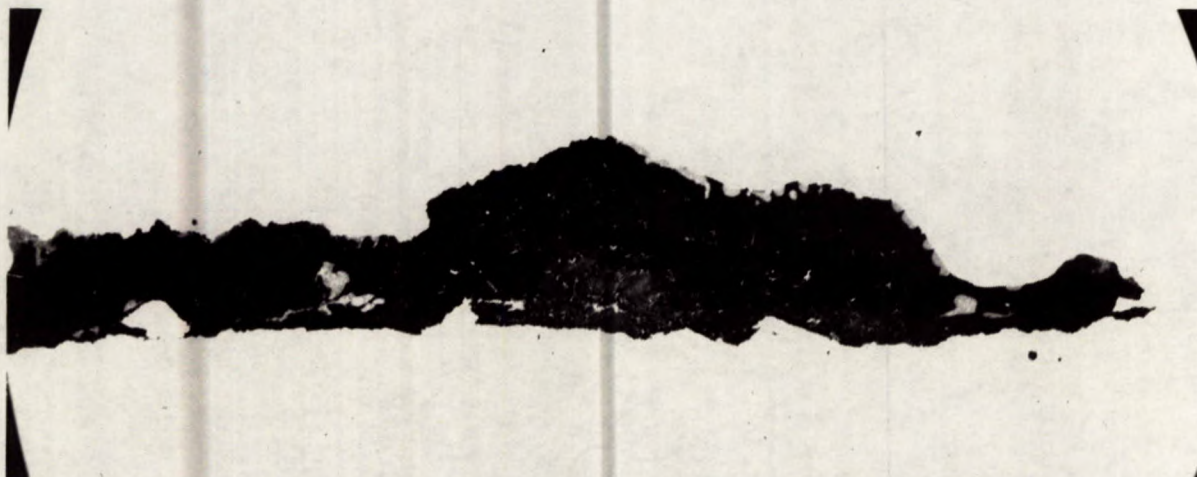
Figure 18. Inclusion from group located in core from M-16 one inch from the bore end. (This corresponds to defect area No. 1, shown in Figure 37 in Appendix 4.)

This inclusion, like all of those observed at this position, contains a dark-grey matrix, vitreous in appearance; pearly-grey globular inclusions, mainly at the periphery; and a crystalline phase, within the matrix, which is darker grey.

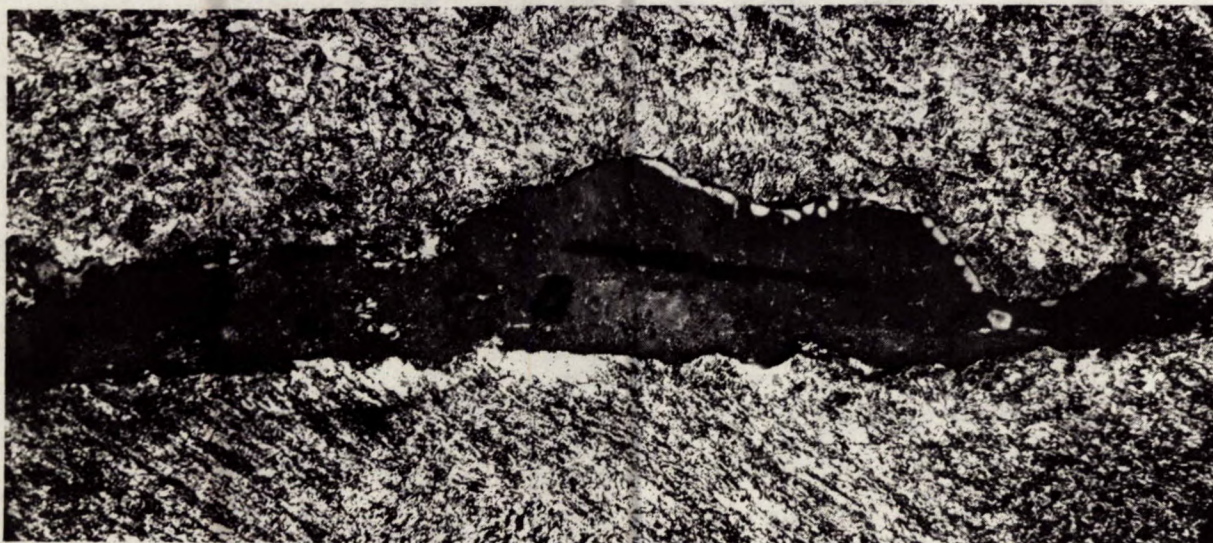
Figure 19. Same as Figure 18, after etching in 10% nital for 10 seconds.

The only change might be a slight attack on some of the globular inclusions, indicating FeO-FeS or FeO-MnO.

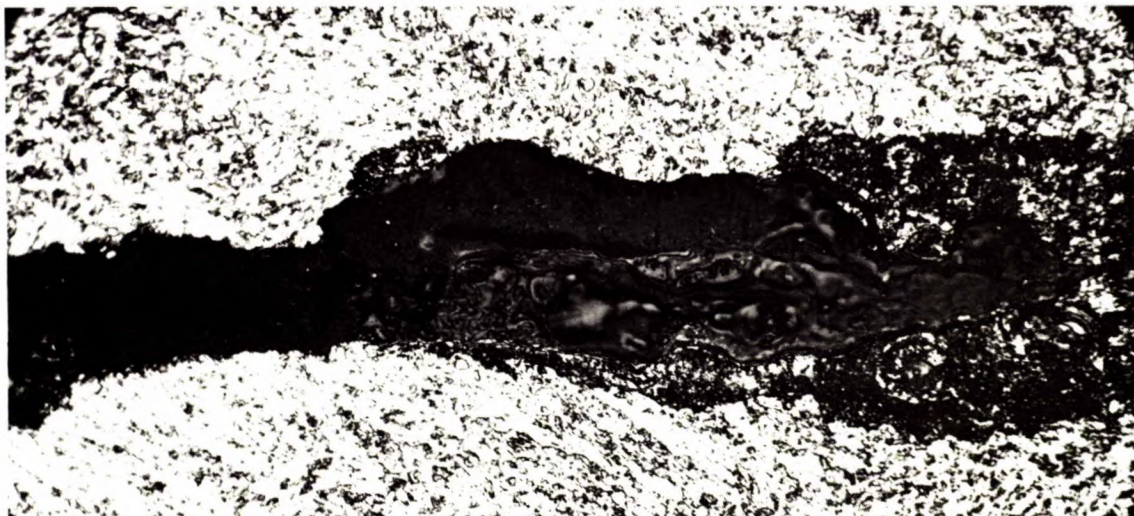
Figure 20. Same as Figure 19, after etching in 10% solution of chromic acid in water for 5 minutes.

The remaining grey globular inclusions were attacked, showing that they consist of FeS-MnS rich in MnS. Some staining has occurred on the lower half of the inclusion.

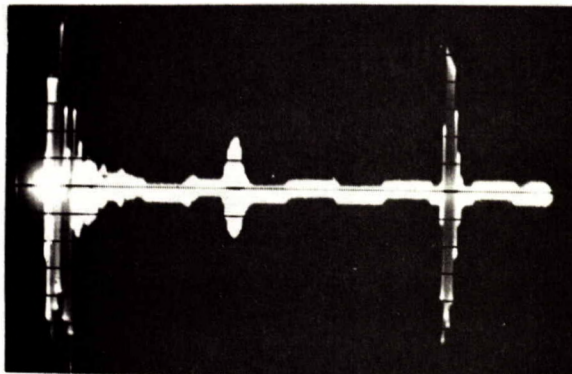
Figure 29. Defect #27 at location of max. size.
Clock reading, 7.30.
Distance from crystal, 7-1/2 in.
Distance from top of 33 in. Ø section, 17 in.
1 Mc Frequency.

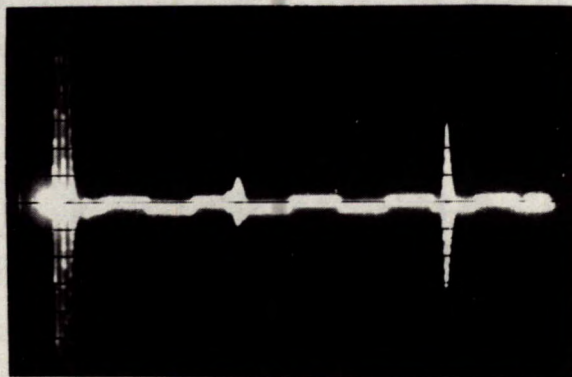
Figure 31. Defect #27 at location of greatest loss of bore reflection.
Clock reading, 7.35.
Distance from crystal, 7-3/4 in.
Distance from top end of 33 in. Ø section, 16-3/4 in.
5 Mc Frequency.

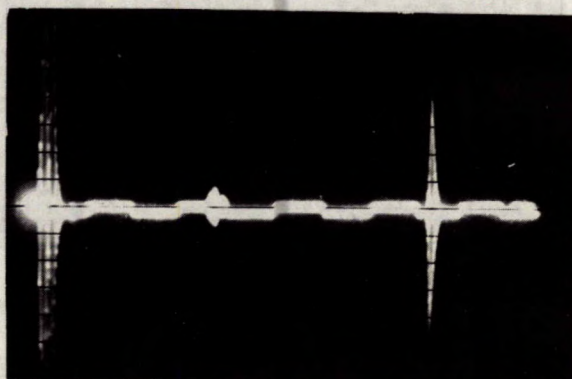
Figure 32. Defect #27 at location of min. distance of defect to crystal.
Clock reading, 7.25.
Distance from crystal, 7-1/4 in.
Distance from top end of 33 in. Ø section, 17-3/8 in.
5 Mc Frequency.

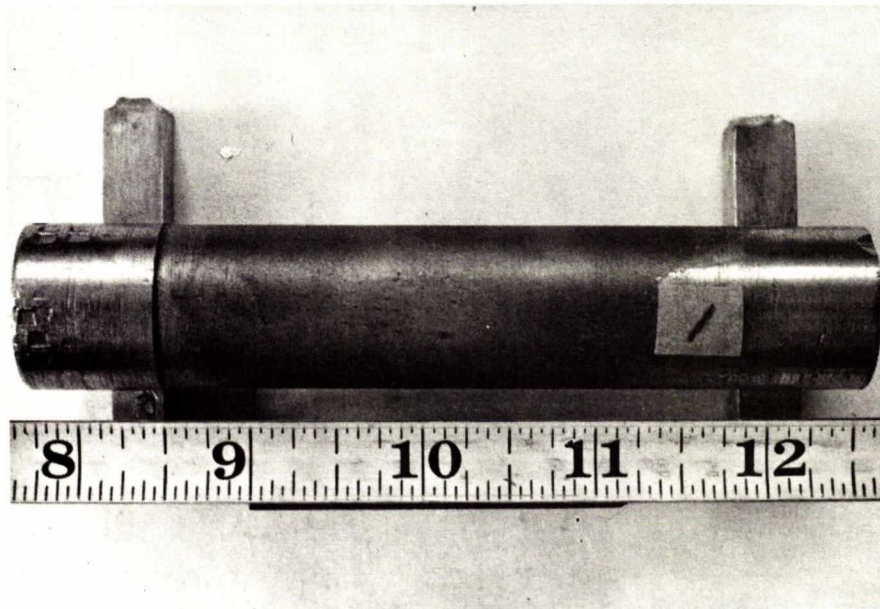
On the surface of the core, non-metallic inclusions could be readily seen. The inclusions passed right through the core from one side to the other. The defects appeared at a point 2-3/8 in. from the outside end of the core and extended over a 5/8 in. length. The appearance of the defects after magnetic particle testing is illustrated in Figures 33 and 34.

Figure 33. Core piece containing defect No. 27, after magnetic particle testing.

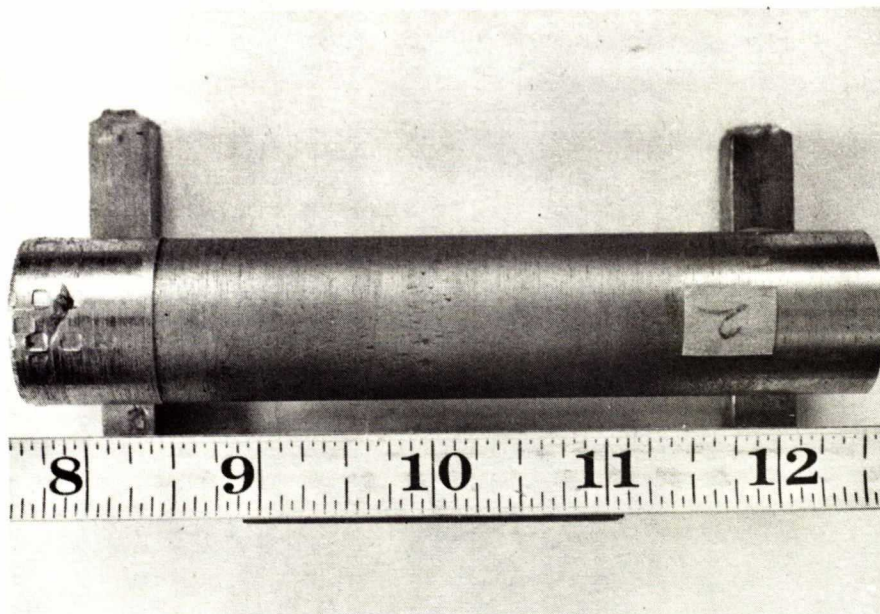
Figure 34. Core piece containing defect No. 27, after magnetic particle testing; the core is turned 180° from the view shown in Figure 33.

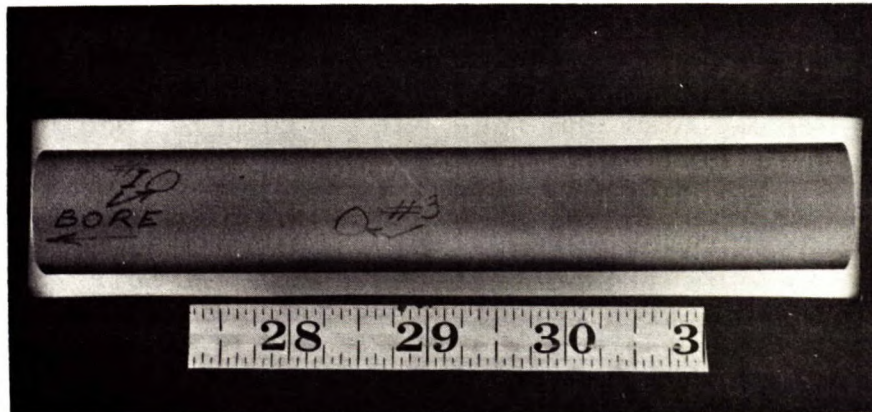
Figure 35. Core piece as removed from rotor M-16, in the non-magnafluxed condition. Defective areas Nos. 1 and 3 are outlined.

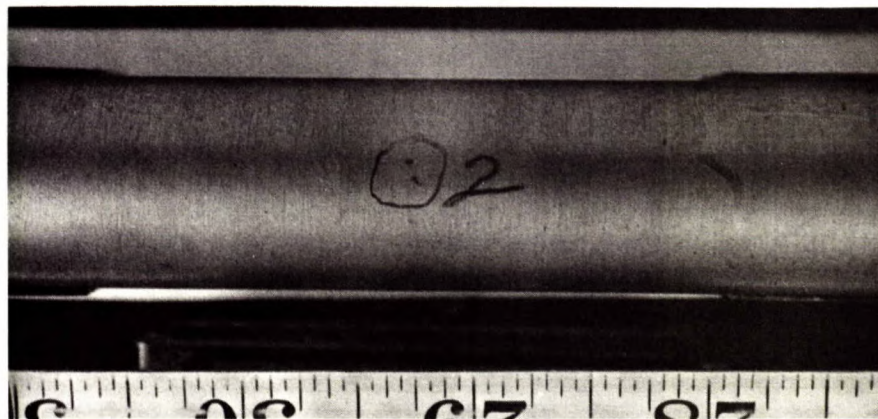
Figure 36. Core piece as removed from rotor M-16, in the magnafluxed condition, turned 180° from the view shown in Figure 35. The No. 2 defect area is located approximately opposite to defective area No. 3. This defective area is invisible without magnetic particle inspection.

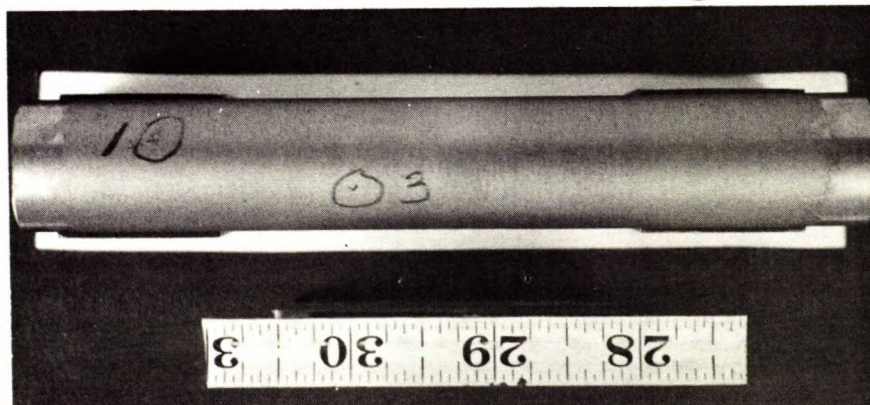
Defects Nos. 1 and 3 stood out more clearly after magnetic particle testing, as illustrated in Figure 37.

Figure 37. Core piece as removed from rotor M-16, in the magnafluxed condition. Defective areas Nos. 1 and 3 are outlined.

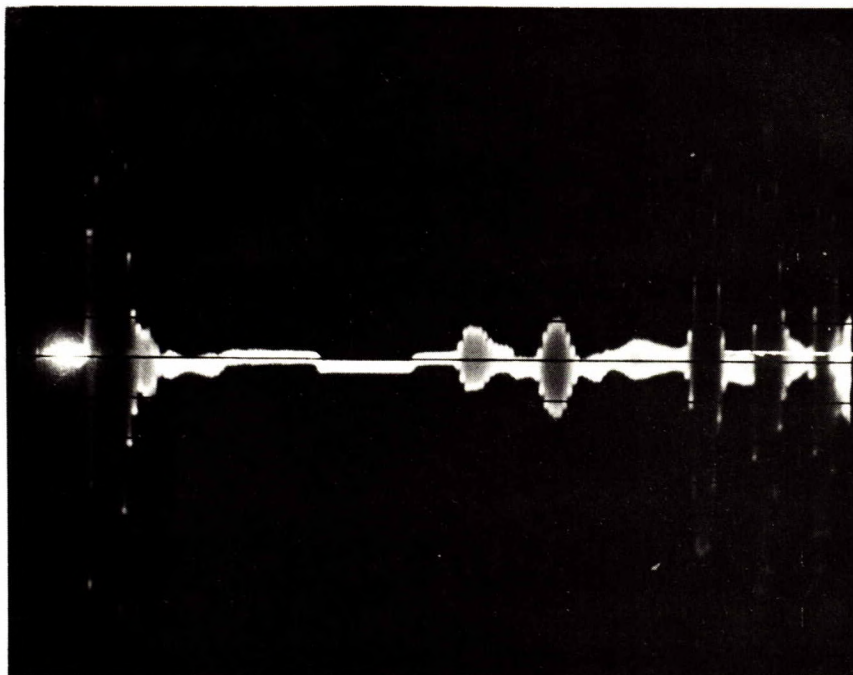
Figure 38. Reflectogram illustrating indications from core containing defect No. 6. $2\frac{1}{4}$ Mc setting.
