MINES BRANCH INVESTIGATION REPORT IR 63-10

**EXAMINATION OF EXHIBITS
FROM THE SCENE OF A NATURAL GAS
EXPLOSION AT 687 ALBERT STREET,
OTTAWA, ONTARIO, JANUARY 10, 1963**

R. F. KNIGHT

FEBRUARY 4, 1963

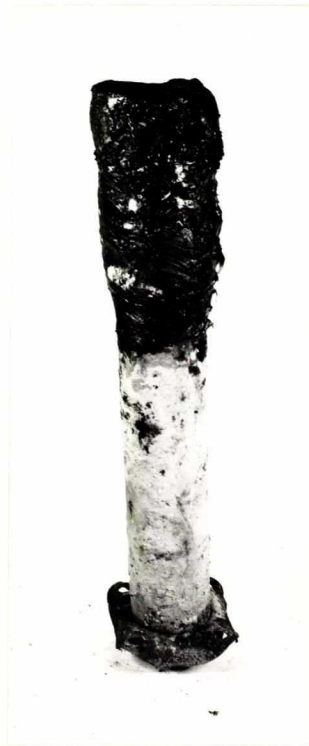
Figure 1. Exhibit No. 1 - As-Received.

This figure is shown for purpose of identification only. The fracture surface is obscured by material applied at the site to seal the break.

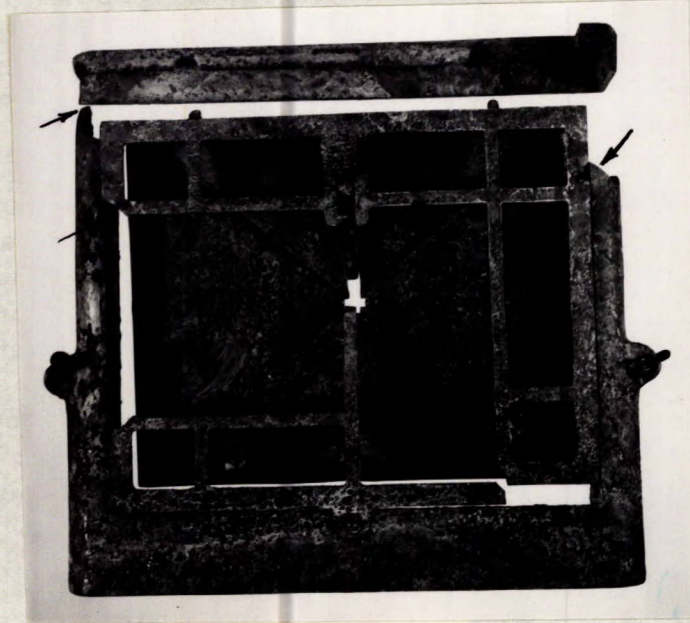
Figure 2. Exhibit No. 2 - As-Received.
The location of the fractures are indicated by arrows.

The orientation of the fractures on Exhibit No. 2 appears to be consistent with the explosion. It is apparent that the damper was swung outward by the blast causing the fractures in the grille. The freed portion of the grille continued to swing outward, resulting in the fracture of the frame. All fracture surfaces were heavily rusted, but no gross defects or indications of pre-existing cracks were apparent. Hence, it is assumed that all fractures resulted from the explosion.

2. The orientation of the fractures in Exhibit No. 2 is consistent with the occurrence of an explosion in the room beneath the register.
3. Exhibit No. 1 is a grey cast iron in the annealed condition. Although the material used would have low strength and negligible ductility, it was certainly adequate for the service required, precluding accident.

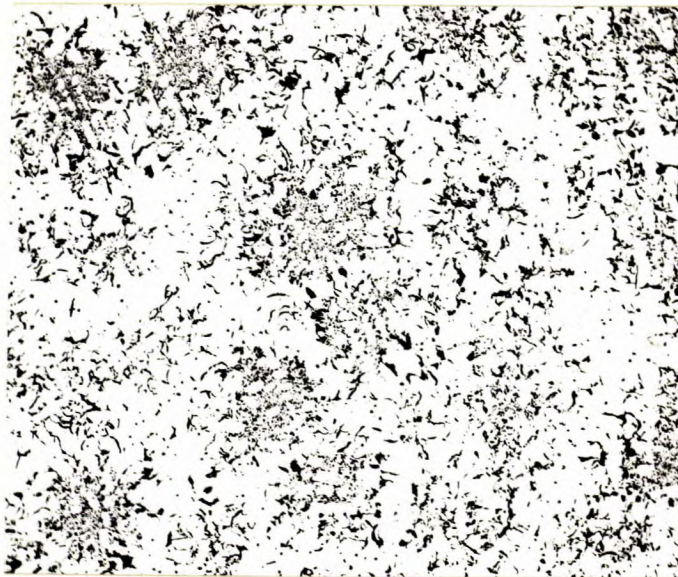
Figure 3. As-polished Sample from Exhibit No. 2.

Shows a random distribution of fine flake graphite, and clusters of undercooled graphite.

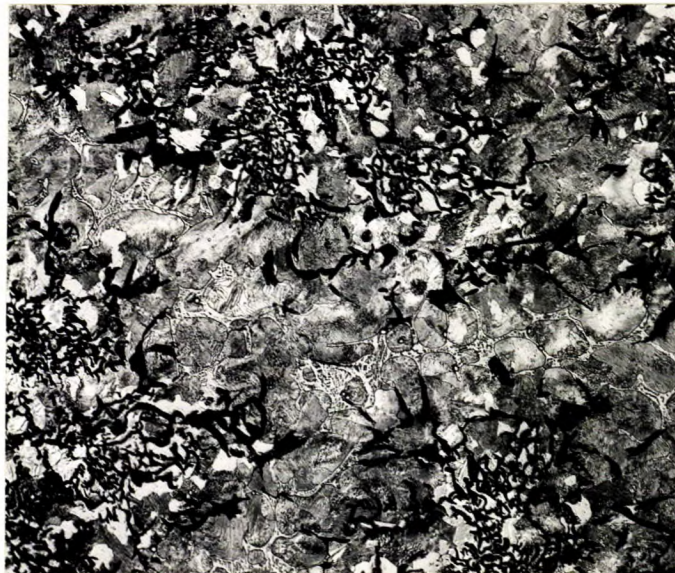
Figure 4. Microstructure of Exhibit No. 2.

The structure consists of a matrix of pearlite (grey), islands of ferrite (white) associated with the graphite (black), and a considerable quantity of phosphide eutectic (mottled intergranular phase).

(Hardness-240 BHN)

The microstructure and hardness of this specimen is as would be expected for high-phosphorus, sand-cast, grey iron. The clusters of undercooled graphite are normal for such thin sections. The large quantity of phosphide eutectic indicates that phosphorus was purposely added, presumably to increase fluidity. By nature this material is extremely brittle, and would absorb little impact energy before breaking in the circumstance of an explosion in the room beneath.

1. Exhibit No. 2 is a pearlitic grey cast iron in the as-cast condition. The material is brittle by nature, but is a normal material for this application.

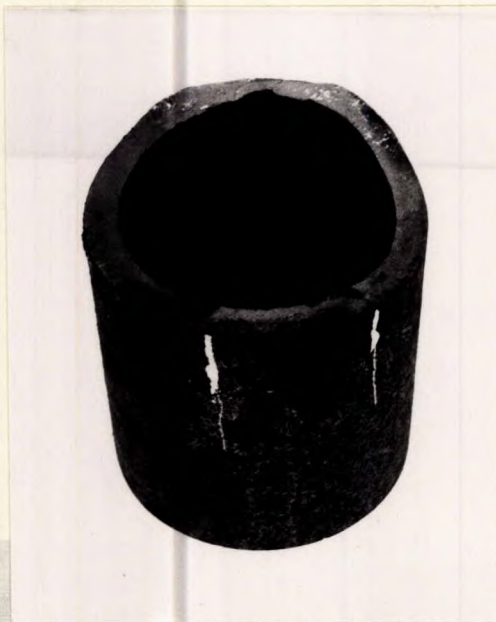
Figure 5. Fracture Surface of Exhibit No. 1

The fracture surface between the white marks, corresponding to the bottom of the pipe, showed considerable rust. The light fracture at the top was deformed due to the compressive forces. The remainder of the fracture was the grey colour characteristic of tensile fractures in grey iron.

Considerable quantities of rust were evident on the portion of the fracture corresponding to the bottom of the pipe. This indicated that a crack had been open for some time prior to the final rupture of the pipe. In removing the sealing compound that had been applied at the site, much of this rust was unavoidably removed as well. However, examination under a stereoscopic microscope revealed sufficient adhering traces of rust to indicate that the initial crack had extended between the white marks of Figure 5.

4. A portion of the fracture surface, corresponding to the bottom of the pipe, was rust-coated, whereas the remainder of the fracture was fresh. This would indicate that a crack was present prior to the final fracture, allowing moisture to seep in and, of course, gas to escape. No estimate of the age of the initial crack could be made.

5. The fracture appearance is consistent with a movement of the free end of the pipe due to ground heaving causing the initial crack to occur where the pipe was constrained from movement by a mass of concrete.

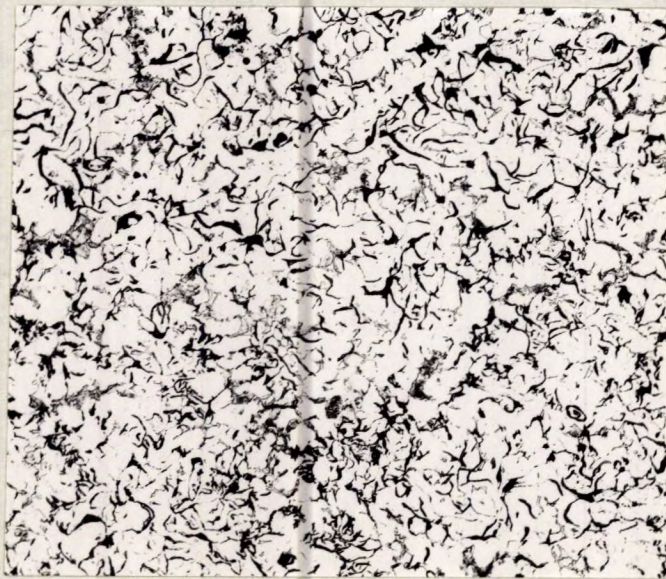
Figure 6. Microstructure Near Pipe Surface.

This photomicrograph shows a ferritic matrix (white, a small amount of pearlite (grey), iron phosphide (small white islands) and "kish" and fine flake graphite (black). The hardness at the surface is 141 BHN.

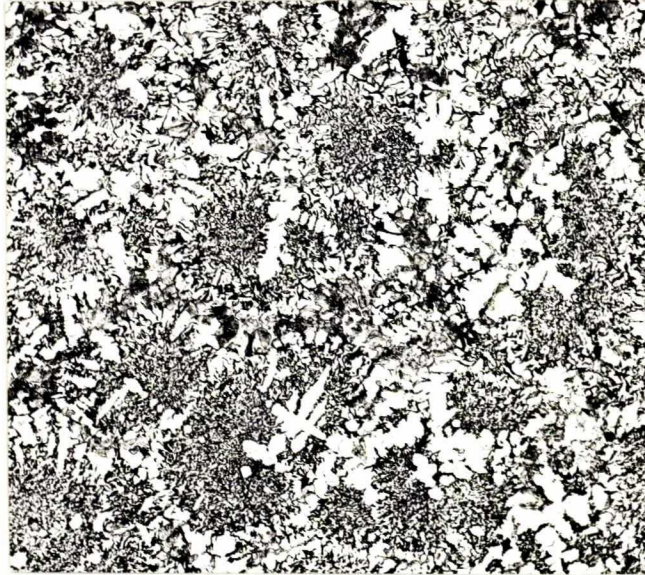
Figure 7. Microstructure Near Centre of Section.

The matrix is mostly ferrite (white dendrites and background). More pearlite (grey) is seen than in Figure 6. Iron phosphide (small white islands) are also discernible. The graphite is in three shapes, "kish", fine flake, and "undercooled". The hardness at the centre is 169 BHN.

The examination revealed no defects in the material that would cause the failure assuming proper handling. Cast iron is brittle by nature and this particular material would probably have a low tensile strength (in the range 25,000 to 30,000 psi). Thus, a reasonable amount of care in handling is required. It has a distinct advantage over mild steel in that it exhibits markedly superior corrosion resistance. Satisfactory protective procedures for mild steel pipe have been perfected only in recent years.
