MINES BRANCH INVESTIGATION REPORT IR 63-54

**METALLURGICAL EXAMINATION OF MITRE
GATE LIFTING DEVICES FORGED SOCKETS**

R. K. BUHR

MAY 24, 1963

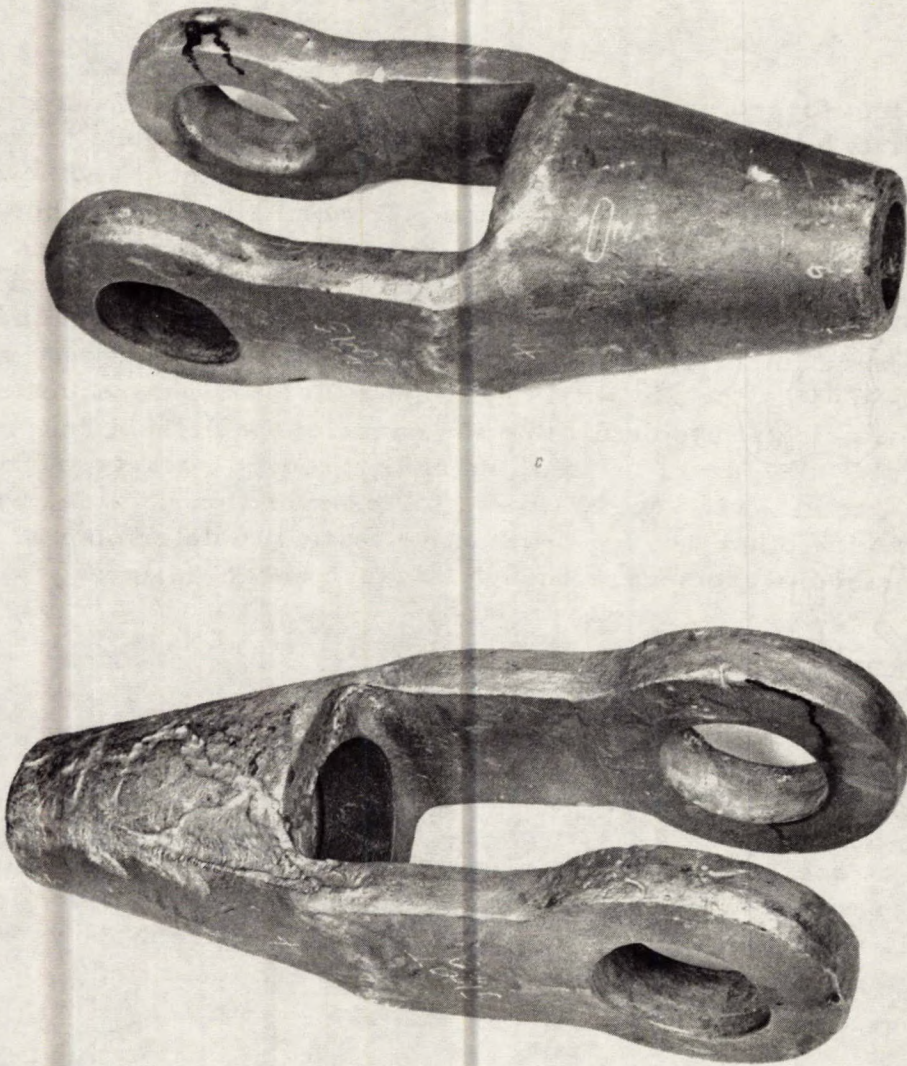
The deep grooves were present on only one side of the sockets. The photographs in Figure 1, show the two sides of the socket identified as "C", and is typical of that found in socket "B". Figure 2 shows socket "A" that contained only a few minor laps, which are identified by arrows.

Figure 1. Photographs of two sides of socket "C" showing the deep grooves on one side only (bottom photograph). A small magnaflex indication is shown circled in the top photograph, identified by "M".

The postulation that the grooving was entirely due to zinc attack at a high temperature has been verified. Recent information has been obtained which states that the forgings were desocketed and renormalized in one operation, i.e., the forgings (with the zinc and wire cables still intact) were piled in a normalizing furnace, heated to 870° to 900°C (1600° to 1650°F) held 1 to 1-1/2 hours, and removed and air cooled. Undoubtedly, what occurred was that the zinc melted and collected on the bottom, surrounding three of the eight sockets. The pool of molten zinc attacked these sockets, resulting in the grooves shown in sockets "B", "C", and

Suspend the sockets, pinhole down, from a rack. Place the rack of sockets in a furnace and heat to 425 to 450°C (800 to 840°F). The zinc should drain out and eventually the cable strands will drop out of the socket. This procedure will avoid undue contact of the sockets with the molten zinc. Tests at the Physical Metallurgy Division gave a desocketing time of about 3 hours, starting in a cold furnace.

The sockets should then be pickled to remove any zinc coating remaining, magnafluxed, renormalized (if this is thought to be necessary), shot blasted, and then regalvanized and the new cables socketted into place, in the normal manner.

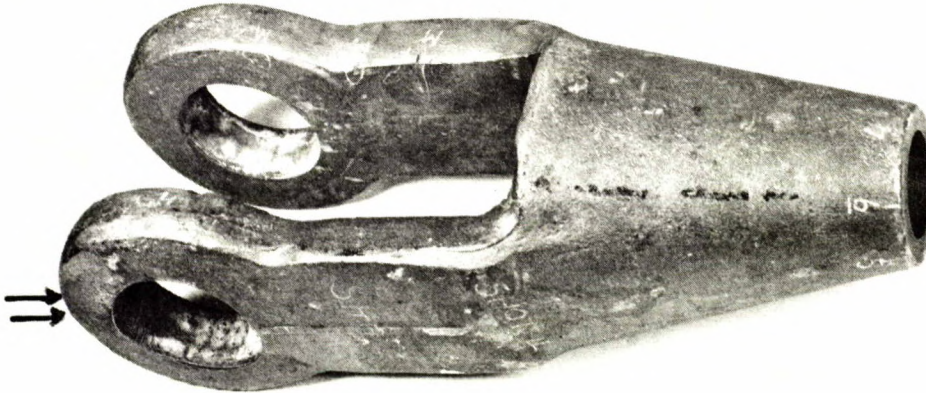
Figure 2. Photograph of socket "A" that contained no grooving as in "B" and "C", but which contained several magnaflux indications - three of which are circled in the upper area of this socket, identified by the letter "M". Arrows point out locations of two hairline cracks also found by magnaflux.

The sockets were then magnafluxed using the wet method and "black" light. This technique did show two hairline cracks at each edge of the parting line on the upper part of the socket above the pinhole in socket "A". The arrows in Figure 2 indicate the location of the two cracks.

The presence of the hairline crack in socket "A" might possibly be cause for concern. It cannot be stated that these cracks were present in service. All that can be said is that they were present before the final normalizing treatment, which occurred after these sockets were removed from service. It is significant that the cracks were too fine to be revealed by X-ray, but magnaflux did reveal them under "black light". Unfortunately, this technique is not readily performed "in situ", but all sockets should be checked by magnaflux when they are removed for cable replacement.

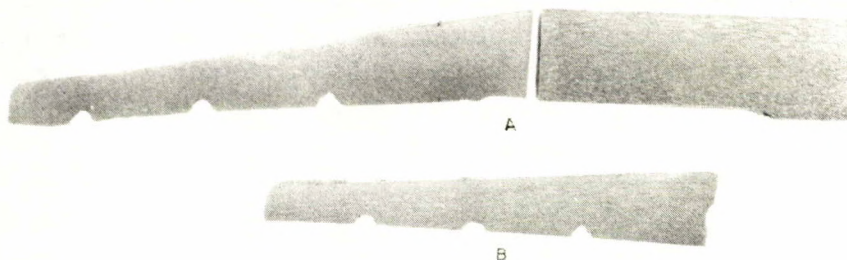
There was some question as to whether these sockets were forged or cast. Certain features of the surface indicated they were forged. However, deep etching was carried out on sections cut from sockets "A" and "B". Photographs of these sections after deep etching in 1:1 HCl at 75°C (165°F) are shown below in Figure 3, and verify that the sockets were forged, as evidenced by the flow lines discernible in the sections.

Figure 3. Photographs of sections from sockets "A" and "B" after deep etching, showing the presence of flowlines.

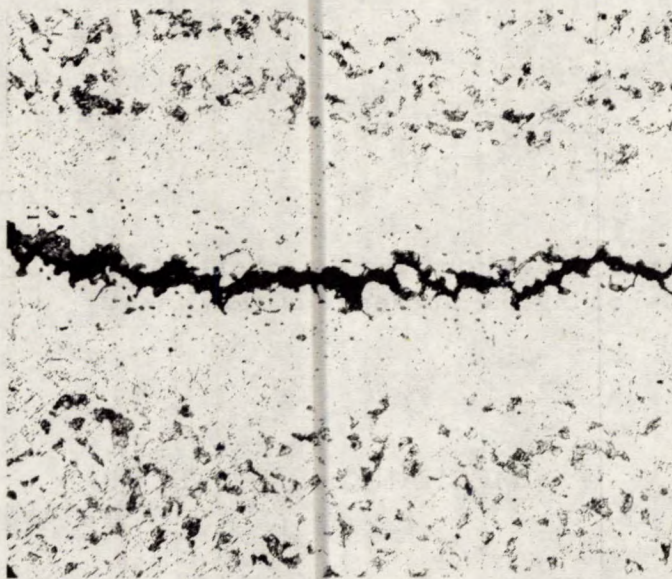
Several samples were cut from the sockets and suitably prepared for metallographic examination. Figure 4 is a photomicrograph taken of one of the hairline cracks found in socket "A". The area adjacent to the crack had been decarburized and indicates that the crack was present prior to the last high temperature heat treatment that the socket had undergone.

Figure 4. Photomicrograph showing one of the hairline cracks in socket "A". Note the decarburized layer adjacent to the crack.

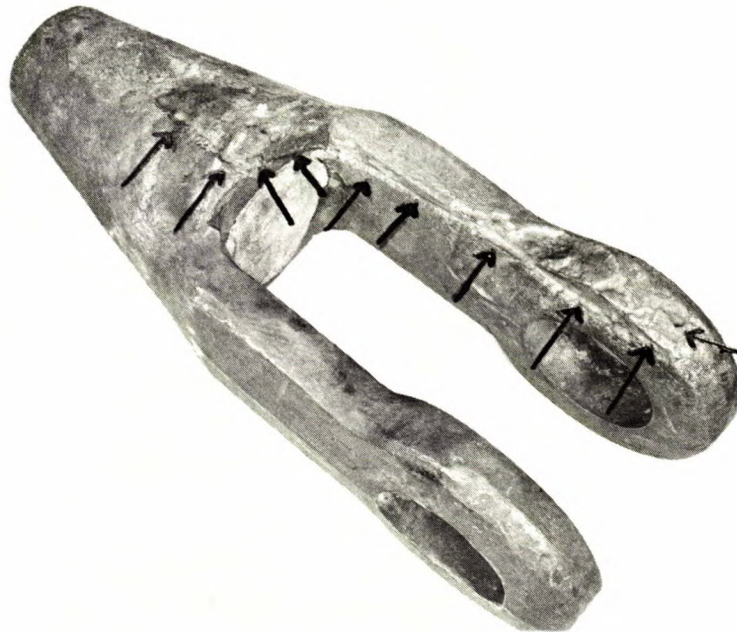
Figure 5. Photograph of socket "D" showing grooving and "liquid level" line (arrows) delineated by the grooves.

With this new evidence, it was postulated that the socket must have been subjected to high temperature heating while in contact with a pool of molten zinc for some period of time. Such conditions could account for the large metal loss.

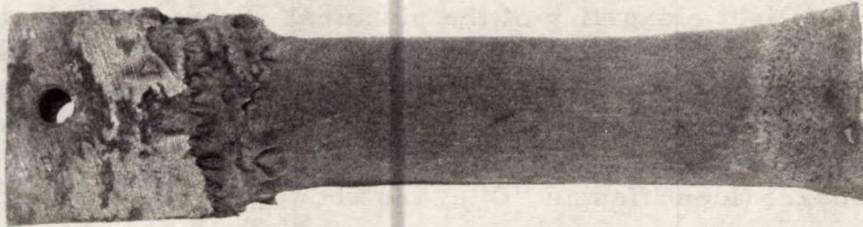
To verify this, a large sample was cut from socket "A" and about three-quarters of it was immersed in molten zinc at 500°C (930°F), heated to 800°C (1470°F) and held there for 1-1/2 hours. Weight loss measurements showed a 35% loss in this time and a type of attack very similar to that found in the sockets. Figure 6 is a photograph of the test sample.

Figure 6. Photograph of test sample after partial immersion in molten zinc at 800°C (1470°F) for 1-1/2 hours. Note smooth attack on body and undercutting at the air-metal interface (actually contained in a bone-ash flux layer to minimize zinc volatilization).
