MINES BRANCH INVESTIGATION REPORT IR 63-57

**EXAMINATION OF TWO SAMPLES OF FIRE
TUBE FROM A SCOTCH DRY BACK BOILER
INSTALLED AT BEACH FOUNDRY LIMITED,
OTTAWA, ONTARIO**

JUNE 11, 1963

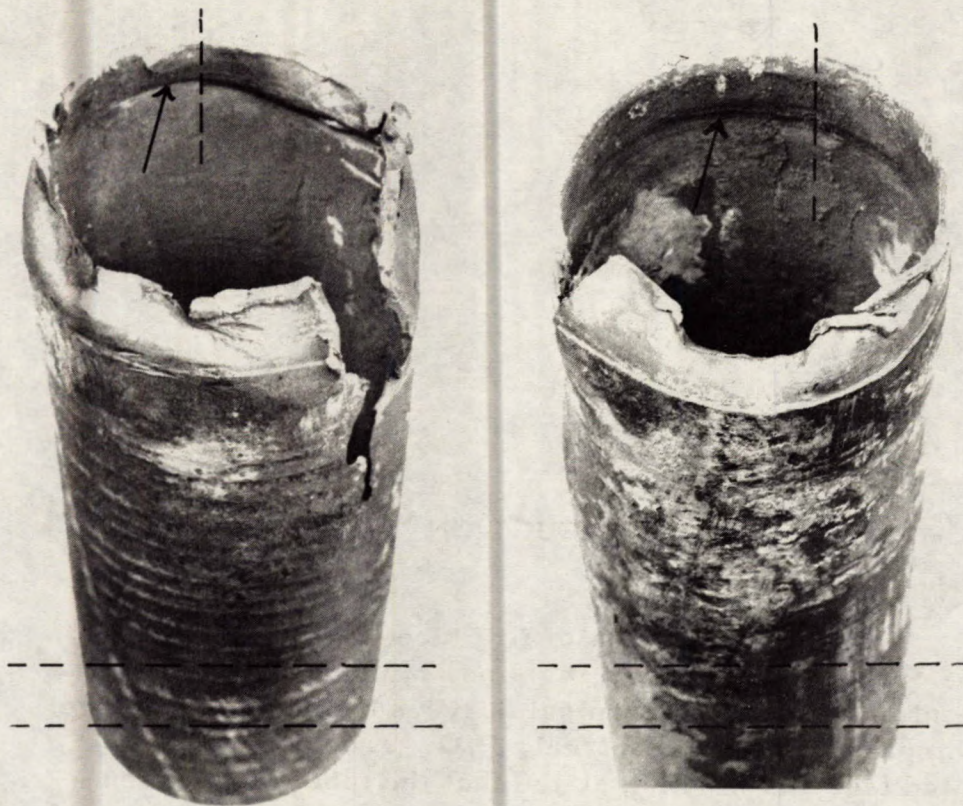
The appearance of the "as-received" samples is shown in Figure 1. The location of each of the circumferential grooves is marked by the arrows.

Figure 1. Boiler tubes with circumferential grooves (arrows).
The location of longitudinal and transverse sections
is illustrated.

The most conspicuous feature observed in each sample was a circumferential groove present on the inside tube surface opposite the ridge caused by the sealing process. These grooves were present for about half the circumference of the tubes and were about $\frac{3}{4}$ in. from the end of the tube. The grooves also contained two or three ring-like marks, which were faintly visible inside and parallel to the main groove.

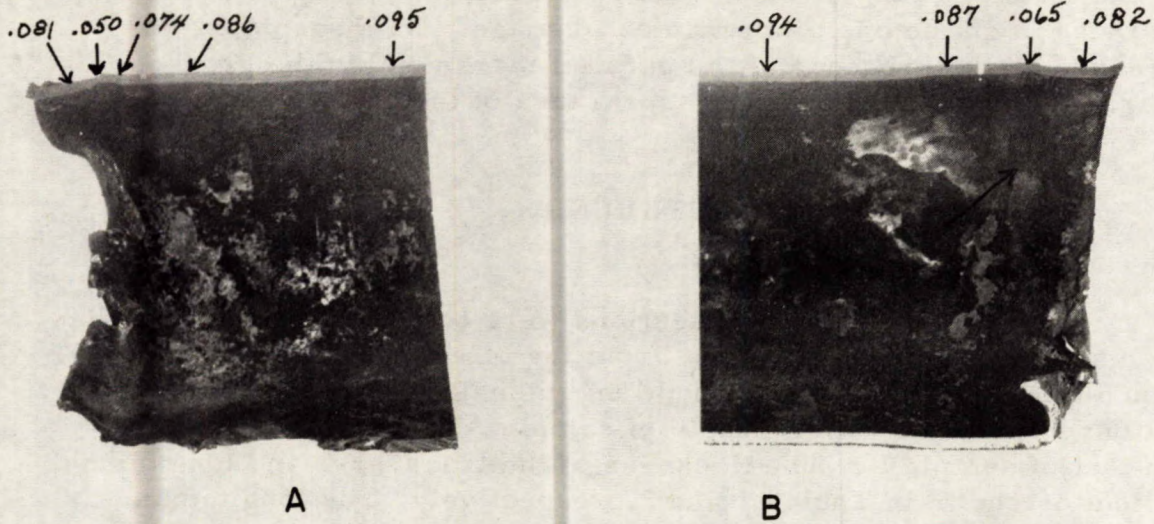
The appearance of the circumferential grooves suggests the possibility that these might be due to mechanical damage. This suspicion was increased by the presence of the parallel marks within the grooves. Figure 2, Sample B, shows the appearance of the parallel marks.

Two transverse sections were cut from each of the tubes at a distance approximately 4 in. from the tube-ends. The remainder of each tube sample was sectioned longitudinally. The longitudinal sections showed the groove-depth of sample A to be slightly greater than that of sample B. The thickness of the transverse and longitudinal sections is shown in Tables 1 and 2, respectively. The longitudinal sections are illustrated in Figure 2.

Maximum reduction of section was observed in sample A. The thickness of this section was reduced to 0.050 in.

Figure 2. Longitudinal half sections adjacent to tube-end. The sections used for the thickness results, listed in Table 2, are shown at the extreme top left and top right of the pictures for samples A and B, respectively. The parallel ring marks inside the groove are shown in sample B (arrow).

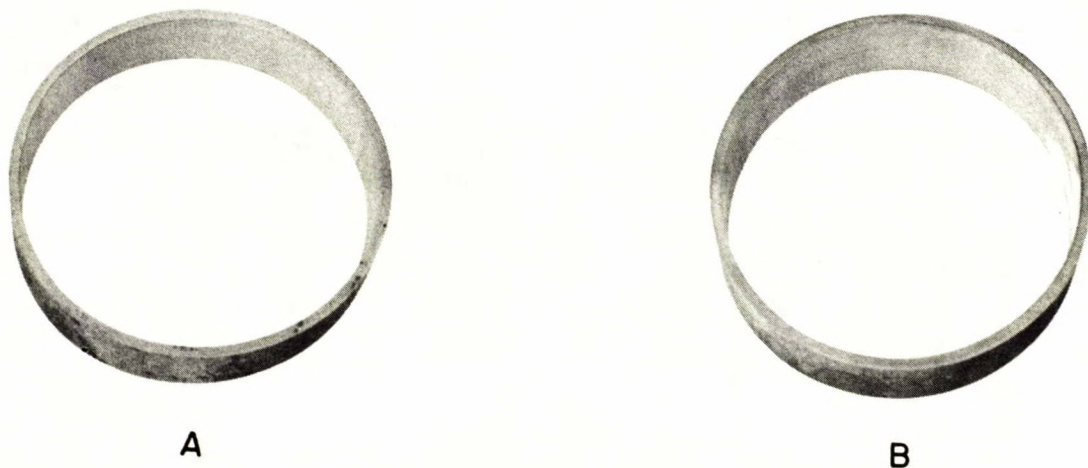
Transverse sections were deep-etched in 1:1 HCl: water at 71°C-76°C (160°F-170°F) for 10 min. The weld area was revealed and appeared to be an electric resistance butt weld. The inside surface of the tube etched uniformly. Shallow pits were observed on the outside surfaces after deep etching.

Figure 3. Deep etched transverse sections, approximately 4 in. from tube-ends. Thickness measurements, shown in Table 1, were taken on these sections. Thinning of these sections is not apparent.

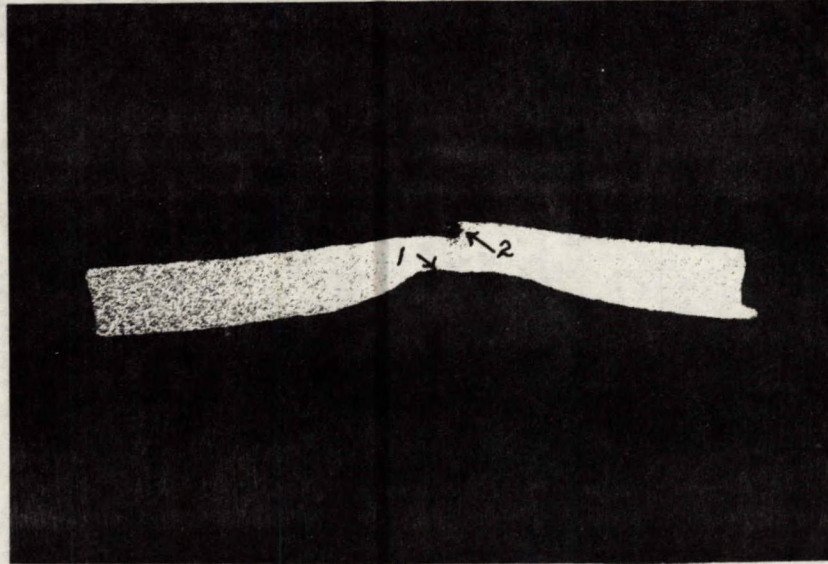
(a) X4
Sample A - Longitudinal Section

The appearance of longitudinal sections through the grooves in samples A and B is shown in Figure 4(a) and (b), respectively. The grooves in each section are marked (arrows 1). The shoulder caused by the sealing ridge is marked (arrows 2).

Figure 4. Longitudinal section through grooves, samples A and B.
Note: Grooves on inside surface arrow 1, sealing ridge arrow 2.

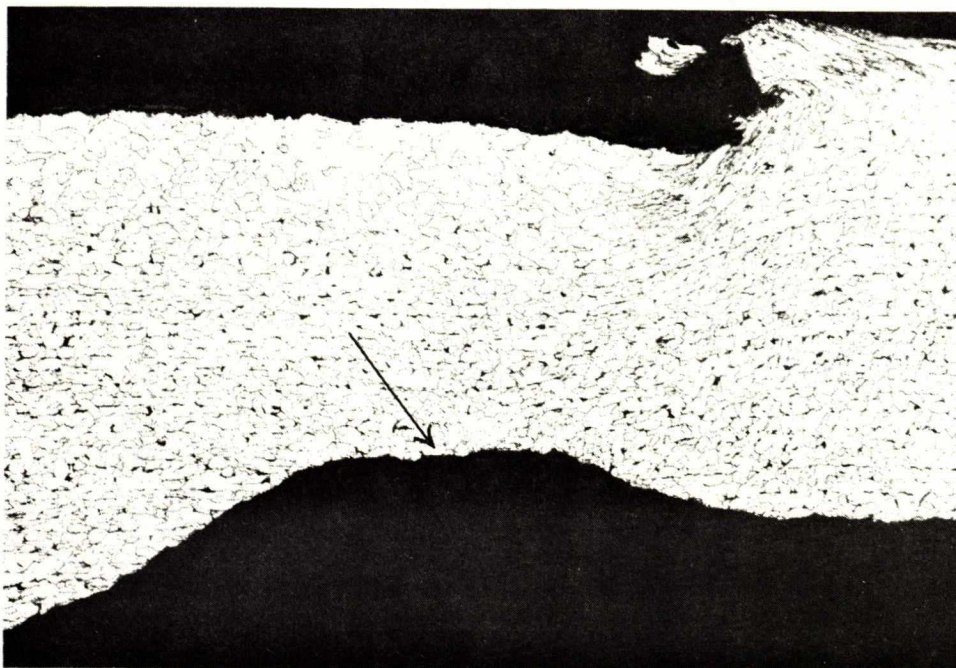
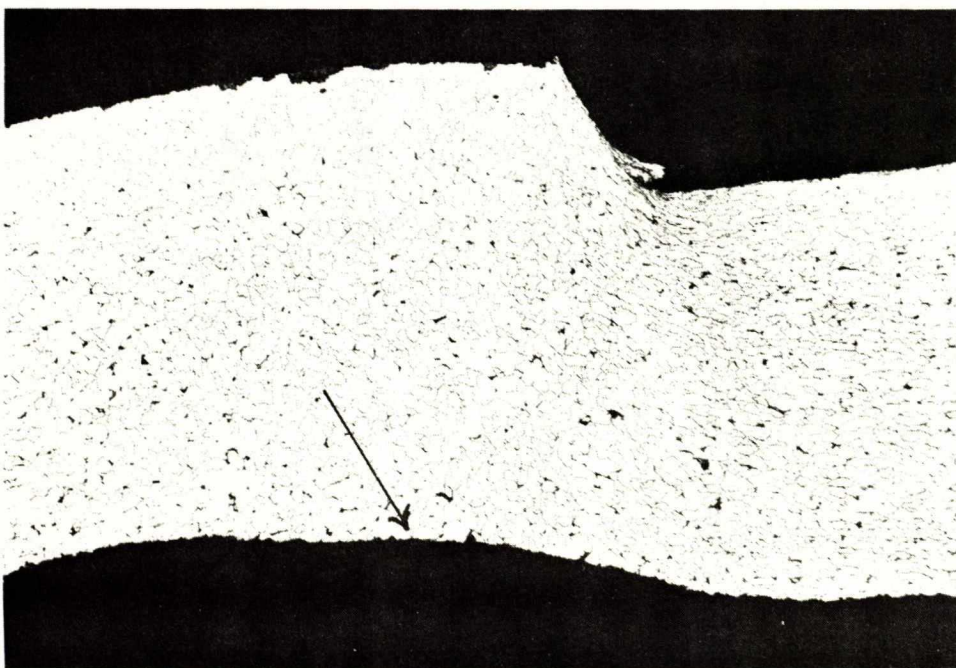
Figure 5. Same areas as Figure 4. Longitudinal sections, samples A and B. Cold-worked metal is visible at the outer surface adjacent to the sealing ridge, but is not conspicuous in the region of the grooves (arrows).

Examination of the tube microstructure, in the region of the grooves, does not show any signs of severe deformation that would be expected as a consequence of mechanical damage. Rather, the extension of the grooves through the flow lines suggests only a corrosion attack in this region.

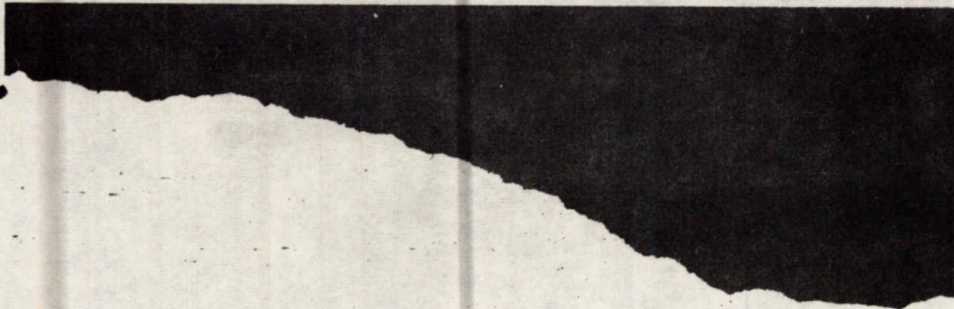
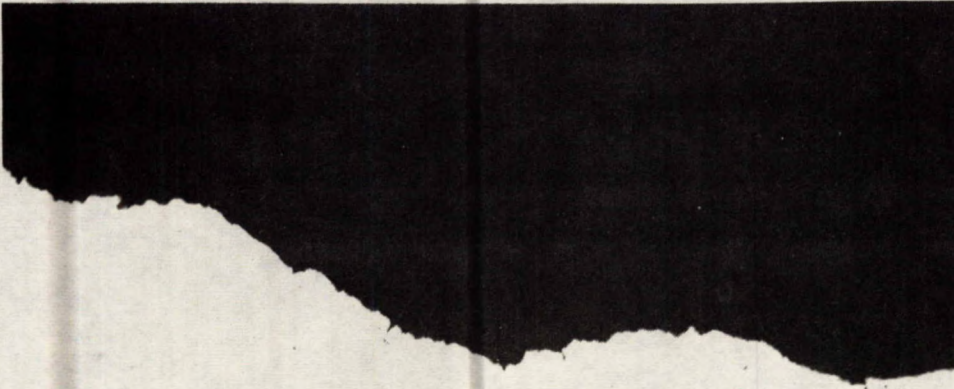
Figure 6. Sample A. Inside tube surface. Generalized pitting and grain boundary attack ascribed to sulphuric acid are visible in Figure 6 (b).

The presence of $\text{FeSO}_4 \cdot \text{H}_2\text{O}$ on the inside surface (fire side) confirms the suspicion that sulphuric acid attack has occurred. The shallow pits on the outside surface (water side) may be due to corrosion by the boiler feed water.

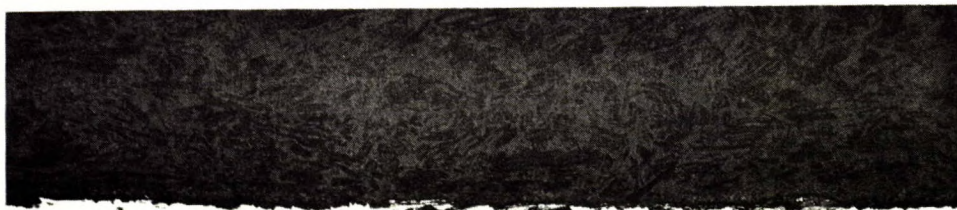
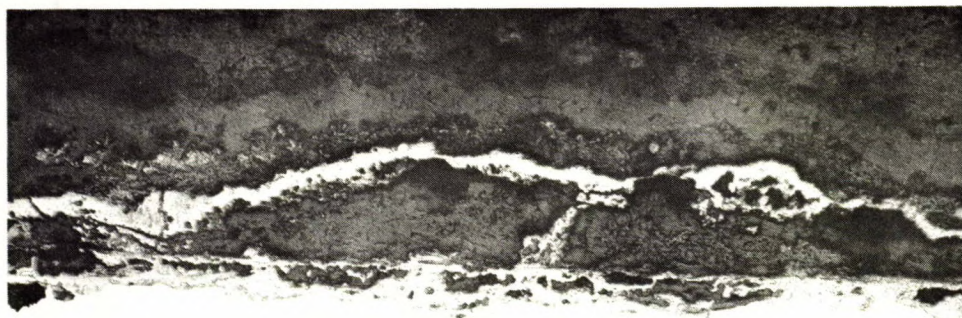
The appearance of the (water side) outside surface scale in sample A is illustrated in Figure 7 (a) and (b).

Figure 7. Scale and pitting on (water side) outside surface, sample A. The extent of scale deposition and pitting are illustrated.
