MINES BRANCH INVESTIGATION REPORT IR 63-65

**EXAMINATION OF BOILER TUBE FROM  
CAMP GAGETOWN, N. B.**

Mines Branch Investigation Report IR 63-65  
EXAMINATION OF BOILER TUBE FROM CAMP GAGETOWN, N.B.

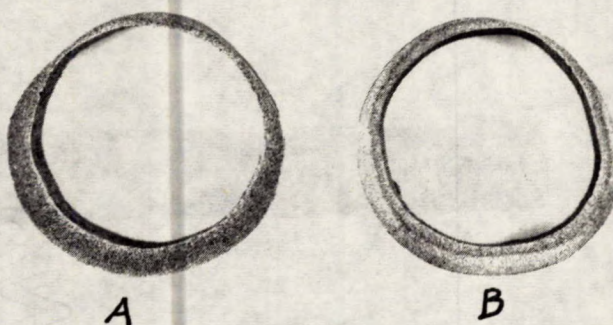
The sample, as-received, was approximately 12 inches long and comprised two pieces of  $1\frac{1}{2}$  inch tubing welded together as a straight length and part of a curved section. For identification purposes the straight length is referred to as Sample A and the curved end as Sample B. Figure 1 illustrates the appearance of Samples A and B in the "as-received" condition.

The outside surface of the tubes for the most part had a dull, rusty appearance with numerous, randomly-distributed patches of white deposit on the fire side of the tube. X-ray diffraction tests showed this deposit to contain two phases,  $\text{FeSO}_4\text{H}_2\text{O}$  and  $\text{Fe}_2(\text{SO}_4)_3\text{H}_2\text{O}$ . The inside surface was covered with a dull black, porous-type scale, having a random dispersal of rust spots throughout.

(a)  
(approximately 1/3 actual size)

This surface of tube was buried in, and protected by furnace refractory.

(b)  
(approximately 1/3 actual size)

This surface of tube was exposed to erosion and flue-gas corrosion by combustion gases.

Note:- patches of white deposit on exposed surface.

Figure 1. Tube Sample "As-Received".  
Tube lengths A and B were butt-welded as illustrated.

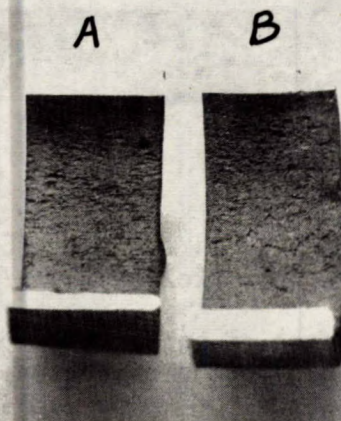
Transverse ring sections, taken from each end of the sample, were deep-etched in 1:1 H.Cl and water at 160°F-170°F for 15 minutes. Sample A etched uniformly, whereas Sample B contained a light etching area extending from the centre of the wall to the outer surface. The fire side of Sample B (thinned side) etched uniformly, with no indication of the light etching material.

Examination of the longitudinal surfaces of the rings showed uniform attack on the outside and considerable pitting on the inside. Figure 2 shows a transverse view of the ring sections. The pitted inner surface is shown in Figure 3.

Figure 2. Deep-Etched Transverse Sections through Thinned Region of Samples A and B.  
A light etching area is visible on the transverse section through Sample B. This effect was attributed to segregation and to the non-uniform grain size. Uniform etching was obtained in pipe section A but, despite the uniform grain size and freedom from segregation, thinning of the wall section occurred to the same extent as in Sample B.

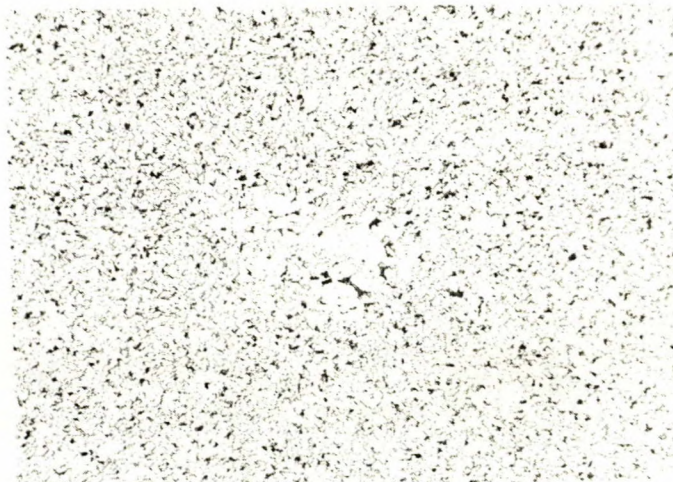
Pitting corrosion was observed on the inside (water) surface of the tube and was attributed to the aggressive character of the boiler water.

Pitting and some intergranular attack by the feed water was noted on the inside surface of the tubes suggesting that the feed water was also corrosive.

Figure 3. Pitting Observed on the Inside Surface (water side) of Boiler Tube Samples A and B.  
The extent of pitting attack on the inside tube surfaces after service suggests that the feed water has been aggressive.

- (1) Consideration and review of combustion conditions with respect to reduction of fuel sulphur content, alteration of combustion conditions and use of protective baffles might advance the possibility of increasing tube life.
- (2) Consideration might be given to use of tubes offering more resistance to erosion and to wastage due to sulphuric acid attack.
- (3) Consideration of the short tube life obtained in this boiler indicates a hazard of dangerous thinning of tubes in relatively short periods of time (1-2 years). Routine safety inspection appears to be necessary.
- (4) Possibly thinning might be alleviated to some extent by review of maintenance and cleaning procedures.
- (5) The tendency to corrosion on the water side of the tubes should be minimized.

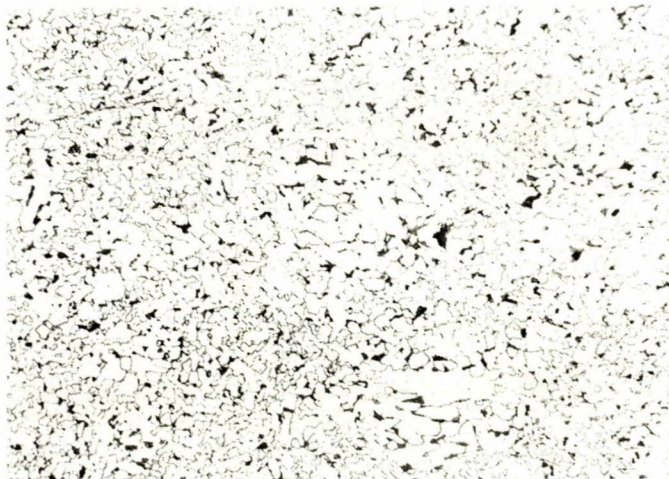
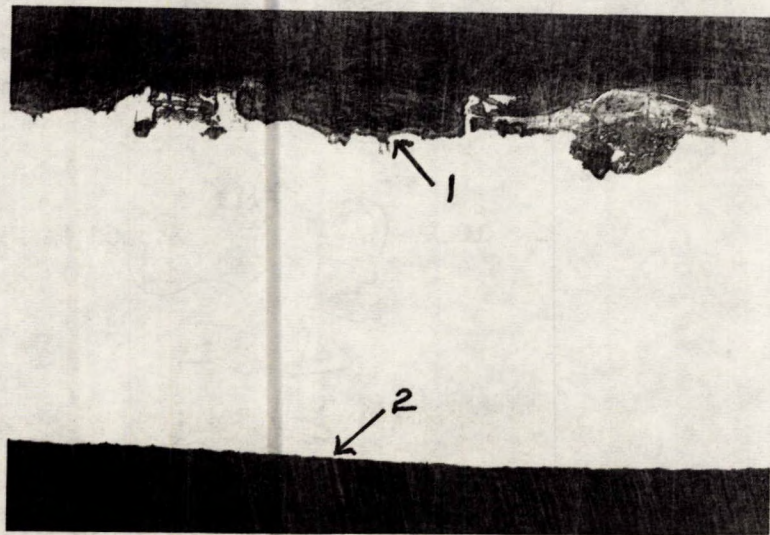
Transverse and longitudinal microsections were examined. No abnormalities in the amount or distribution of non-metallic inclusions were observed. The etched structure showed Sample A to have a grain size of less than ASTM No. 8 with scattered areas of enlarged grains (ASTM No. 5) throughout. Sample B has a mixed grain size (ASTM 5 to 7) somewhat larger than A. The longitudinal microstructures of A and B are shown in Figure 4.

Figure 4. Longitudinal Sections, Sample A - (a); Sample B - (b). Both steels have equi-axed microstructures and lamellar pearlite - No spheroidization of carbide was observed. The "as-manufactured" grain size of both steels is non-uniform. The variation in grain size is more conspicuous in Sample B. (The mixed grain size is attributed to manufacturing practice and does not correlate with thinning or with service temperature).

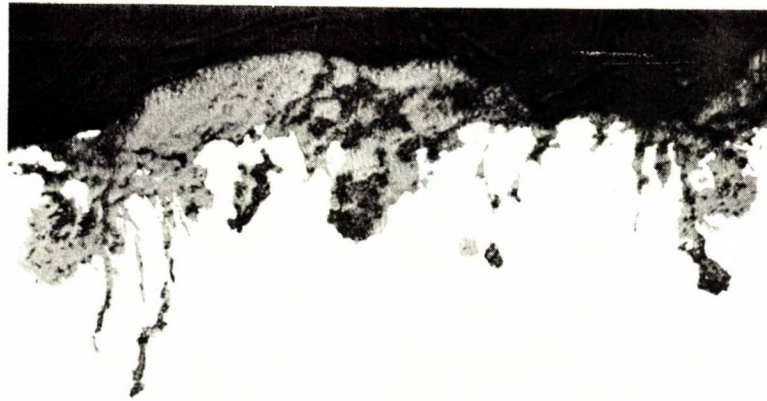
Examination of the inside and outside surfaces in section showed severe pitting and traces of intergranular attack on the water side, (inside surface). The fire side (outside surface at the thinned portion) was eroded and showed a pitting type of attack believed to be due to flue gas corrosion. Figure 5 illustrates the appearance of both surfaces at a thinned region in Sample B. The difference in the type of attack observed is shown in Figure 6.

Figure 5. Pitting and Grain Boundary Attack on the Inside Surface of Sample B: (Arrow 1). Compared to Shallow Pitting Observed on the Outside (fire side) Surface (Arrow 2).

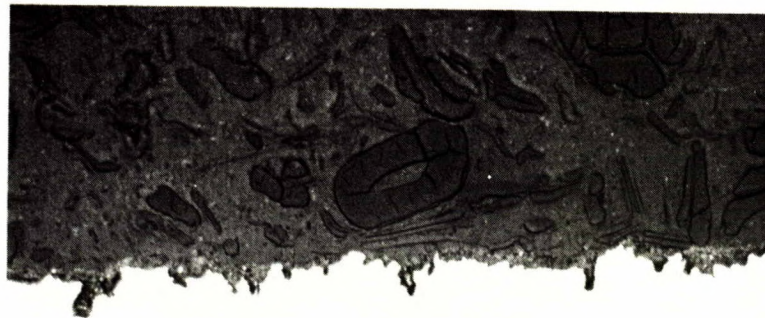
Figure 6. Sample B. Thinned Section - Water Surface (a)  
Combustion Surface (b).

(a) Deposits and grain boundary oxidation from feed water.
