MINES BRANCH INVESTIGATION REPORT IR 63-68

FAILURE OF A WINDOW CLEANER'S ANCHOR BOLT

This investigation shows that the broken window cleaner's anchor bolt, which was removed from the Federal Building in Halifax, N.S., was a faulty casting probably damaged prior to its final failure. The two specimens studied are in the "as-cast" condition and contain a highly brittle compound. It is recommended that all the anchor bolts now on the building be replaced by adequate equipment.

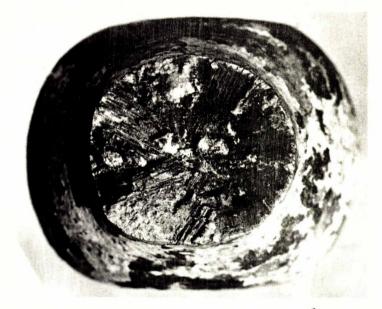
The fracture surface of the broken anchor bolt appeared as shown in Figure 1. Approximately one-third of the surface was covered with a black deposit that adhered to the underlying metal even after prolonged ultrasonic cleaning. The numerous corrugations, which can be seen, are obviously exposed solidification dendrite ends.

The part of the fracture, which corresponds to the dark area of Figure 1, is coated with a layer of oxide showed in Figure 6. Although the layer of oxide is loosely adherent to the underlying metal in many places, it is, however, continuous and indicates that a large portion of the fracture surface had been exposed to the atmosphere for an appreciable time. The middle part of the fracture surface (Figures 3 and 7) consists of highly porous material which would offer little resistance to crack propagation. The remaining part of the fracture, left hand side of Figure 3, was reasonably sound.

Figure 1. Fracture showing oxidized area (right), presumably the site of an old crack, and dendrites.

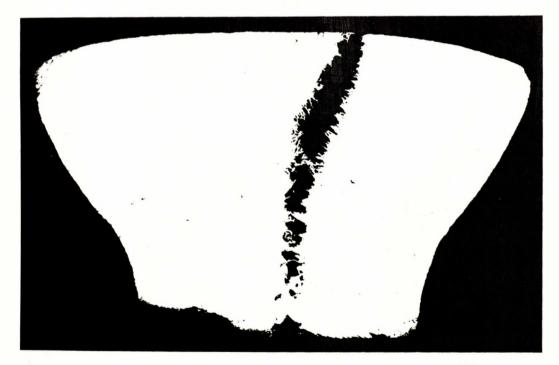
The broken bolt was longitudinally split in two halves. One of the halves (Figure 2) had a long shrinkage pipe running from the top of the bolt to the fracture. The wall of the pipe consisted of dendrite ends and the defect resulted from lack of feeding due to improper casting techniques.

Figure 2. Section through middle of broken anchor bolt showing shrinkage pipe caused by improper feeding.

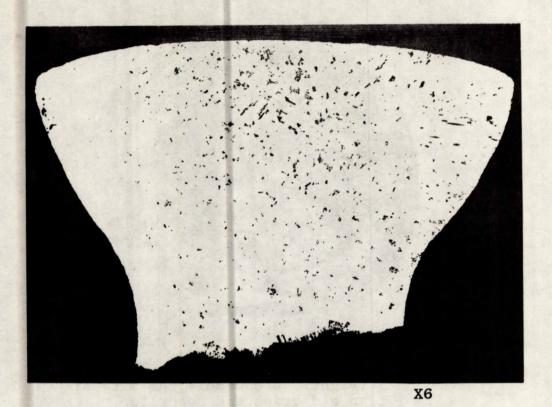
The other half of the broken bolt and a similar section through the unbroken bolt were polished and photographed under low magnification (Figures 3 and 4). Figure 3 shows that the section through the broken anchor bolt contained a large amount of macroporosity that seemed to be interconnected especially near the fracture, thus weakening the critical section appreciably. The full bolt, on the other hand, is sounder and the critical section shows no porosity at all. The defect seen on the right hand side of Figure 4 is probably due to an oxide inclusion.

Figure 3. Other half of bolt from Figure 2 after polishing shows very severe general porosity.

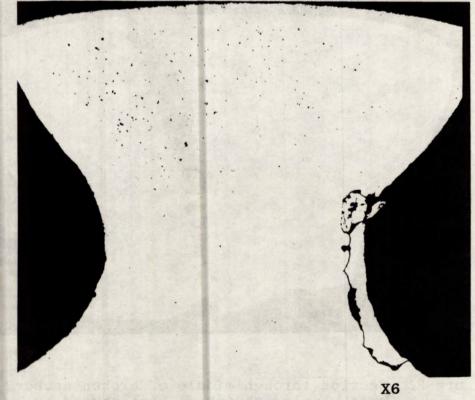
Figure 4. Section through full bolt after polishing shows much less porosity than Figure 3. Oxide inclusion (right).

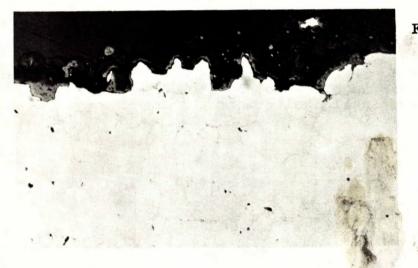
Figure 6 X150 Section through the fracture of the broken anchor bolt. The presence of an oxide layer on part of the fracture indicates that a crack had taken place sometime before the final failure. As-polished.

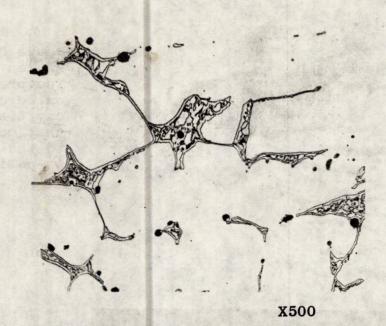
The microstructure of both specimens contained at least five phases: an alpha solid solution, beta, a blue constituent, which is probably tin-rich and which shall be called "delta" because of its resemblance with the delta constituent of tin bronzes, globules of lead and particles of oxide. Figures 8 and 9 are representative of the microstructures of the specimens. As can be seen, although they both have the same constituents, the relative amounts of each vary from one specimen to the other. A large amount of "delta" phase was present in the broken bolt (Figure 8) and formed a continuous network around the grains of alpha. Some beta was apparent inside of pools of delta. In the full bolt, on the other hand, there were large pools of beta separated from the alpha matrix by a thin layer of "delta" (Figure 9). There were also more oxide particles in the broken bolt than in the full one.

Figure 8. Broken anchor bolt. Alpha phase with "delta" and some beta in delta areas. Particles of lead and oxides appear as black dots. Etched for 2 sec in alcoholic ferric chloride.

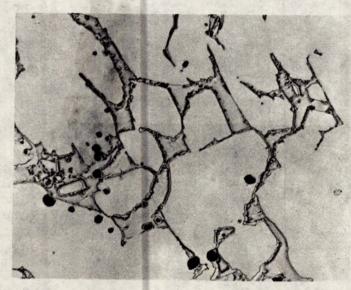
Figure 9. Full anchor bolt. Same phases as in Figure 8, but beta is more abundant and there is less "delta". Etched for 2 sec in alcoholic ferric chloride.

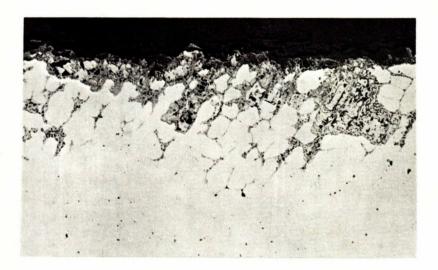
Both specimens showed evidence of dezincification corrosion on their outside surface but the full bolt was much more generally dezincified than the broken one. In both cases, the maximum penetration in the sections examined was of the order of 0.002 in. A typical dezincified area from the full bolt is shown in Figure 10. It appears that dezincification started in the beta and "delta" phases and then invaded the whole structure.

X100 Typical section at the edge of the full anchor bolt showing dezincification. The dark areas consist of redeposited copper. The beta and "delta" phases are attacked in the first stage and, later on, the attack becomes general. As-polished.
