MINES BRANCH INVESTIGATION REPORT IR 63-71

THE FAILURE OF A WING EYEBOLT FROM NORSEMAN V AIRCRAFT CF-BHW

Mines Branch Investigation Report IR 63-71

THE FAILURE OF A WING EYEBOLT FROM
NORSEMAN V AIRCRAFT CF-BHW

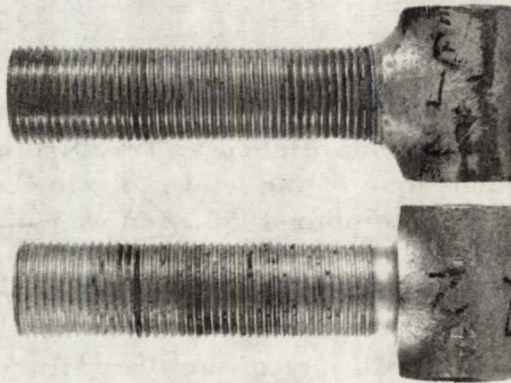
Figure 1. Two Types of Eyebolt Fitting.

The original design (upper eyebolt) did not have the fillet undercut, and this modification was introduced on March 1st, 1944. It is understood, however, that there are a number of the old design fittings in service at the present time. The failure under investigation, CF-BHW, involved an eyebolt of the earlier design, whereas the first failure (CF-BSJ) involved one of the later, modified design.

The failed eyebolt is of the earlier design, without an undercut fillet. It is widely accepted that this configuration is structurally inferior to the later design, and for this reason alone it is recommended that no further eyebolts of this design be placed in service. It is also recommended that all such eyebolts already in service be removed at the first aircraft inspection that necessitates removal or loosening of the part. However, both fractured eyebolts responsible for the accidents failed at the first thread in the lock-nut as far as can be ascertained, and, consequently, the absence of an undercut fillet can only be, at most, a minor contributory factor.

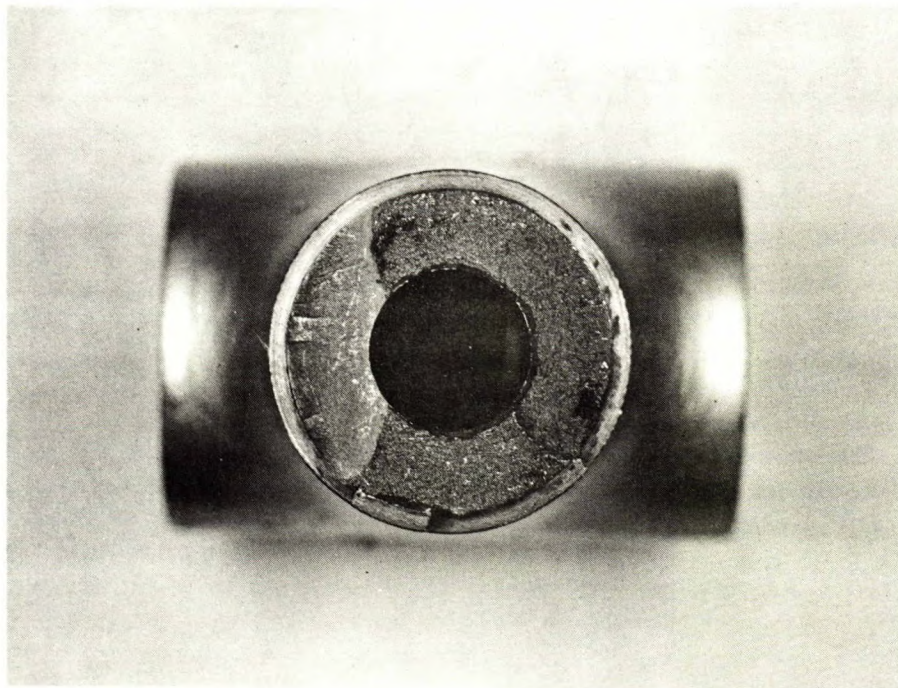
Figure 2 shows the fracture surface of the failed port front fitting from aircraft CF-BHW. It is apparent that the failure was primarily due to fatigue, and that the crack initiated in a thread root and propagated through about one-third of the cross-section. At this stage, brittle fracture of the remaining cross-section occurred. The most significant feature of the failure is that initiation and propagation lie parallel to the axis of the cross-bolt, and thus along the longitudinal axis of the aircraft. An examination of the remains of the fractured fitting from aircraft CF-BSJ showed that the failure initiated and propagated in a similar manner.

Figure 2. Fracture Face, Port Front Fitting, CF-BHW.

Some indication of the nature of the additional loading can be obtained from the appearance of the fracture surface (Figure 2). The fatigue cracks in both the present eyebolt and the eyebolt from aircraft CF-BSJ initiated and propagated in a direction transverse to the axis of the wing. Their appearance was consistent with the superimposition of cyclic plane-bending loads. Such loads, parallel to the axis of the aircraft, could have been caused by some unobserved structural defect, e.g., excessive ~~decrease~~ ^{clearance} in the wing root fixture, or by transverse flexure of the wing.

It is considered improbable that continuous high stress cycles, resulting from such a defect, both initiated and propagated the crack; it is far more likely that a limited application of high stress cycles occurred during a rough take-off or landing to initiate the crack and, subsequently repeated applications of a lower cyclic stress propagated the crack to failure.

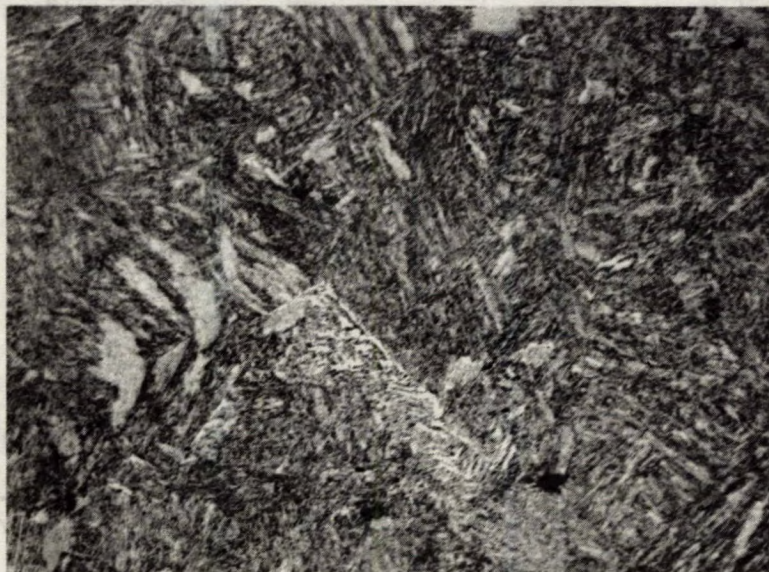
Polished and etched cross-sections from each of the samples were examined. Three of the four samples of SAE 2330 composition exhibited normalized structures with small differences in structure and grain size, probably reflecting differences in thermal history. The other SAE 2330 type sample, CF-BHW port front, showed a quenched and tempered structure as would be expected from the hardness readings. CF-BHW port rear (SAE 4140) eyebolt had an annealed type of structure of much coarser grain size than any of the other samples. The photomicrographs are shown in Figures 3 to 7.

Figure 3. CF-BHW Port Front.
Etched in 2% nitric acid in alcohol. X500.

The metallurgy of the failed sample does not in any way indicate a reason for failure. The fractured unit had been heat-treated to a considerably higher strength than the other samples, but, due to the associated increased notch sensitivity, the overall service strength of the fitting was probably not greatly different from that of the others. It is therefore to be concluded that, despite the different structure and mechanical properties, the metallurgy of the part cannot be considered as a contributing factor to the failure.

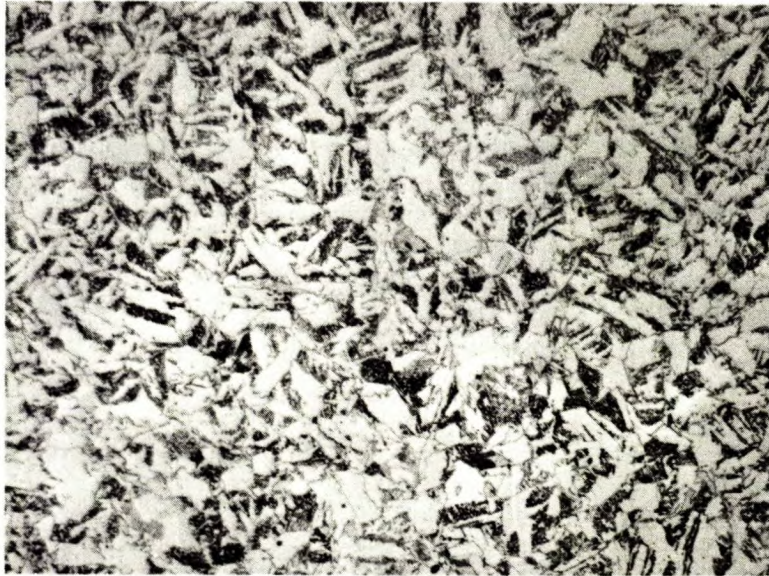
Figure 4. CF-BHW Port Rear.
Etched in 2% nitric acid in alcohol. X500.

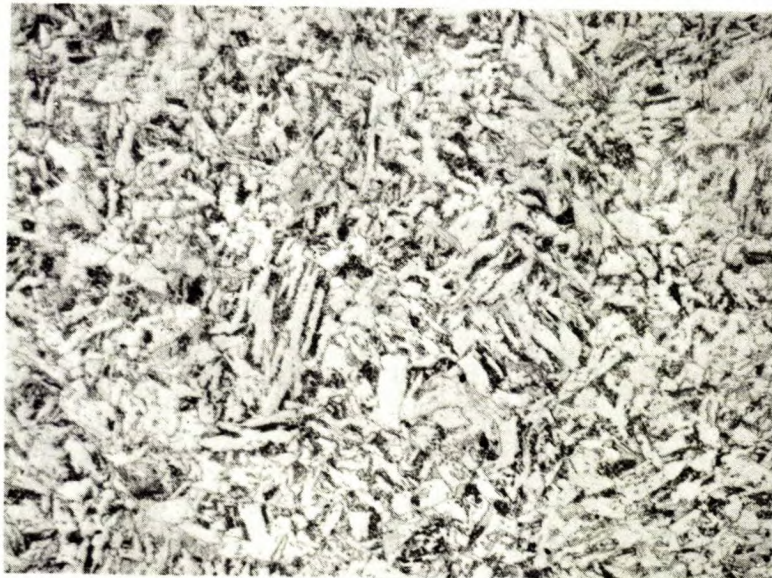
Figure 5. CF-IGG Starboard Front.
Etched in 2% nitric acid in alcohol. X500.

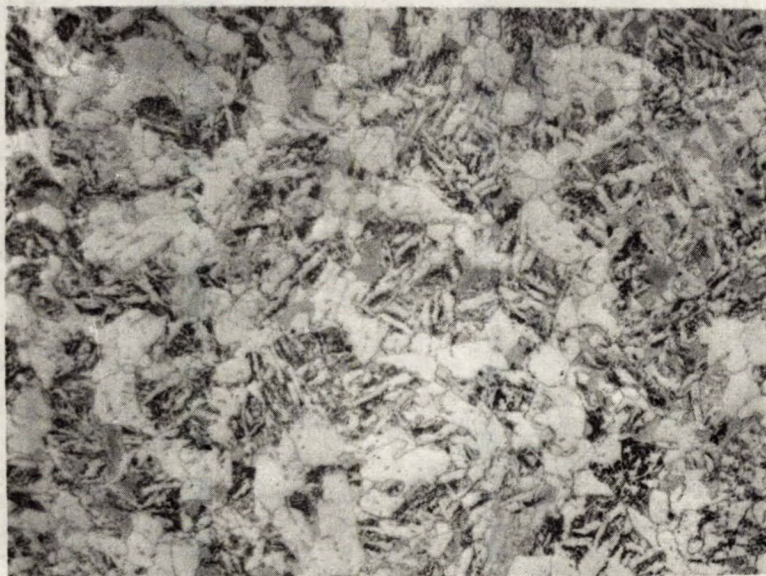
Figure 6. CF-OBN Starboard Front.
Etched in 2% nitric acid in alcohol. X500.

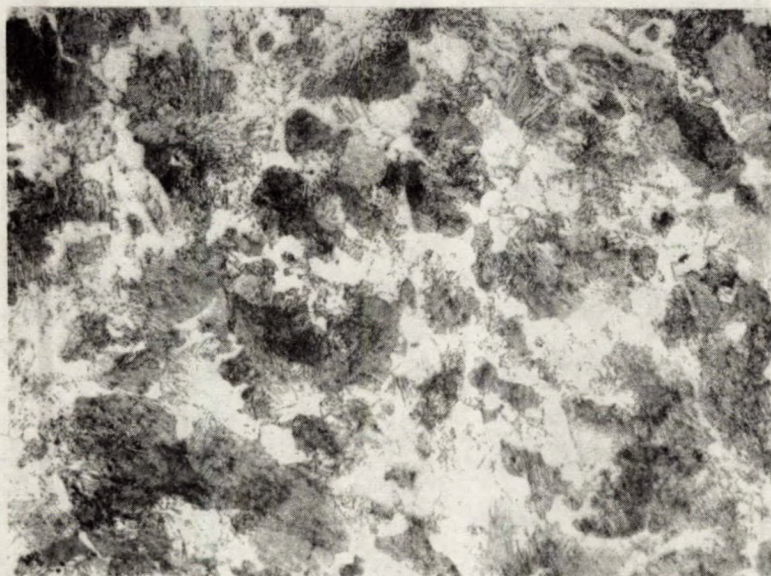
Figure 7. CF-BSJ Starboard Rear.
Etched in 2% nitric acid in alcohol. X500.
