Dr. J. Conway

DEPARTMENT OF MINES AND TECHNICAL SURVEYS

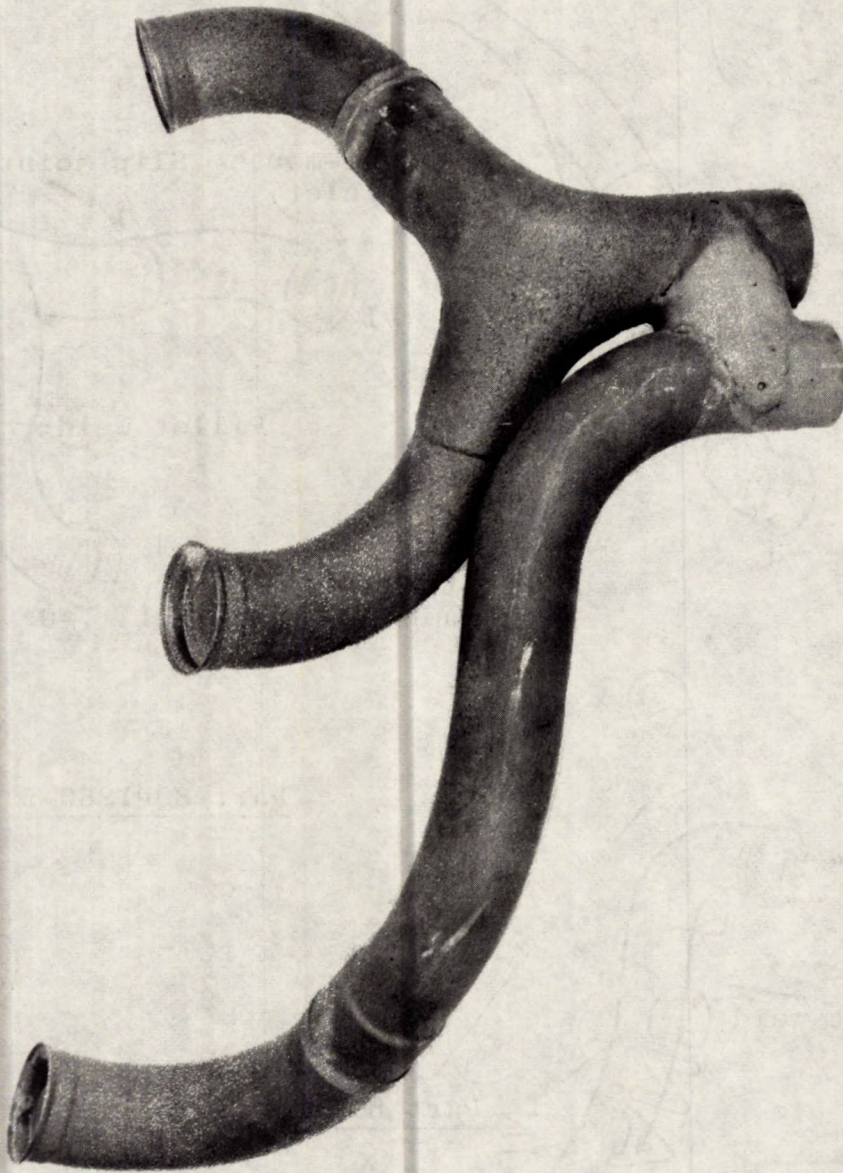
Figure 2. Assembly of Part 89P1280-5 as-received. Rejected due to cracking of transverse connecting tube near discharge end. Identified in Table 1 as Sample A. Approx. 1/4 size.

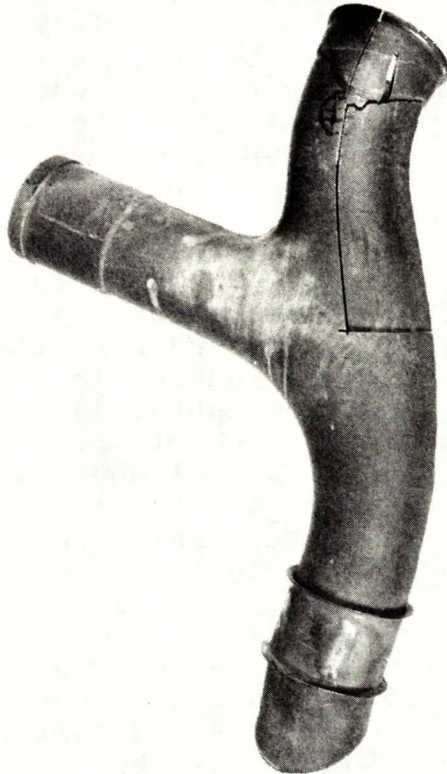
Figure 3. Part 89P1285-1, as-received, except for saw cutting to remove section for microexamination. Severe cracking along toe of fillet weld between bell-mouth end piece and fabricated Y piece, and extending away from weld into the Y piece. Identified in Table 1 as Sample D. Approx. 1/4 size.

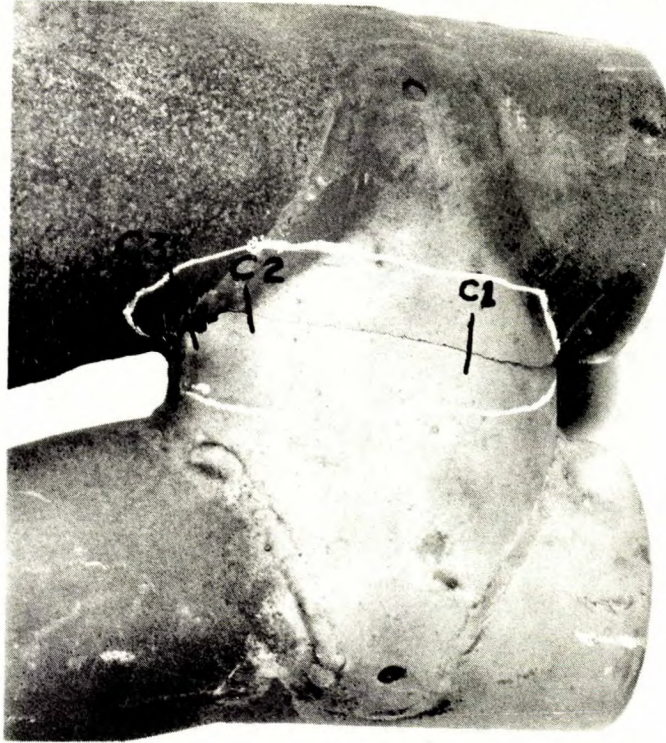
Figure 4. Sample A, showing cracking in the connecting tube along the toe of the fillet weld at its junction with the connecting tube. Small pieces of weld metal have been dislodged. The locations of three sections which were removed for microexamination are also shown. The Y-tube is at the top. Approx. 1/2 size.

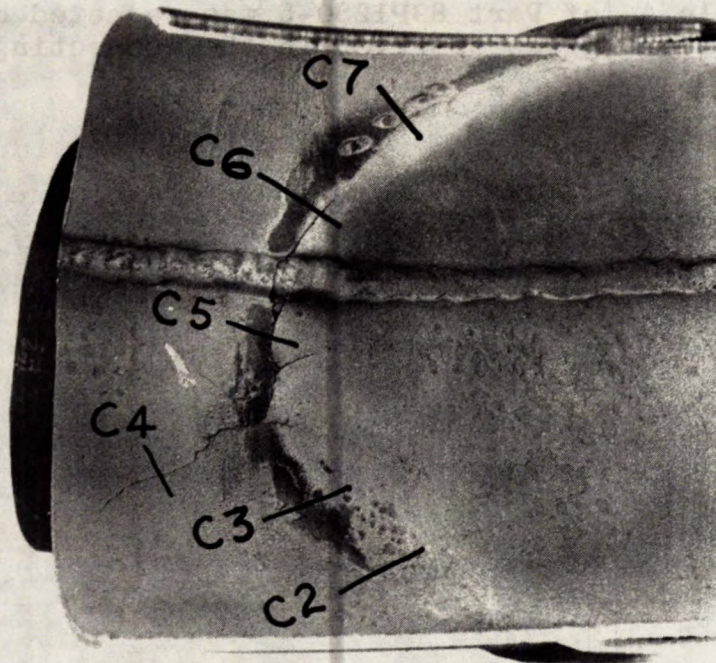
Figure 5. Sample A, showing inner surface of Y-tube below the weld with the connecting tube. Locations of microsections are also shown. Approx. full size.

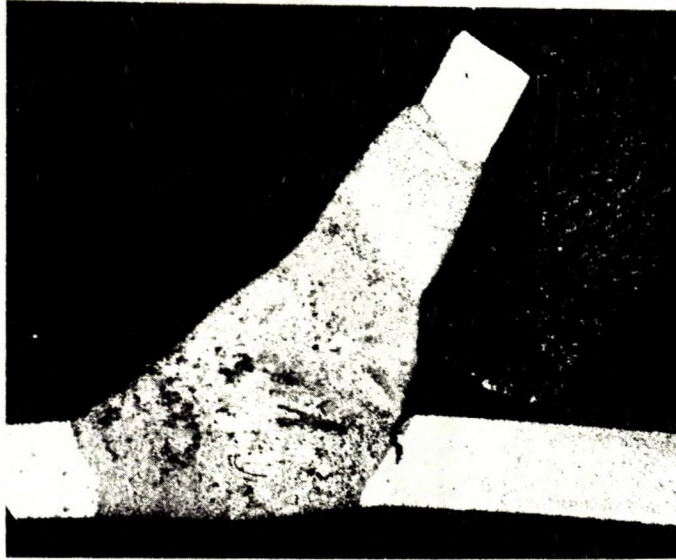
Figure 6. Section C2, showing fracture of connecting tube (at top of picture) and crack starting at inner junction of the weld with the Y-tube, and extending partly through the wall. Note that the weld penetrates through the Y-tube.

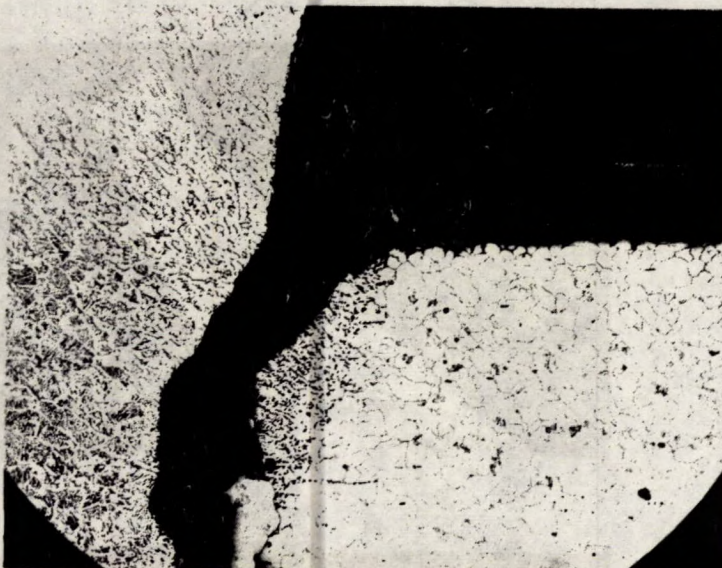
Figure 7. Section C2, showing the upper portion of the crack in the Y-tube, seen in Figure 6. Note carbide precipitation and oxide penetration at grain boundaries along outer surface of the Y-tube. The weld is on the left side. Etched NaCN X60

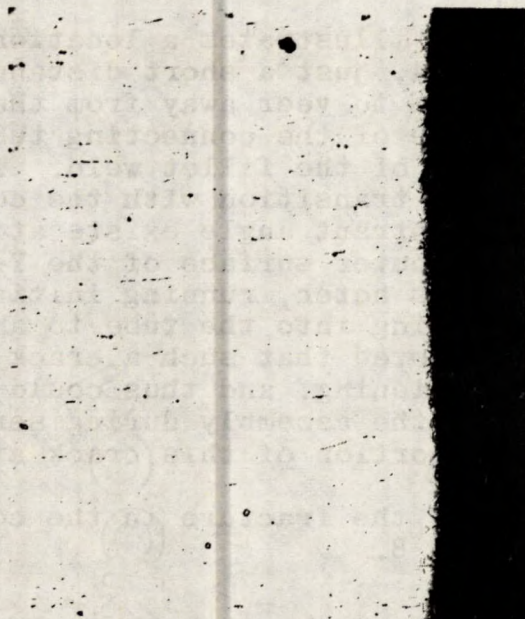
Figure 8. Section C2, showing transgranular path of fracture in the connecting tube, and absence of carbide precipitation. Etched NaCN X250

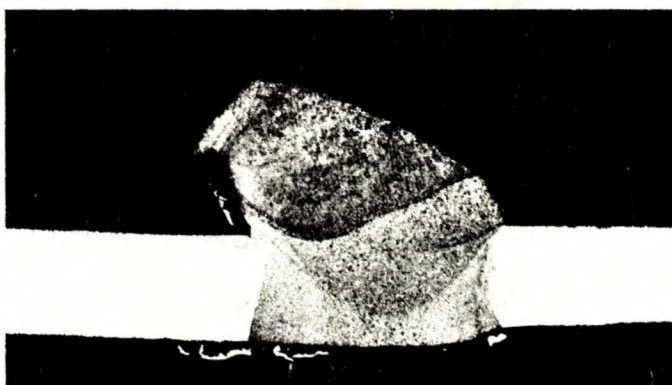
Figure 9. Section C3, showing fracture in weld metal near junction with connecting tube. Etched Oxalic Acid X8

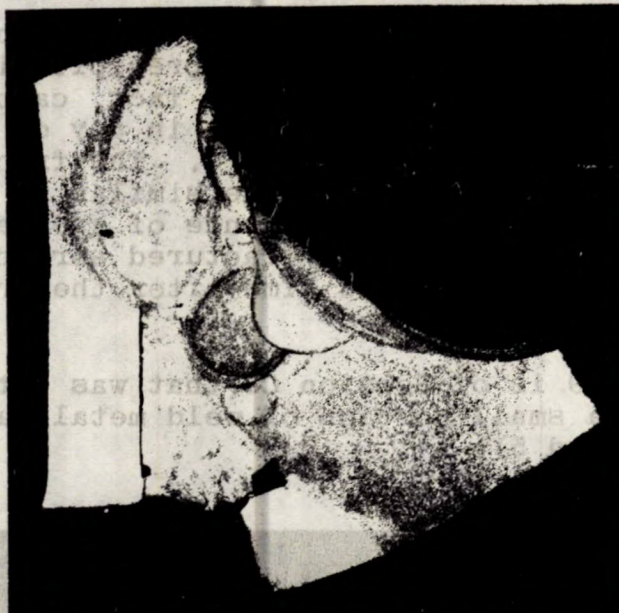
Figure 10. Section C5, showing fractures of the Y-tube (horizontal piece) on each side of the weld penetration, and the presence of lack of penetration and severe lack of fusion at the weld root.
Etched Oxalic Acid X8

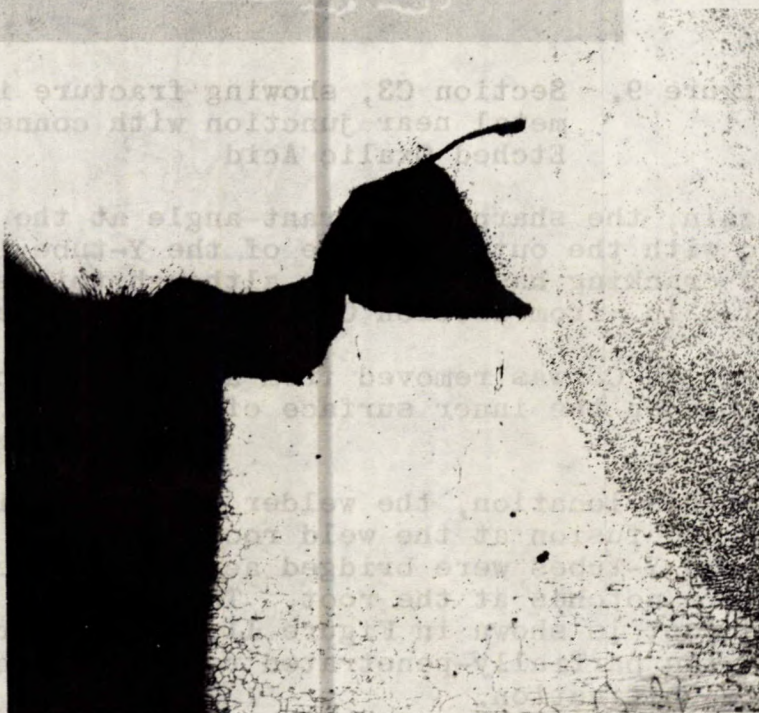
Figure 11. Section C5, showing fracture in Y-tube at weld root, and cracking extending inward from outer surface of the tube starting at a partially-penetrated weld root. Extensive carbide precipitation is apparent.
Etched NaCN X50

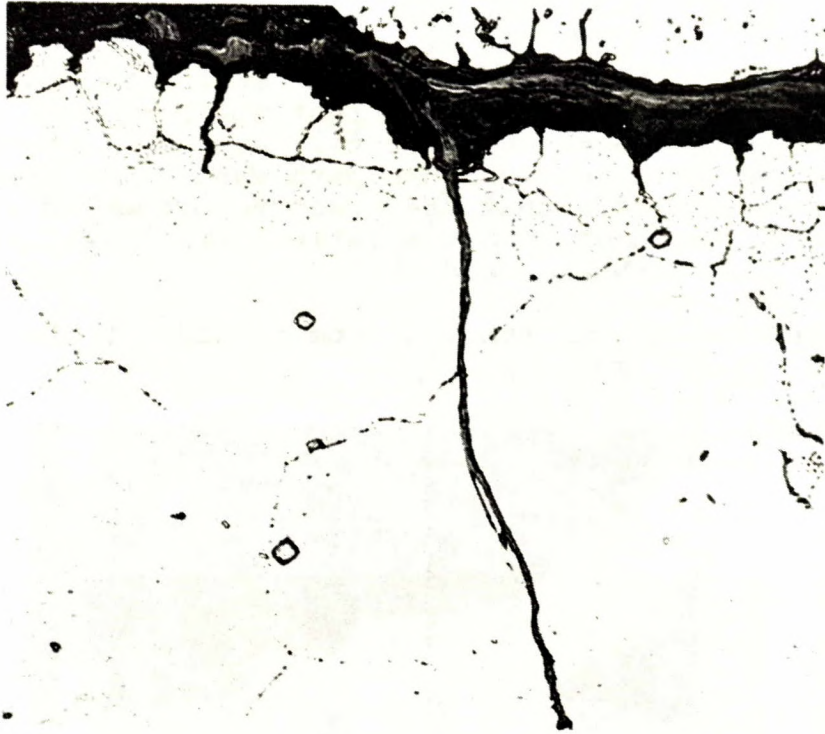
Figure 12. Section C5, showing upper portion of larger crack evident in Figure 11. The crack is oxidized and does not follow the grain boundaries in which chromium carbide has precipitated. This crack has started, most probably, from a notch formed by penetration of oxide along surface grain boundaries, such as shown above.
Etched NaCN X1000

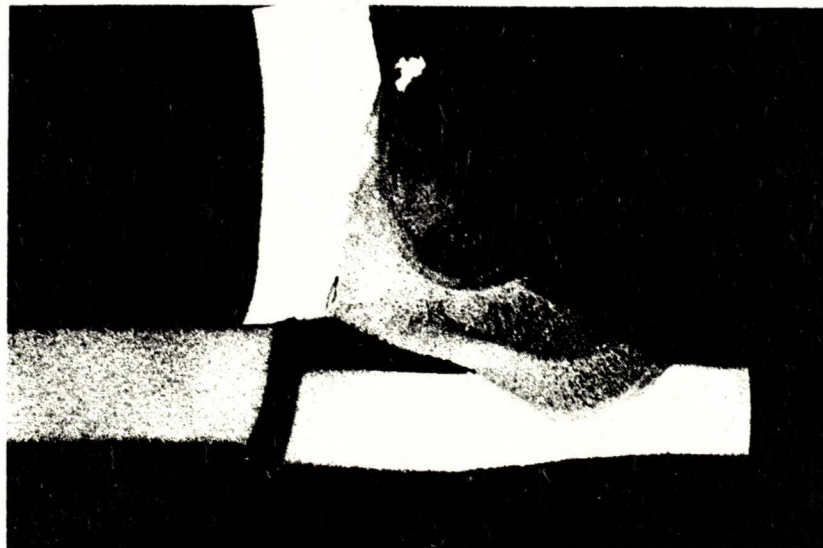
Figure 13. Section C6, showing incomplete root penetration and fracture of the Y-tube at the weld root.
Etched Oxalic Acid X8

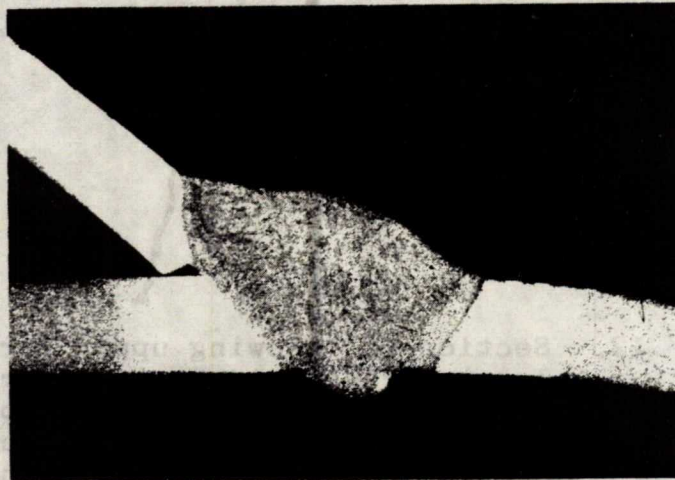
Figure 14. Section C7, showing a notch at junction of the weld with the two tubes, complete penetration of the Y-tube, and absence of cracking.
Etched Oxalic Acid X8

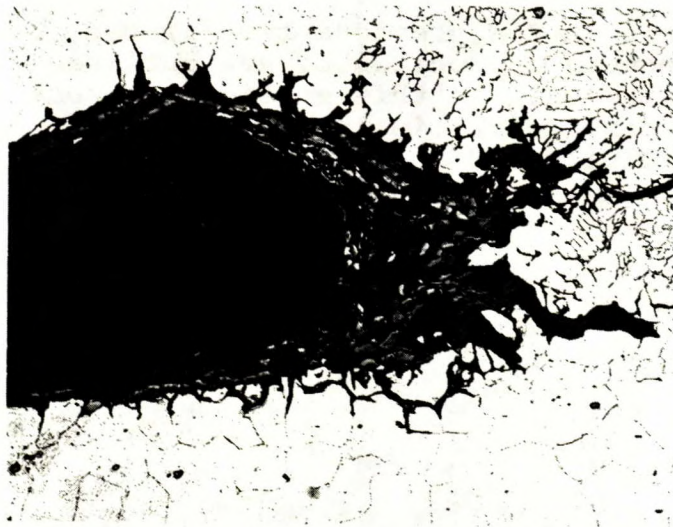
Figure 15. Section C7, showing junction of weld with Y-tube at the inner side of the connecting tube. Note the carbide precipitation, and the oxide penetration along grain boundaries at the surface of Y-tube.
Etched NaCN X250

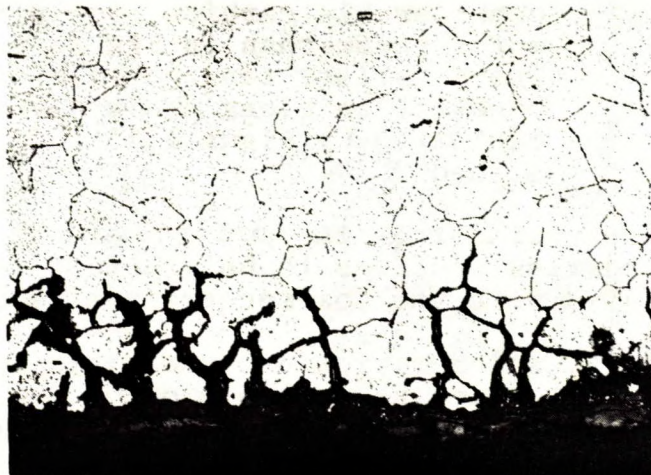
Figure 16. Section C7, at the inner surface of the Y-tube opposite the area shown in Figure 13. Note carbide precipitation and oxide penetration along grain boundaries.
Etched NaCN X250

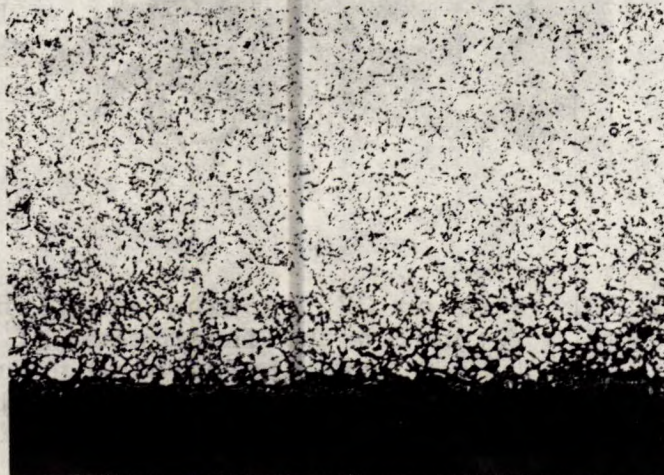
Figure 17. Section C7, at the inner surface of the Y-tube away from the weld. Note considerable carbide precipitation, but more random than in Figures 15 and 16. There is less tendency for oxide penetration along grain boundaries than exhibited by Figures 15 and 16.
Etched NaCN X250

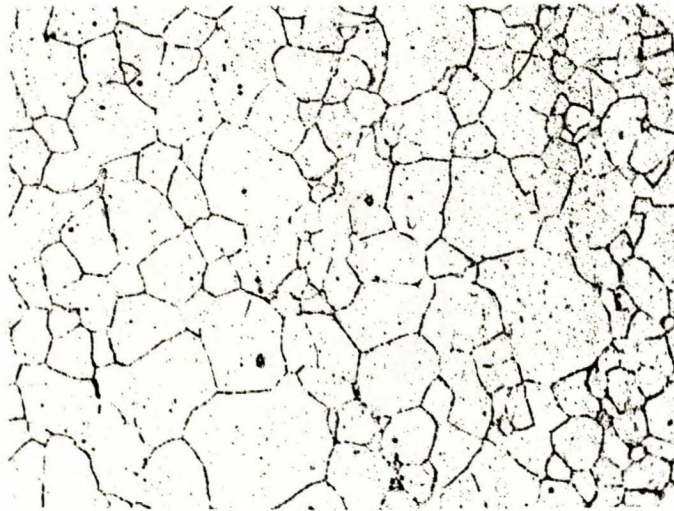
Figure 18. Showing microstructure of Y-tube stamping remote from weld on the side shown in Figure 4. Etched NaCN X250

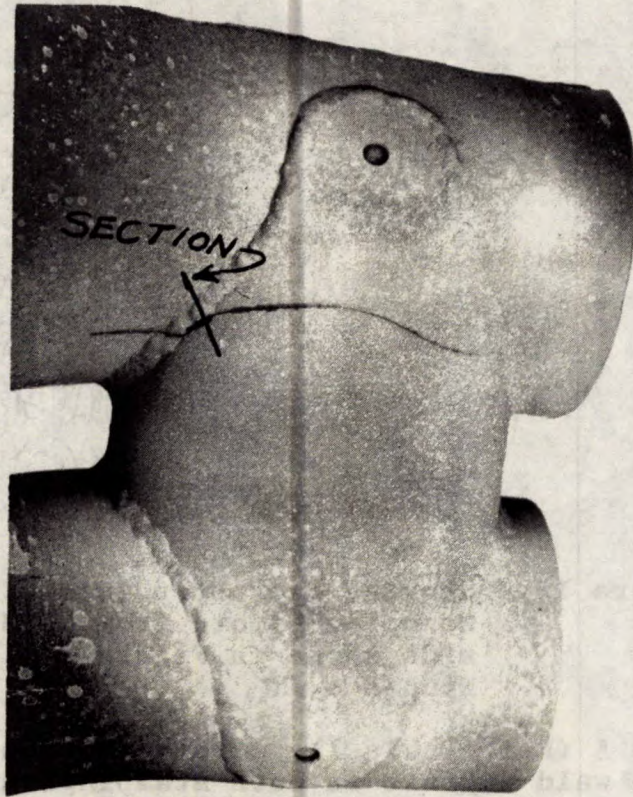
Figure 19. Sample B, after sand blasting and penetrant inspection, showing path of cracking. Approx. 1/2 size.

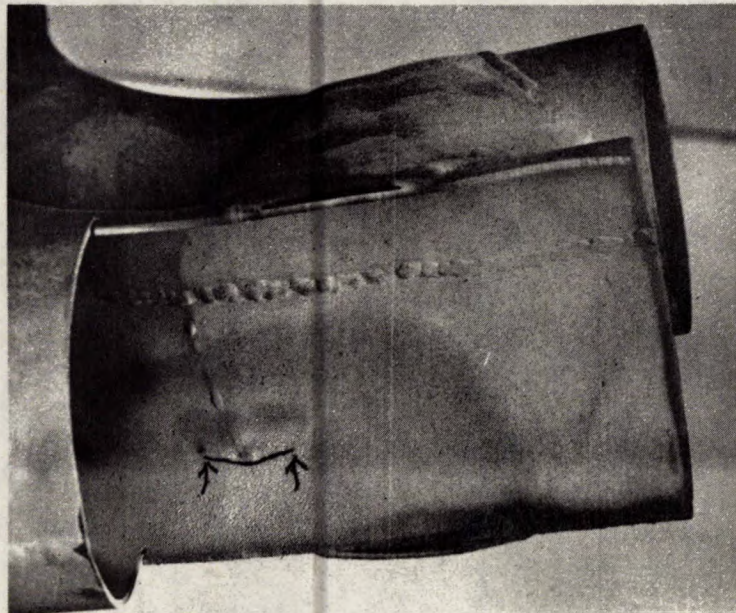
Figure 20. Sample B, showing inner surface of Y-tube at weld with connecting tube, after sand blasting and penetrant inspection. Approx. 2/3 size.

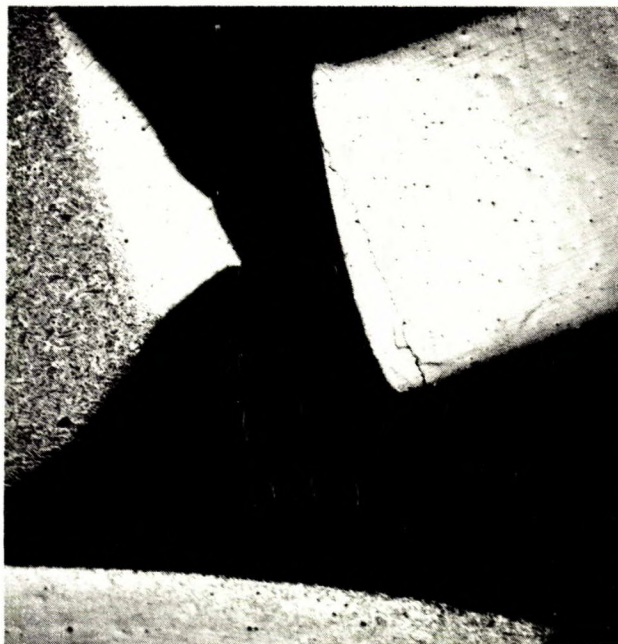
Figure 21. Section from Sample B, showing fracture and secondary crack in the connecting tube.
Etched NaCN X40

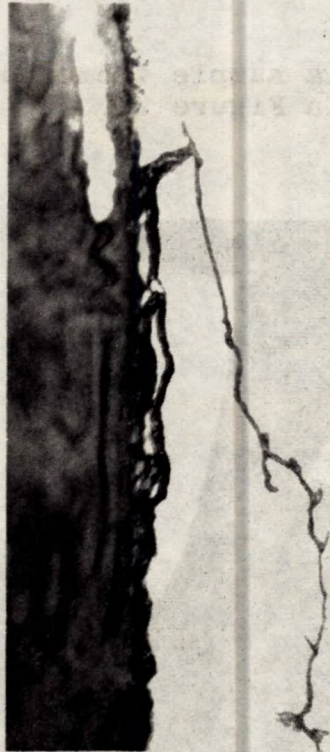
Figure 22. Crack and fracture shown in Figure 21
at higher magnification.
Unetched X600

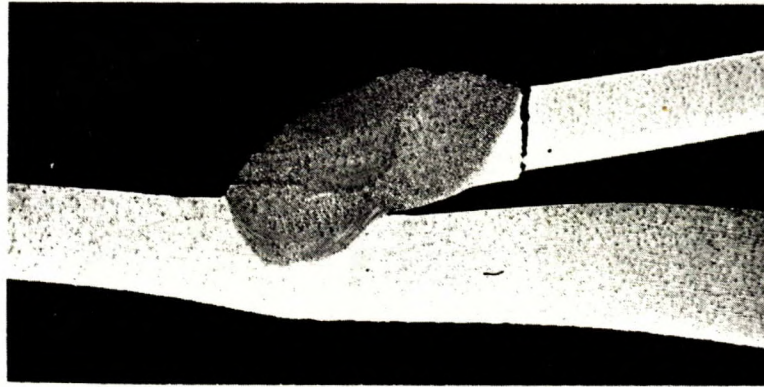
Figure 23. Section through 1/8 in. long crack indication found by penetrant inspection. The crack has started at the toe of the weld with the connecting tube in Sample C on the side such as shown in Figures 4 and 19 for Samples A and B respectively.
Etched Oxalic Acid X8

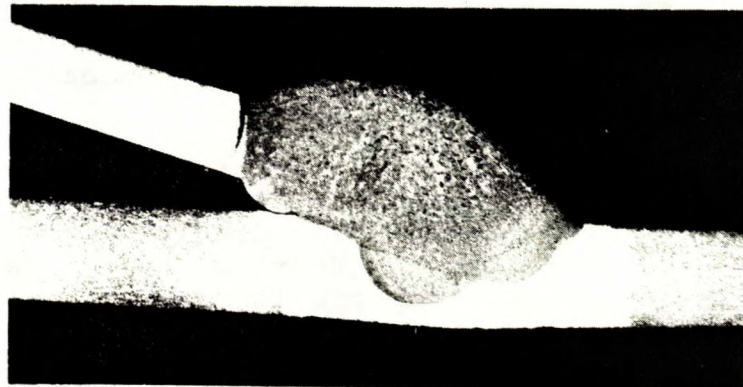
Figure 24. Section through 1/8 in. long crack indication found by penetrant inspection at fillet weld junction with connecting tube in Sample C on the side of the assembly opposite that illustrated by Figures 4 and 19 for Samples A and B respectively.
Etched Oxalic Acid X8

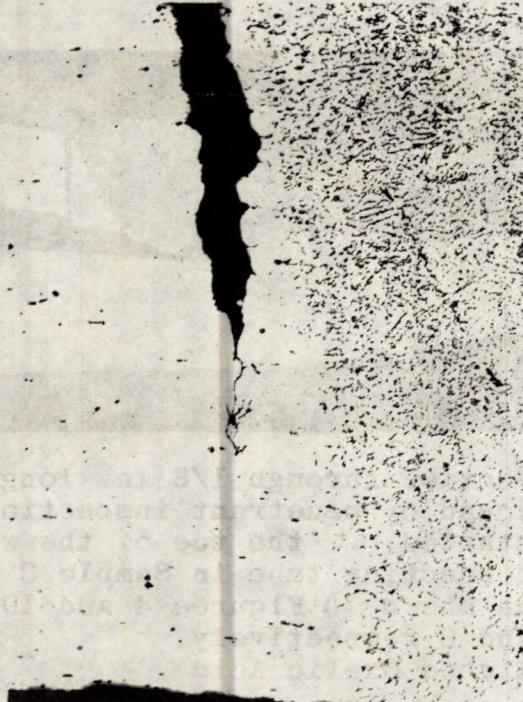
Figure 25. Section as in Figure 24, showing lower portion of crack and absence of carbide precipitation in the connecting tube.
Etched NaCN X100

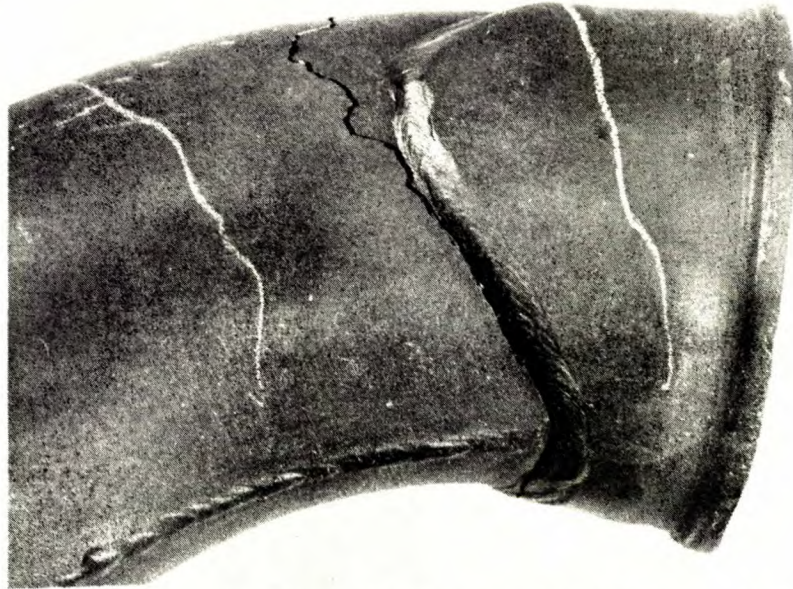
Figure 26. Sample D. View of probable crack initiation location at the toe of a fillet weld. Crack extends into the fish-mouth piece at the lower side and into the tube at the upper side, relative to this picture. Approx. full size.

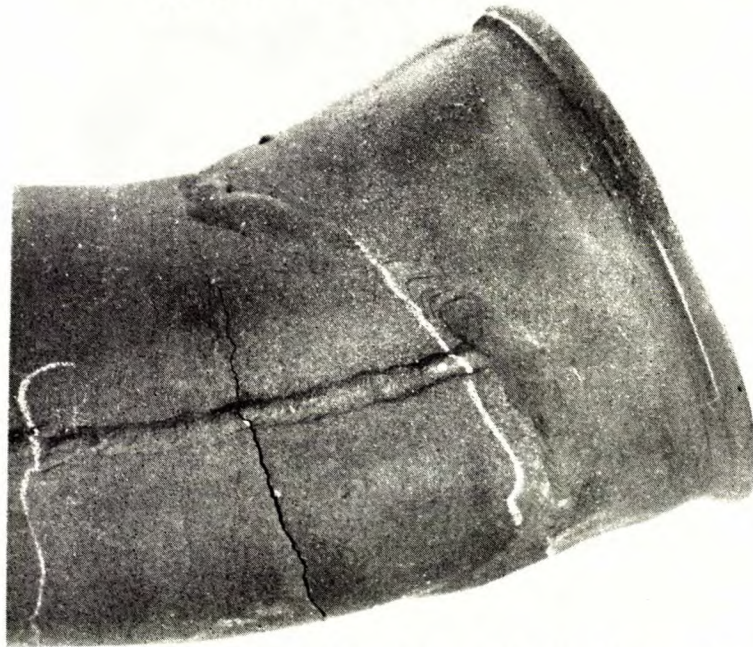
Figure 27. Opposite side from that shown in Figure 26. Approx. full size

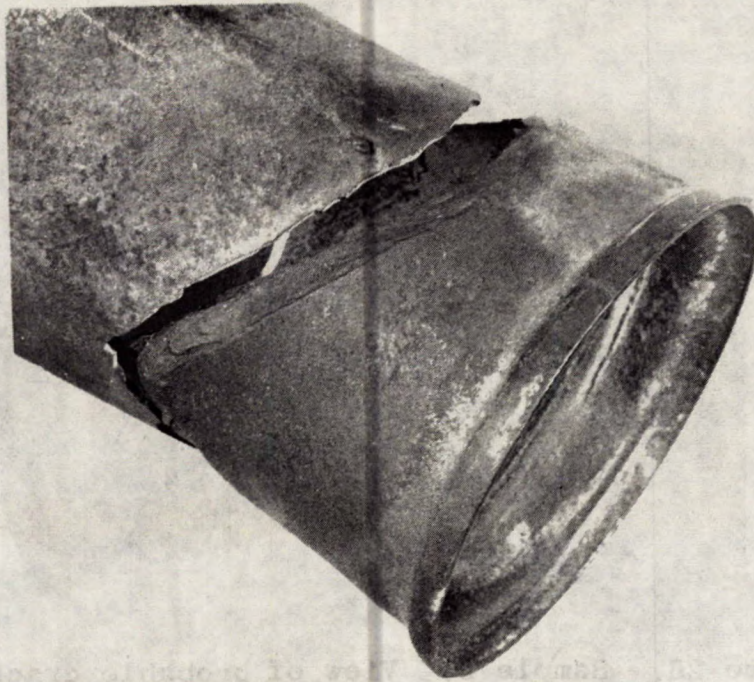
Figure 28. Sample E. View of probable crack initiation location at toe of fillet weld. Approx. full size.

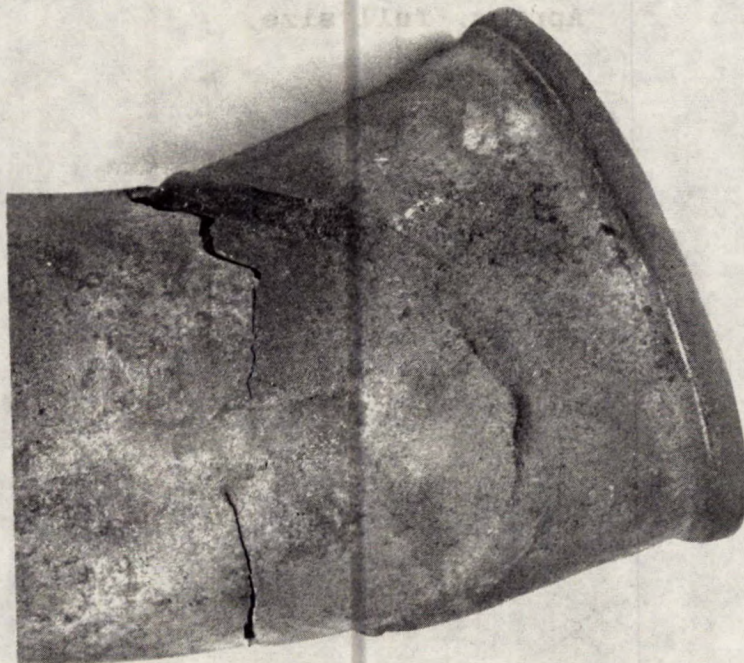
Figure 29. Opposite side from that shown in Figure 28. Approx. full size.

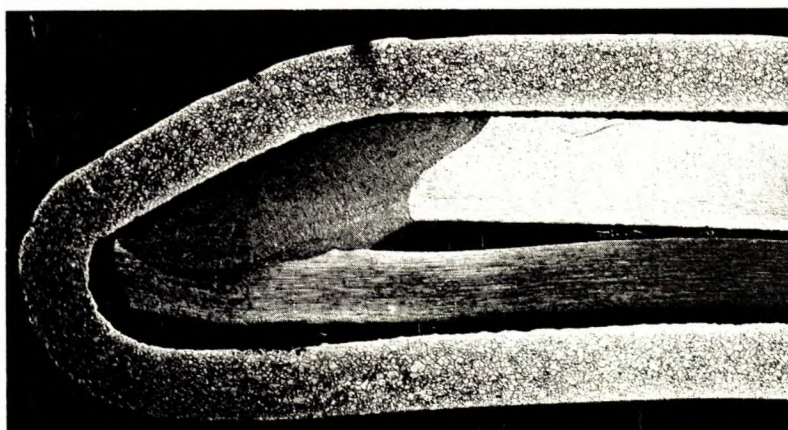
Figure 30. Representative of each section removed from corresponding locations in Samples D and E, at probable crack initiation locations. The bell-mouth portion is the upper member joined by welding. (Disregard enclosing U shaped piece, used to protect the edge of the specimen during polishing).
Etched Oxalic Acid X8

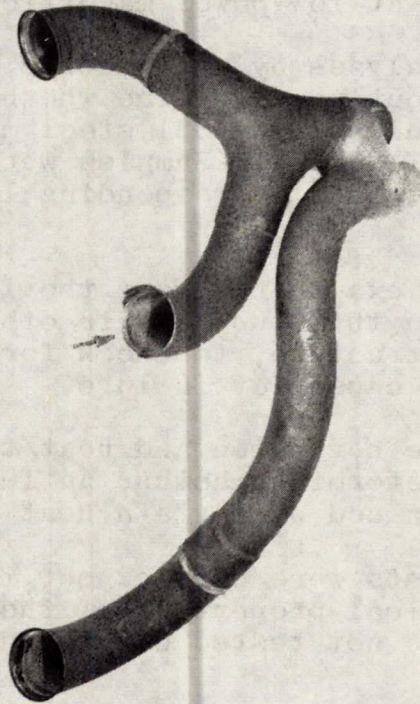
**Figure 31. Collector assembly for cylinders
No. 1, 9 and 8 showing failed
section on No. 9. 1/8 actual size.**

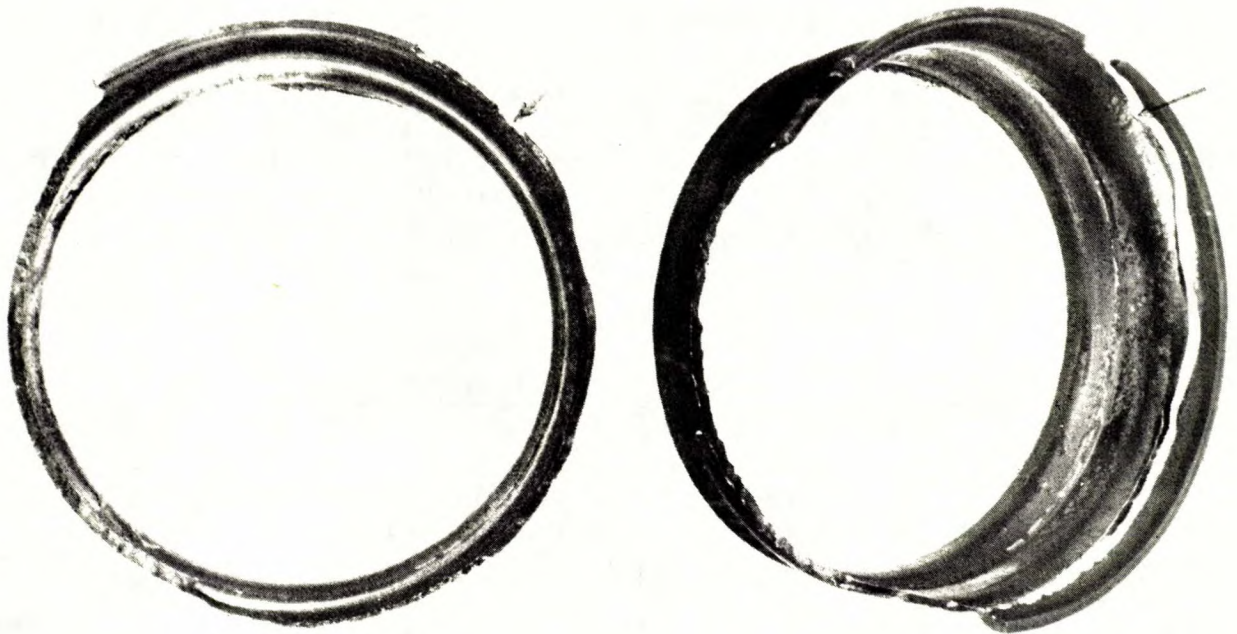
Figure 32. Fracture in collector pipe for No. 9 cylinder with arrow indicating location where fracture probably originated. This location is just under the edge of the ring clamp when assembled. The fracture progressed clockwise at the bend, longitudinally to the line which marked the location of the edge of the internal fitting, then continued circumferentially to failure.

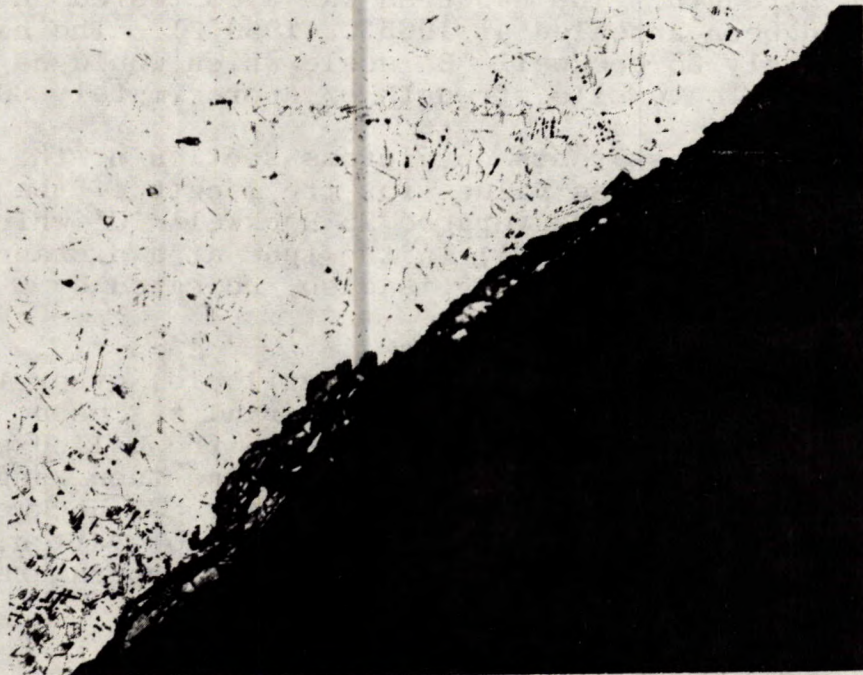
Figure 33. Microstructure and surface of the fracture (right) near the location where the fracture was believed to have originated (arrow Figure 32). There was no evidence of sensitization and the fracture was mainly transgranular such as normally occurs in low temperature fatigue fractures. Etched electrolytically in 10% oxalic acid. X250

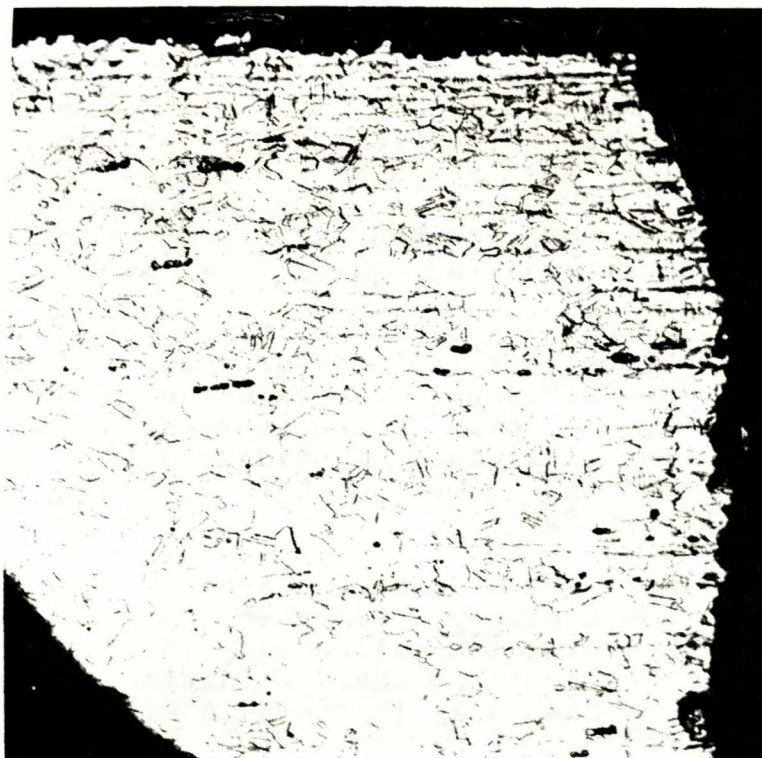
Figure 34. Section of fracture (right) and inner surface (top) at the bell-mouth. This field is almost diametrically opposite the field shown in Figure 33. The fracture is partly intergranular. Etched electrolytically in 10% oxalic acid. X250

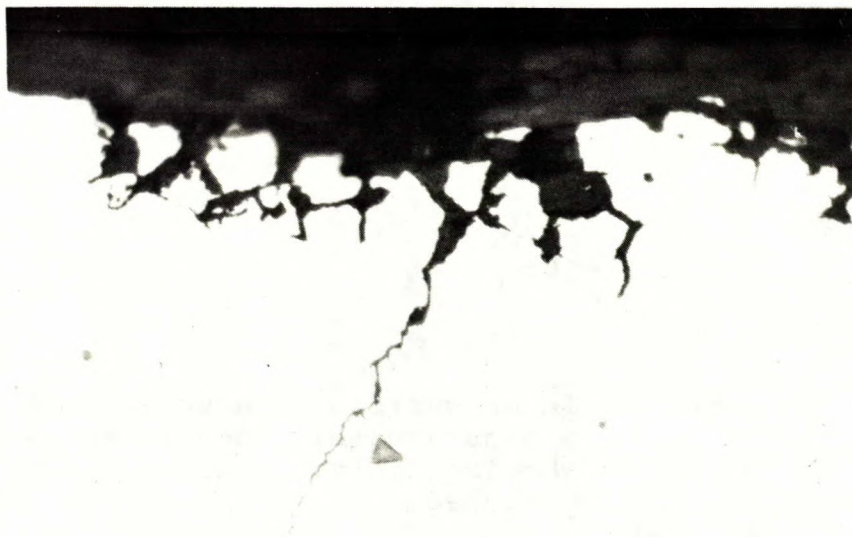
Figure 35. Grain boundary oxidation and crack which had propagated from the inner side of the tube near the fracture and adjacent to the field shown in Figure 34. Unetched X1000

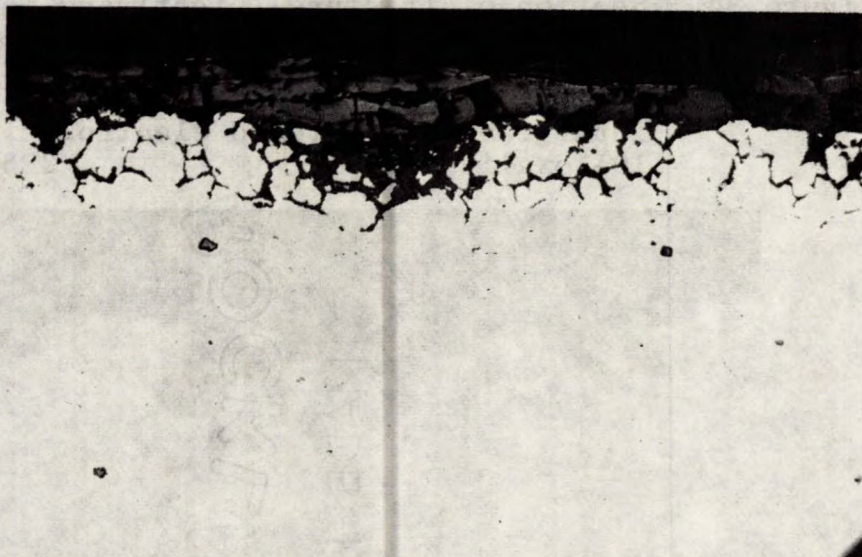
Figure 36. Inner surface at a bell-mouth from a pipe assembly identified as Sample A showing typical grain boundary oxidation. Unetched X250

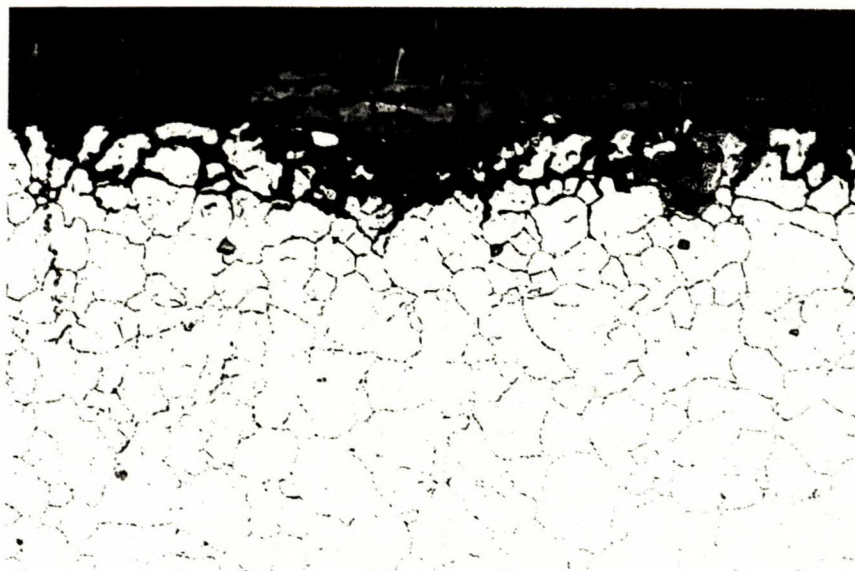
Figure 37. Same location as Figure 36. A similar grain boundary carbide pattern was observed in the failed pipe but not at the fracture.
Electrolytic etch in 10% NaCN X250
