MINES BRANCH INVESTIGATION REPORT IR 63-76

CAUSES OF LEAKAGE IN COMMODITY TANKS; RCAF D-38 REFUELLERS

M. J. NOLAN & W. A. POLLARD

JULY 31, 1963

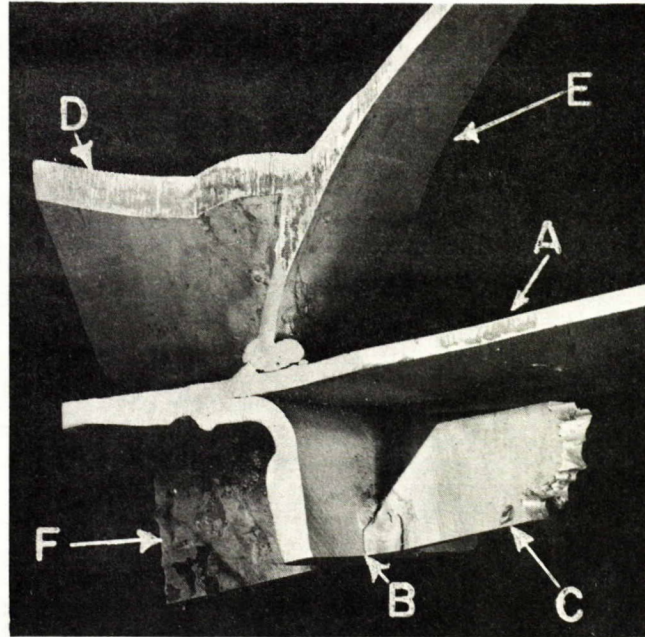
Radiographic inspection of welds in critical areas of the tank was carried out by The Warnock-Hershey Company. The resultant films and the removed sections of the tank were sent to the Physical Metallurgy Division for detailed examination. Figure 1 shows the section from the port side above #3 bolster and identifies the various components of the tank.

Figure 1. Section from port side above #3 bolster showing:
A - tank sheet, B - sump wall, C - sump reinforcement, D - baffle, E - baffle reinforcement, F - bolster.

Note: (1) crack in weld joining B to C
(2) crack in weld joining E to A

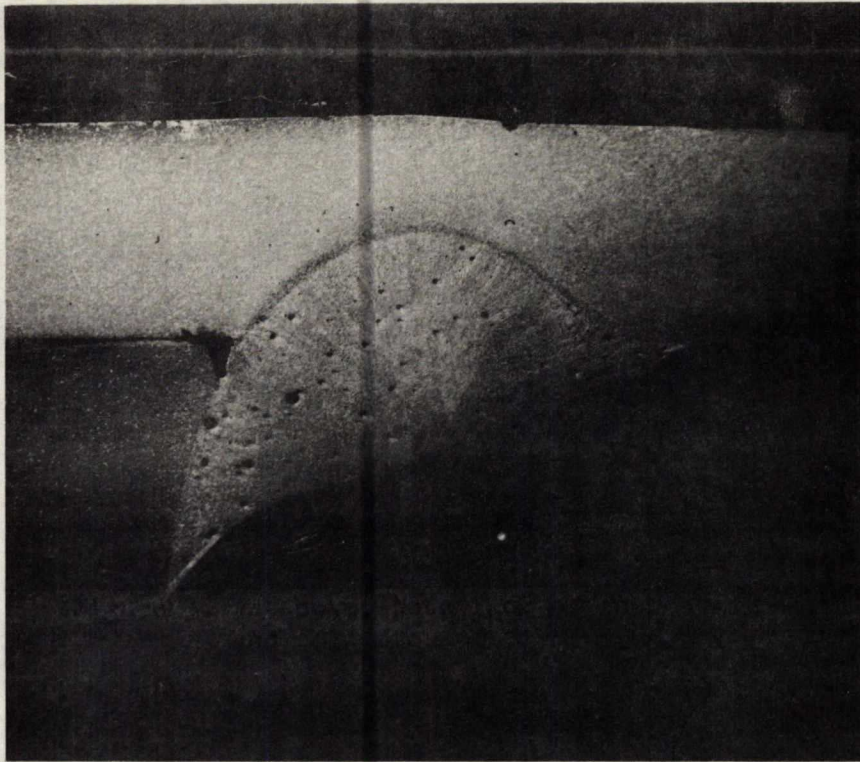
Figures 2 and 3 are single-pass welds typical of those made in the production of the tanks. Figures 4 and 5 are multi-pass welds, indicating that repairs had been made in these areas either during production or after initial testing. It is evident in Figures 2 and 3 that greater fusion has been obtained in the tank sheet than in the sump section. The resultant fillets are poorly formed and suffer from lack of root fusion. The effective strength of the section is considerably reduced and severe notches are provided by the defects. In Figures 4 and 5, a greater cross-section is provided by the multi-pass welds but similar root defects exist and there is evidence of cracking originating at the roots of these welds.

Figure 2. Single pass weld joining tank sheet (above) and sump section (below).
Note: poor fillet weld contour and lack of root fusion. (Keller's etch; X6)

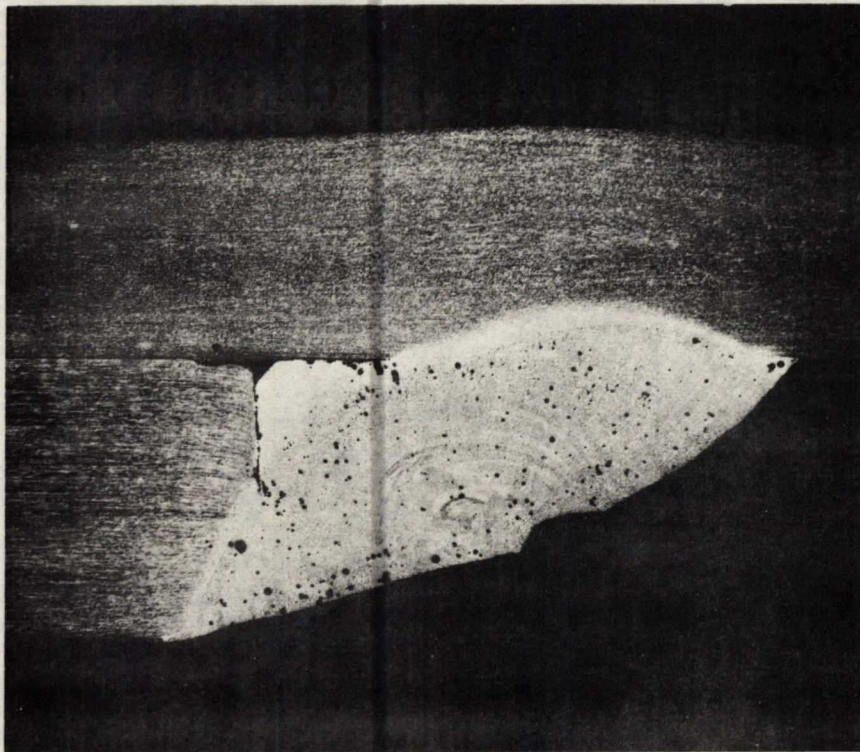
Figure 3. As above. Note lack of fusion at root and cold flow of filler metal.
(Keller's etch; X6)

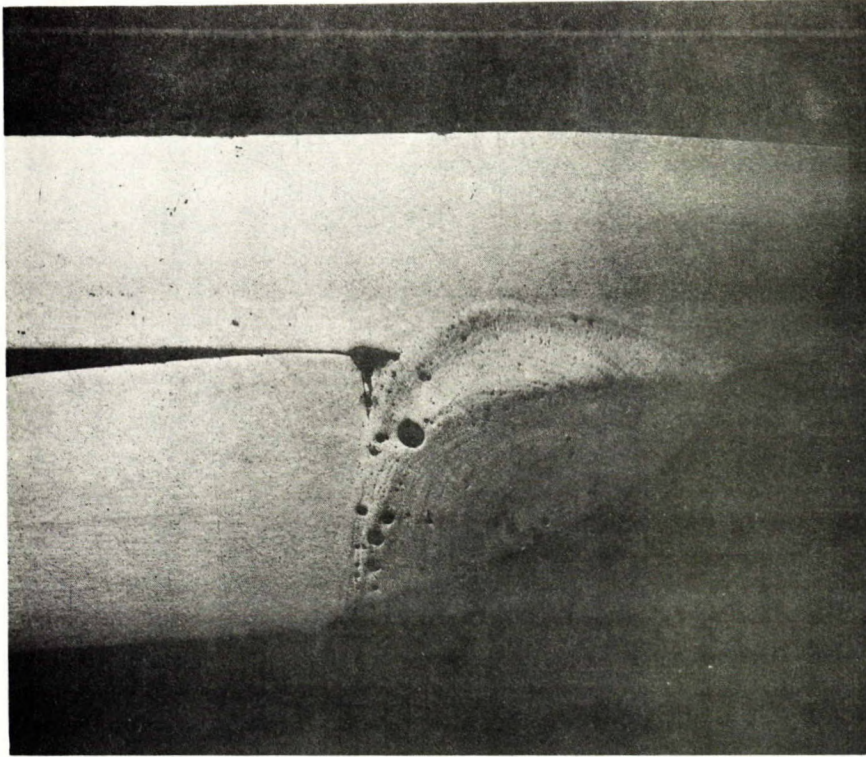
Although examination of sections of the joint in question did not reveal any cracks that penetrated the joint completely, incipient cracks were observed (Figures 4 and 5) and, in most cases, welding defects such as uneven or insufficient penetration, porosity and insufficient throat section, would be expected to reduce the fatigue resistance of the joint even further.

Figure 4. Multi-pass weld with incipient cracking in root defect. (Keller's etch; X6)

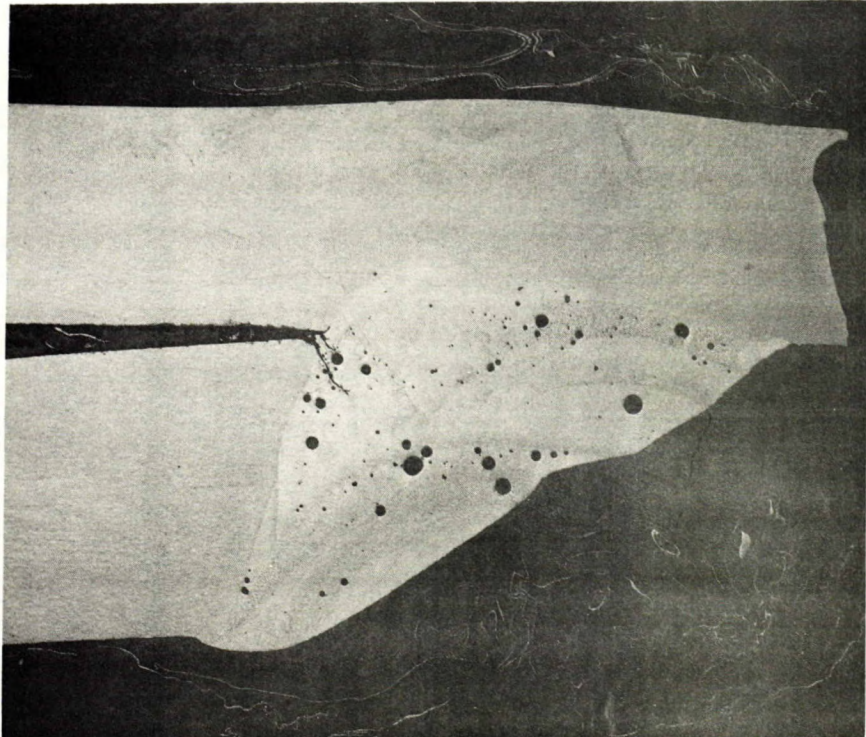
Figure 5. As in Figure 4. (Keller's etch; X6)

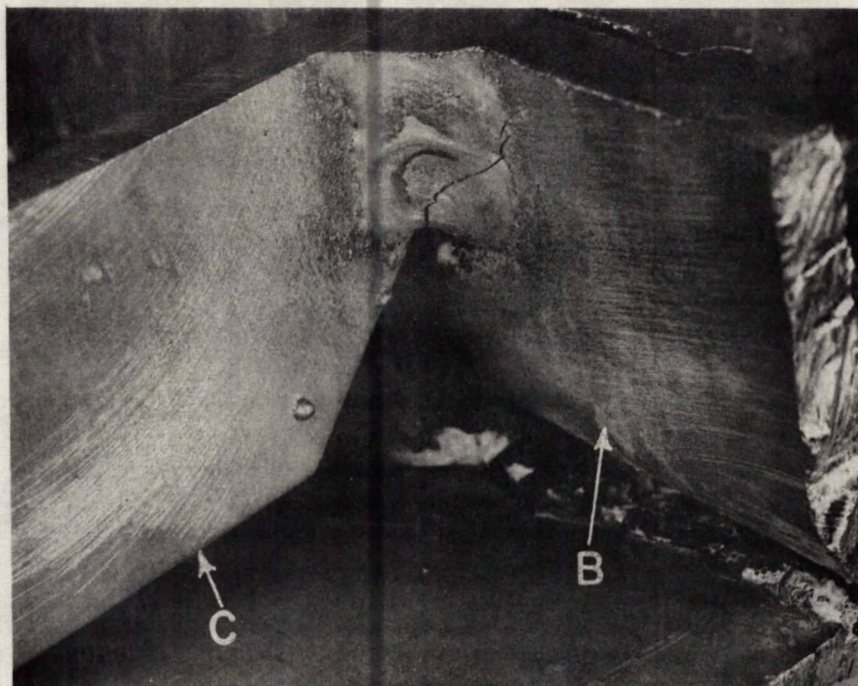
In Figure 1, attention is drawn to a crack in the weld joining the sump reinforcement (C) to the sump wall (B). This crack is shown in greater detail in Figure 6 and a macrophotograph of a cross-section taken from this weld is shown in Figure 7. It will be noted that the crack, which had its origin in the crater of the weld, has extended and run into the parent metal at the toe of the fillet weld. Figure 7 also shows a crack in the weld extending from a root defect and a small crack in the sump section a short distance from the main crack. After this section had been photographed, it was broken and the surfaces of the metal in the crack were examined. The appearance of these surfaces and the lack of evidence of deformation before fracture indicated that the crack was caused by fatigue.

The significance of the cracking of the sump wall at the joint with the sump reinforcement (Figures 6 and 7) is uncertain as no leaks have actually been observed in this region. However, in future designs the possibility of fatigue in this situation should be considered.

Figure 6. Showing crack in weld joining sump reinforcement to sump wall. C - sump reinforcement, B - sump wall. (X2).

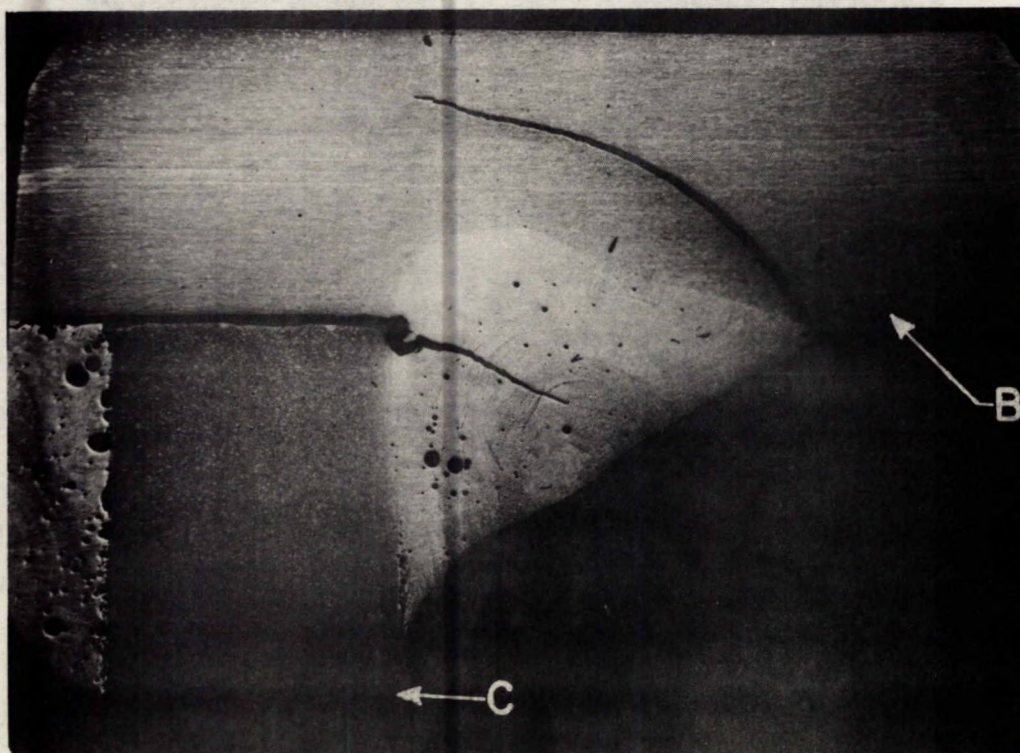
Figure 7. Macro photograph of cross section of weld shown in Figure 6. (Keller's etch; X6).
