DEPARTMENT OF MINES AND TECHNICAL SURVEYS

MINES BRANCH INVESTIGATION REPORT IR 63-77

EXAMINATION OF CAST-ON ALUMINUM ALLOY FLANGES ON WAVE-GUIDE SECTIONS

EXAMINATION OF CAST-ON ALUMINUM ALLOY
FLANGES ON WAVE-GUIDE SECTIONS

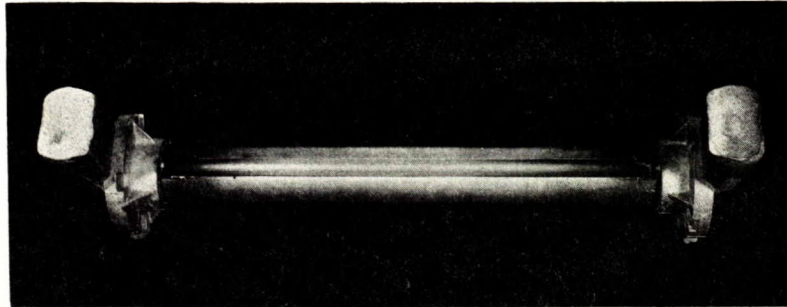
Figure 1 shows a length of wave-guide with a cast-on flange at each end. The risers had not been removed. The length of the section was about 20 in. and consisted of a tubular section (see Figures 2 and 3) of extruded 65S-T6 aluminum alloy, having an outside diameter of 2 in.

Figure 1. Length of wave-guide with cast-on flange at each end.

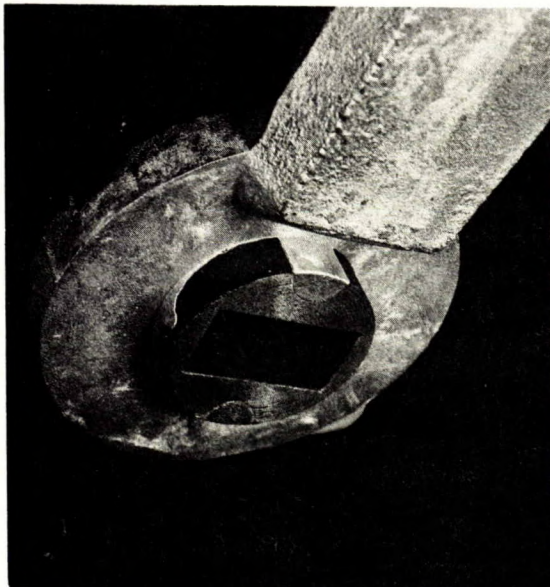
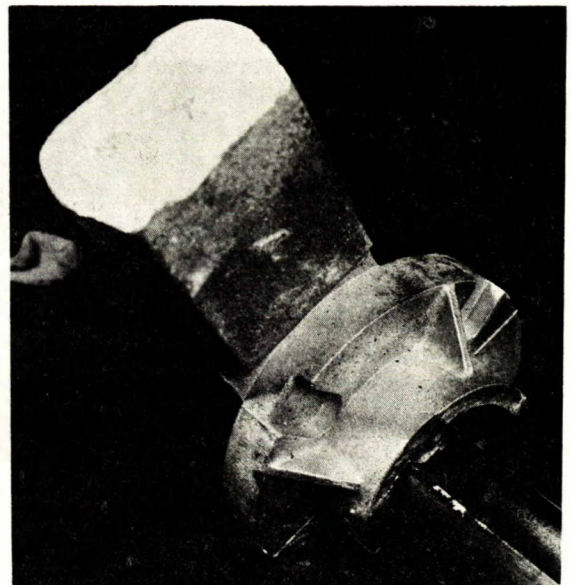
Coarse circumferential grooves had been machined in each end of the tube sections to key the flanges. In the written notes supplied it was stated that the ends of the tube were preheated to 450°F just before casting. A permanent mould is used. After removal of the riser the projecting ends of the tube (see Figure 2) are machined off flush with the faces of the flanges.

Figures 2 and 3. Cast-on flange before machining showing riser and tube section.

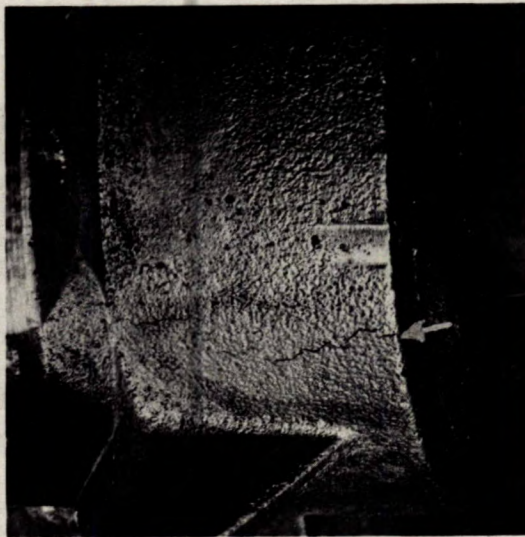
In the failed specimen supplied, which had been machined, several cracks could be seen with the unaided eye, as shown in Figure 4. These cracks occurred on the small diameter inner part of the flange, as shown in Figure 3. By sawing through the larger diameter part of the flange one of the cracks was opened with little difficulty and revealed that the section was almost completely penetrated (see Figure 5). The fracture surface was discoloured, indicating prior separation over its whole area except about 1/4 in. from the saw cut. (see Figure 5).

Figure 4. Flange showing crack (arrow).

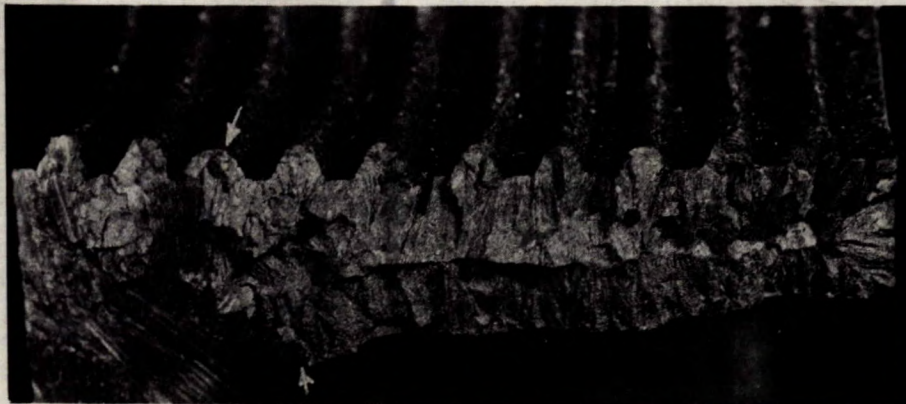
The appearance of the fracture surface suggested the presence of very coarse grains of the columnar type growing from the sides and meeting approximately in the centre of the section.

Figure 5. Fracture surface of crack. Saw cut shown at left. The discoloured section (not shown clearly in photograph) extended from the right hand end to a line indicated by the arrows.

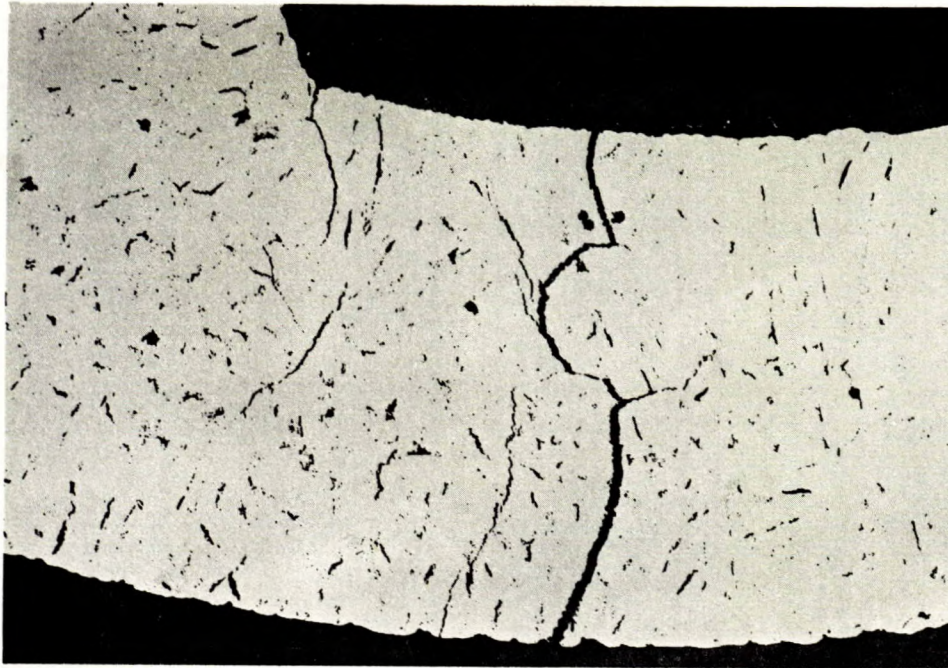
After polishing, examination at low magnification revealed severe porosity in both sections, as shown in Figures 6 and 7. It will be seen that many pores were elongated and it was apparent that the cracks had occurred through suitably oriented defects of this type.

Examination of the sections at higher magnification confirmed that some parts of the crack passed through elongated grain boundary pores, whereas at other sections failure had apparently occurred at sound grain boundaries. It was not possible to determine conclusively whether the cracking had occurred in the solid or semi-solid state.

Severe unsoundness in all of the flanges probably contributed to their failure and, especially in the cracked flange, the chemical composition of the alloy was seriously outside specification limits.

Figure 6. Section through the crack showing severe unsoundness at grain boundaries and within grain.

It is suggested that as the incidence of cracking is intermittent and occurs only in about 30% of castings, improving the soundness and strength by better temperature control, degassing and, possibly, grain refinement would be sufficient to eliminate the defect. Control of the chemical composition of the melt is obviously also an important factor.

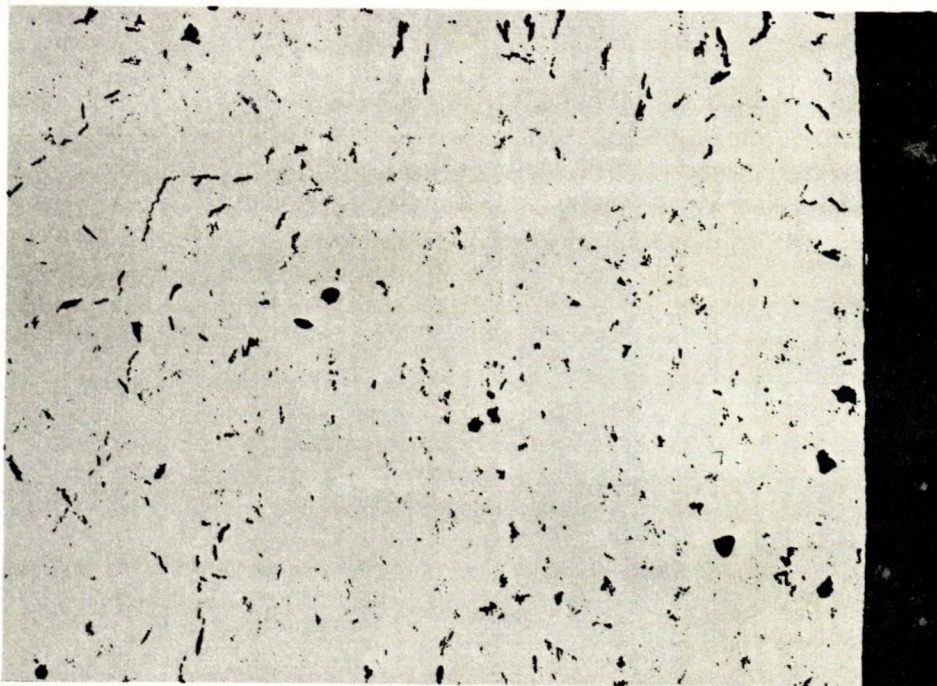
Figure 7. Section through cracked flange remote from the crack (outer part of flange) showing unsoundness.
