MINES BRANCH INVESTIGATION REPORT IR 63-79

EXAMINATION OF TWO LENGTHS OF 4-6% CHROMIUM STEEL TUBING

D. E. PARSONS

AUGUST 9, 1963

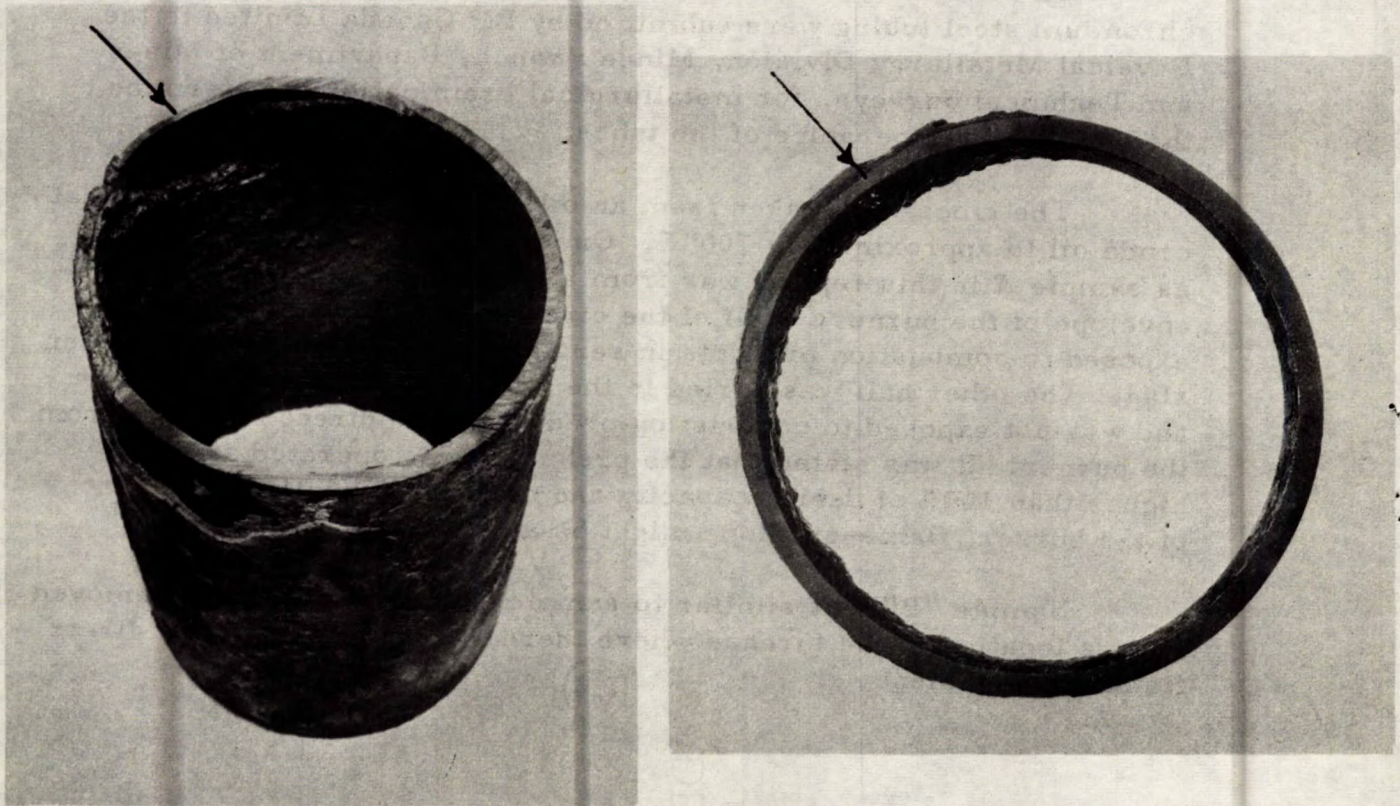
Figure 1. Sample A. Illustrates coke build-up on inside tube surface and presence of slag on outside surface. The exposed surface is shown at the left side of both pictures. Arrows (1) illustrate the reduction of wall thickness at the exposed surface.

Sample A: The exposed half-surface of this tube was coated with frozen slag on the outside surface and contained a deposit of coke on the inside surface in the area corresponding to the flame-exposed area of the tube. Reduction of wall thickness from 1/4 in. to 1/8 in., approximately, had occurred in the most severely affected region of the sample.

1. Reduce the operating temperature of the 5% chromium steel tubes in accordance with allowable stresses up to maximum service temperature of 1100° F.
2. After temperature is controlled, review burner and oil-ash character to obtain maximum tube life.

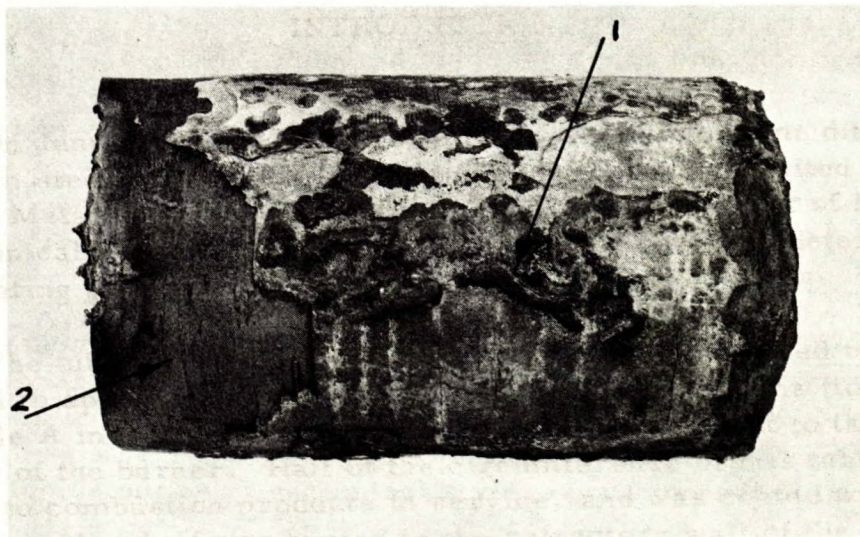
Figure 2 illustrates the appearance of the exposed area of the outside surface of sample A. This surface was coated with frozen slag. Solidified droplets of slag are visible (arrow 1). The appearance of the thinned tube, after removal of the slag, is shown (arrow 2).

Figure 2. Sample A. Illustrates exposed surface of tube and slag coating. Droplets of slag are shown, (arrow 1). The appearance of the tube surface after removal of the slag is shown, (arrow 2).

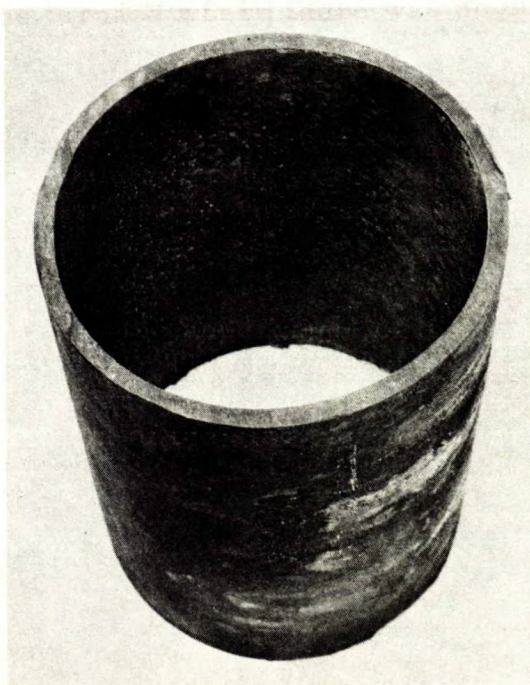
Figure 3. Sample B. Reference sample from furnace area not affected by burner-flame.

Sample B: The wall thickness of this tube-length was approximately 1/4 in. and had not been reduced. Slag and coke deposits were not present. There was no apparent difference between the exposed and the protected surface of this sample. (Presumably, this tube was heated by radiation and convection but without direct impingement of the burner-flame).

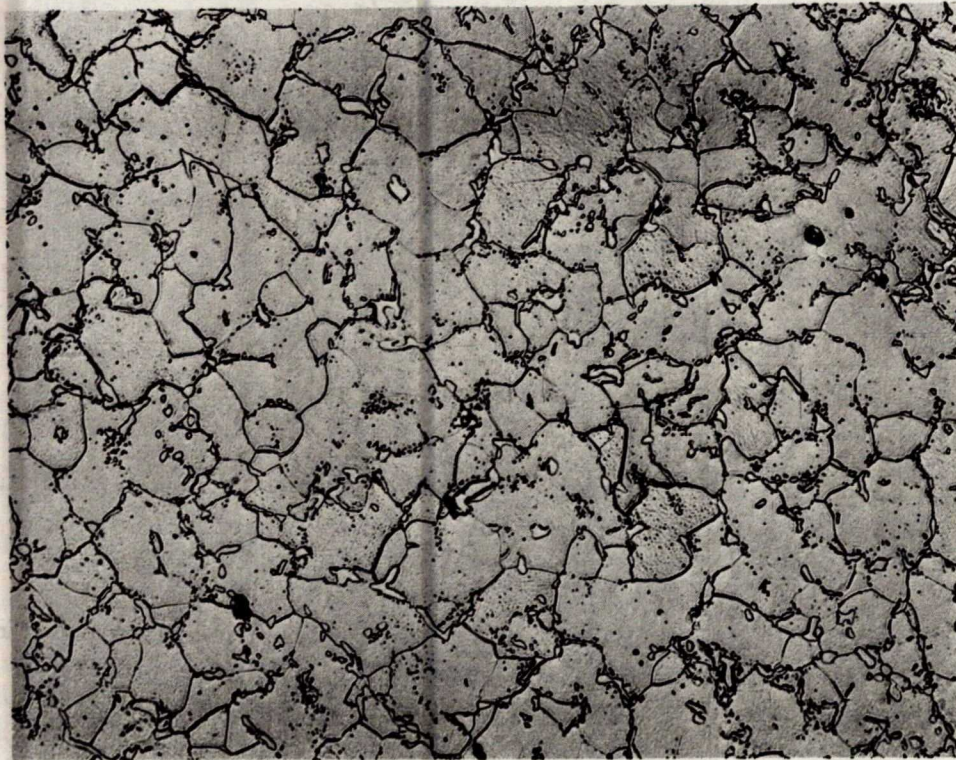
Figure 4. Sample A. Area where section was reduced to 1/8 in. The microstructure consists of ferrite and coalesced, spheroidized carbide, indicating temperatures of 1300° - 1400°F in this location.

The presence of coalesced carbide, completely through the section in the region where the thickness had been reduced to 1/8 in. indicates that the tube operated at a temperature of 1300°-1400°F in this location. The inside surface temperature was sufficiently high to cause solution of the massive carbide. Subsequent precipitation caused formation of a shallow zone of metal at the inside surface where a dispersion of small carbides (dots) was observed, indicating that 1400°F was a more probable service temperature than 1300°F.

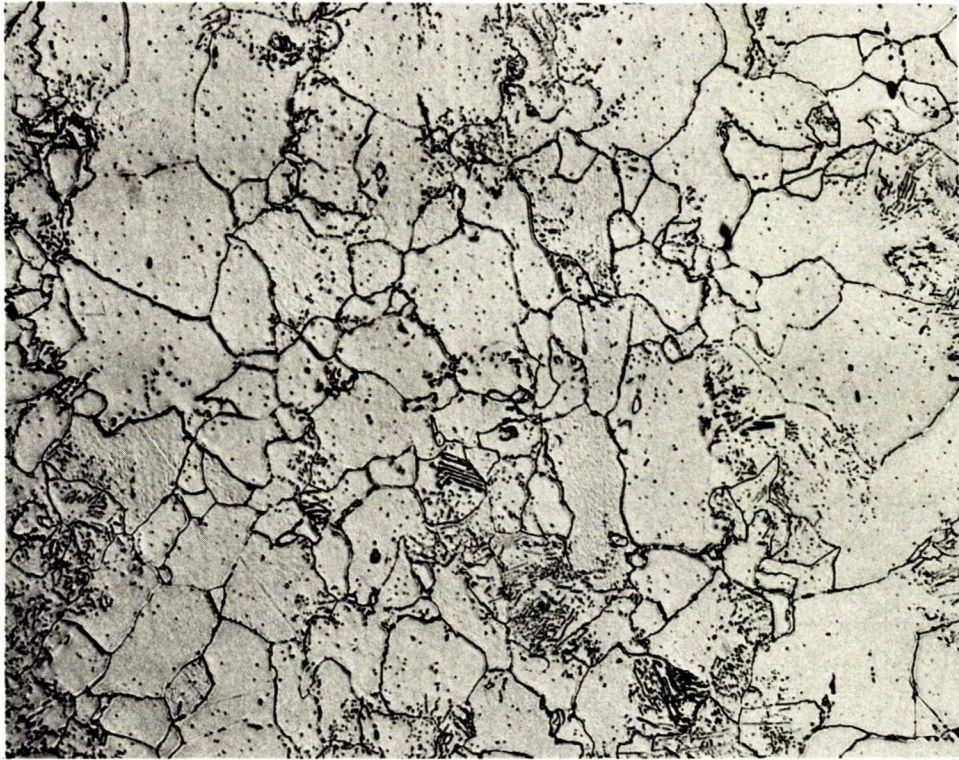
Figure 5. Sample A. 180 degrees from section shown in Figure 1. This section of the tube was covered by furnace refractory and was 180 degrees from the exposed section illustrated in Figure 1. The carbide is partially spheroidized, but has not coalesced.

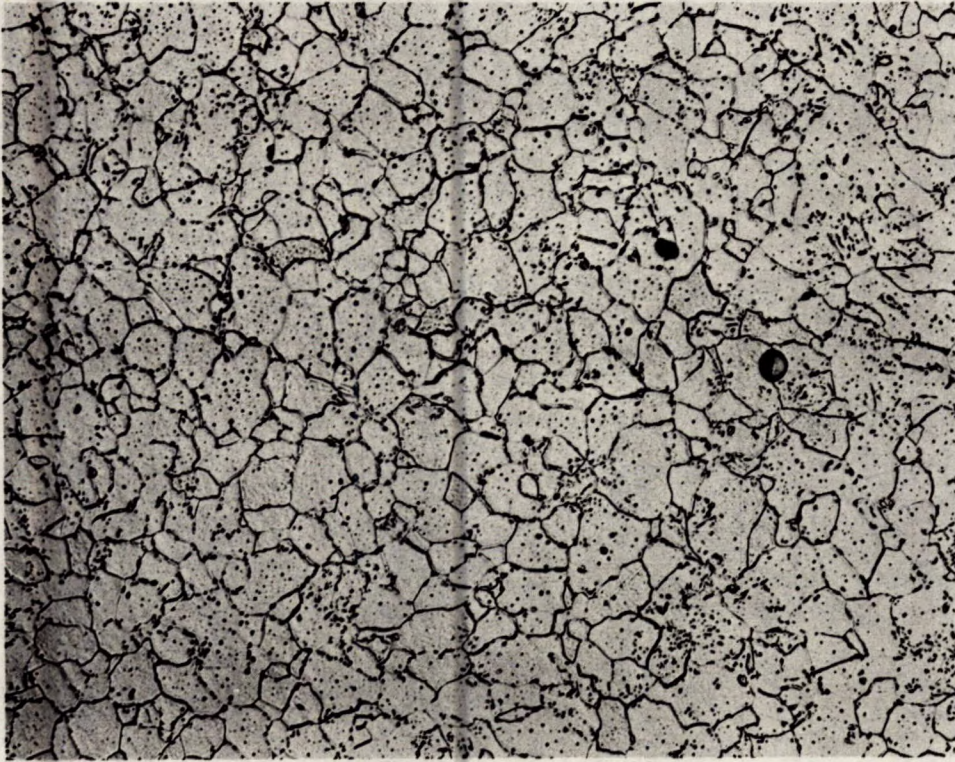
Figure 6. Sample B. Reference sample. This section was stated to be representative of the structure of the tubes after installation.

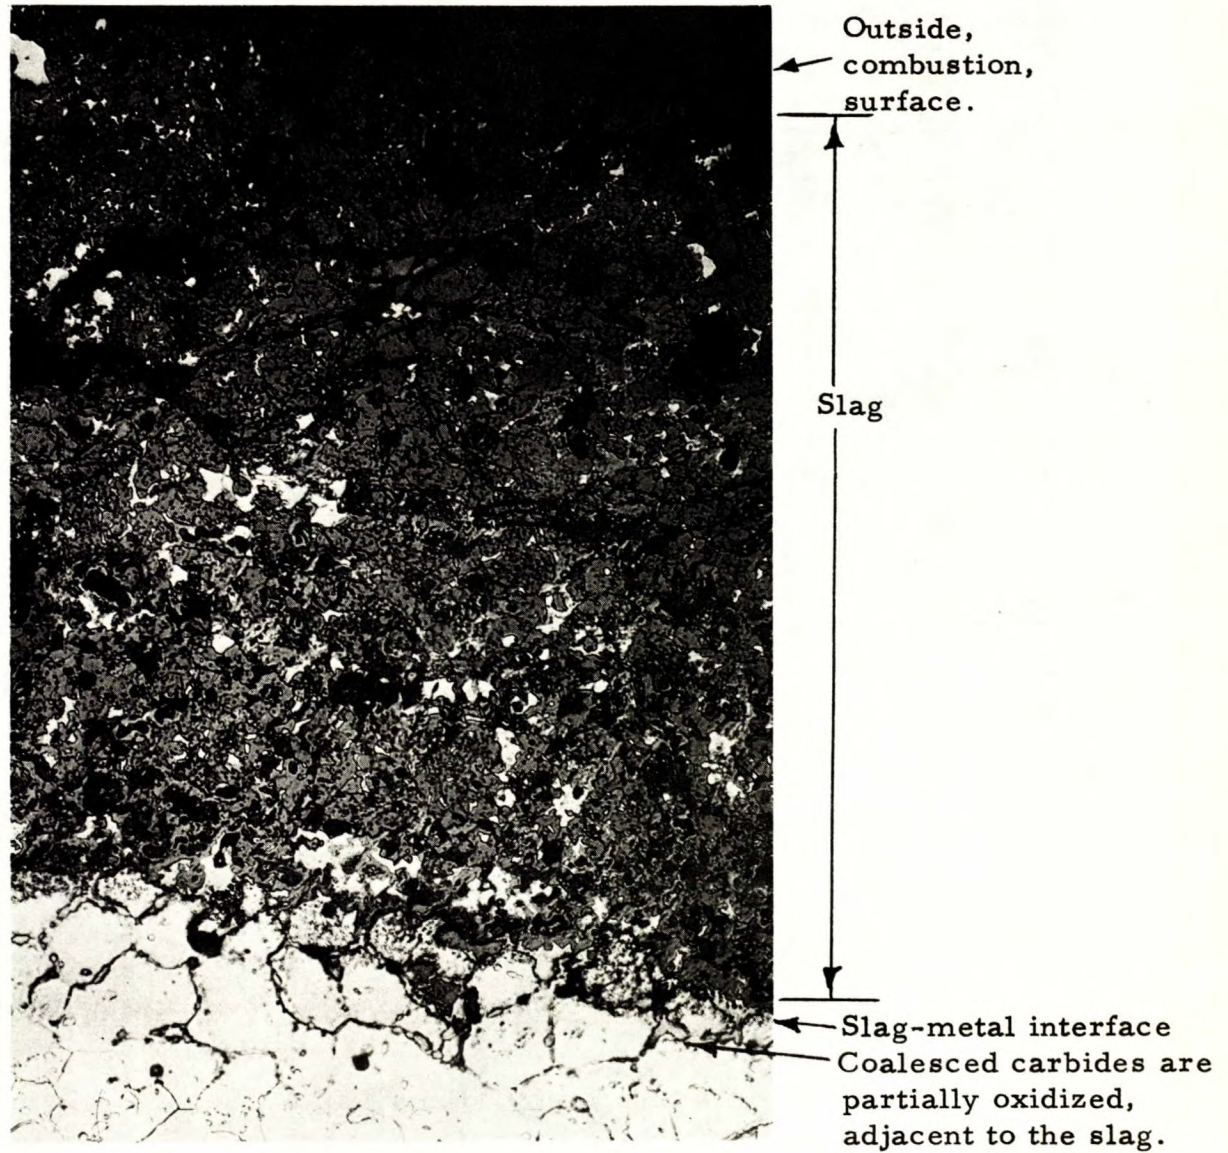
Figure 7. Sample A. Section at outside surface of reduced section illustrating the slag deposit and slag-metal interface. The slag contains metallic particles.

The reduction in wall thickness at 1400°F appeared to be due to erosion, by siliceous (refractory) slag, of surface metal weakened by intergranular oxidation. Any contribution of the oil ash (V and S) or due to the nature of the burner flame (oxidizing, neutral or reducing) was masked by the dominant temperature effect. No sulphur compounds were detected in the slag. Iron was present as a major trace, vanadium was a minor trace element. Chromium was not detected.

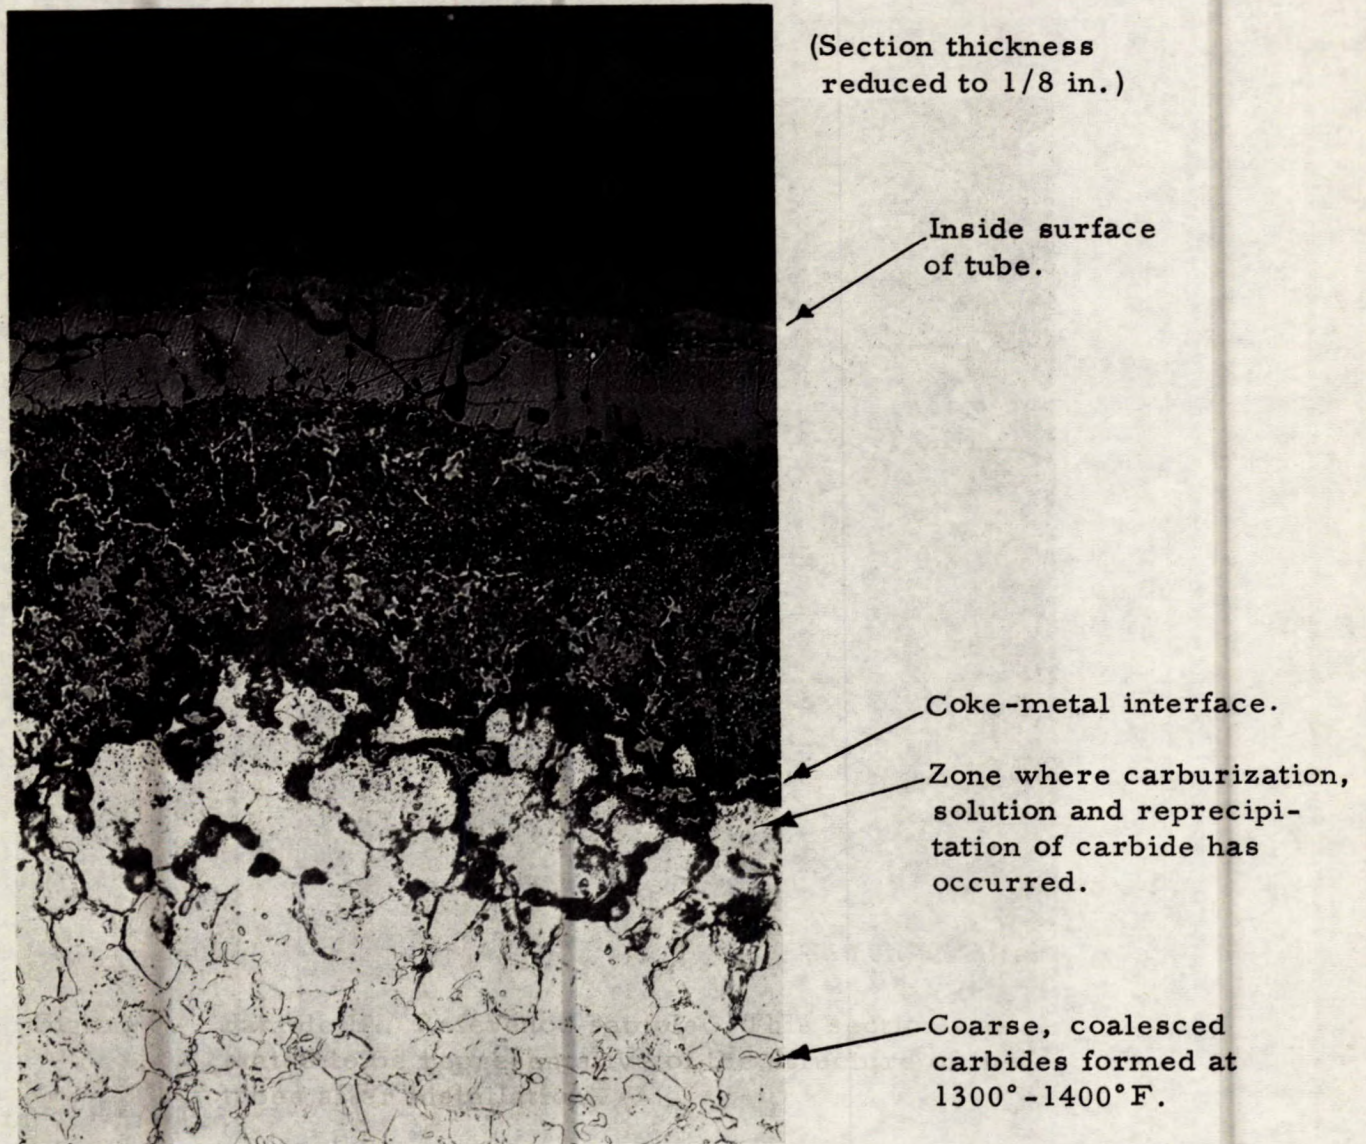
Figure 8. Sample A. Section taken at the inside surface in the region corresponding to maximum reduction of section.

The coke deposit and coke-metal interface are shown. The carbides have coalesced and are present as coarse particles, indicating service temperature of 1300°F-1400°F. Solution of coalesced carbide, accompanied by carburization and subsequent precipitation of small carbides, appears to have taken place in a narrow zone at the coke-metal interface.

The presence of this shallow zone is more consistent with tube temperature of 1400°F than 1300°F; whereas the residue of undissolved, coalesced carbide through the section indicates that the temperature has not exceeded 1450°F.
