MINES BRANCH INVESTIGATION REPORT IR 63-105

**METALLURGICAL EXAMINATION OF
GALVANIZED REFRIGERATION
UNIT SAMPLES**

J. J. SEBISTY

OCTOBER 23, 1963

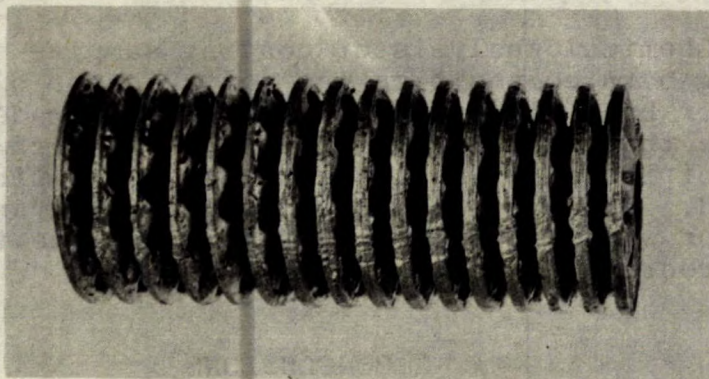
Photographs of the submitted samples showing normal and abnormal galvanizing behaviour of the finned tubes are given in Figures 1 to 3. Figure 1 represents a piece from a tube (Sample 3) which had developed an abnormally thick coating on the fins throughout the full 18-ft tube length. On another tube (Sample 1) there was a sudden transition from normal (A-end) to abnormal (B-end) coating formation on the fins as shown in Figure 2. In the longitudinal cross section in Figure 3 (Sample 2), the abnormally thick coating on the fins can be seen; this exceeded $1/16$ in. Affected tubes were stated to be located without any definite pattern as to position within the unit or to position of the unit during the galvanizing operation.

Figure 1. Sample 3 ($X_{\frac{1}{2}}$).

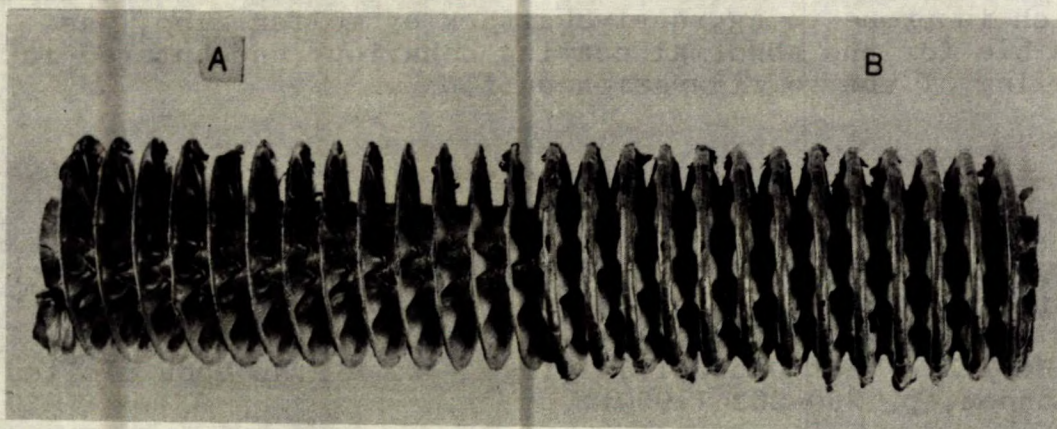
The sudden transition from normal to abnormal coating formation on Sample 1 in Figure 2 was of particular interest and this area was stripped for further examination. The change from thin to thick coating was found to coincide exactly with a spot-welded joint in the spiral-wound fin as illustrated by the lower sample in Figure 4. Pieces of the fin steel from either side of this joint were analysed by the Analytical Chemistry Subdivision of the Mineral Sciences Division, Mines Branch and the reported results are given in Table 1. For comparison the composition limits for tin plate steel⁽¹⁾ are also given.

Figure 2. Sample 1 ($X_{\frac{1}{2}}$).

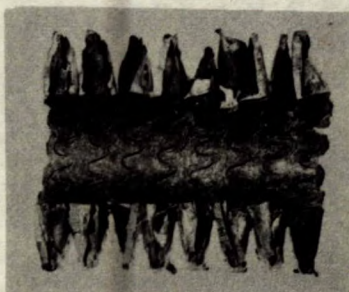
Figure 3. Sample 3 ($X_{\frac{1}{2}}$).

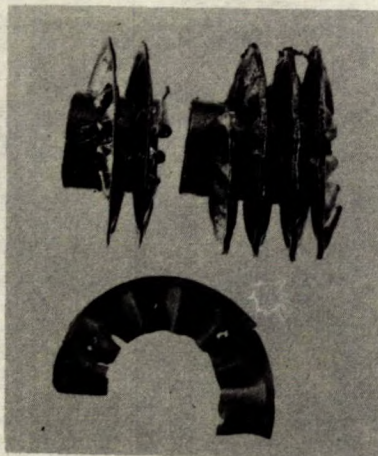
As a matter of interest, laboratory dipping tests were made with sections cut from the A- and B-end of Sample 1 in an iron-saturated zinc bath alloyed with 0.002% Al and 1% Pb. The original coating was removed by acid stripping and the sections regalvanized for 1/2 hr at 450°C (840°F) and also at 470°C (880°F). At the lower temperature, only moderate differences in coating build-up on the low- and high-carbon fin steels was apparent. The higher temperature produced much more exaggerated build-up on the high-carbon steel as illustrated in Figure 4, but this was still considerably less than on the submitted samples in Figures 1 to 3. The coating microstructure in this case also reflected a less advanced stage of steel attack and iron-zinc alloy growth. As would be expected from the geometry of the crimped fin, most severe attack was concentrated on the maximum-radius surface of each crimp as illustrated in Figure 9.

Figure 4. Upper samples represent regalvanized sections from Sample 1 (A- and B-end to left and right respectively). Lower sample shows fin joint in Sample 1 transition area. $X_{\frac{1}{2}}$

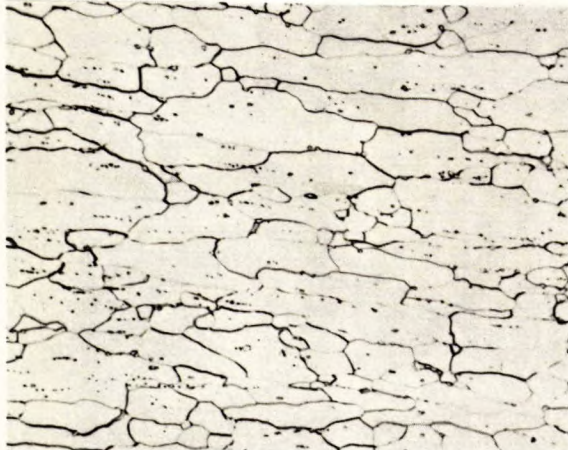
Although of otherwise acceptable composition, both materials exceeded the accepted maximum of 0.12% C. In the one case the carbon was slightly high only but was more than double the above figure in the material that galvanized abnormally. This difference in composition was reflected in the steel base microstructure and hardness. The low carbon material had a larger grain size and, as illustrated in Figure 5, a scattered dispersion of spheroidized cementite particles indicated it to be more or less typical of normal tin plate steel; the Rockwell hardness was 69 (30-T scale). In contrast, the high-carbon steel had a very fine grain structure combined with an excessive and uniform dispersion of spheroidized cementite as shown in Figure 6; the Rockwell hardness was 76 (30-T scale). Of particular significance is the fact that the latter type of spheroidized structure is known to exhibit very aggressive attack after lengthy immersion in molten zinc, even at normal galvanizing temperatures⁽²⁾.

Figure 5. Microstructure of fin steel from A-end of Sample 1. Nital etch, X500.

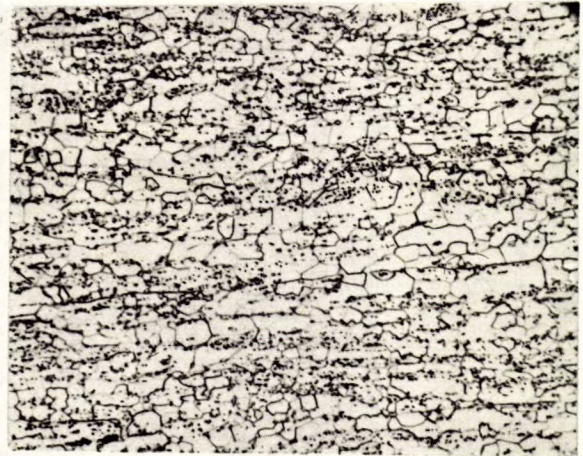
Figure 6. Microstructure of fin steel from B-end of Sample 1. Nital etch, X500.

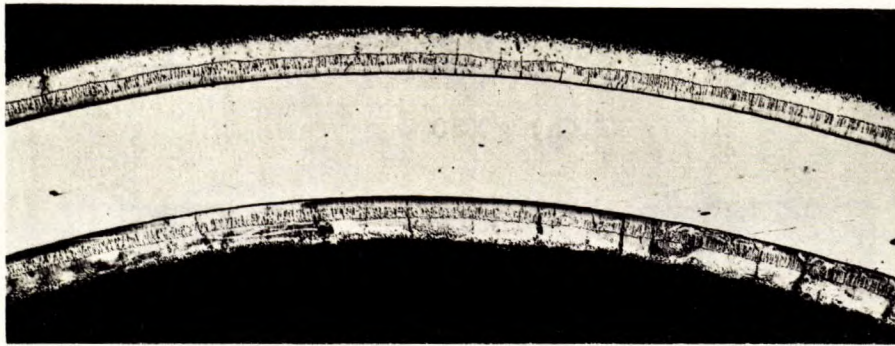
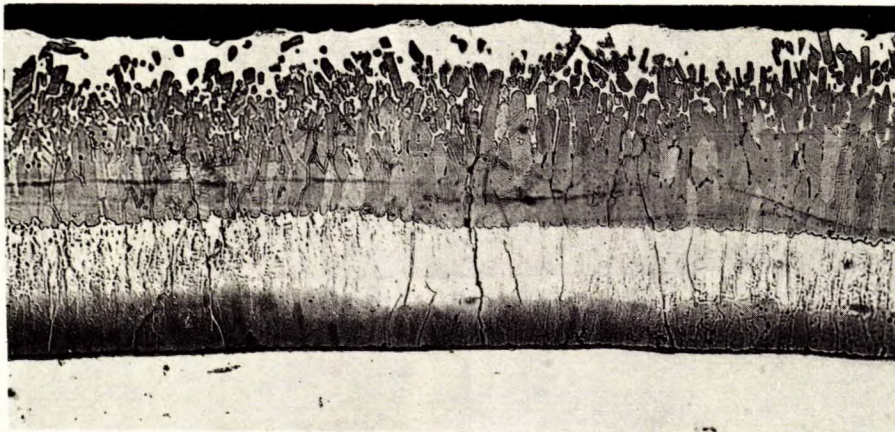
Specimens cut from Sample 3 and from the A- and B-end of Sample 1 were mounted, polished, etched and examined microscopically. As expected, the fin steel on the A-end of Sample 1 exhibited a "normal" coating with a typical layered structure of iron-zinc alloy phases as in Figure 7. All of the individual phases were present including a thin gamma iron-zinc layer adjacent to the steel base. From the thickness and structure of the duplex delta-prime phase above the gamma layer, it would appear that an extended immersion time was used.

Figure 7. Microstructures of normal coating on A-end of Sample 1 at low and high magnifications. Picric etch.

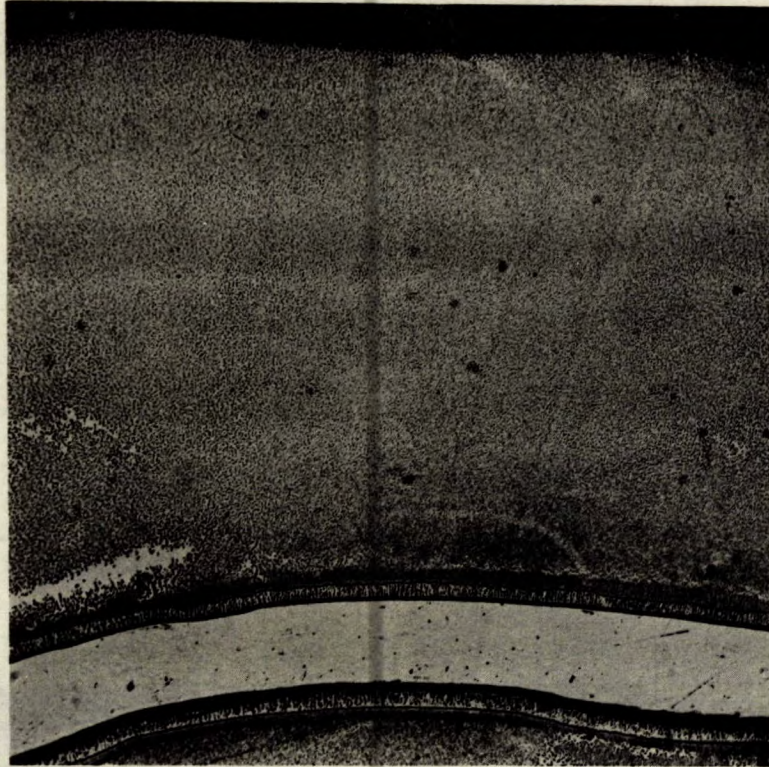
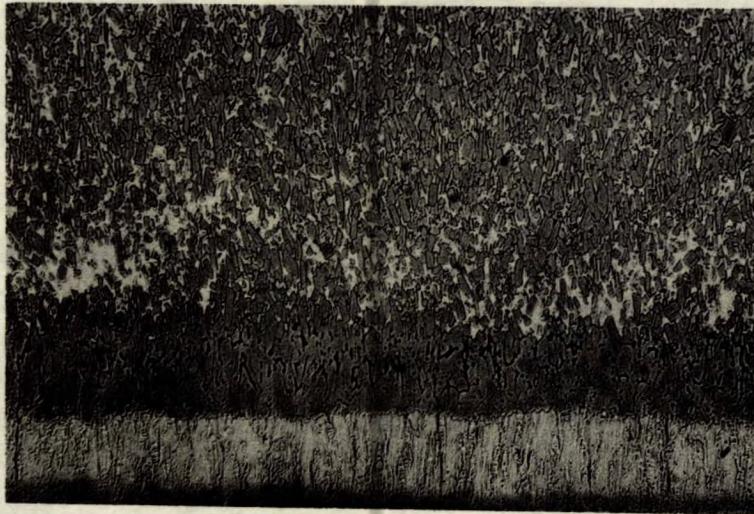
It was also confirmed that the abnormal coating on Sample 3 and the B-end of Sample 1 was related to extremely aggressive zinc attack of the high-carbon fin steel. Pronounced growth of the zeta iron-zinc phase in the form of a loose to densely-packed mass of small crystals embedded in a zinc matrix accounted for the thick coating formed. This also explains the high and variable iron content.

Typical microstructures found near the outer edge of the heavily-coated fin are shown at low and high magnifications in Figures 8(a) and 8(b). The absence of a gamma iron-zinc layer adjacent to the steel base is to be noted, as is also the similarity in structure and uniformity of the delta-prime phase in this coating and the coating on the low-carbon steel in Figure 7. This appears to conflict with a high iron-zinc reaction rate in the case of the high-carbon steel but is, however, consistent with the high rate of formation of the delta prime phase under such conditions, and the rapid reaction of this phase with zinc to form the zeta iron-zinc phase. Supporting evidence for the pronounced galvanizing activity of the high-carbon steel was provided by the irregular cross-section thickness of the steel base in the microstructures. This was reflected in marked unevenness of the steel surface, which was observed in prior stripping tests.

Figure 8. Microstructures of abnormal coating on B-end of Sample 1 at low and high magnifications. Picric etch.

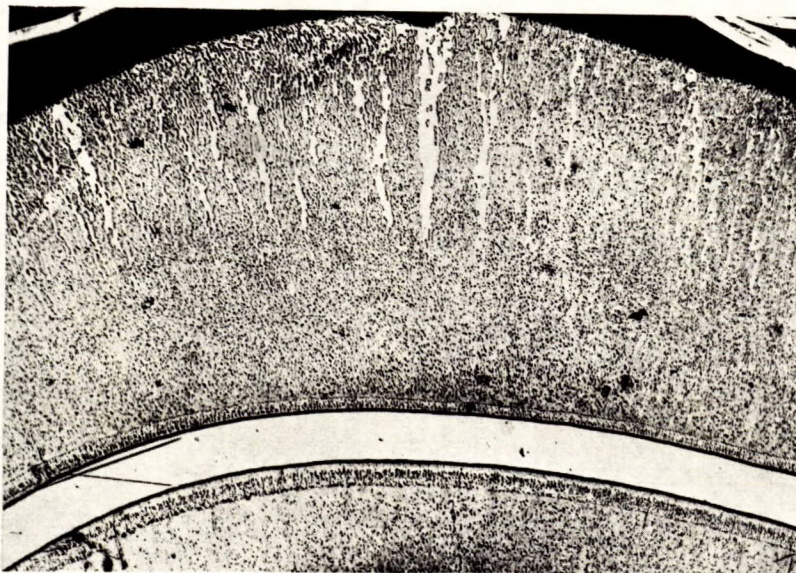
It will be appreciated that these tests were not made with the original steel surface intact, i.e., as applicable when the refrigeration unit was initially galvanized. Despite this difference, the results of the laboratory galvanizing tests strongly suggest that the immersion time and/or bath temperature conditions employed in the plant galvanizing operation contributed significantly to the gross coating formation encountered.

Figure 9. Microstructure of coating formed on B-end of Sample 1 by regalvanizing for 1/2 hr at 470°C (880°F).
Picric etch, X50.
