MINES BRANCH INVESTIGATION REPORT IR 63-107

EXAMINATION OF TWO BROKEN ICEBREAKER STUB PROPELLER BLADES

D. E. PARSONS

NOVEMBER 1, 1963

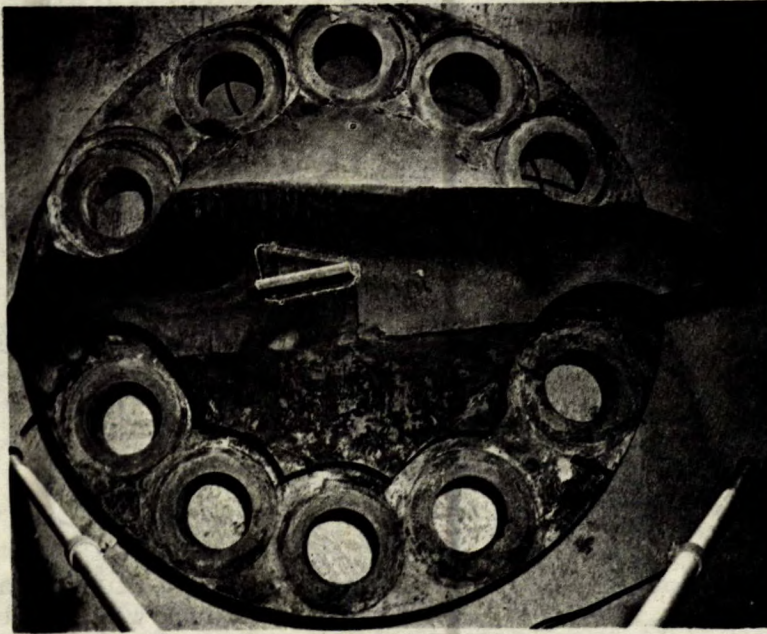
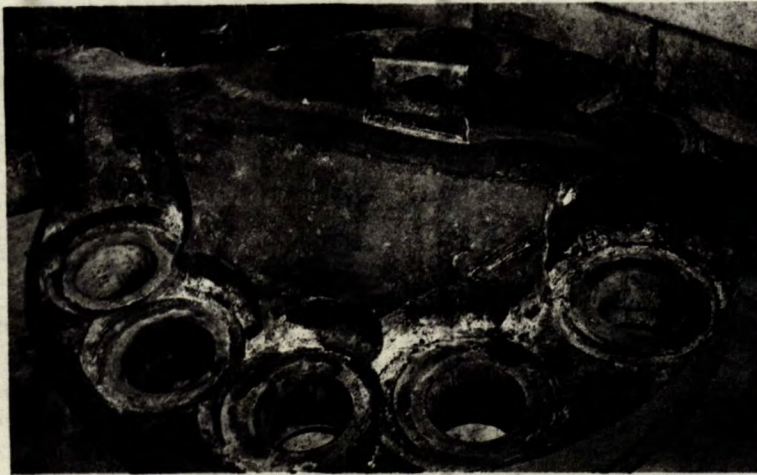
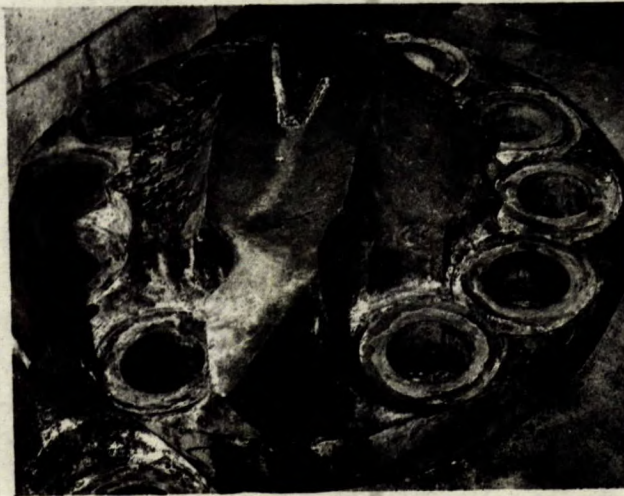
Both fractures showed little, if any, deformation and would be classed as "brittle-failures". Stub "S" had a relatively smooth fracture, whereas stub "R" was rougher and contained areas of coarse-grained, intergranular fracture commonly referred to as "rock-candy" fracture.

Figure 1. Broken Blade, CCGS John A. MacDonald, Sample "S" (3 views). The fracture is brittle and shows no evidence of plastic deformation.

The fracture surfaces were cleaned and de-rusted using HCl:SbCl₃ solution and were examined for evidence of fatigue. No beachmarks were observed. However, the fractures were distinctive in having smooth areas on the concave side at the reduced section of each blade (arrows Figure 1a, Figure 2a). It was not determined whether these smooth areas were fatigue origins - or were due only to the smaller grain size present at the thin sections of the castings. The absence of beachmarks made the section effect appear more probable.

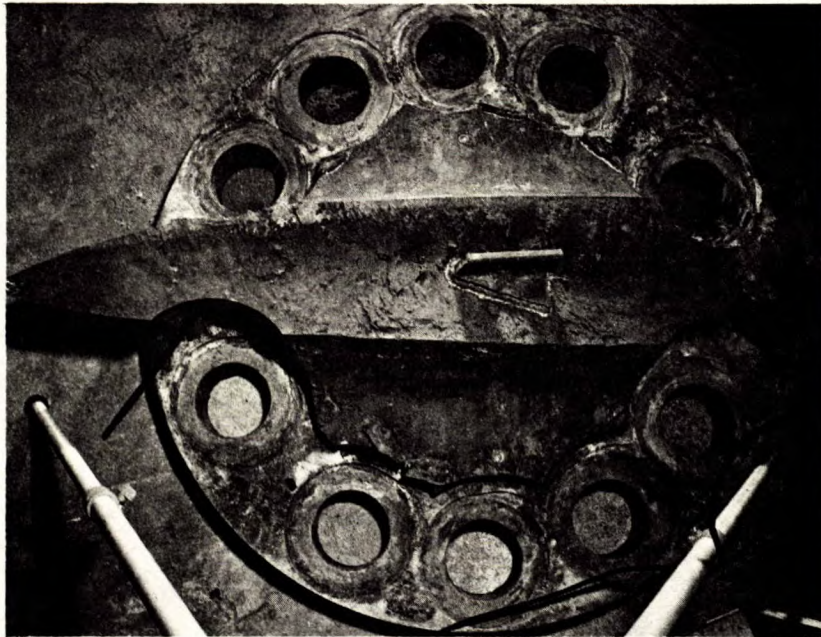
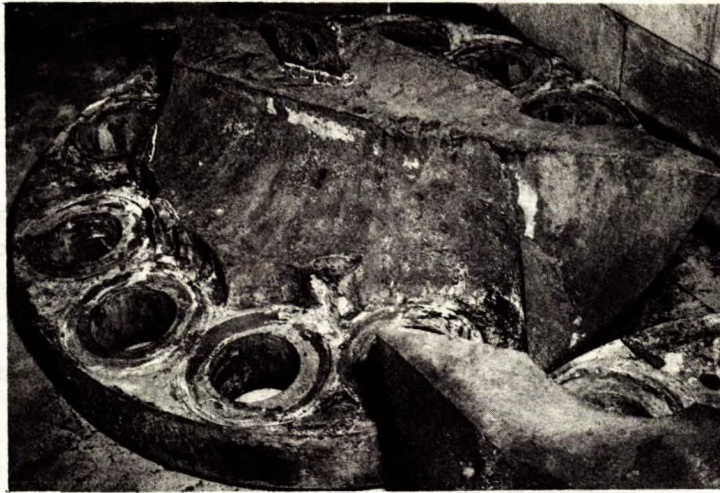
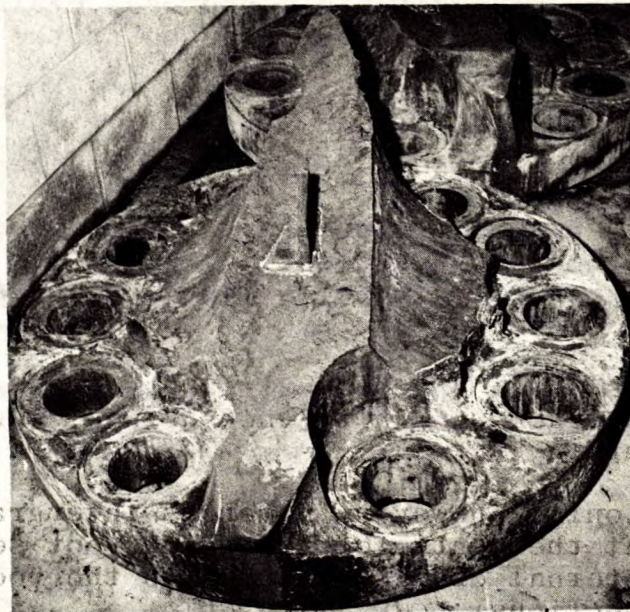
Figure 2. Broken Blade, CCGS John A. MacDonald, Sample "R"
(3 views). The fracture is brittle and shows little evidence of plastic deformation. The fracture surface is more irregular than that illustrated in Figure 1.

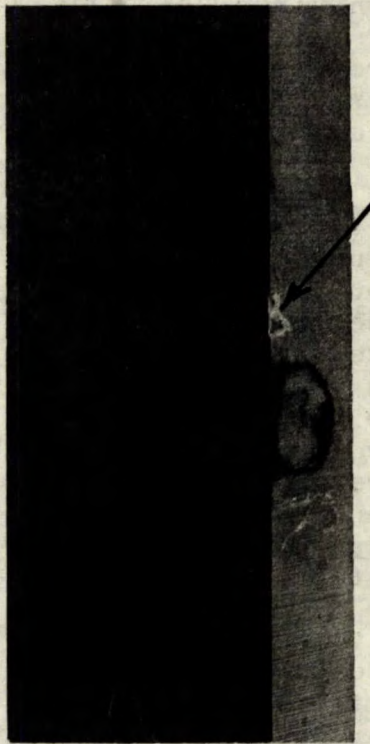
The appearance of a section through the thick part of casting "R" is illustrated in Figure 4 after machining and magnetic particle inspection. Areas containing cracks similar to those detected in the tensile bars are marked in the photograph. In the process of machining, a "rock-candy" fracture occurred at the corner marked by the arrow.

Figure 4. Section from Thick Part of Casting R. The edge surface corresponds approximately to the centre axis of the casting at the thickest section. Numerous hairline cracks were detected by wet fluorescent magnetic particle inspection and are circled. The arrow marks an area of rock candy fracture formed during machining.

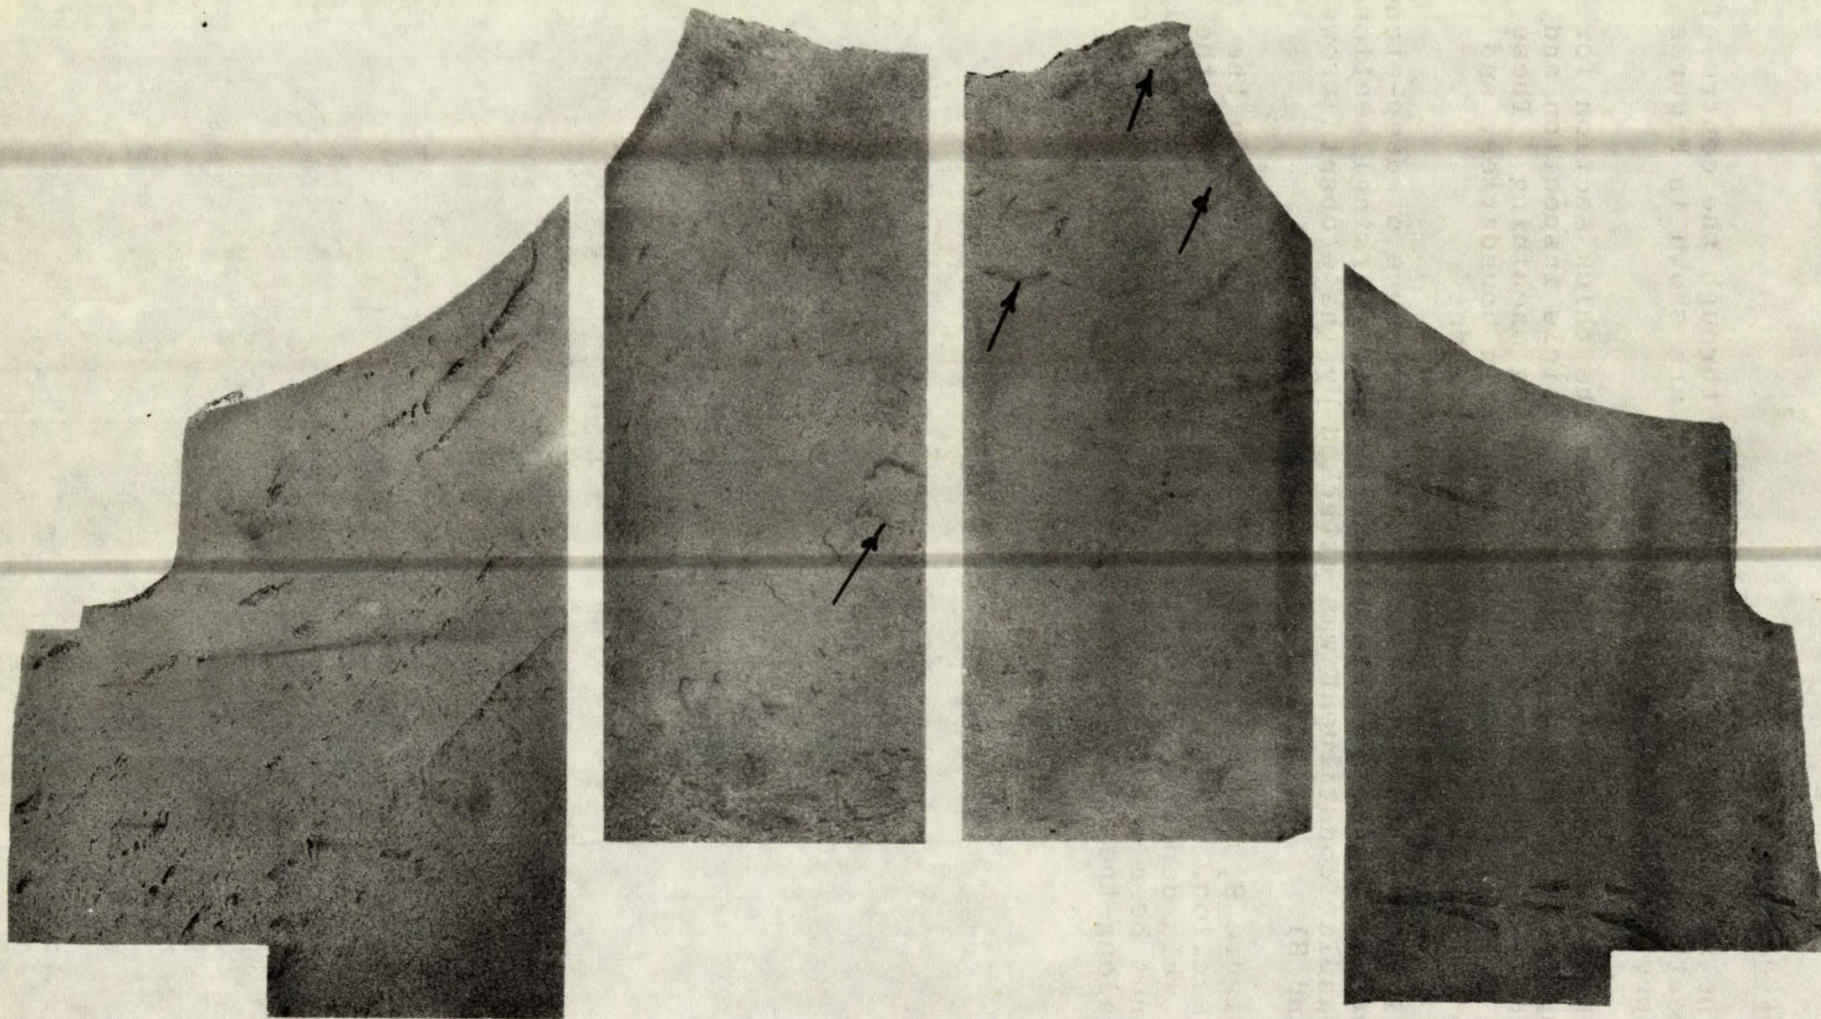
The hairline cracks, visible in the thick section for each casting, were detected by magnetic particle inspection and by the tendency to rock candy fracture during machining. These cracks were present in primary austenite grain boundaries, and appeared to follow the grain boundary constituent.

Figure 5. Deep-Etched Sections through Stub "R"
(Heavy Section). Intergranular hairline
cracks are illustrated (arrows).

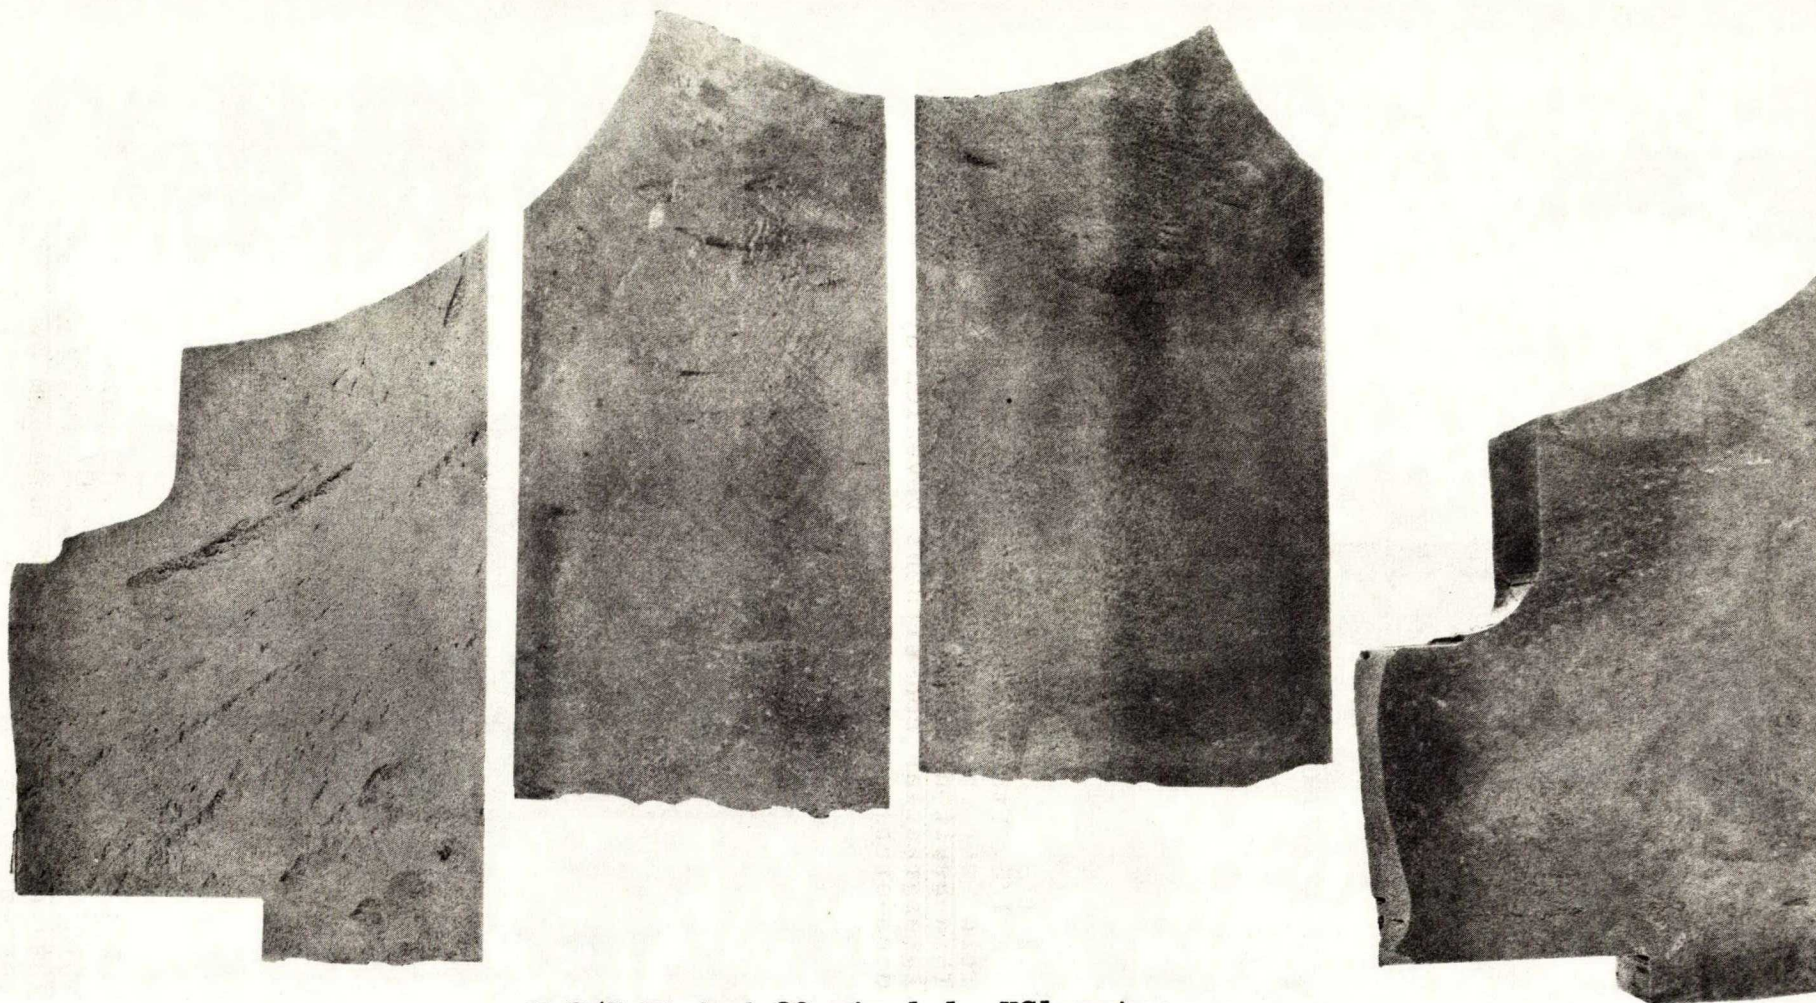
Figure 6. Deep-Etched Sections through Stub "S" (Heavy Section).
This casting appeared to be free from hairline
cracks.

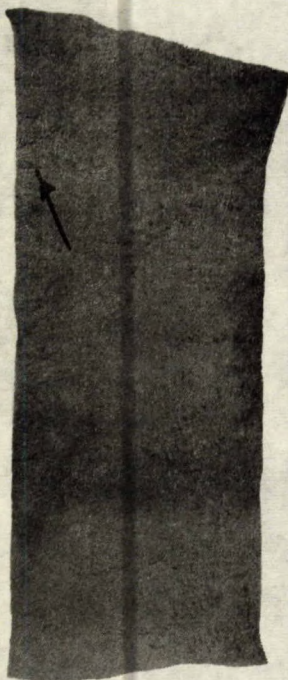
Figures 7 and 8 illustrate the appearance of deep-etched sections through the critically-stressed, thin (working) sections. The intergranular constituent was attacked by the etchant (arrows Figures 7 and 8).

Figure 7. Thin Section, Stressed Region, Casting "R".
Intergranular constituent revealed by
deep-etching (arrow).

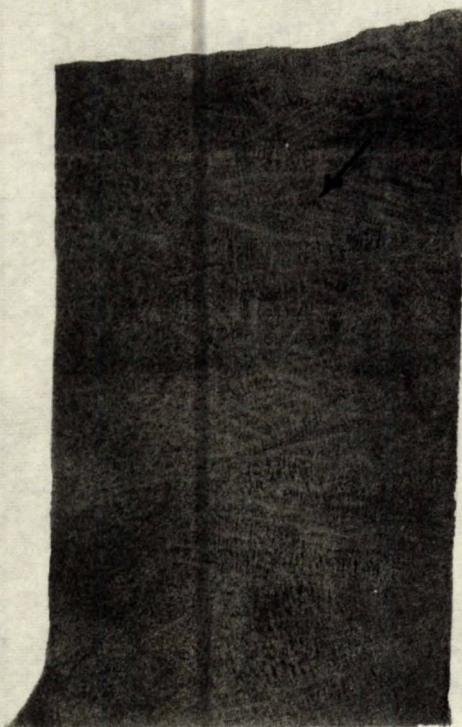
Figure 8. Thin Section - Stressed Region, Casting "S".
Intergranular constituent revealed by
deep-etching (arrow).

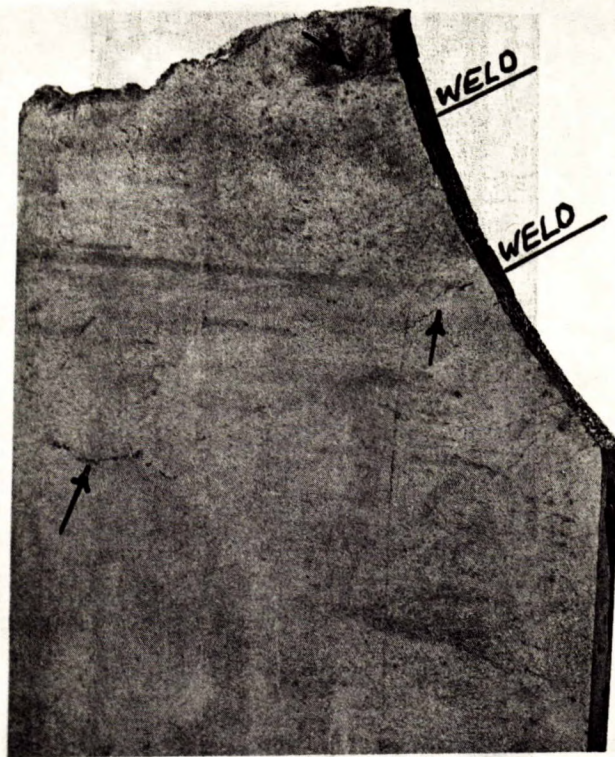
Figure 9, however, illustrates typical cracks in the thick root section. These cracks (arrows) were detected at the root of the weld deposits prior to etching. Either the original cracks had not been completely removed or after welding new cracks had formed along the grain boundary.

Figure 9. Casting "R", Thick Section, Illustrates Intergranular Hairline Cracks. The cracks marked by the arrows were detected in the "as-machined" condition (prior to etching).

After sectioning, open cracks were observed at the roots of some of the weld deposits. The presence of these cracks could be due either to failure to completely eliminate the original defect prior to welding, or to propagation of the defect subsequent to welding and formation of second generation cracks. The extent to which hydrogen contributed to cracking was not established however, some tensile test bar fractures showed evidence of hydrogen in addition to the prominent intergranular and cleavage aspects.

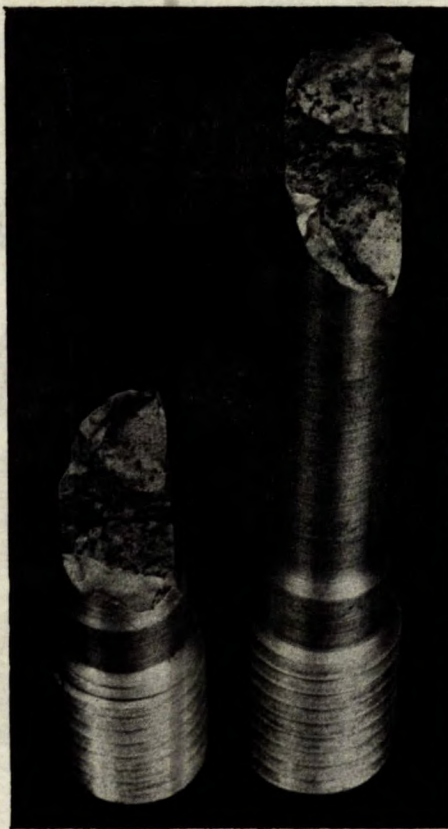
The appearance of tensile bar R-8 taken from the same area as illustrated in Figure 9 is shown in Figure 10.

Figure 10. Casting "R", Thick Section, Tensile Bar R-8.
Rock candy facets are associated with hairline cracks.

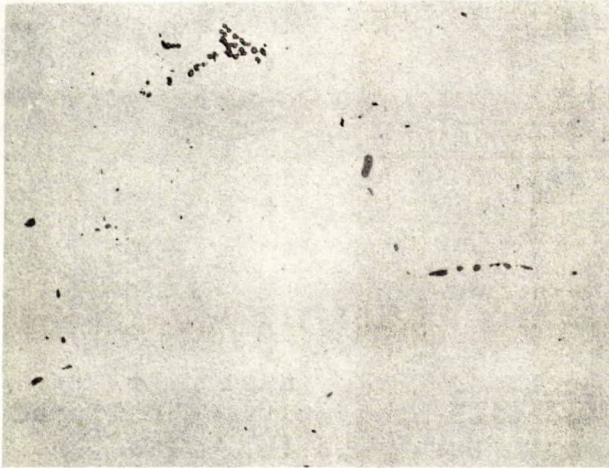
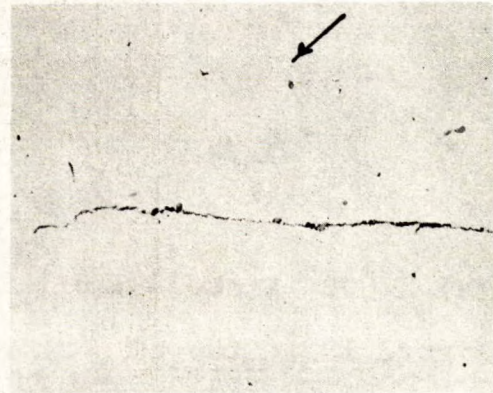
The microstructure of casting "R" contained a grain boundary constituent, believed to be AlN, eutectic sulphides, hairline cracks and network distribution of pearlite. All these effects were traceable to deoxidation practice and to the slow cooling rate obtained in this thick section.

Figure 11. Stub "R", Thick Section. Zirconium nitride (arrow), alumina, and eutectic sulphides. An oxidized intergranular hairline crack and grain boundary constituent are illustrated in photomicrograph (b).

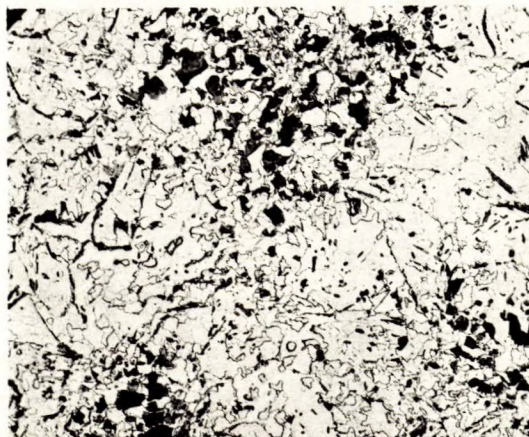
Figure 12. Stub "R", Thick Section. Illustrates the heterogeneous distribution of pearlite. Pearlite is distributed in dendritic form and outlining ferrite grains.

Pearlite networks were observed within and outlining ferrite grains. This condition is attributed to slow cooling - (mass effect) and to insufficient hardenability for the thick section.

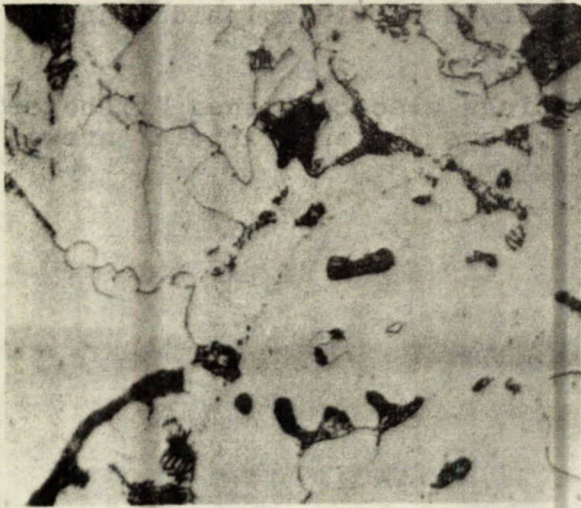
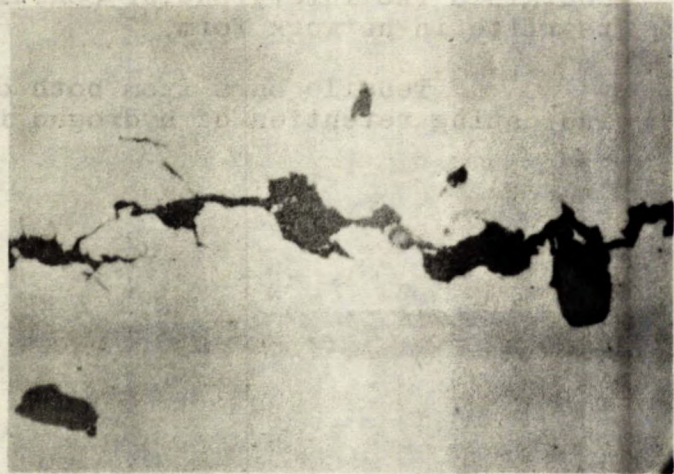
Figure 13. Stub "R", Thick Section. Prior austenite grains are outlined with a constituent believed to be AlN (a). Photomicrograph (b) shows that the hairline crack formed after solidification of the sulphides, and that oxidation of these sulphides occurred. The crack contains a thin film believed to be FeO.

The internal cracks were slightly oxidized but were not decarburized, suggesting that these had formed at intermediate temperatures, after solidification of sulphide and precipitation of nitride but prior to recrystallization.

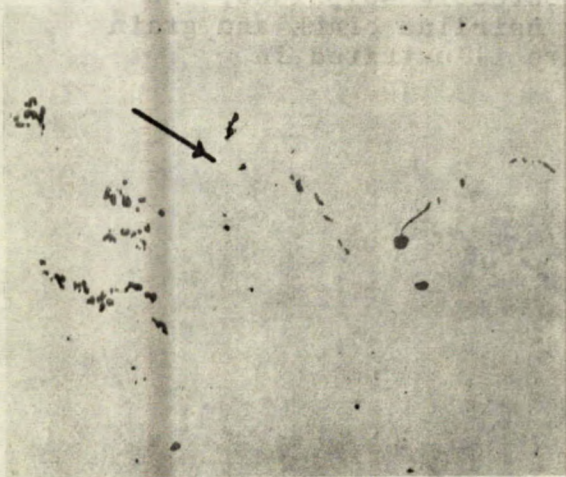
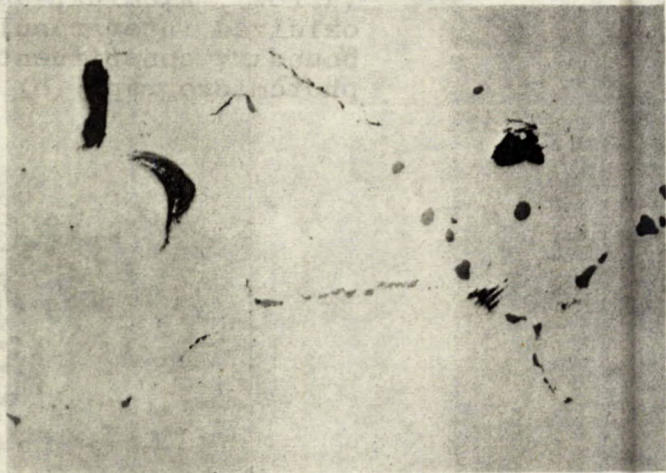
Similarly, casting "S", while free from hairline cracks, contained the intergranular constituent, eutectic sulphides and pearlite in network form.

Figure 14. Stub "S", Thick Section. Zirconium nitrides (arrow), eutectic sulphides, and gas porosity are illustrated. Al₂O₃ inclusions are visible in (a).

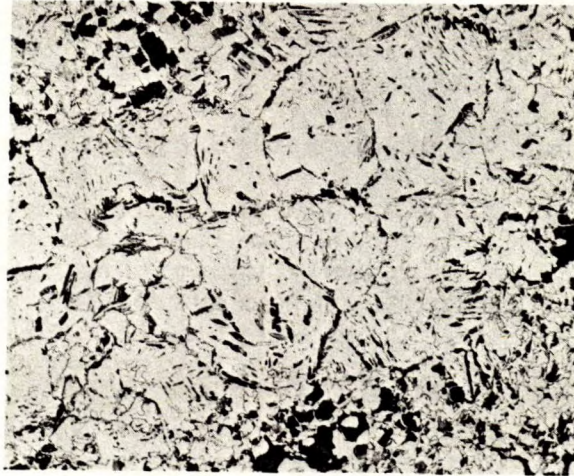
Figure 15. Stub "S", Thick Section. Illustrates the distribution of some of the pearlite outlining ferrite grains and present on cleavage-planes within the ferrite grains.

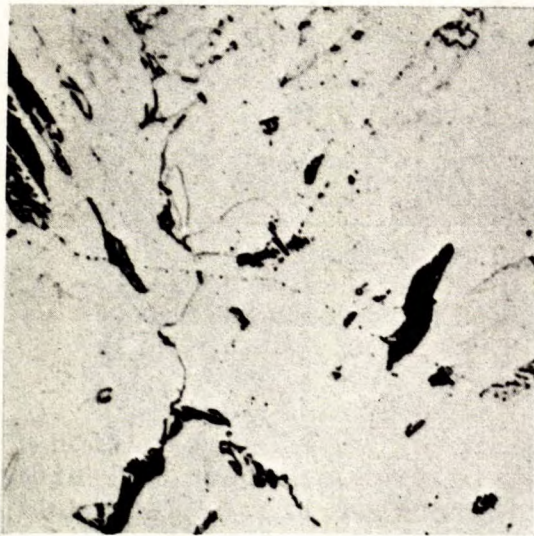
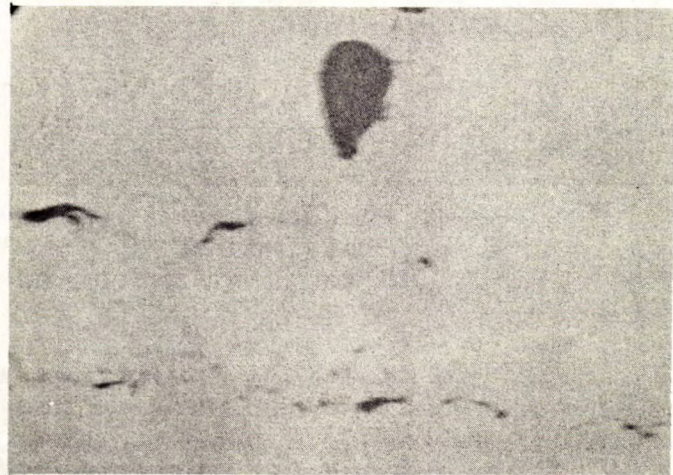
Figure 16. Stub "S", Thick Section. Prior austenite grain boundaries are outlined with a constituent believed to be AlN (a). Photomicrograph (b) illustrates an area filled by sulphide prior to solidification.
