MINES BRANCH INVESTIGATION REPORT IR 64-3

FAILURE OF "BANJO" FITTINGS IN INFLATABLE LIFERAFTS

A. COUTURE

JANUARY 22, 1964

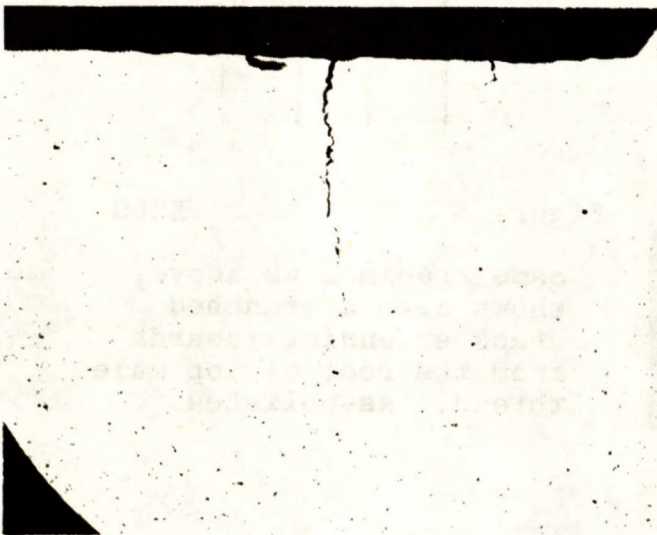
Figure 2

Figure 3 was taken from the fracture surface of one of the nipples that failed through the male threads. Although the whole fractures do not present as long secondary cracks as those of Figure 3, every fracture shows one or more similar areas. Some fractures and cracks are coated with a deposit having the appearance of cuprous oxide. One of the fittings that had failed through the male threads shows evidence of dezincification on both sides of the fracture. The lower ends of only two of the fittings that failed in the male threads were available and they both show cracks extending from the central chamber as in Figure 2. In

Specimen failed through the Allen screw threads but shows extensive cracks running outwards from the inside chamber towards the male threads. As-polished.

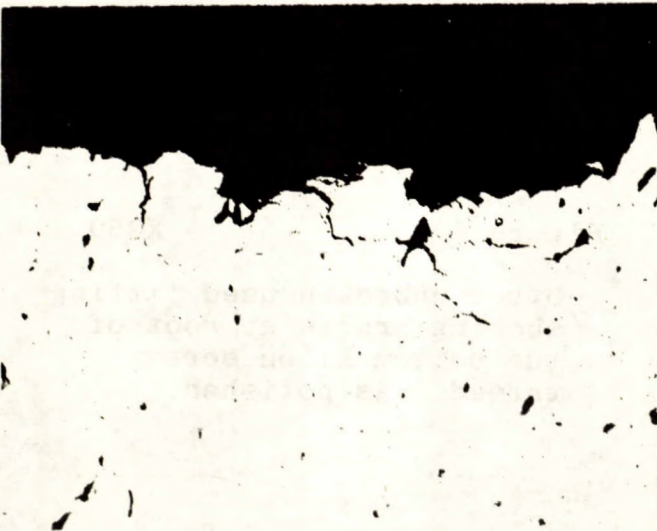
Figure 3

The two fittings that had failed near the head present the following features. Failures took place through the first female thread at the bottom of the Allen screw hole and cracks were also apparent at the root of the second thread. No crack was seen in the male threads. However, one specimen has very long cracks (Figure 2) extending from the central chamber towards the first or second male thread above the lower shoulder. Some of the cracks are almost equal to half the wall thickness in that area. The fractures of both specimens are similar to those described below (Figure 3).

Fracture of nipple broken through the male threads. Although the whole fracture does not present as many sub-cracks, all fractures contain similar fields as are shown here. As-polished.

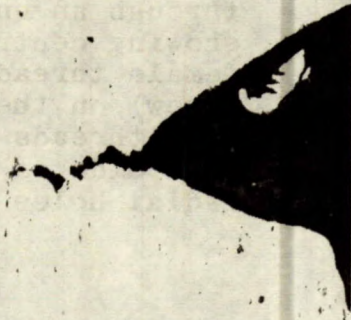
Figure 4

Out of the three unbroken but used fittings that were examined one had the crack, shown in Figure 4, at the root of the bottom Allen screw thread. The same specimen had a crack in the fillet between the head and the cylindrical part of the fitting and a hairline and branched crack at the root of the top male thread (Figure 5). The other two specimens showed numerous cracks at the root of the bottom Allen screw threads as in Figure 6, or fairly long and branched cracks similar to that shown in Figure 5. Some narrow cracks are full of a substance having the appearance of cuprous oxide.

Unbroken used fitting showed a wide crack originating at the root of the bottom Allen screw thread. As-polished.

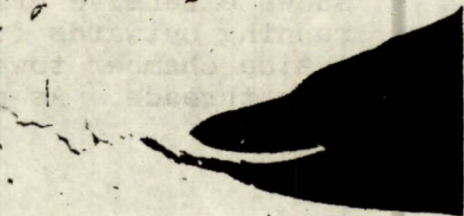
Figure 5

Same specimen as above, shows also a branched crack extending inwards from the root of top male thread. As-polished.

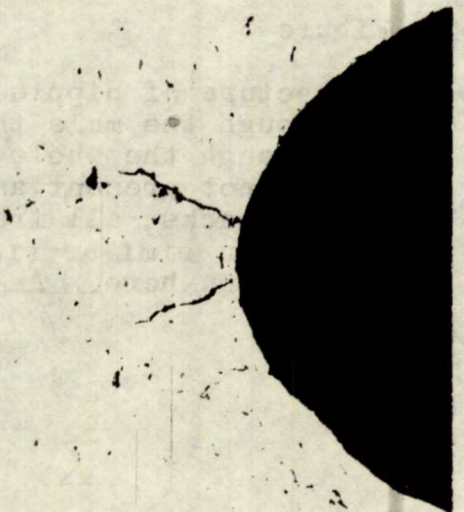
Figure 6

Other unbroken used fitting showing cracks at root of the bottom Allen screw thread. As-polished.
