MINES BRANCH INVESTIGATION REPORT IR 64-6

FATIGUE FAILURE OF WATER PUMP SHAFT

D. E. PARSONS

FEBRUARY 4, 1964

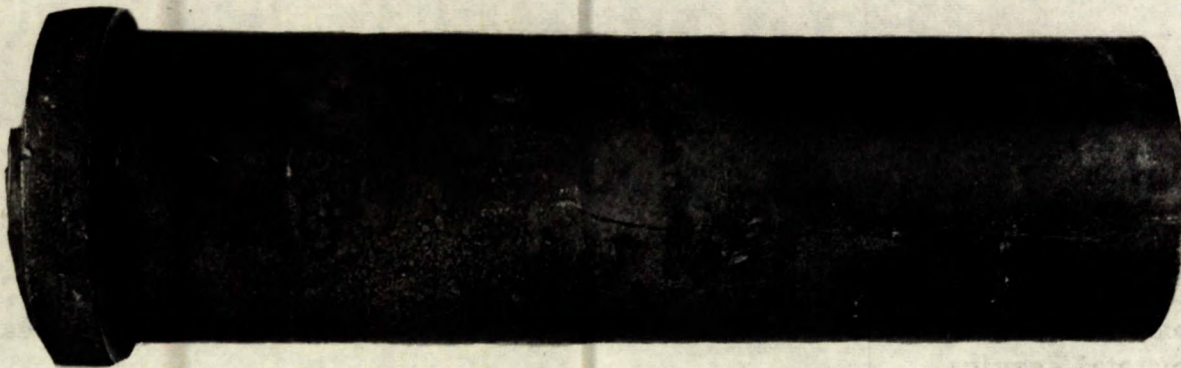
The appearance of part of the broken shaft, extending from the fracture for about 12 inches toward the drive end, is shown in Figure 1.

Figure 1. Broken Pump Shaft. Fracture at Extreme Left of Picture.

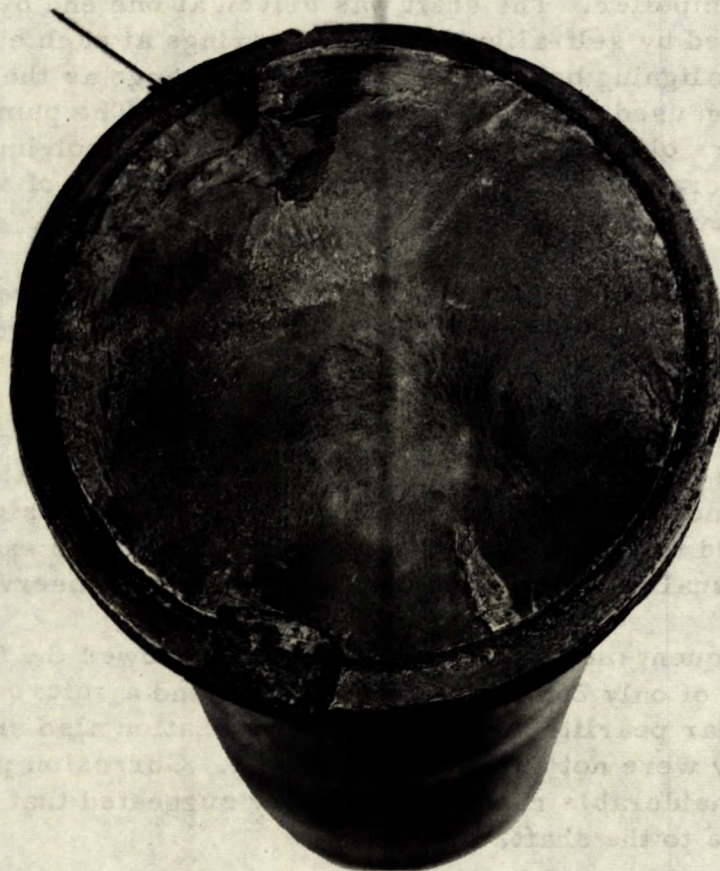
Figure 2 illustrates the fracture surface with a fatigue crack starting at the rusted keyway and progressing in two directions to meet at the point where final rupture occurred, (position indicated by the arrow).

Figure 2. Appearance of Fractured Pump Shaft. Fracture appeared to start at the keyway and to propagate to the region of final rupture marked by the arrow. The applied stresses were light in relation to the shaft sections.

2. The shoulder fillet and the keyway appeared to lack adequate radii.
3. Severe rusting of the keyway surface and pitting of the shoulder indicate access of water to the steel surface. This would be expected to reduce the endurance limit of the steel.

4. Fracture was due to fatigue failure caused by excessive deflection and reverse bending stresses acting on annealed steel in the presence of moisture. Fracture appeared to start at a poorly radiused keyway and to progress under the repeated application of cyclic stresses. The magnitude of the applied stress appeared to have been relatively light since the cracks propagated without failure until final rupture on the small area marked in Figure 2.

2. The keyway and shoulder should be properly filleted; the shaft should be polished and should be protected from water during service. (Reduction of the endurance limit to less than 30% of normal value has been reported for steel in water, stressed in reversed bending.)

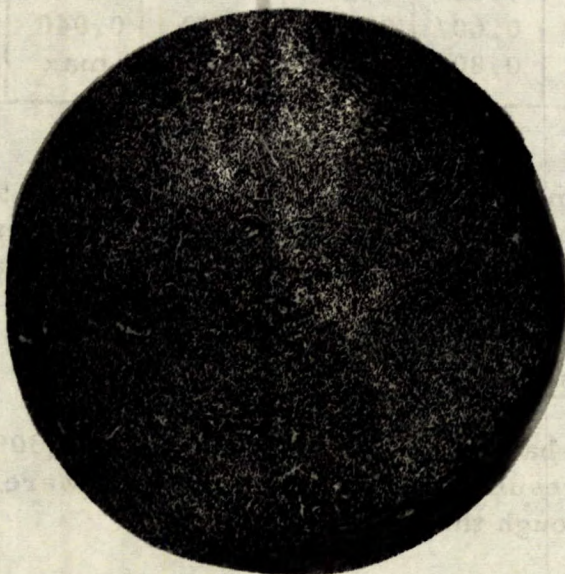
Figure 4. Sulphur Print of Ground Transverse Section Through the Shaft.
This test revealed no unusual quantity or distribution of non-metallic inclusions in this bar.

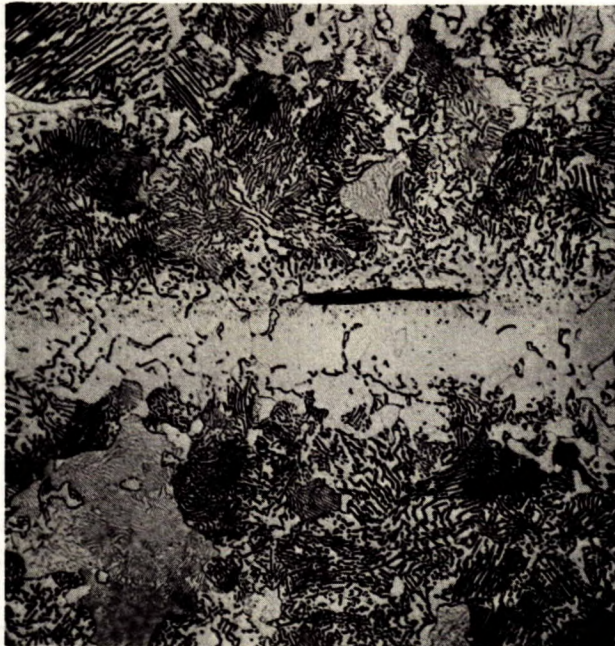
The appearance of a photomicrograph taken on a transverse section through the broken shaft is shown in Figure 5. The microstructure consists of ferrite and lamellar pearlite and contains pearlite-ferrite bands due to slow cooling.

Figure 5. Transverse Section Through Broken Shaft.

The microstructure and hardness (BHN approximately 200) show that this shaft was used in the annealed condition.

The chemical composition and quality of the bar used for the shaft appear to be satisfactory; however, use of this steel in the annealed condition at 200 BHN provided a low yield strength of approximately 75,000 psi, whereas in the oil quenched and tempered 538°C (1000°F), condition at 340 BHN a corresponding yield strength of 125,000 to 150,000 psi would have been obtained. Information since receipt of the original

1. Replacement shafting should contain sufficient alloying elements to allow through-hardening in the 3 inch section by quenching and tempering. For example, the steel used in the present shaft, or steel conforming to the chemical requirements of AISI-4340, could be used at 340 BHN hardness corresponding to a yield strength of 150,000 and to an endurance limit of approximately 80,000 psi in reversed bending.
