MINES BRANCH INVESTIGATION REPORT IR 64-9

EXAMINATION OF RUPTURED NEW BRUNSWICK HYDRO PIPE

Mines Branch Investigation Report IR 64-9

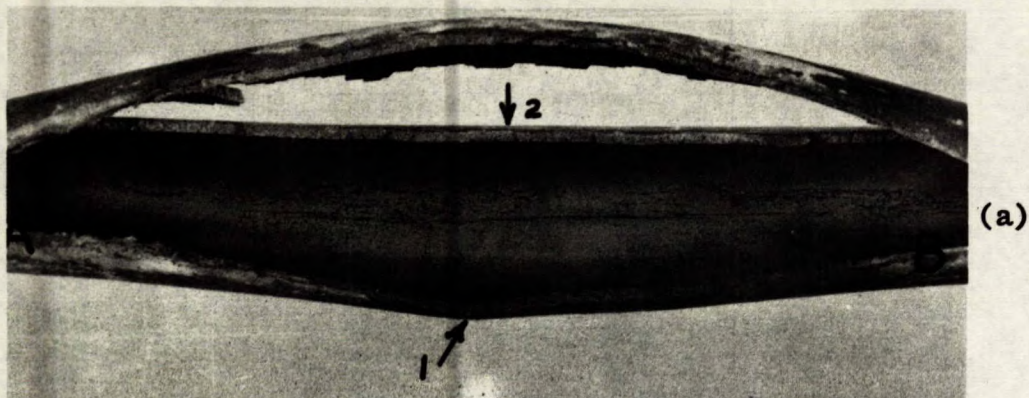
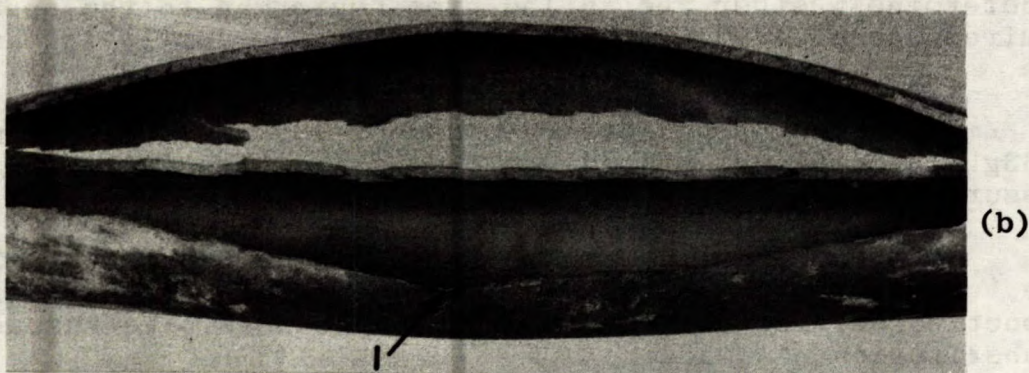
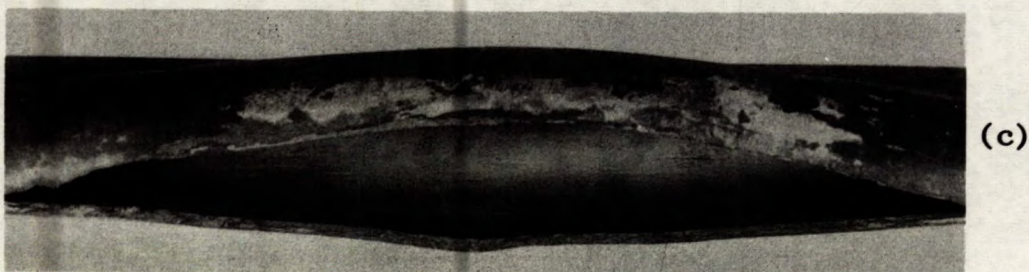
The origin of the rupture appears to be at the position marked by arrow 1. The fracture propagated from the origin to A and B. A final rupture occurred along the surface marked, arrow 2.

The fracture is of the high pressure type with the final stages occurring in brittle fashion. The origin of the crack at arrow 1 appears to be stained, possibly indicating leakage prior to rupture.

Figure 1. Ruptured Pipe. Three Views Illustrate the Appearance of the Fracture Surfaces. (All 1/3 actual size).

Visual examination showed a small shear lip in the region where rupture appeared to start. The remainder of the fracture appeared to be of the high velocity type, resulting in brittle fracture without reduction of section.

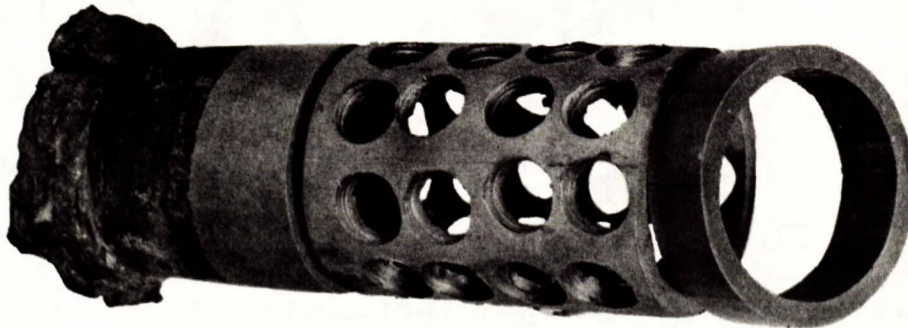
X3/4

Seams were visible on both surfaces of the pipe, particularly on the inside surface. The seams were not continuous and, although undesirable from the viewpoint of reduction of section, would probably be acceptable in terms of ASTM A53. None of the internal seams was observed to coincide with the thinnest 0.156 in. section, nor did the location of rupture appear to be affected by the presence of the longitudinal seams.

Figure 2. Deep Etched Pipe Sections Adjacent to Weld and Including Portion Drilled for Chemical Analysis.

Both external and internal seams are visible in the drilled and in the ring sections.

A sulphur print was taken on the ring section shown at the right in Figure 2. The sulphur content of this steel was low. No concentration of sulphur was observed in the metal section or in the associated scale.

Seams were observed on both surfaces of the pipe and, although these were not continuous and did not coincide with the thin zones, they did effect a 10% reduction of wall section. This reduction is allowable by ASTM and European specification unless agreement is reached between manufacturer and purchaser.

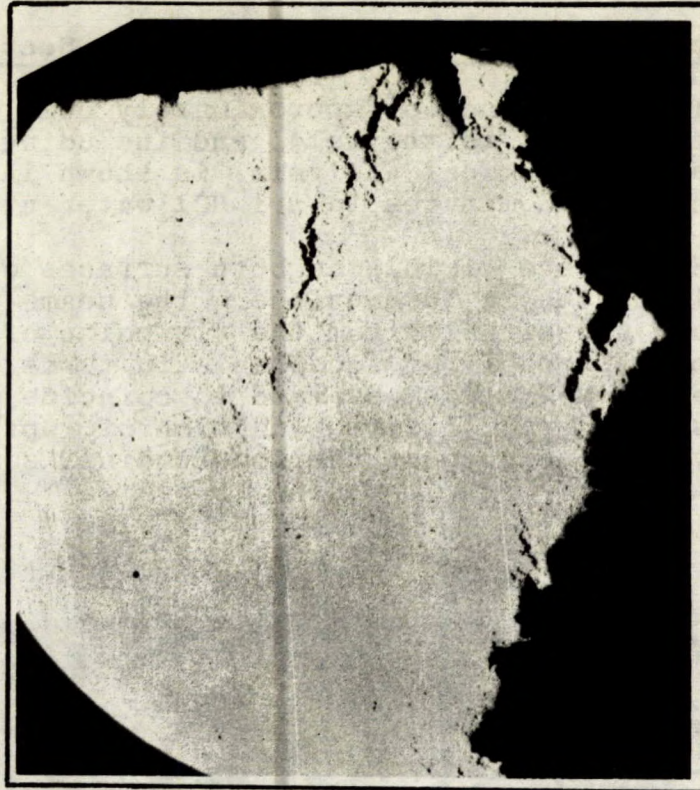
X36 As-polished

Figure 3. View of Fracture Surface in Bulged Area. (Steam side at top, fracture at right of photomicrograph).

This transverse section intersects regularly spaced longitudinal stress cracks, one of which appeared to have acted as an origin for rupture. Intergranular oxidation typical of stress rupture, extending from the steam surface through 2/3 of the section adjacent to the fracture, is visible.

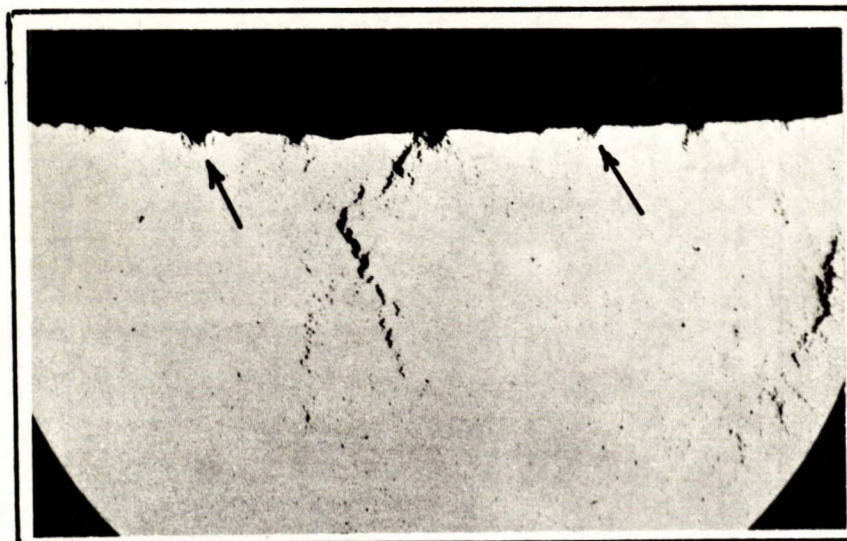
X36 As-polished

Figure 4. View of Steam Side. This area adjoins the surface illustrated in Figure 1 and contains a typical (stress rupture) oxidized intergranular crack viewed in transverse section. The intersection of this section with regularly spaced longitudinal cracks at the steam surface is illustrated, (arrows).

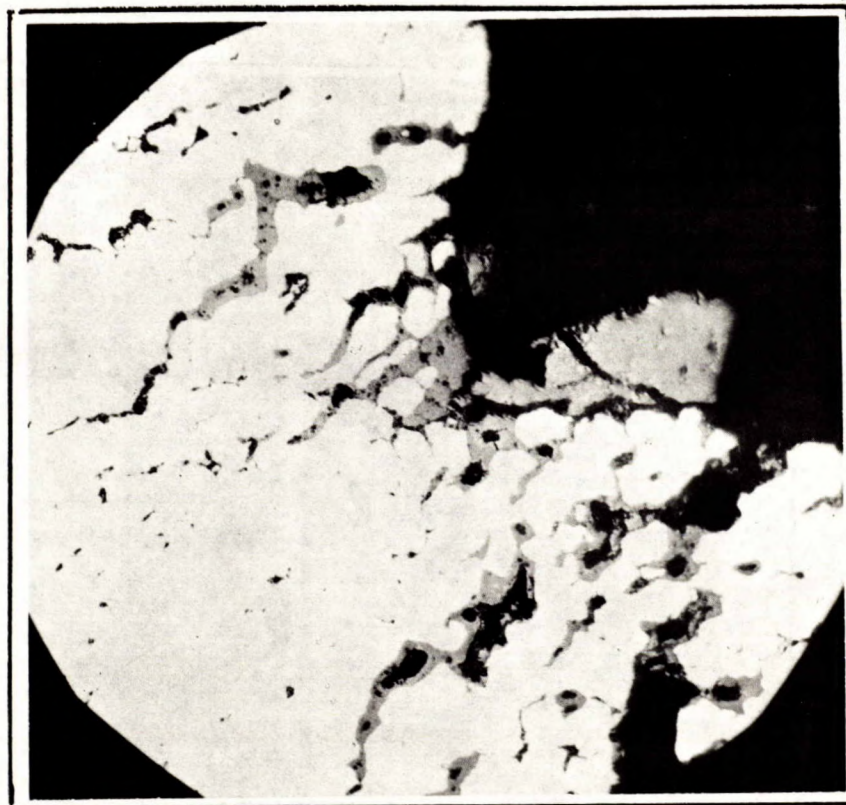
X500 As-polished

Figure 5. View of Oxidized (Stress Rupture) Fracture Surface. Severe intergranular oxidation, indicating failure by stress rupture, is shown.

The metal in the vicinity of the origin of rupture showed severe intergranular oxidation. A thick layer of heavily rooted scale was observed on the steam side and to a lesser extent on the fireside. Failure appeared to be of the stress-rupture type, starting from oxide roots at the steam surface. The appearance of the scaled surface indicated that the metal did not have adequate oxidation resistance for a service requirement of 538°C (1000°F).

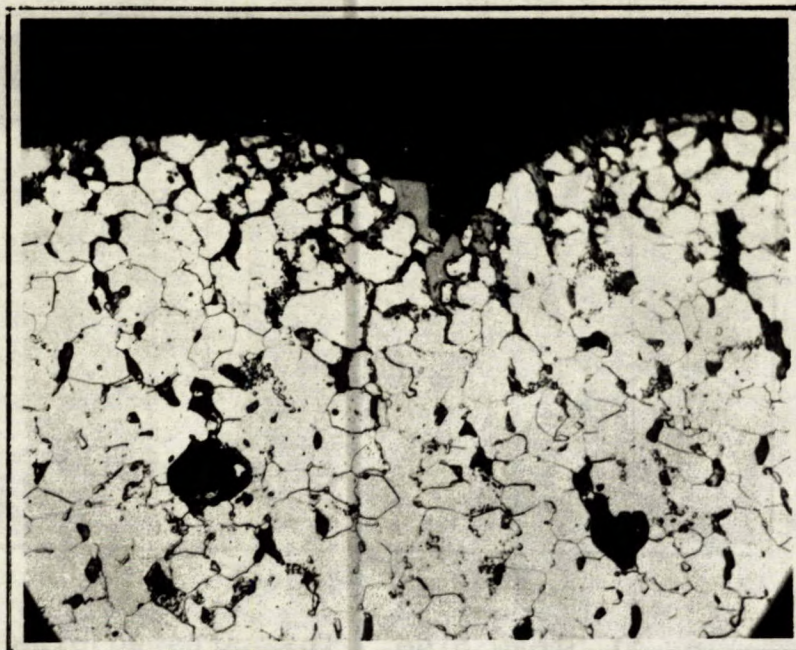
X500 Etched in 2% Nital

Figure 6. View of Steam Side. (Inside Surface). Transverse Section. Scaling and oxidation had occurred on the steam surface. No evidence of grain coarsening was observed. The pearlite was spheroidized but had not coalesced.

The microstructure of the pipe consisted of fine grained, equiaxed ferrite and spheroidized but non-coalesced carbide.

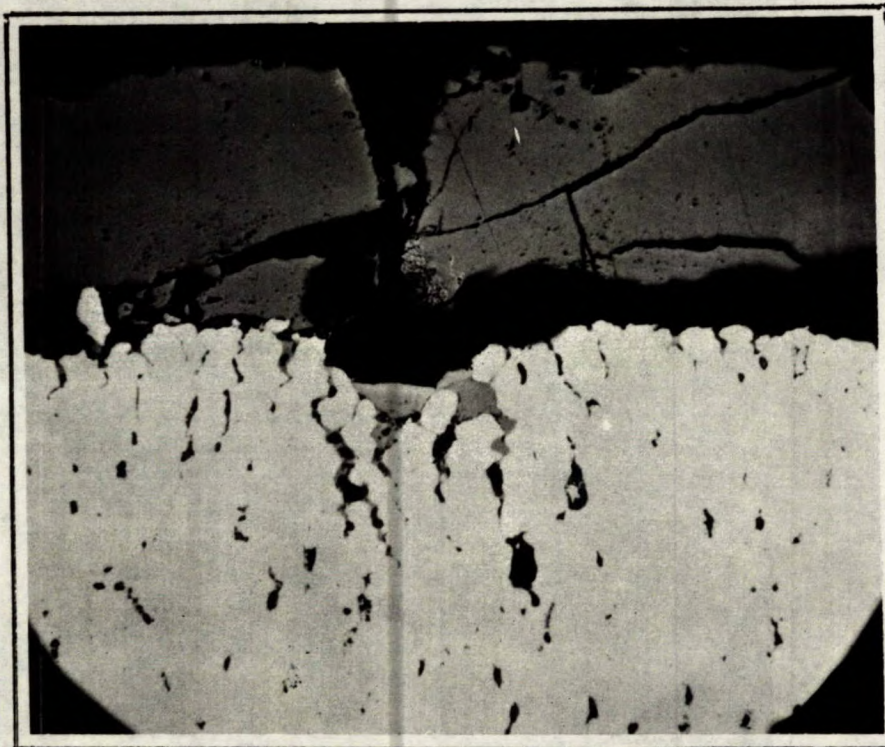
X500 As-polished

Figure 7. View of Cracked Side and Oxide Roots on Steam Side. Cracks in the thick layer of scale coincide with regularly spaced longitudinal stress-cracks.
