MINES BRANCH INVESTIGATION REPORT IR 64-23

**EXAMINATION OF "TOP-HAT"  
MINESHAFT GUIDE SUBMITTED BY  
GECO MINES, LIMITED**

**D. K. FAURSCHOU**

MARCH 16, 1964

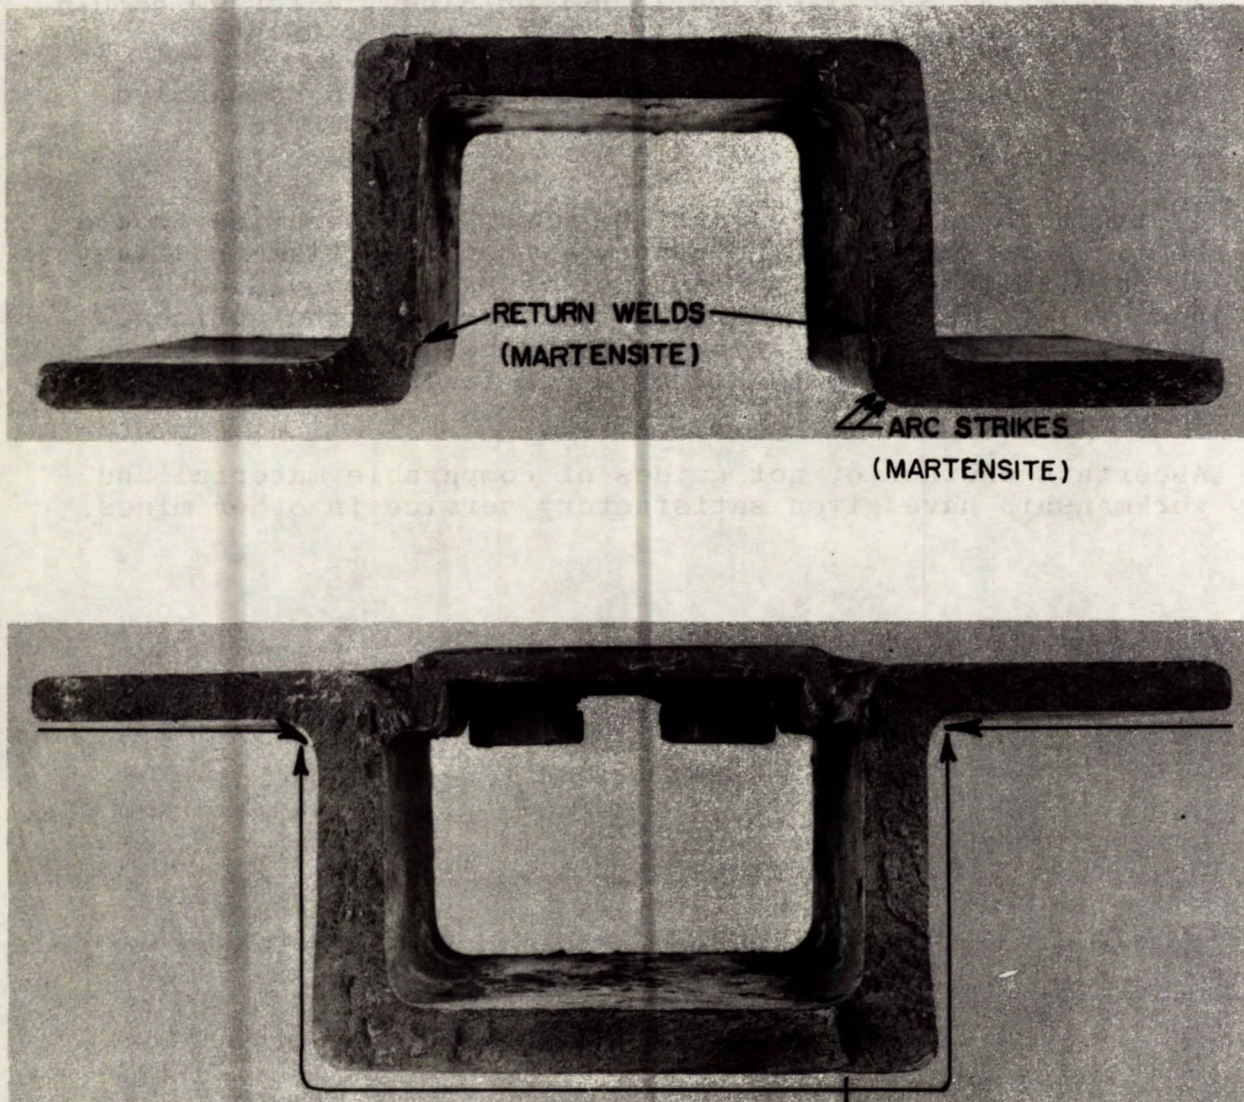
Figure 1. Mating Fracture Surfaces of a Geco "Top-Hat" Mineshaft Guide. (X 1/2)

Figure 1 (X 1/2) shows the mating surfaces of the fracture. The failure occurred transversely at the mid-length of the 30 ft guide. The arrows show the direction of the chevron markings pointing back to where the cracks initiated at the ends of the welds which were made to attach a connecting plate to the guide section. The appearance of the fracture surface was characteristic of brittle failure.

The upper section, as shown in Figure 1, was stripped of paint and deep-etched in 1:1 HCl and water at 160-180°F for thirty minutes. This clearly revealed that major points of fracture initiation were on the inner surface of the guide section at or close to the edges of short weld deposits (subsequently termed "return welds") which had been made across the ends of the longitudinal weld deposits joining the connecting plate to the guide. An additional point of fracture initiation, on one side of the guide section, was an arc strike in line transversely with the return weld. A second arc strike, offset transversely from the return weld, was also observed. The arc strikes contained cracks open to the surface.

In the upper view, arrows point to areas where fracture was initiated.

The lower view shows the mid-length connecting plate. Arrows parallel the chevron markings which point back to the areas where cracks initiated.

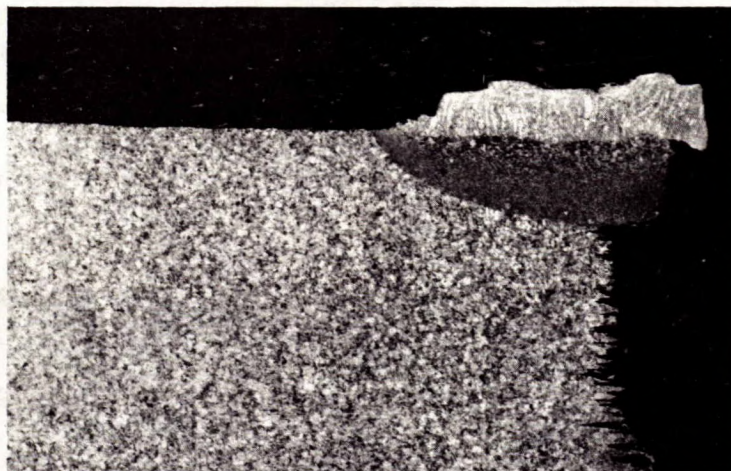
**Figure 2. Section Through a Shallow Return Weld  
Covering the End of a Four-Pass Weld  
Deposit. Etched in nital (X7)**

Figure 2 (X7) shows a partial cross-section, perpendicular to the deep-etched fracture surface, through the end of one of the culprit return welds. This section was polished and etched to reveal the shallow overlay of weld metal, the underlying heat-affected zones of the base metal and the unaffected base metal. Underbead cracks were observed in the zone of martensite. Details of the microstructure are shown more clearly in Figure 3 (X500). The structures in a section through an arc strike were similar, except for a shallow cratering effect instead of a deposit of weld metal.

A Tukon hardness survey, using a diamond indenter and a 500-g load, revealed the hardness of each zone shown in Figure 2, and the abruptness of the change in hardness between zones. The hardness results are shown below in Table 1.

The fracture surface at the right has been deeply etched. The weld deposit has a columnar as-cast structure. In the base metal immediately beneath the weld deposit there is a zone of brittle martensite (virtually at maximum hardness) and martensite plus bainite. The base metal has a structure of pearlite grains enveloped by proeutectoid ferrite.

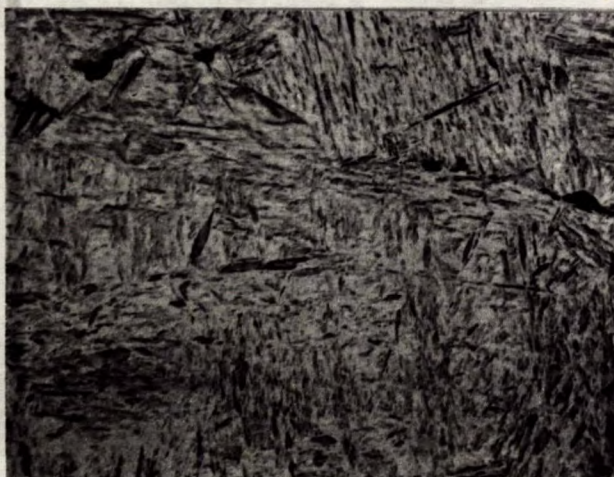
Martensite in Base Metal  
(underlying the weld deposit)

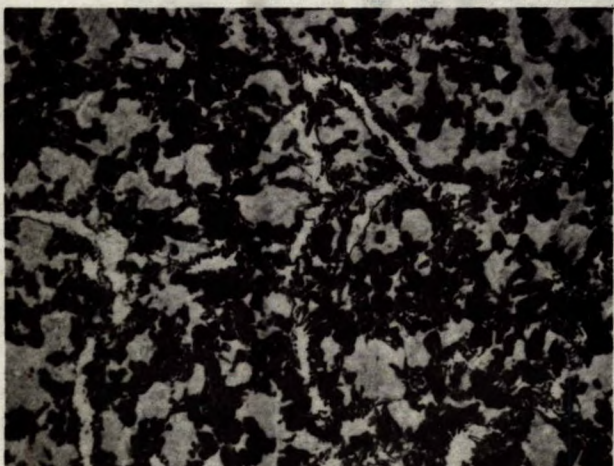
Martensite and Upper Bainite  
(transition zone between  
martensite and base metal)

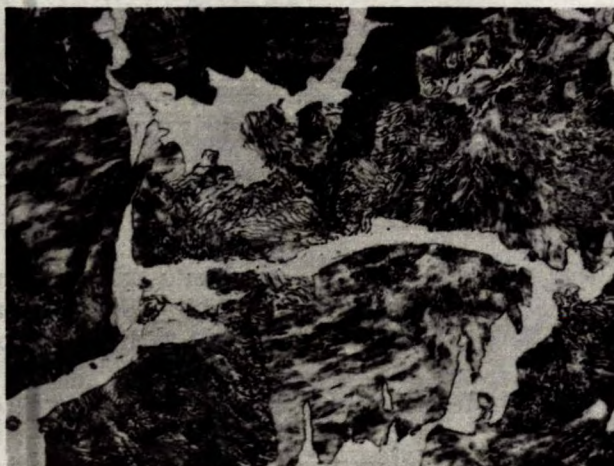
Base Metal (as-rolled or  
normalized structure)

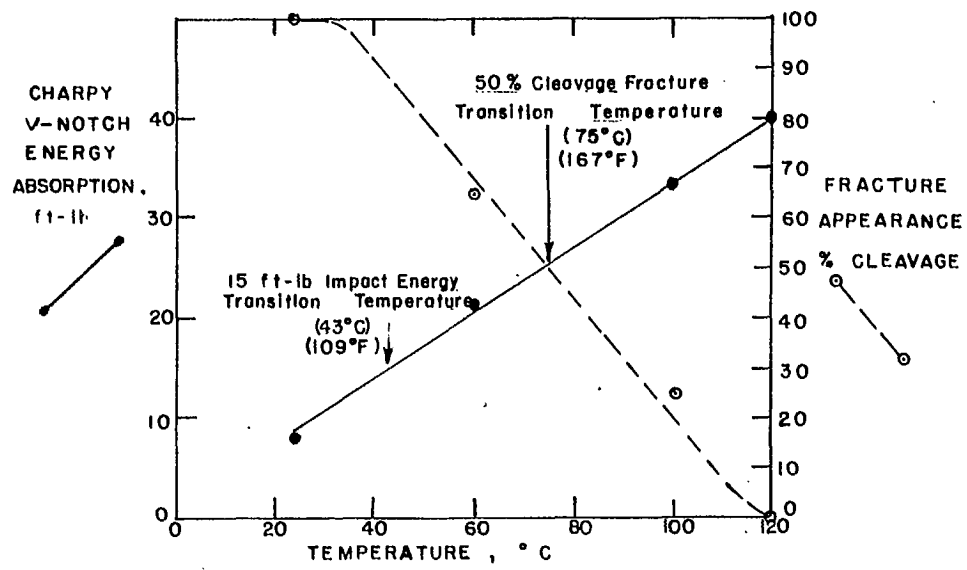
Figure 4. Charpy V-Notch Impact Results versus Testing Temperature.

Charpy V-notch impact bars were cut longitudinally from the U-channel portion i.e. in the direction in which the "Top-Hat" section was rolled. The bars were notched perpendicularly to the plane of rolling. Figure 4 shows average impact energy absorption and per cent of cleavage fracture plotted versus testing temperature. The energy curve is virtually linear over the temperature range from 24°C to 120°C (75°F to 248°F). The 15 ft-lb transition temperature is 43°C (109°F). The 50% cleavage fracture transition temperature is 75°C (167°F).
