**MINES BRANCH INVESTIGATION REPORT IR 64-28**

**FAILURE OF LOW PRESSURE BOILER TUBE**

**D. E. PARSONS**

FAILURE OF LOW PRESSURE BOILER TUBE

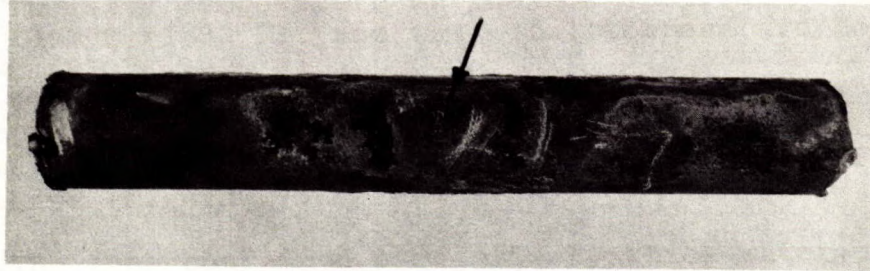
The affected area had a diameter of about 2 in. and showed deformation with a short split progressing inwards from the fire side of the tube. Examination showed that failure was due to flame impingement aggravated by attack of the outside tube metal surface by FeO.FeS slag. The appearance of the tube is illustrated in Figures 1 to 4 inclusive.

Figure 1. Tube Sample, as-received - Affected Area (arrow).

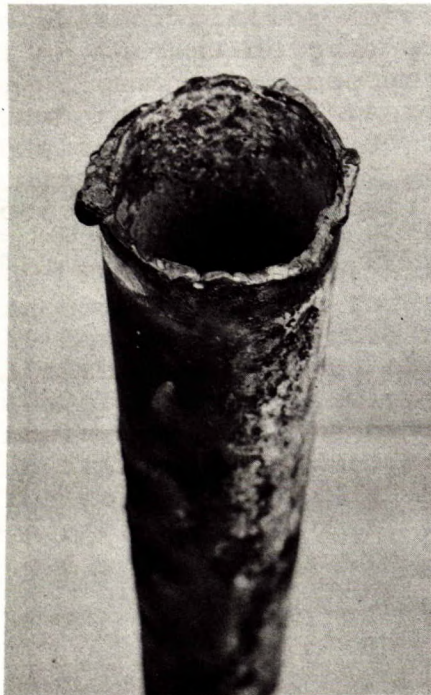
Figure 2. Illustrates Deposit on Inside Tube Surface and Sulphur Deposition on Outside of Tube.

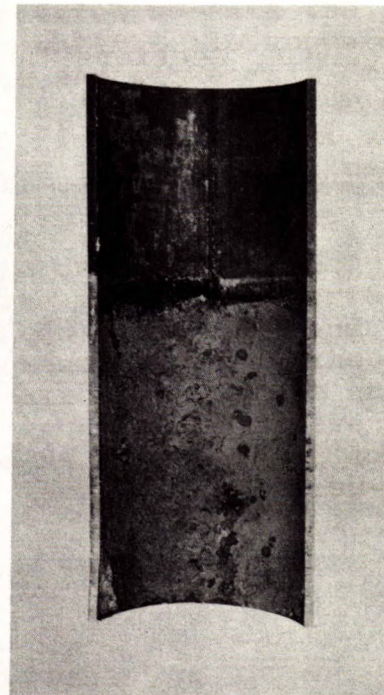
Tests were also made to determine if the water scale could be removed from the inside surface of the tube and to observe whether pitting corrosion had occurred beneath the deposit on the inside tube surface. The water scale appeared capable of removal by mechanical cleaning and was easily removed by laboratory pickling treatment in HCl-Sb<sub>2</sub>O<sub>3</sub>. No pits or damage were observed on the inside tube surface, indicating that attack was localized in the small area (approx. 2 in. diameter) caused by direct flame impingement.

Figure 3. Illustrates Cleaned Area of Inside Tube (Top) after Laboratory Pickling in  $\text{HCl}:\text{Sb}_2\text{O}_3$  Solution. This water side scale is loose and can probably be removed mechanically.

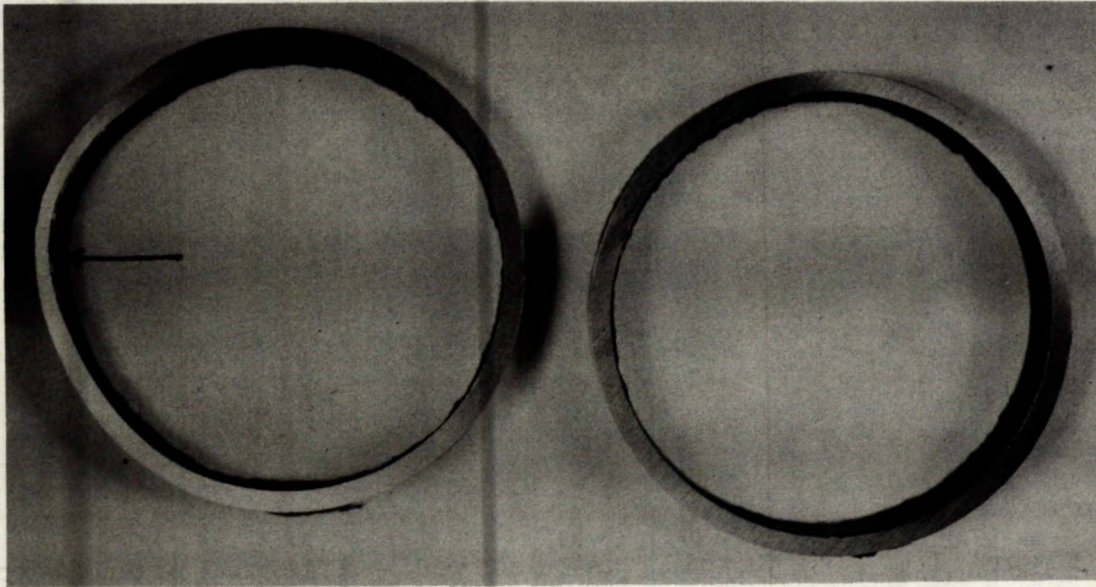
Figure 4. Sections Through Tube at Burst (Bulge and reduced section, arrow, extreme left of picture) - 10 in. from Burst (section at right).

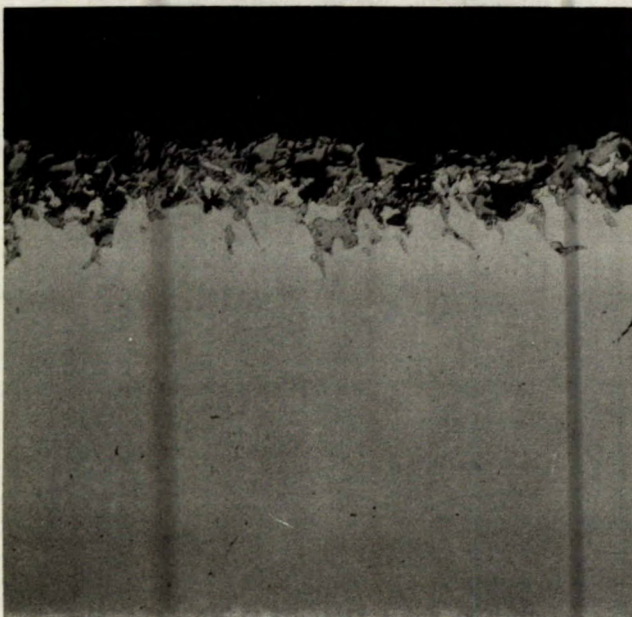
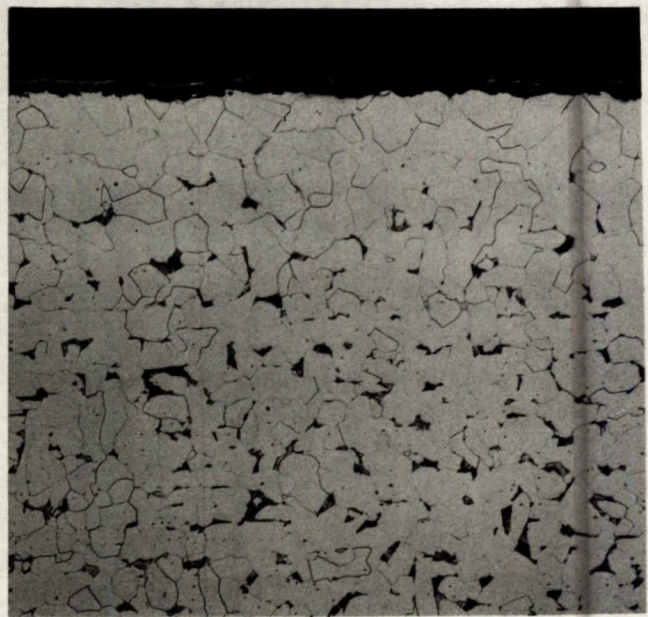
Figure 5. Outer Tube Surface at Bulge (a) - 10 in. from Bulge (b). Corrosive attack by eutectic slag is visible at the outside surface of the hot spot (a).

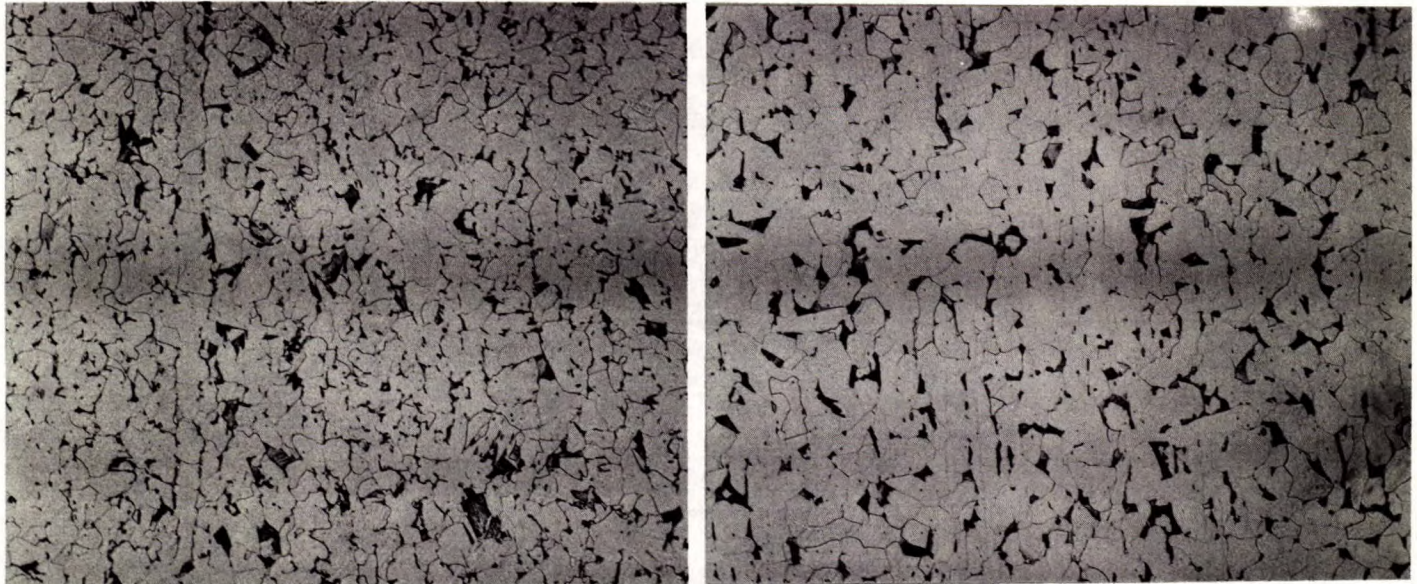
Figure 6. Etched Microstructure at Bulge (a) - 10 in. from Bulge (b).

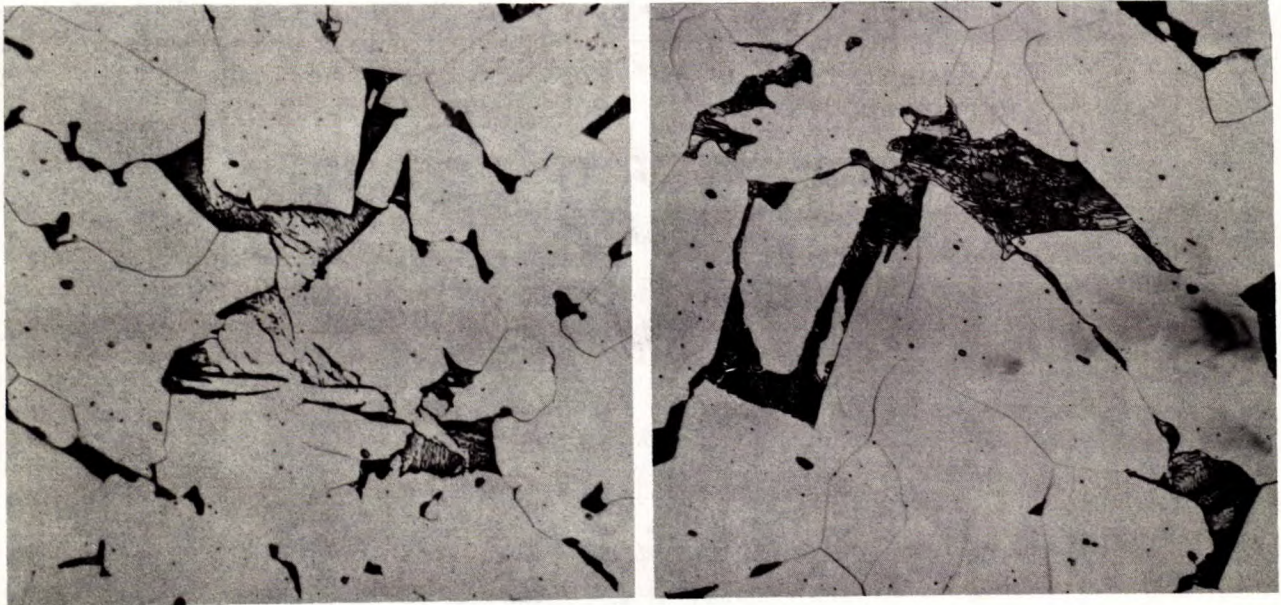
The microstructure of the steel tube consisted of ferrite and fine lamellar pearlite (Figures 5 to 7 inclusive). Spheroidization of the pearlite had commenced in the heat-affected zone (beneath the fused slag) but had not proceeded to the stage where pearlite lamellae were eliminated or carbide had coalesced. This suggested that the metal temperature beneath the fused slag had not exceeded 538°C (1000°F), but that the metal had been heated above 454°C (850°F). No grain growth was seen in any of the pipe. No change in microstructure was observed except in the 2 in. diameter affected zone.

Figure 7. Etched Microstructure at Bulge (a) - 10 in. from Bulge (b). Pearlite appears to be starting to spheroidize (a) but still retains partial lamellar form. The pearlite in areas other than the 2 in. diameter hot spot is lamellar and is unaffected (b). No coalesced carbide was observed.

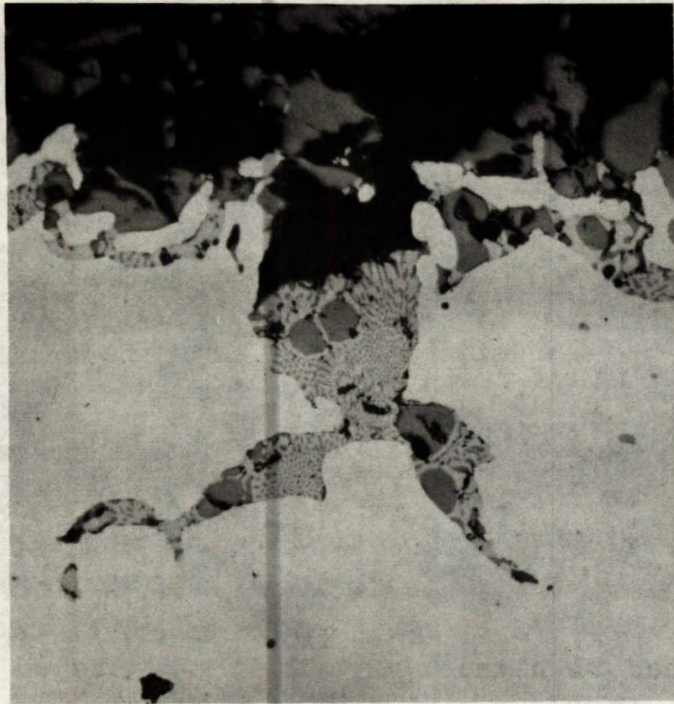
The melting point of the slag was reduced by the presence of sulphur and by formation of a low-melting FeO.FeS eutectic phase (Figure 8).

The presence of sulphur (due to deposition under reducing conditions) on the outside of the tube was observed along the full length of the tube sample, but had only fused and reacted with the steel in the local overheated area of the burst. Formation of corrosive sulphur-rich eutectic slag in the area of flame impingement on the outside of the tube caused severe intergranular attack and reduction of section at this surface contributing to subsequent failure by high temperature stress-rupture in the presence of notches.

Figure 8. Corrosive Attack by Fused Sulphur-rich Slag at Outside Surface. The eutectic phase was identified as  $\text{FeO.FeS}$  and has a melting point of approximately  $1000^{\circ}\text{C}$  ( $1832^{\circ}\text{F}$ ).

1. Avoid direct flame impingement on tube surfaces. Possibly this can be done by use of protective baffles --- although the possibility of change in the location of the flame with change in fuel or combustion conditions should be noted.
2. Avoid deposition of sulphur (reducing conditions) especially in hot zones.
3. Improve the efficiency of the water conditioning plant to control deposition of water scale.
4. Consideration should be given to the choice of a chromium-molybdenum alloy, seamless tube, with wall thickness based on allowable stress if service temperature of the steel is above 454°C (850°F).

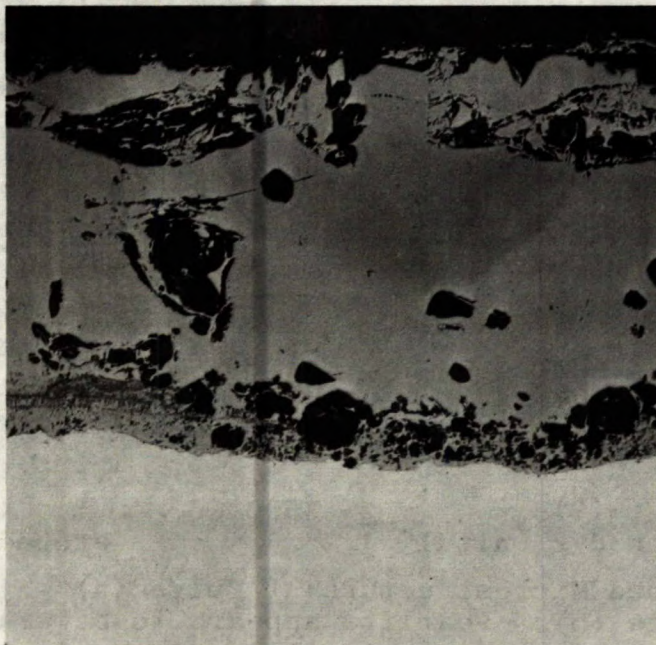
The tube contained a relatively thick water scale deposit on the inside tube surface. This material has been identified as alkaline carbonate and has been deposited despite use of water conditioning apparatus (Figure 9).

Figure 9. Illustrates Thick Water Scale on Inside Surface. This scale is relatively non-adherent.
