MINES BRANCH INVESTIGATION REPORT IR 64-34

**EXAMINATION OF FAILED END PIECE  
FROM A BAILEY BRIDGE PANEL**

**W. P. CAMPBELL**

**APRIL 10, 1964**

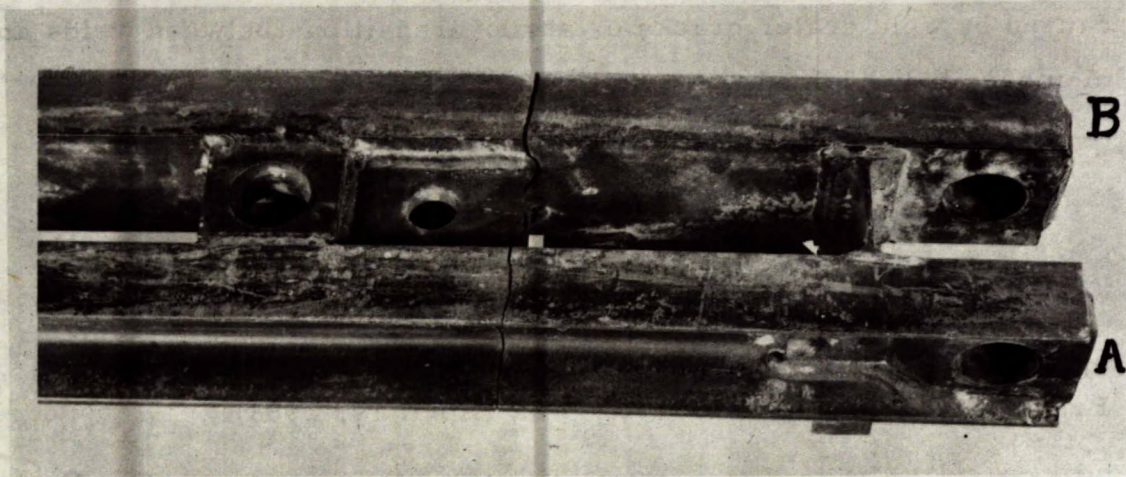
**Figure 1 - View from the under side of the fractured end piece, with channel A at the bottom and channel B at the top of the picture.**

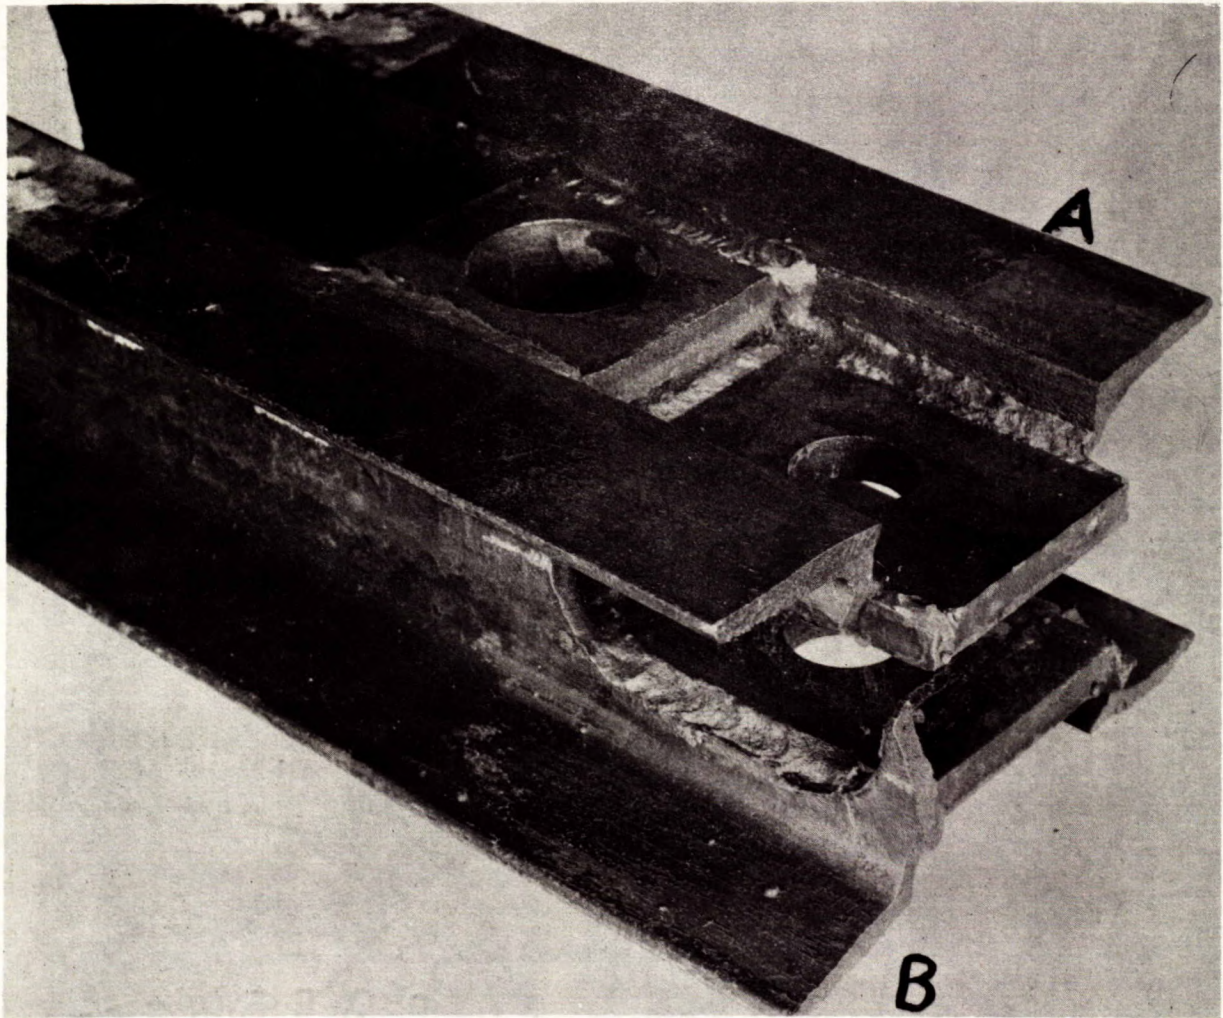
The magnetic particle examination of the end piece, after removal of paint, did not reveal any cracks associated with the welds other than those at the locations of the B1 and B2 microsections (See Figure 5). These cracks had been evident on visual examination, although the crack at the B2 location was made more prominent by the magnetic particle examination. Four cracks of lengths from  $1/2$  to 1 in. were found on the outer surface of channel B at about the longitudinal centre line (See Figure 2). One short crack was found extending from the flame cut slot at the longitudinal centre line of channel A. None of the cracks which intersected the flame cut slot or the fracture were found by magnetic particle examination to extend through the thickness. Sections, cut transversely to cracks in each channel, showed that the cracks were not more than about  $1/32$  in. in depth, and were associated with an accumulation of non-metallic inclusions. These must have occurred during the manufacture of the channels. The cracks played no part in the failure of the end piece.

**Figure 2 - View of one part of the fractured end piece.**

White marks indicate cracks located by magnetic particle examination. These include, in channel B, a crack running across the lower weld near its starting point and down into the web, and four short cracks on the outer surface of the web approximately along the centre line. None of these cracks played any part in the failure. About 1/2 scale.

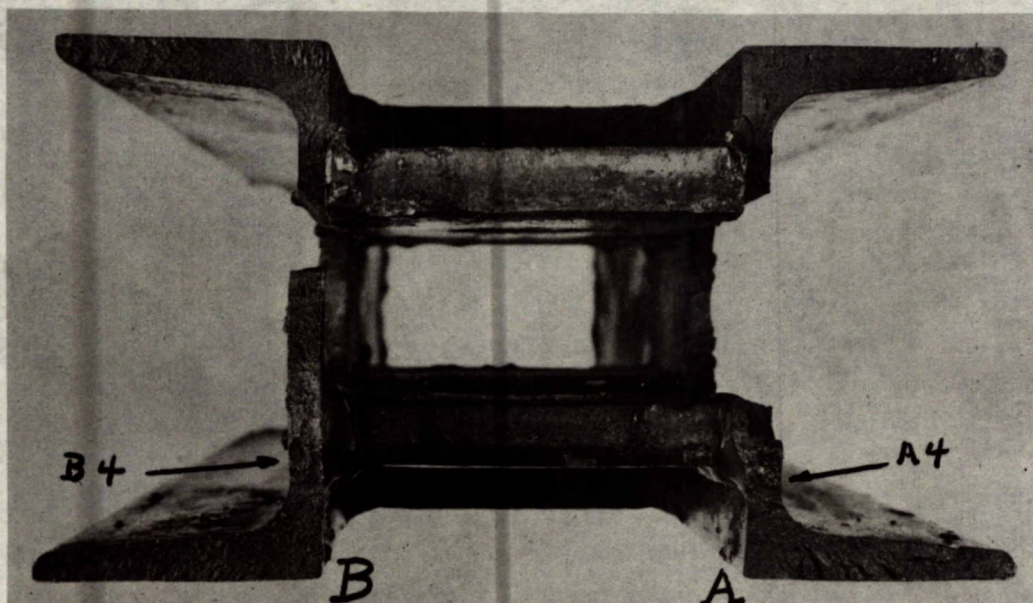
In the end piece examined previously<sup>(1)</sup>, the lower fracture started at or close to the edges of the weld crater of the outer lower fillet welds. It is evident from Figures 5 and 6 that failures could readily have started from similar locations in the second end piece, although at the starting points rather than at the termination points of welds. However, only secondary fractures were initiated at these weld starting points. In channel B, the crack did not extend more than about 3/4 in. downward into the web (See location of section B2 in Figure 5). In channel A, the crack ran at an angle until it intersected the main fracture (See Figure 6). The joining of the secondary and primary fractures, and the failure of a portion of the fillet weld which crossed the end of the connecting piece (See Figure 3), resulted in the loss of a small triangular shaped piece of metal.

Figure 3 - View of the fractured surfaces in the two channels and showing also the locations of sections A4 and B4 which were subsequently removed for examination.

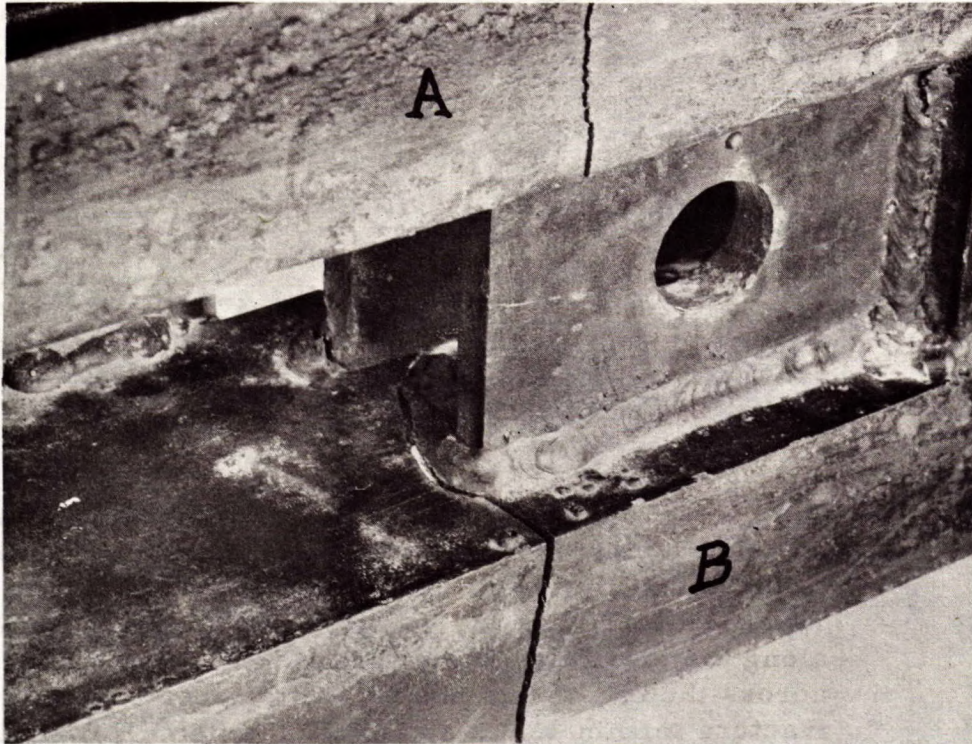
It can be concluded that, on the lower side of the channels in the second end piece, the preferred primary fracture paths were along the toes of the inner fillet welds, as they crossed the end of the connecting plate. This is particularly evident in Figures 3, 4, and 8 for channel B. The exact location of the primary fracture path is less evident in channel A because of the loss of the small triangular shaped piece of metal. However, in Figure 3 it can be seen that at least a portion of the primary fracture was close to the junction of the end fillet weld with the inner surface of the web of channel A. Also, the sections A3 and A4 (See Figures 6 and 7) showed only a small remnant of the fillet weld on the part of the channel located on the left side of Figure 6. In addition, a comparison of Figures 5 and 6 illustrates the similarity of the primary lower fracture paths in both channels.

the weld throats over a distance of about  $1/2$  to  $3/4$  in. between the upper fractures in the webs and the end of the connecting plate. Fractures also occurred through the weld deposits made around the end of the upper connecting plates; as illustrated in Figure 4. The shearing through the throats of these welds must have occurred after the brittle fractures in the channels. After the end piece was completely severed, the two portions had been held closely together by the rigidity of the span, although some longitudinal movement must have occurred subsequently. The longitudinal shear fractures in the upper, inner fillet welds (Figure 2) had been polished, and there was some evidence of battering at a few points on the fractured surfaces.

Figure 4 - Showing the lower fracture path in channel B, looking from the bottom side. Note that the fracture path follows along the toe of the fillet weld made around the end of the central connecting plate joining it to the inner surface of the channel.

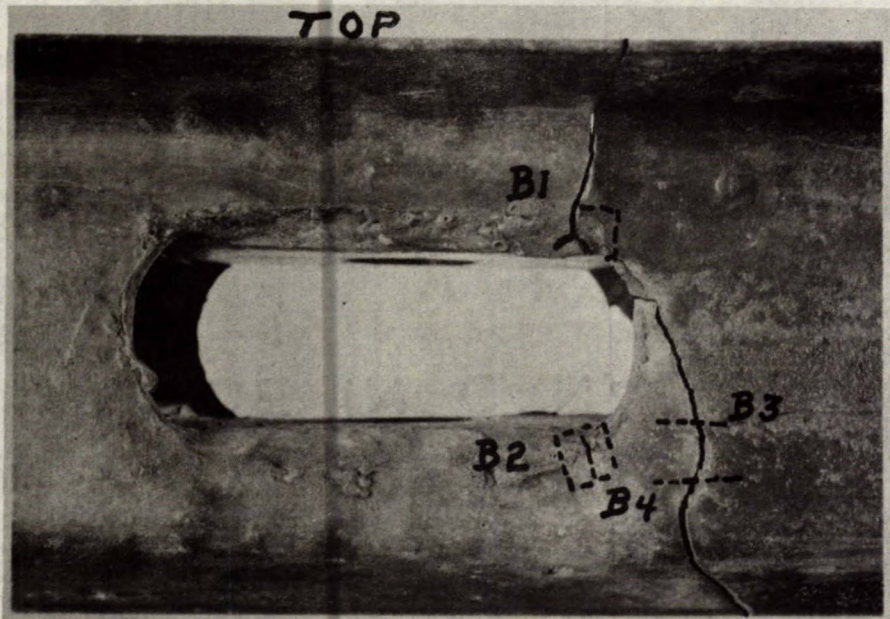
An examination of Figures 5 and 6 shows that the upper fracture paths were similar to each other. The initiating point of fracture in channel A was at or very close to the edge of the weld crater at the termination of the outer fillet weld. The upper fracture in channel B started at a crack in the weld crater at the termination of the corresponding weld. In Figure 2, it can be seen that the fillet welds, between the inner surfaces of the channel webs and the upper surface of the connecting plate, were fractured along

Reference was made previously to the crack at the location of the B2 section (See Figure 5). If failure had occurred at this location, the lower fracture would have been almost identical to that found in channel B of the first end piece (See Figure 4 of the previous report<sup>(1)</sup>). Microscopic examination indicated that the crack was a brittle fracture which had been initiated at or near the start of the outer fillet weld in the martensitic heat-affected zone.

concentration at the toes of fillet welds could be sufficient to initiate brittle failures in this steel at low ambient temperatures even in the absence of brittle martensitic heat-affected zones. Weld metal defects, such as the crater crack in the upper fillet of channel B (See Figure 5) can initiate brittle fractures at low temperatures. In fact, any notch, such as provided in an irregularly made flame-cut surface, might initiate fractures in this steel under severe conditions of service.

Figure 5 - Side view looking at channel B with top side of channel at top of picture. The lower fracture path is not related to the outer fillet weld joining the lower connecting plate. As shown in Figures 3, 4, and 8, the fracture runs along the toe of the inner fillet weld which was made across the end of this plate. At its upper end, this fracture terminates at a notch in the flame cut slot. Although not involved in the failure, a crack, starting close to the right hand end of the outer lower fillet weld (actually the starting end of the weld), runs across the weld and about  $3/4$  in. downward into the web. This crack was faintly visible on the sample as received, as a result of rust staining. It was much more evident on magnetic particle examination after removal of the paint.

The upper fracture travels through the centre of the weld crater at the end of the outer fillet weld and then travels roughly straight upward through the web and flange. A crater crack, joining with the fracture was detected by magnetic particle inspection. This crack most probably initiated the upper fracture.

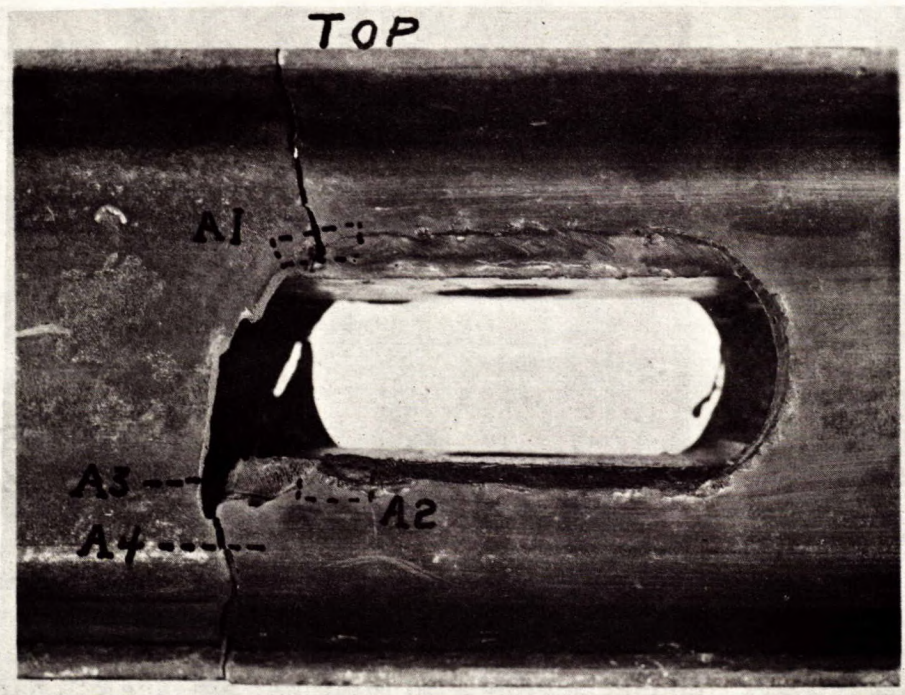
Figure 6 - Side view looking at channel A with top side of channel at top of picture. The lower fracture followed a path similar to that in channel B, but in addition a secondary fracture ran from close to the edge of the starting point of the lower weld out to the main fracture. Thus, a triangular shaped piece of metal from the web is missing. The upper fracture travels along the edge of the weld crater at the termination of the outer fillet weld and then almost straight upward through the channel web and flange.

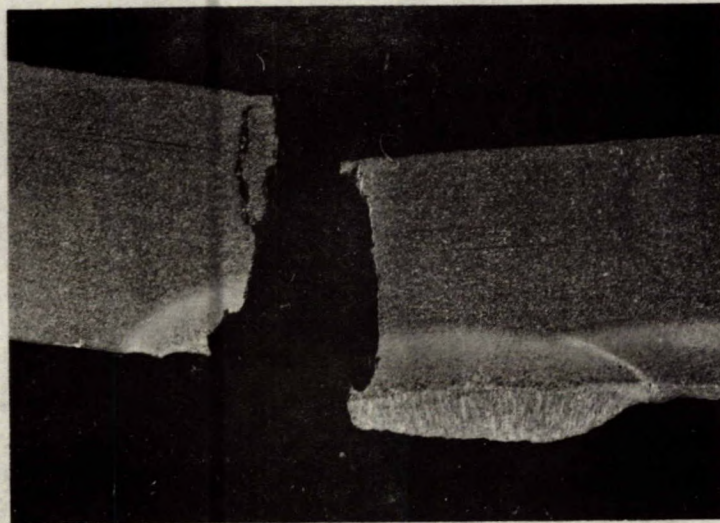
Hardness values, obtained in a traverse across section B4 (Figure 8), were 95 to 98 Rockwell B in the weld deposit, 97 Rockwell B to 21 Rockwell C in the unaffected base metal, and 34 to 50 Rockwell C in the heat-affected zone. In section A4 (Figure 7), hardness was 21 to 29 Rockwell C in the weld metal, 97 Rockwell B to 21 Rockwell C in the unaffected base metal, and 32 to 52 Rockwell C in the heat-affected zones. The higher hardness values of the weld deposit and heat-affected zone in section A4 were due to the much thinner deposit which had cooled more rapidly than the larger deposit in section B4. The maximum hardness values were obtained in the coarse-grained martensite of the heat-affected zones close to the weld fusion lines.

Figure 7 - Section A4 (See Figures 3 and 6) showing that the lower fracture in channel A was at or very close to the toe of the fillet weld joining the connecting plate to the inner surface of channel A. The section was taken close to the termination of this weld.

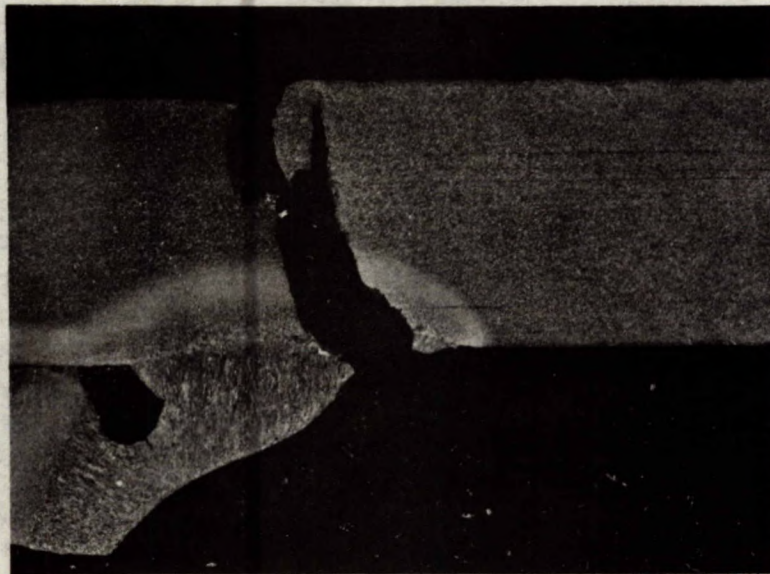
Figure 8 - Section B4 (See Figures 3 and 5) showing path of fracture close to the toe of the fillet weld joining the connecting plate (lower left) to the inner surface of channel B.

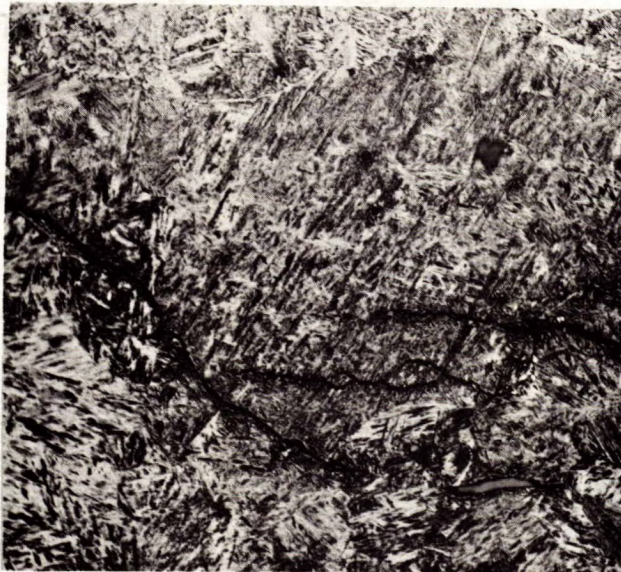
Most of the sections removed from the locations illustrated in Figures 5 and 6 were found by microscopic examination to have predominantly martensitic heat-affected zones. Heat-affected zone cracking was detected only in sections A4, B3, and B4. The microstructure and cracking were

similar to that found in the end piece examined previously<sup>(1)</sup> and one of the photomicrographs shown in that report is reproduced in Figure 9 to illustrate the same features in the second end piece. The microstructure of the channels, in areas unaffected by welding, was similar to that in the first end piece shown in Figure 16 of the previous report<sup>(1)</sup>.

It is evident that the welding procedures, like those used in the fabrication of the first end piece<sup>(1)</sup>, were inadequate and resulted in brittle martensitic zones and heat-affected zone cracking. The composition of the steel is such that considerable care must be taken to avoid such defects. Even if the welding procedure had been capable of eliminating heat-affected zone cracks, it cannot be concluded that brittle failure would not be initiated by brittle martensitic heat-affected zones. It is quite possible that the stress

Figure 9 - Illustrating the predominantly martensitic microstructure close to the fusion line of most of the welds, and heat-affected zone cracks found in some of the sections. Weld metal is at top.

Defects such as brittle heat-affected zones, and cracks in the heat-affected zones or weld deposits, can be avoided by using proper welding techniques. The notch effect at the toes of fillet welds can be reduced by avoiding abrupt transitions. However, even if great care is taken during welding, there will still be stress concentration at the terminations of welds. Therefore, in order to have greater assurance that brittle fractures will not occur, particularly under low temperature conditions, it would be logical to select a steel having very much better notch-ductility than the steel which was used in the channels of the two end pieces.
