MINES BRANCH INVESTIGATION REPORT IR 64-39

**EXAMINATION OF A FAILED BOLT FROM
THE CONNECTING ROD OF A DIESEL ENGINE
USED FOR POWER GENERATION**

Mines Branch Investigation Report IR 64-39

EXAMINATION OF A FAILED BOLT FROM
THE CONNECTING ROD OF A DIESEL
ENGINE USED FOR POWER GENERATION

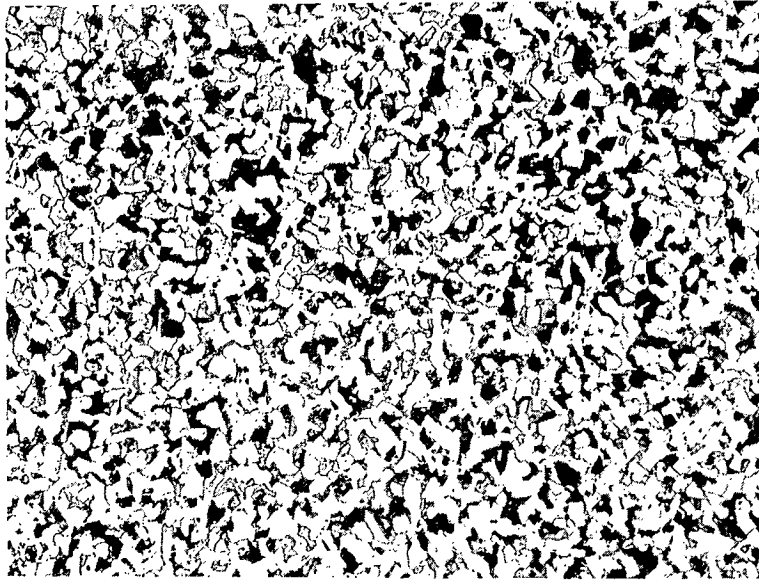
Microscopic examination of the bolts showed that the good bolt had been quenched and tempered, whereas the failed bolt had a normalized microstructure, consisting of ferrite and pearlite. Figure 1 shows the microstructures of the two bolts.

The metallurgical examination indicated that both bolts were made from the same grade of steel. They differ, however, in the final heat treatment they had received. The normalized microstructure of the failed bolt would be expected to have a higher notch sensitivity and a lower ultimate tensile strength than the quenched and tempered microstructure of the good bolt.

(a) Microstructure of failed bolt

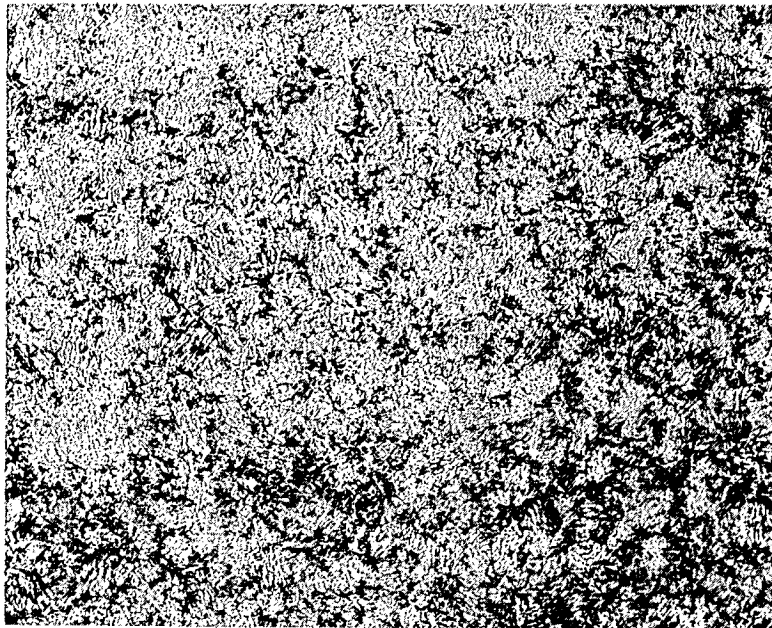
(b) Microstructure of good bolt
