MINES BRANCH INVESTIGATION REPORT IR 64-41

METALLURGICAL EXAMINATION OF WORN SNUBBING CASTER SUPPORT SHAFT

C. M. WEBSTER & R. D. McDONALD

MAY 8, 1964

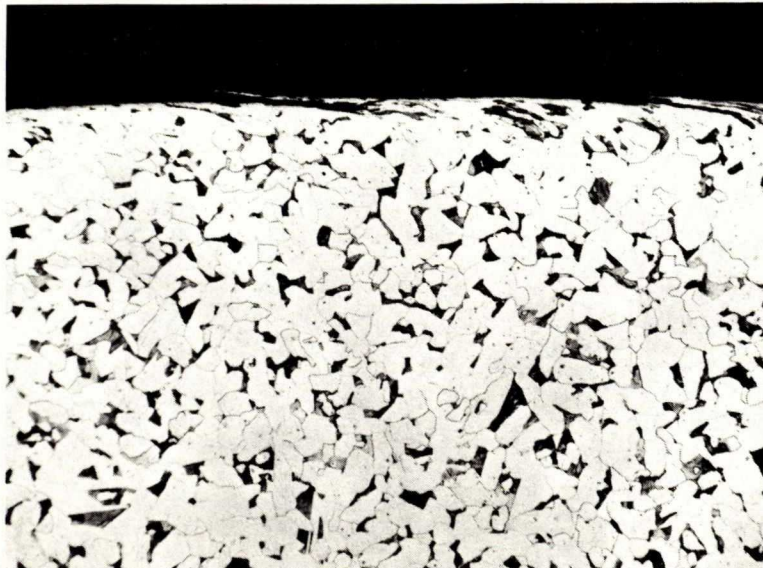
(a)
Etched 2% nital - X100

A specimen was cut from the worn region of the shaft, so that the worn and unworn surfaces could be examined microscopically. The microstructure, shown in Figure 2, resembles that which is developed by a normalizing treatment. There was no evidence that a case carburizing or hardening treatment had been carried out on this shaft.

Figure 2. (a) Unworn surface not carburized
(b) Worn surface showing worked metal.
