MINES BRANCH INVESTIGATION REPORT IR 64-65

EXAMINATION OF A FAILED CROSSARM BOLT

JULY 14, 1964

On 2 April, 1964, a broken 3/4 in. galvanized machine bolt was received from the New Brunswick Electric Power Commission via the Technical Information Services Division of the National Research Council. The letter from the Power Commission, file 3-352A, Line Design General, dated 12 March, 1964, inquired:

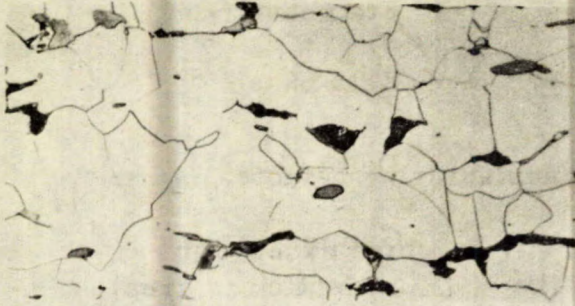
The microstructure of the shank adjacent to the head of the bolt is typical of hot rolled mild steel, consisting of approximately equiaxed ferrite grains and patches of fine pearlite (Figure 1a). At 1/2 in. from the fracture, there is clear evidence of cold deformation of the ferrite (Figure 1b). At 1/4 in. from the fracture, there is severe cold work shown by the heavily deformed ferrite and also elongated, pearlite patches (Figure 1c). Immediately adjacent to the fracture, most of the ferrite has recrystallized, and the pearlite patches have been deformed to stringers of carbide particles (Figure 1d).

(a) Adjacent to bolt head.

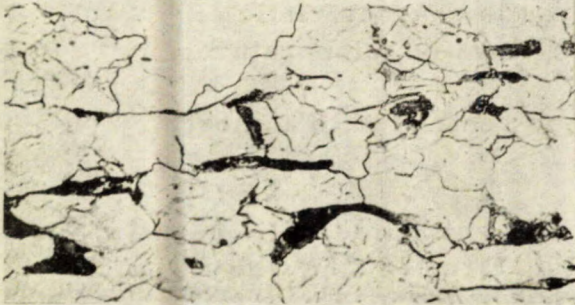
(b) 1/2 in. from fracture.

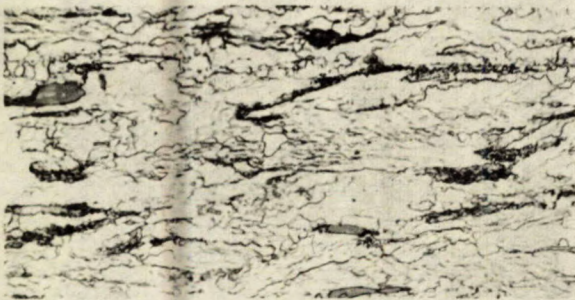
(c) 1/4 in. from fracture

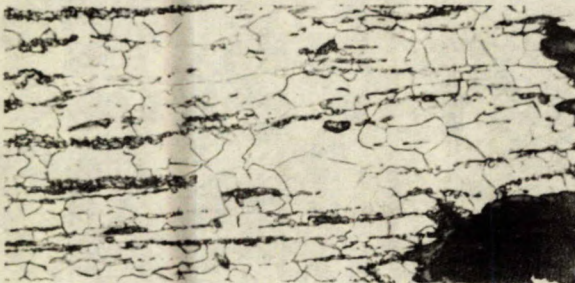
Microstructural features of the bolt shank established approximate temperature limits for the service fracture although the limits are widely spaced. Recrystallization of hot-deformed iron requires a temperature in excess of 460°C (860°F)*. Variations in material composition, time, etc., between the service failure under consideration and the test work which established the above figure would, of course, lead to a discrepancy in the minimum recrystallization temperatures in the two cases. However, this discrepancy would probably not be so large as to invalidate the use of 460°C (860°F) as an approximate minimum service failure temperature. The fact the recrystallization was not complete and that some evidence of deformation persists immediately adjacent to the fracture indicates the temperature did not exceed the lower critical transformation temperature of 720°C (1330°F). An accurate assessment of the actual temperature reached within this 260°C (470°F) range depends upon information, especially elapsed time, which is not available. However, assuming a time at high temperature to be of the order of a few minutes, a failure temperature between 650°C (1200°F) and 705°C (1300°F) is probable.

(d) Fracture

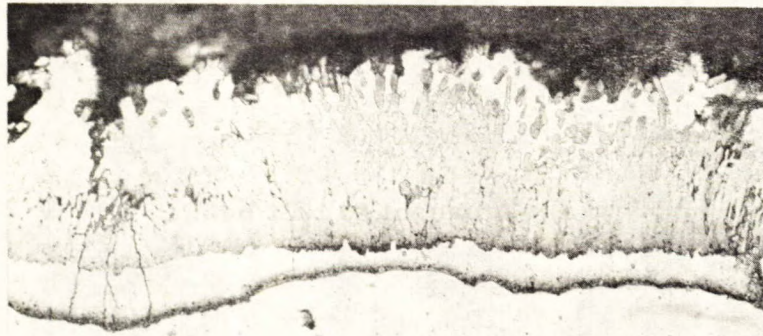
Examination of the galvanized coating revealed further evidence of elevated temperature. Figure 2a illustrates the galvanized microstructure on the shank approximately 3-1/2 in. from the fracture toward the threaded end. This reveals the original structure which shows the normal iron-zinc alloy phase layers, which are characteristic of this type of coating. There is no evidence of heating. At a point approximately 1 in. from the fracture the coating has been altered. There is little pure zinc, and the delta layer has grown at the expense of the columnar zeta layer (Figure 2b). Approximately 1/4 in. from the fracture the zeta layer has been completely replaced by the delta layer and, most significantly, the gamma layer has increased greatly (Figure 2c). These changes in microstructure are characteristic of post-galvanizing heating. The differences between the structures at 1/4 in. and 1 in. from the fracture are clear evidence that the section nearer the fracture was at a significantly higher temperature.

(a) 3-1/2 in. from fracture
Eta phase (zinc)

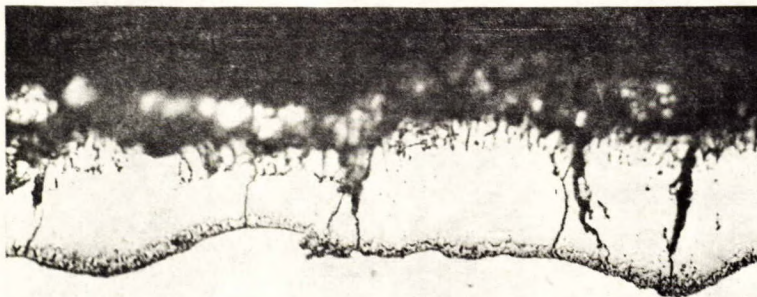
(b) 1 in. from fracture

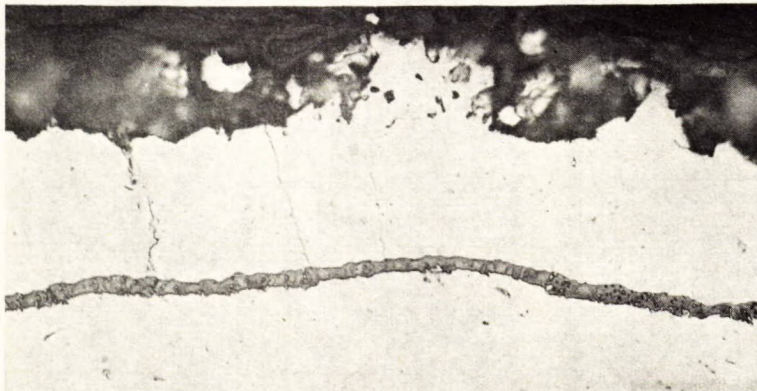
Changes observed in the galvanized coating provide clear evidence for the localization of the elevated temperature to a maximum of under 3-1/2 in. from the fracture, and indicate a sharp rise in temperature in the immediate vicinity of fracture. The changes in structure indicate a probable maximum temperature of about 650°C (1200°F) on the surface of the bolt at 1/4 in. from the fracture.

(c) 1/4 in. from fracture
