MINES BRANCH INVESTIGATION REPORT IR 64-88

**EXTRUSION DEFECTS ON 90/10 AND
70/30 COPPER-NICKEL TUBES**

E. WINKLER & J. A. PERRY

SEPTEMBER 20, 1964

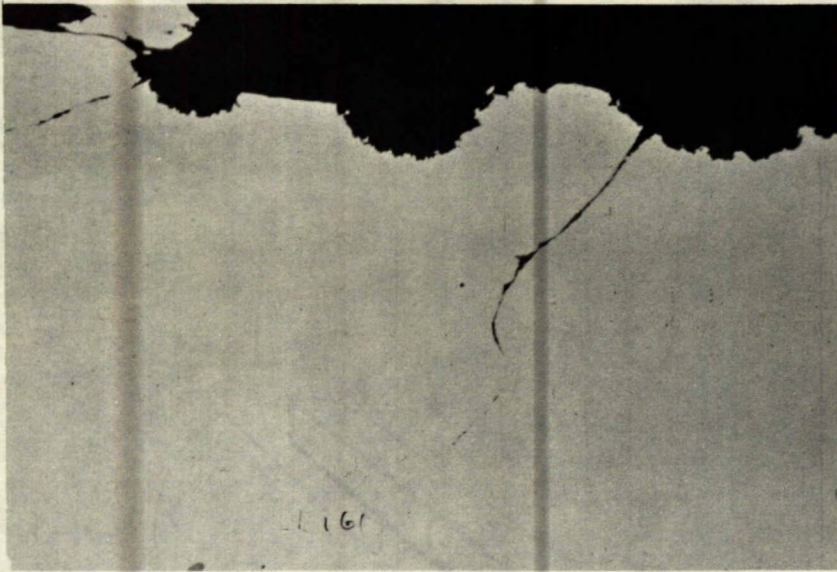
Figure 2A.

Figure 2A and Figure 3A show the failures observed on plane A. The grey phase is the resin, the white one the metal. It can be seen that the surface appears very irregular and that from the valleys on this surface, cracks run off to a depth of approximately 0.022 in. (0.5 mm). Figures 2B and 3B show the extension of these cracks in the longitudinal direction after the sample has been polished on side B. (See Figure 1). It can be seen clearly that these cracks show the tendency to form attached flakes of varying thicknesses. For both alloys, the same results were obtained as can be seen in Figures 4A and 5A, and 4B and 5B.

Cross-sectional view of a polished 90 Cu-10 Ni alloy tube surface impregnated with resin.

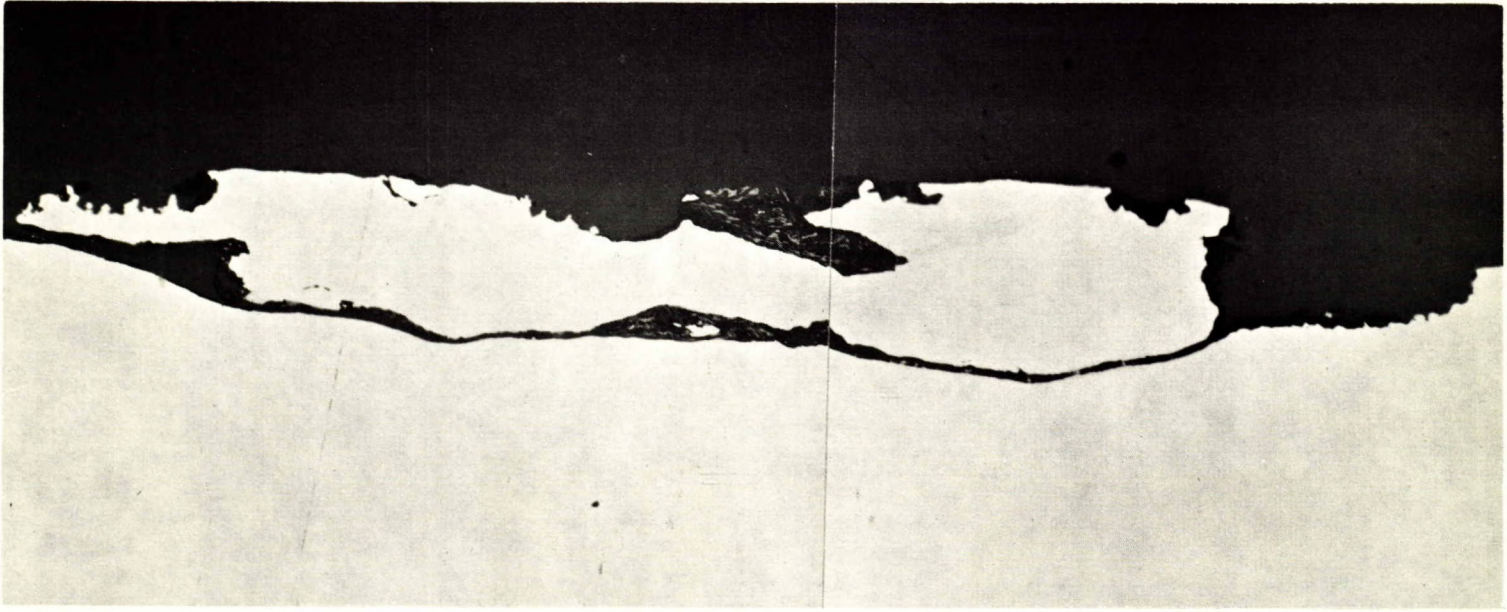
Figure 2B

Longitudinal view of as polished 90 Cu-10 Ni alloy tube surface impregnated with resin.

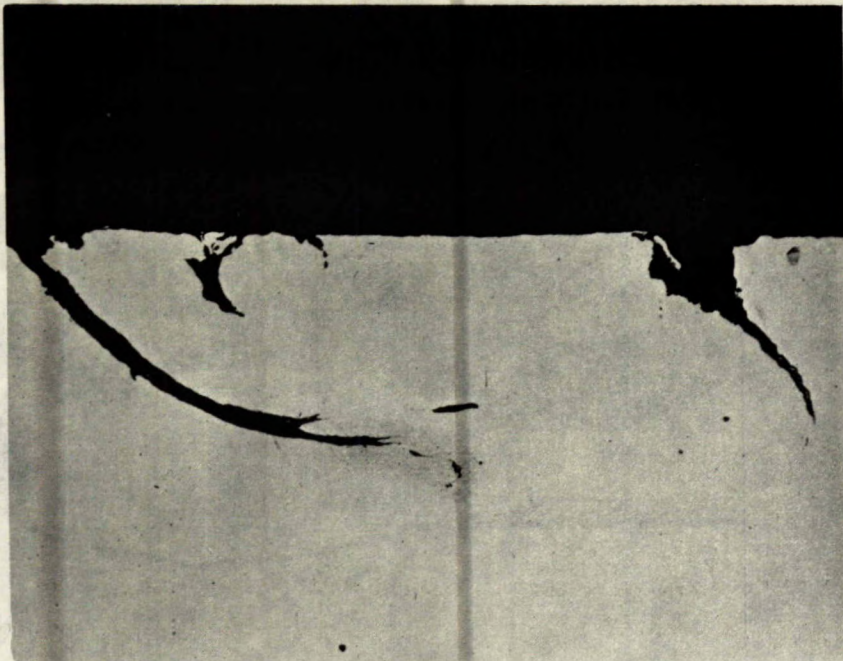
Figure 4A.

Cross-sectional view of a polished 70 Cu-30 Ni alloy tube surface impregnated with resin.

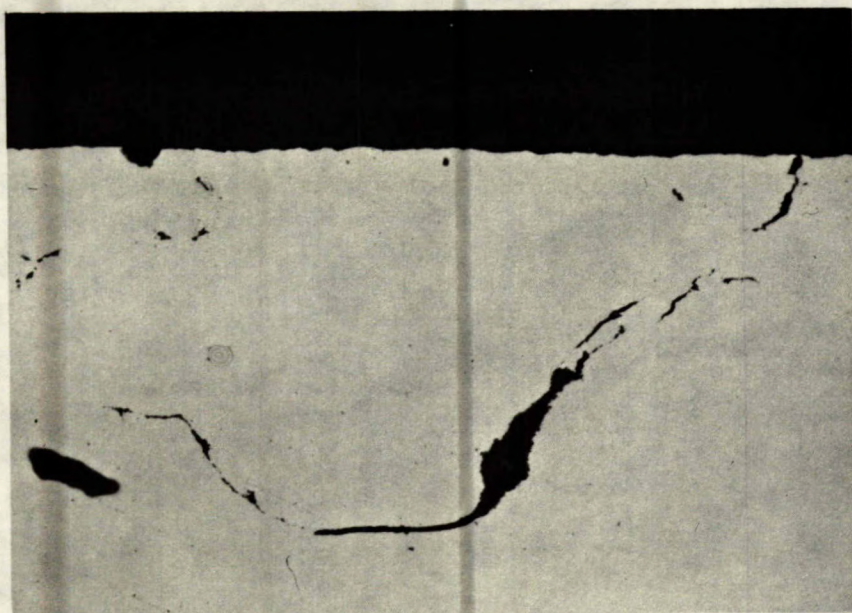
Figure 5A.

If it is realized that every extrusion process is more or less limited by the amount of friction, it will be easily understood that the changes in friction during the extrusion process will influence the material flow on the surface considerably. At the beginning, static friction is the ruling element and this gradually changes to dynamic friction, and back to static again as the butt is reached. Until the flowing material can transport sufficient lubricant to the die surfaces, and this will be at the beginning of the extrusion, the unlubricated or barely lubricated die surfaces will introduce shearing forces which make the material flow in other than the intended directions. This leads to a partial separation of the material as is well demonstrated in Figures 5 to 7.

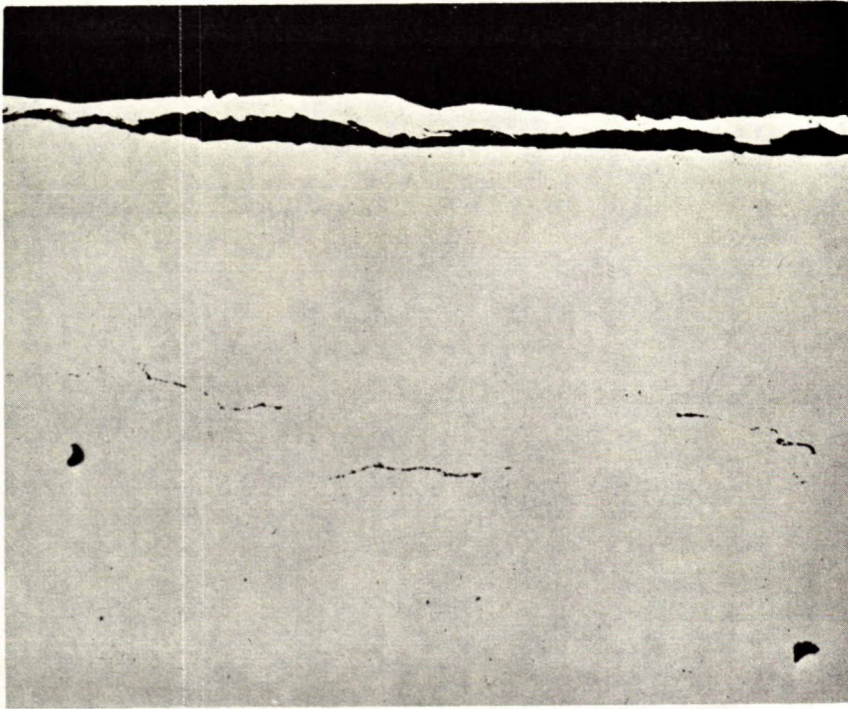
Figure 4B

Longitudinal view of a polished 70 Cu-30 Ni alloy tube surface impregnated with resin.

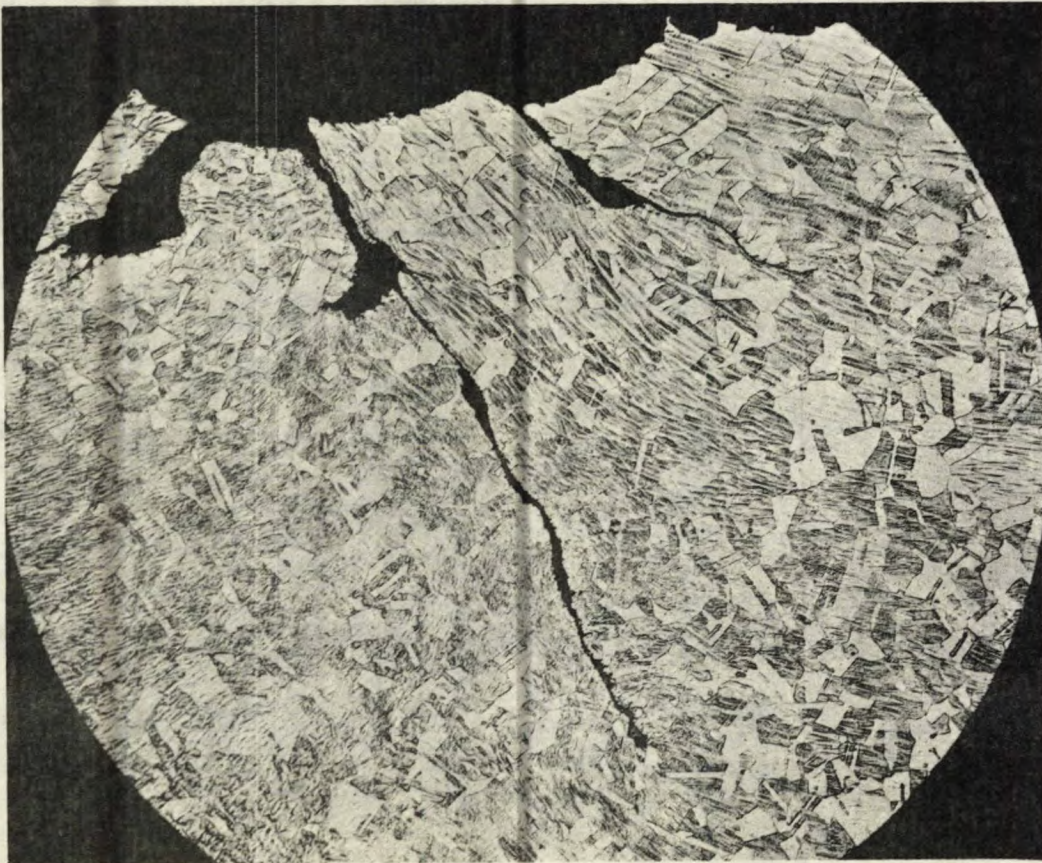
Figure 7. 90 Cu-10 Ni Alloy.

Note the lamellar appearance which suggests some local shear as opposed to the main extrusion direction.

1. The billet should be superheated on the leading end by an amount sufficient to accommodate the heat losses.
2. The extrusion speed should be low at the beginning and be increased during the extrusion.
3. Care should be taken that the die surface is lubricated properly right from the beginning.
