**MINES BRANCH INVESTIGATION REPORT IR 64-92**

**EXAMINATION OF TWIN WATER-WALL  
BOILER TUBE SAMPLE**

A sample of twin water-wall boiler tube, 11 in. long, taken from the sidewall of #8 Babcock-Wilcox boiler at the Grand Lake Generating Station was forwarded to the Physical Metallurgy Division, Mines Branch, Department of Mines and Technical Surveys by Mr. J. R. Dean of the New Brunswick Electric Power Commission.

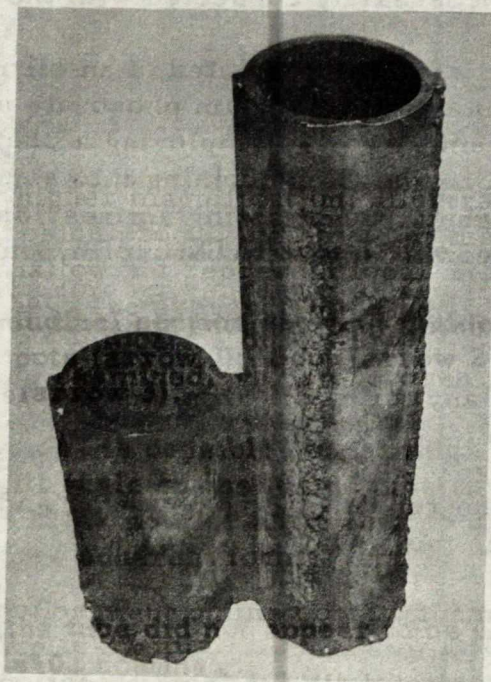
Figure 1 shows the tube in the "as-received" condition. The tubes are viewed from the combustion surface.

Figure 1. Water-wall tube sample, combustion surface. The combustion side and the back (outside) surface of the water-wall sample appeared to be in almost new condition.

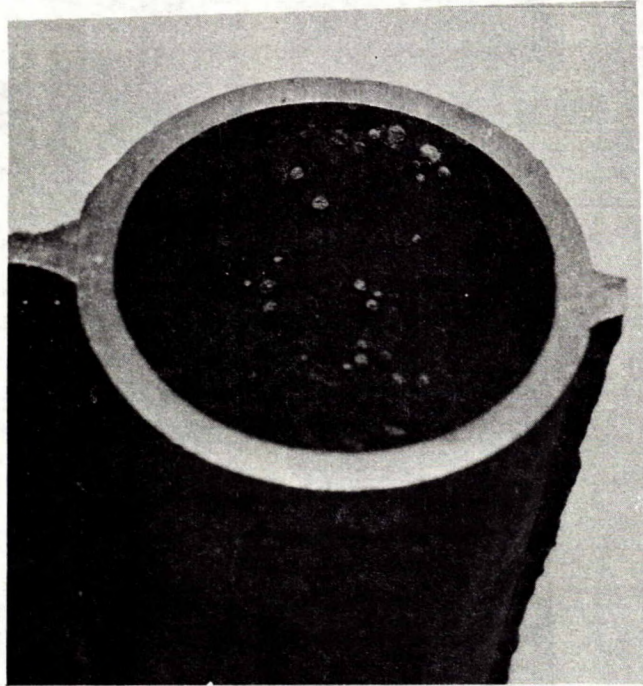
Figure 2 illustrates the appearance of the "red spots" (corrosion product concealing pits).

Figure 2. "Red spots" on inside tube surface. The clean outer surface of the tube is visible in this photograph.

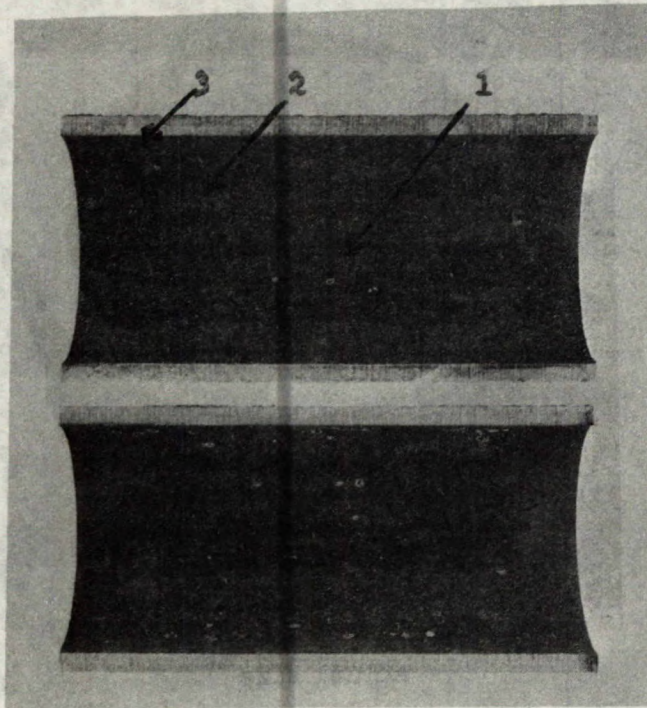
Figure 3 illustrates a split 6 in. length of tube containing red spots (arrow 1), sooty material (arrow 2) and black scale (arrow 3). The latter constituent was suspected of being mill scale that had not been removed by pre-operational cleaning.

Figure 3. Longitudinal section showing inside tube surface. Red spots (arrow 1); Soot (arrow 2); Suspected scale (arrow 3).

Analysis of material scraped from the red spots (pits) showed a significant quantity (2% to 5%) of copper and strong traces of zinc. The corrosion product consisted of  $\text{FeO} \cdot (\text{OH})$  - lepidocrocite (hydrated iron oxide) and  $\text{Fe}_3\text{O}_4$  - magnetite. The loose black powder and the black patches were identified as magnetite. No decision could be made as to the origin of this constituent, i. e., whether it was residual mill scale (not removed by pre-cleaning) or magnetic iron oxide formed by steaming. Metallographic examination of the surface suggested that the latter was more probable.

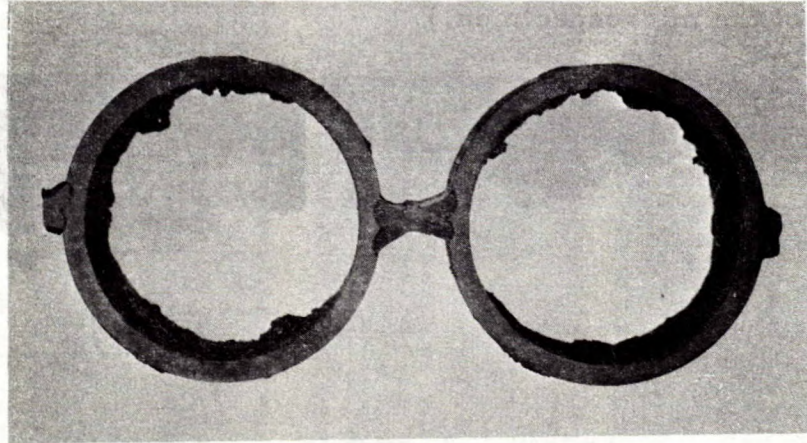
A transverse section through the sample, Figure 4, was deep-etched to determine if the tube was of seamless manufacture.

Figure 4. Deep-etched transverse section. (The tubes were of seamless manufacture).

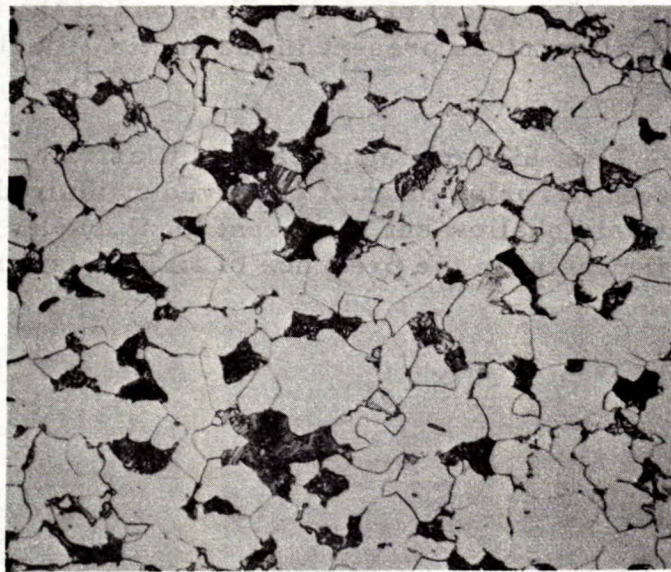
The transverse microstructure of one of the tubes is illustrated in Figure 5 and consists of ferrite and lamellar pearlite. The ferrite grains are equiaxed and refined. The hardness, measured on the clean (outside) surface of the tube was Rockwell B 68.

Figure 5. Microstructure of tube viewed in transverse section. The microstructure appears normal with respect to constituents, cleanness, hardness and grain size for seamless tubing manufactured from killed steel to the requirements of ASTM A-210.

The tube appeared to conform to ASTM-A210, medium carbon, seamless, killed steel, in the annealed or normalized condition. The surface hardness, Rockwell B 68, and the microstructure appeared satisfactory for this grade.

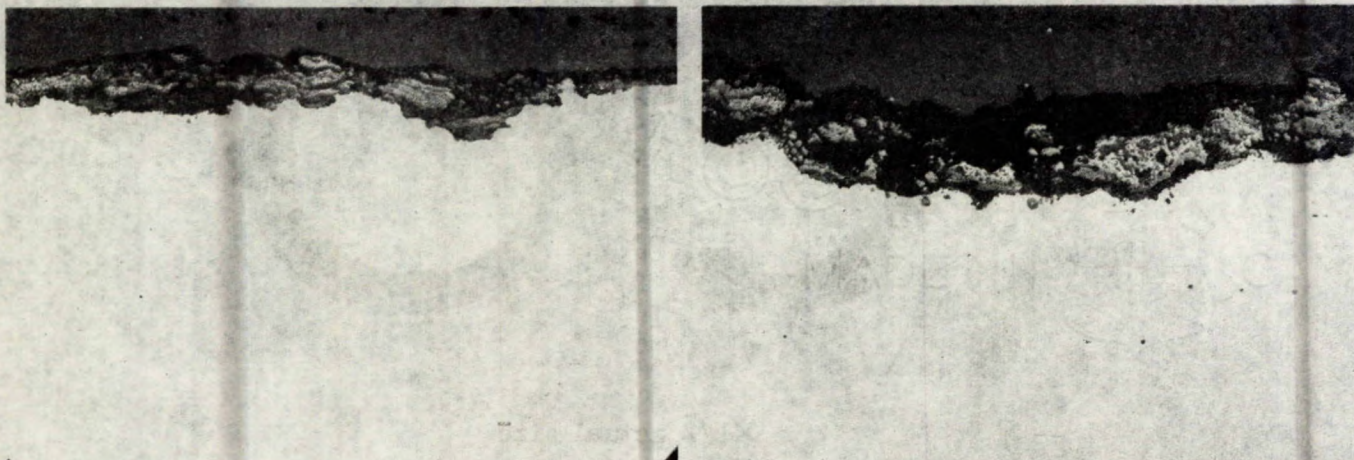
Figure 6 illustrates the appearance of transverse sections taken through "red spots" on the inside water surface of the tube. (The corrosion product has been compressed by the bakelite mould material used for preparation of the microspecimen.)

Figure 6. Sections through red spots at the surface of the tube. The corrosion product has been compressed by the bakelite (grey) visible at the top of the photomicrographs. The water-side scale, illustrated at the left of this figure, is typical of unpitted regions of the inside surface. A shallow pit is present in the section illustrated at the right.

The tube wall thickness appeared to be approximately 0.188 in., with a 2.516 in. OD and 2.141 in. ID, approximately. The pits have a depth of 0.004 in. to 0.010 in., the location of each pit being marked by the yellow-red spot of hydrated iron oxide. Reference is made to the previous letter (1) and to a Mineral Processing Division letter and report (2) (3).

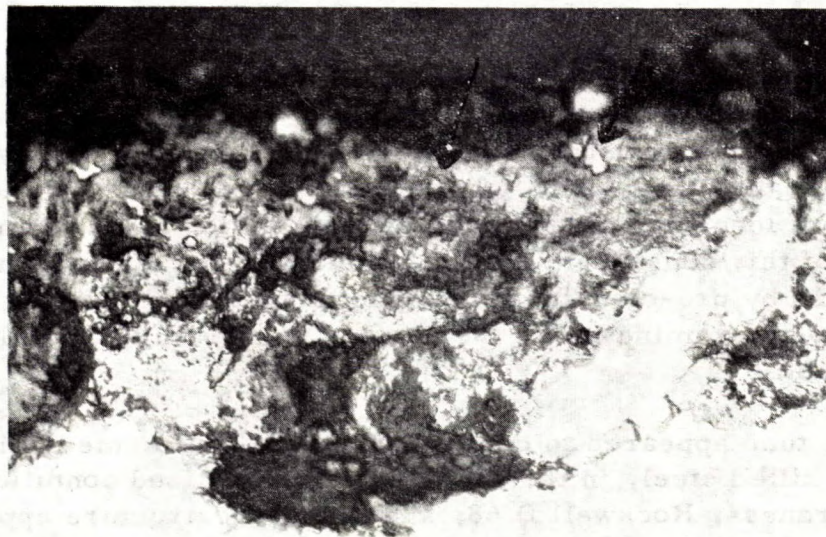
Figure 7, at higher magnification, illustrates the appearance of the compressed corrosion product observed at the red spots. These pits are relatively shallow but represent local anodes that may continue to penetrate the metal in the presence of an adequate supply of oxygen.

**Figure 7.** Inside (water surface) of tube. Section taken at red spot. The corrosion product consisted of magnetite and hydrated iron oxide,  $\text{FeO}(\text{OH})$  lepidocrocite. Copper-coloured constituent is visible (arrows) in the corrosion product.
