MINES BRANCH INVESTIGATION REPORT IR 65-17

# COPPER AND ZINC CONTENTS OF WASTE WATERS AND RECEIVING STREAM WATERS •AT BRUNSWICK MINE, NEW BRUNSWICK

**FEBRUARY 17, 1965**

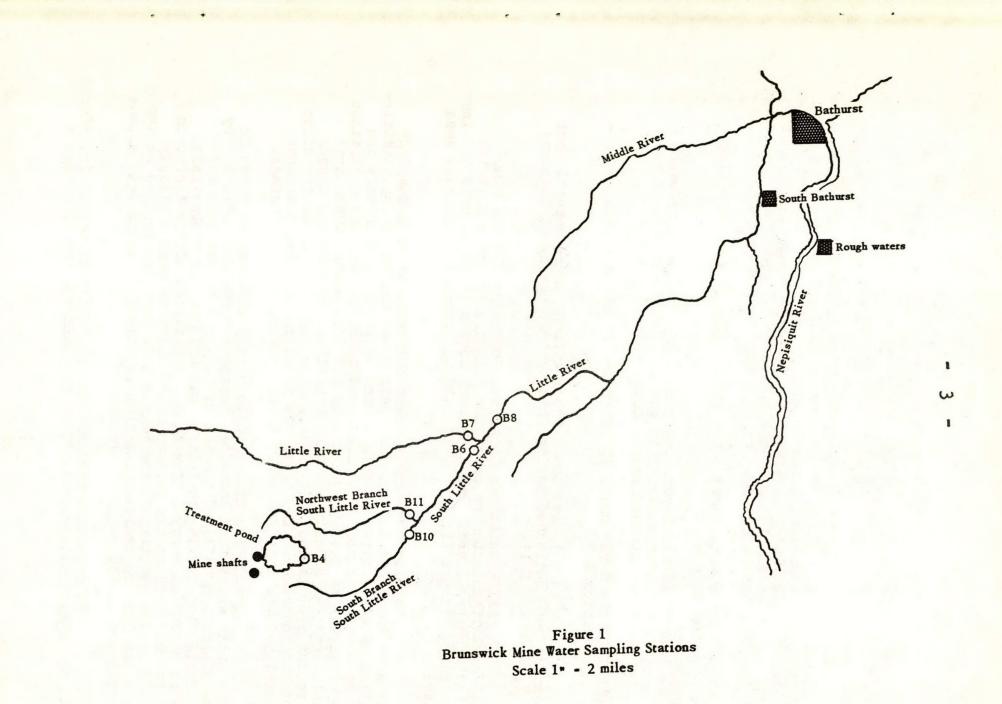
The alkaline tailings or wastes from the concentrator enter a large ponding area where they mix with an acid water pumped directly to the pond from the mine. This mixture is then treated with lime to raise the pH and to precipitate the base metals (copper, zinc and lead). The treated wastes settle in three ponds in series, the overflow from the third pond flowing into the drainage system of the Little River, via the tributary stream, South Little River (see Figure 1).

Personnel of the Department of Fisheries periodically collected samples from the pond overflow and from receiving streams at the Brunswick mine property. Early in November 1964, a biweekly sampling program was initiated to check the high zinc contents already noted in the Little River; samples were collected at the following locations over a 3-week period (see Figure 1):-

Figure 1 also shows the locations where several spot samples were collected during this period, namely at Stations B 7, B 10 and B 11.
