MINES BRANCH INVESTIGATION REPORT IR 65-20

**EVALUATION OF FAILED SUCTION-ROLL
HEAD FROM THE DRIVE END OF THE
NO. 3 PRESS OF THE NO. 5 PAPER MACHINE
AT PORT ALBERNI, B. C.**

D. K. FAURSCHOU

MARCH 10, 1965

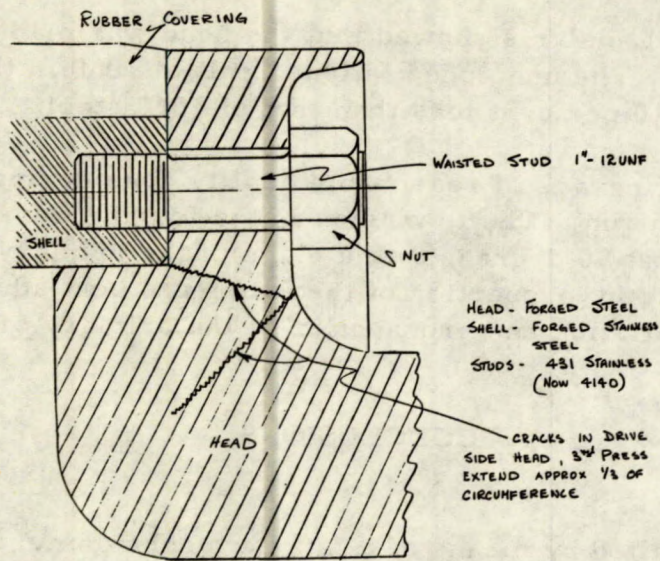
Figure 1. Cross-Section of the Head: Shell Joint (courtesy of M.B. and P.R.).

Figure 1 (from M.B. and P.R.) indicates the shape and dimensions of the spigot and flange. It also shows the studding arrangement. It is understood that D.E.W. specifies that the reentrant angle between the spigot and the flange have a 6/32-inch radius.

Although the Dy-Chek penetrated completely through the section, the angle of dip of the observed cracks suggested that two independent cracks, as suggested on Figure 1 were involved in the failure.

Note: A blind crack, as indicated on the drawing, was not found to exist.

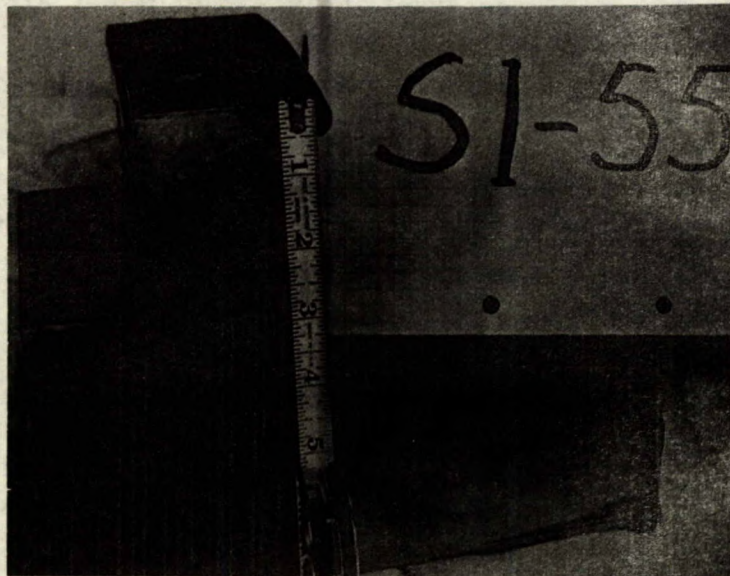
Figure 2. Transverse Cross-Section at Stud Position No. 27-3/4, Through the Spigot and Flange of the Failed Head. Etched in nital. (Courtesy of D.E.W.)

Figure 2 (from D. E. W.) shows a transverse cross-section of the severed part. This cross-section, through stud position No. 27-3/4, has been etched in nital to reveal macroscopic details of the weld repair on the spigot and to reveal the internal soundness of the forging in this region. The crack extends from the reentrant angle to a depth of about 3/8 inch. The etch showed that the weld passes were laid in sequence from the end of the spigot toward the reentrant angle; the reentrant angle lies in a region affected by heat during welding and the forging is internally sound. Deeper etching of similar sections revealed that the forging flow lines were favourably oriented at almost 90 degrees to the direction of propagation of the reentrant angle cracks. The forging flow lines were unfavourably oriented with respect to the secondary crack or crack length which was open on the exterior root.

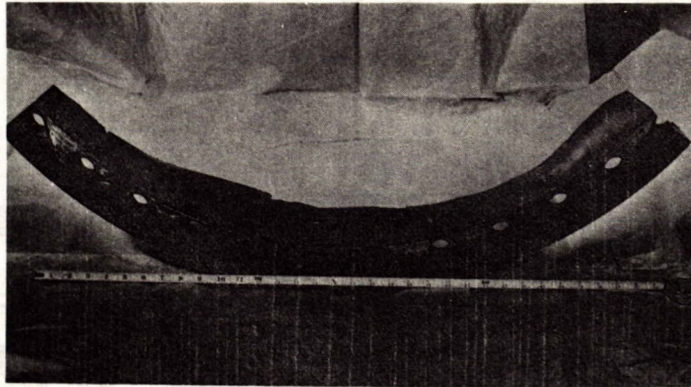
(a)

Figures 3a and 3b (from D. E. W.) show the exposed fracture surface between studs No. 13 and No. 24. The whole of the fracture surfaces were coated with a dark adherent coating of corrosion product and possibly residue from black liquor. Nevertheless, it was obvious that failure had initiated at several points along the 90-degree reentrant angle between the spigot and the flange. Characteristic "beach" markings on the fracture surface showed that multiple fatigue fracture had initiated midway between "anchoring" studs. Unfortunately, the photographs do not show these markings clearly. Visual inspection of the surfaces showed a series of convex scallops pinned to the surface at each stud position. Figure 3a shows one of these scallops or "clamshells" on the left end between studs No. 13 and No. 14. As these fatigue cracks progressed they inevitably overlapped and merged together. The ridges or hackle marks, especially evident close to each stud hole in Figure 3a, are traces left where individual cracks, in slightly different planes, abruptly joined together. The separate fatigue cracks apparently grew and merged into one large crack which progressed, between studs No. 13 and No. 24, to within 1/4 inch of the exterior root of the flange and the main body of the head. This large primary crack is shown exposed in Figure 3a.

Figure 3. Exposed Fracture Surfaces Between Stud No. 13 (on the left) and Stud No. 24 (on the right). Cleaned in alcohol. (Courtesy of D. E. W.)

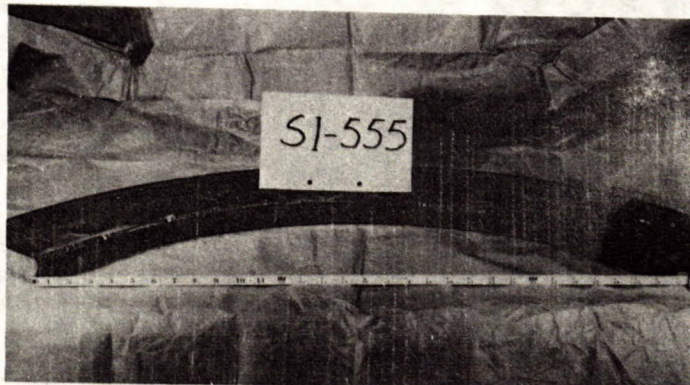
(b)

The nature of the crack surface shown in Figure 3b is not unequivocally understood, except that it was not a primary cause of failure and its existence depends on the primary fatigue crack. It is either a continuation of the primary fatigue crack, in which case a change of direction was determined by changes of the pattern of stress distribution which brought the crack into alignment with forging flow lines, or it is a separate secondary crack which propagated from the exterior. (Refer to Figure 1).

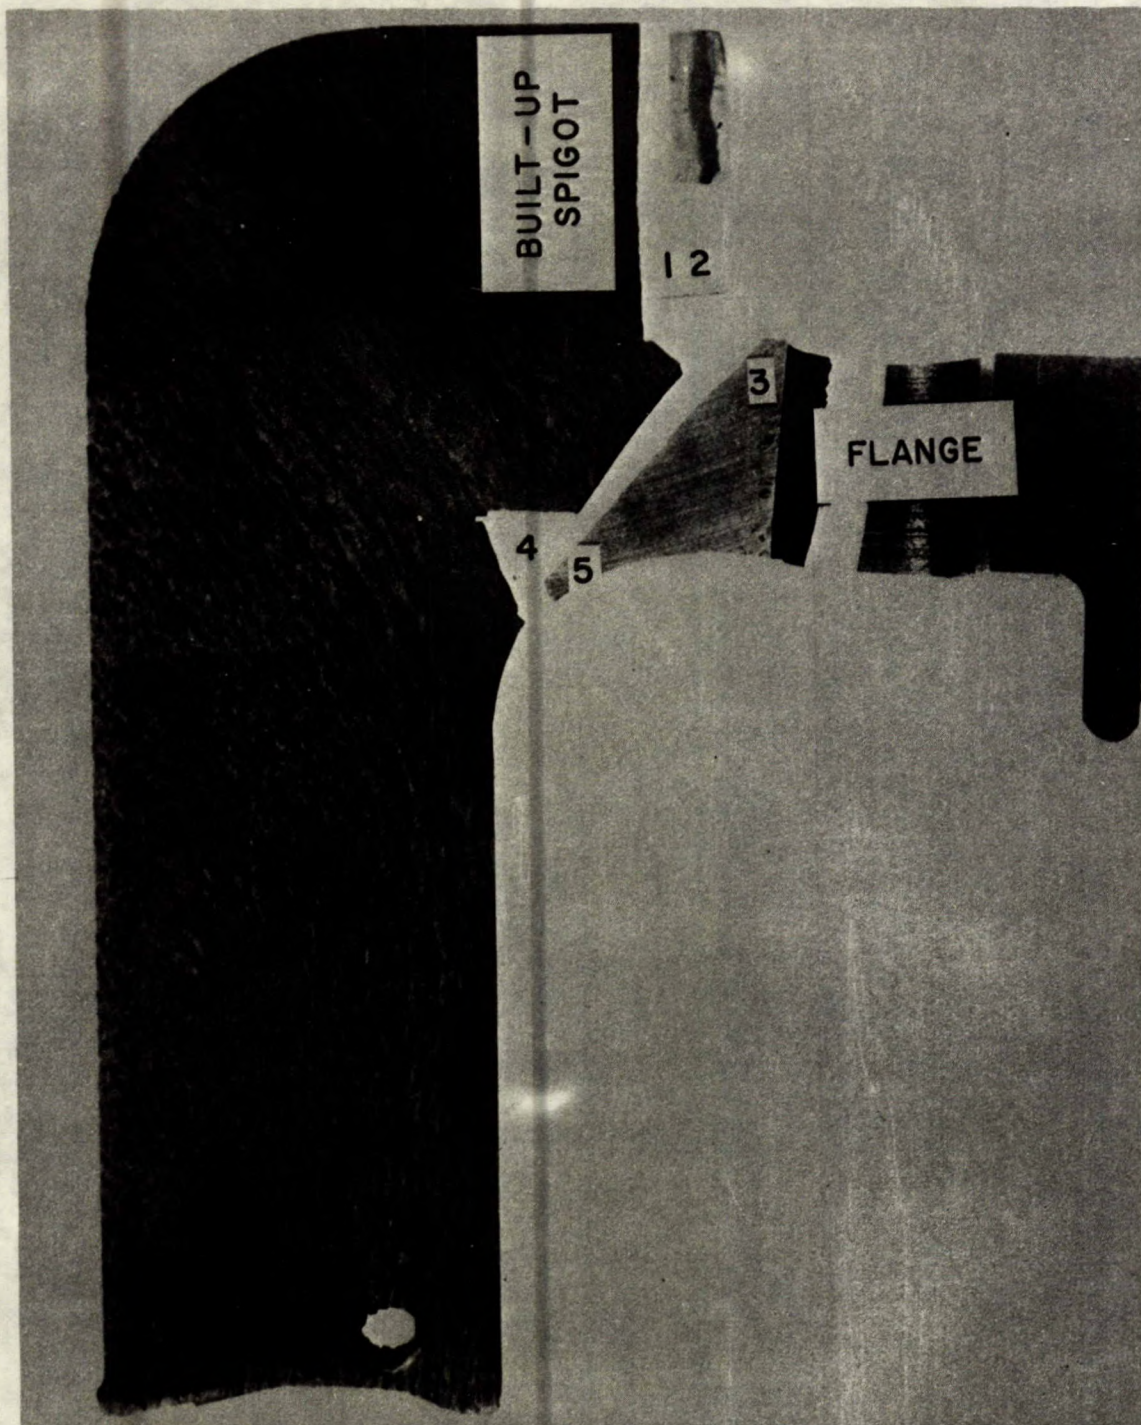
Figure 4. Section Through Spigot and Flange, Passing Through Stud Hole in No. 17, Which Was Examined at the P.M.D. Deep etched. The locations of five specimens removed for microscopical examination are indicated. Etching in 1:1 HCl and water at 160-180°F has revealed the forging flow lines.

A half-inch cross-sectional slice of the fracture region was removed by sawing with one side passing through stud hole No. 17. This section and the location of specimens removed for microscopic examination are shown in Figure 4. It is understood that the microstructure of an adjacent slice was studied at D.E.W.

Figure 4 shows the forging flow lines as they are related to the reentrant angle. The main i. e. the primary part of the fracture transversed the flow lines almost at right angles. The small final or secondary part of the fracture occurred in a plane of the forging flow lines. (The planes of the flow lines represent planes of weakness relative to other planes in the forging, just as grain in wood represents planes of weakness and low resistance to initiation and propagation of fracture.)

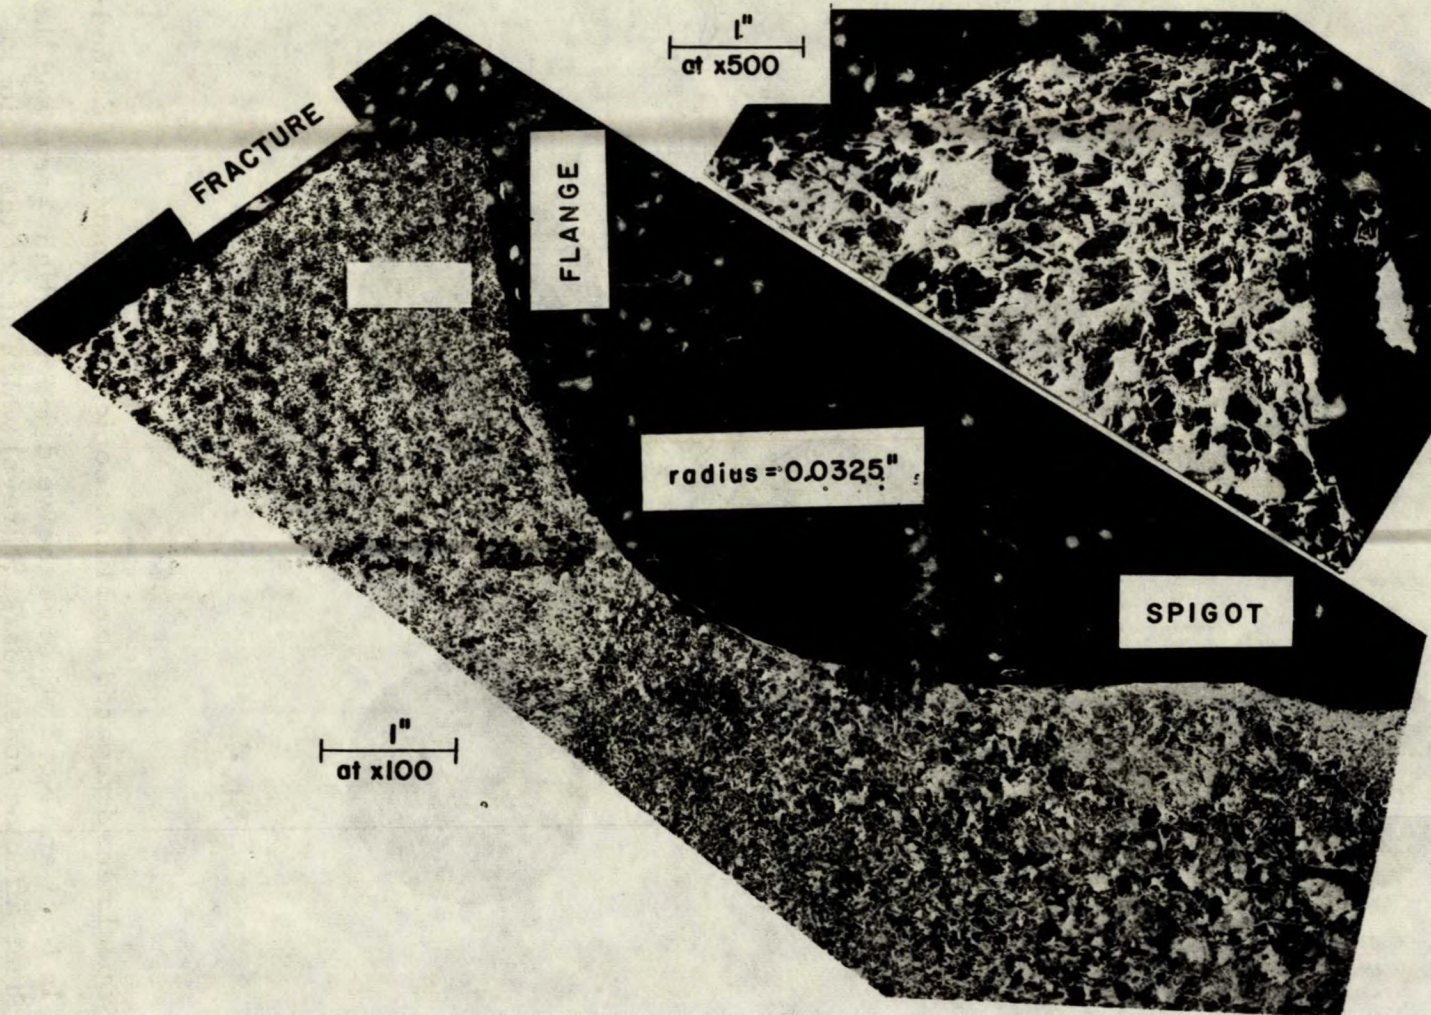
Figure 6. Reentrant Angle Region of Specimen No.1. Nital etch. X100 and X500 (inset).

Figures 6, 7 and 8 show that the failure started in microstructures produced as a result of heating incidental to the weld repair of the spigot. Also, the fillet in the reentrant angle is shown to have a nominal radius of only 1/32 inch. The failure initiated on the flange side of the fillet (Figures 6 and 7) and in the fillet on the flange side (Figure 8). Two incipient primary cracks are also shown in the centre of the fillet of Figure 7.

In Figure 6 the main fracture and in Figure 7 the two incipient fractures originated in parent metal (as opposed to weld metal) which had been heated effectively to just above the upper critical transformation temperature, which for 1032 steel is about 1485°F. The structure at this temperature was fine-grained austenite which on cooling transformed to acicular and to grain-boundary ferrite and to other transformation products such as bainites and fine pearlite. No martensite was observed in this fine-grained region. Untempered martensite was observed in the coarse-grained region immediately adjacent to the weld deposit.

The fracture initiated in a region which, during the repair, was effectively heated to above the A_{c3} temperature (just above 1485°F).

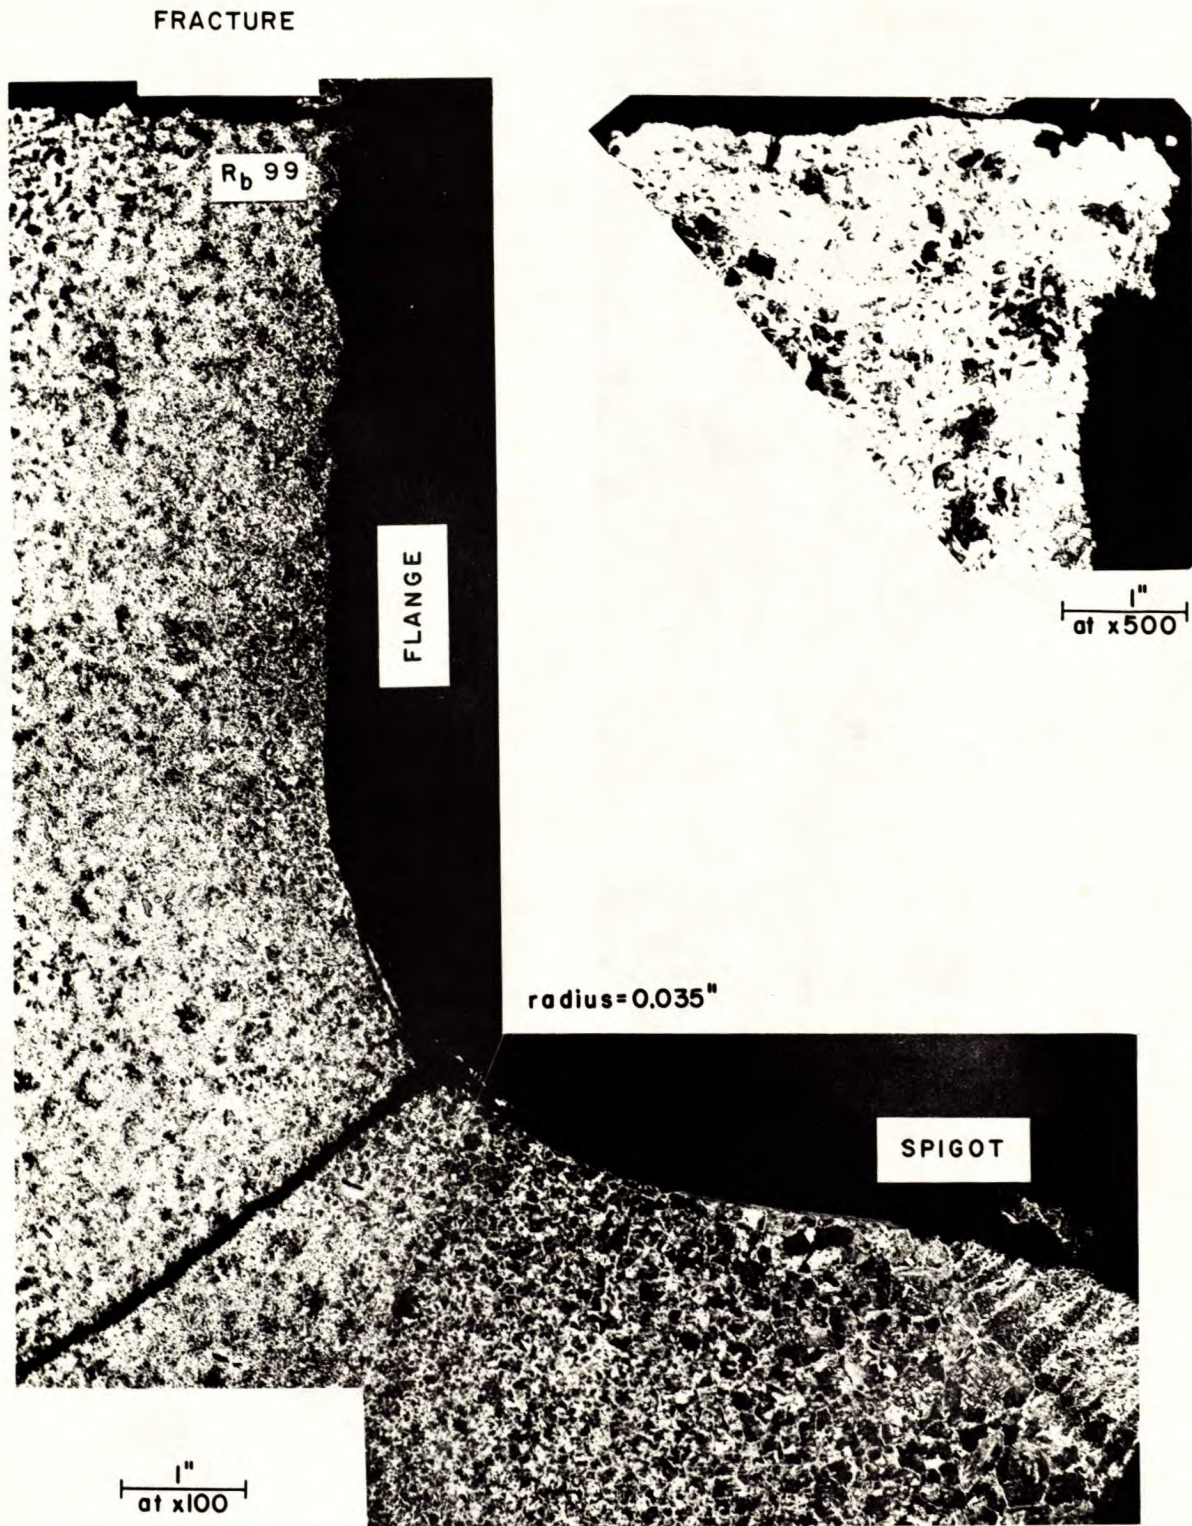
Figure 7. Reentrant Angle Region of Specimen No.2. Nital etch. X100 and X500 (inset)

In Figures 7 and 8 the primary fracture originated in parent metal which had been heated effectively to temperatures between the lower and upper critical transformation temperatures, which for 1032 steel is between about 1350 and 1485°F. In this temperature range the structure consists of ferrite and austenite; or, ferrite, spheroidized pearlite and austenite. The austenite within the critical transformation range has a higher than nominal carbon content. The fracture surfaces were too corroded, both generally and by pitting, to allow a determination of whether the path of the fracture had progressed primarily through or around the grains of ferrite and pearlite. It was observed that the path of each incipient crack, shown in Figure 7, was predominately intercrystalline. This is a characteristic of stress corrosion or corrosion fatigue. The width of the incipient cracks, at the fillet surface, is also suggestive of mild corrosion fatigue. However, Figure 9 shows that in its terminal region the primary crack is predominately transcrystalline. This is a characteristic of fatigue cracks.

The fracture developing to failure initiated in a region which was effectively heated close to but below the A_{c3} temperature (just below 1485°F) allowing partial transformation (high carbon regions) to austenite. The incipient cracks occur in a region similar to that in which the crack of Figure 6 occurred.

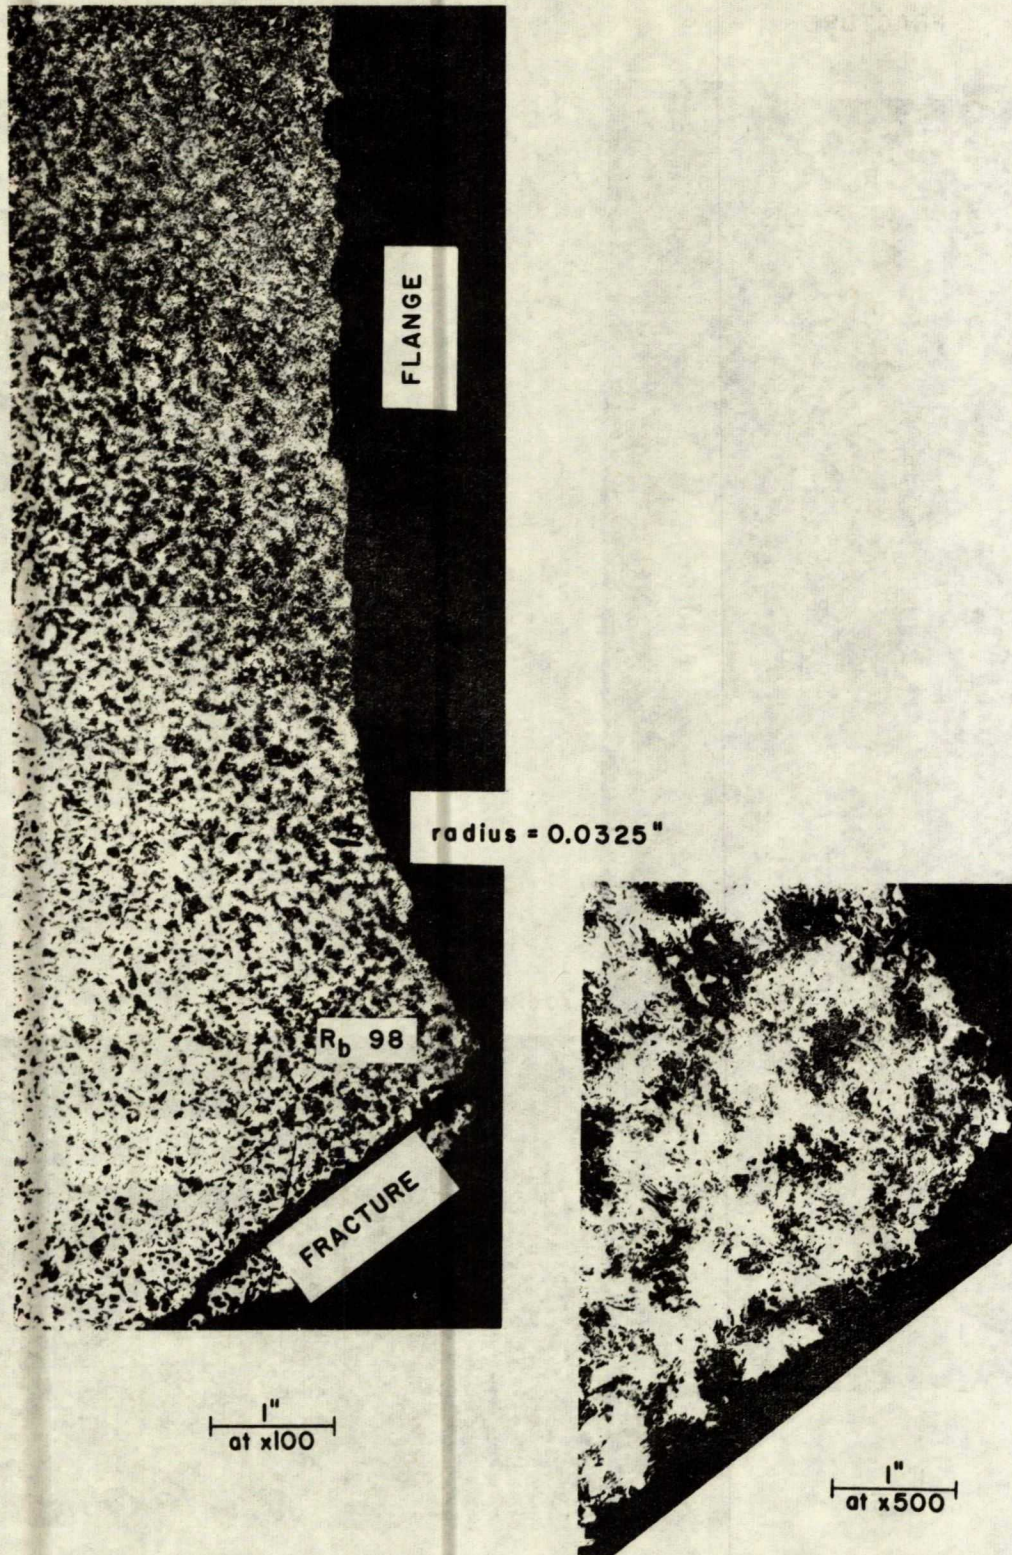
Figure 8. Flange Region near Crack of Specimen No. 3. Nital etch X100 and X500 (inset).

The fracture initiated in a region which, during repair, was effectively heated just over the A_{c1} temperature (just over 1350°F)

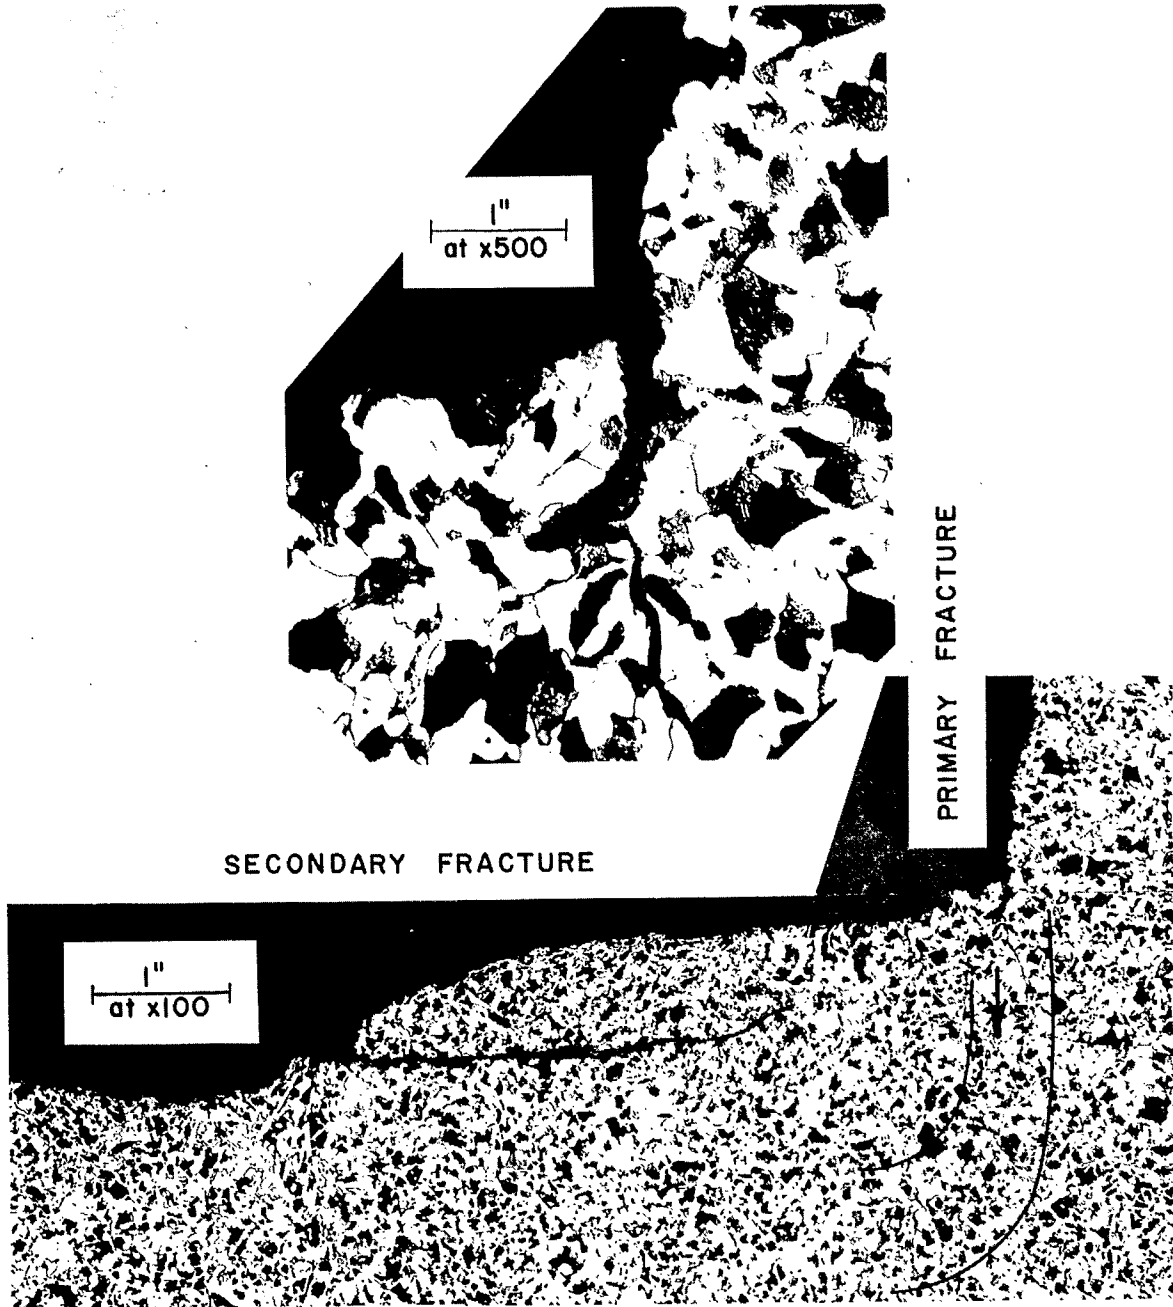
Figure 9. Terminal Region of Primary Fracture Showing "Junction" with Secondary Fracture. Nital etch. X100 and X500 (inset).

Figure 9 shows that the secondary crack in the crack observed on the exterior junction of the flange and the main body of the head does not extend past the primary fracture in the fracture observed in the reentrant angle. Indeed the terminal end of the primary crack veered 90 degrees suggesting that the secondary crack is merely an extension of the primary crack. Contrary to this observation the "lap" on the secondary fracture shown in Figure 9 appears to have been formed by a crack progressing toward the primary fracture. The main portion of the section through the secondary fracture, not shown in Figure 9, was plastically deformed to a depth of several grains measured in from the fracture surface; also, this portion of the secondary fracture surface was corroded and pitted. The extent of the plastic deformation and of the corrosion did not indicate conclusively which way the secondary crack had progressed.
