MINES BRANCH INVESTIGATION REPORT IR 65-25

**EXAMINATION OF A FAILED
UNDERGROUND FAN FROM DENISON
MINES LIMITED, ELLIOT LAKE, ONTARIO**

PHYSICAL METALLURGY DIVISION

MARCH 25, 1965

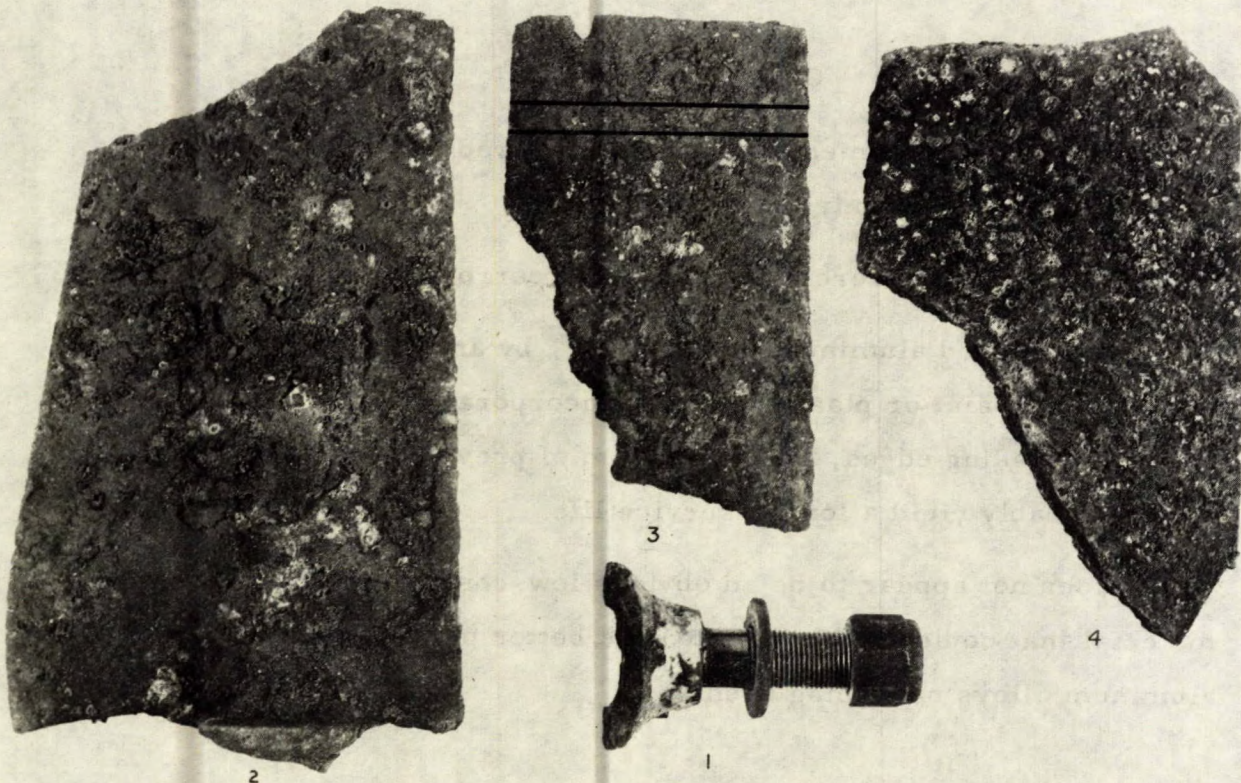
The pieces of the fan blades and the hub were photographed in the as-received condition (Figure 1). There appeared to be a total of six fracture faces (the notched end of sample 3 being the tip of a fan blade). The samples were apparently selected at random, as none of the fracture

faces could be fitted together. Three of the as-received pieces were covered with a dark, thick adherent deposit, which suggested that they might have been stored in some dirty, perhaps highly corrosive, location after failure. The hub (Sample 1, Figure 1) exhibited patches of an adherent, white chalky substance, but showed less of the dark adherent deposit noted on the other three pieces.

The overall corrosive action of the thick deposit, subsequent to the fractures, prevented as clear-cut a demonstration of a two-stage cracking process for the other fracture faces. However, it could be seen (Figure 1) that the fractures usually exhibited two intersecting planes, inclined at

different angles to the edge of the blade. Presumably, one of the planes represented a relatively slow corrosion-assisted cracking, and the other rapid cracking, which occurred when the amount of remaining metal became insufficient to support the operating load.

Figure 1 - Pieces of as-received fan blade and hub. The location from which a transverse section of the blade was taken is indicated by black lines on Sample No. 3.

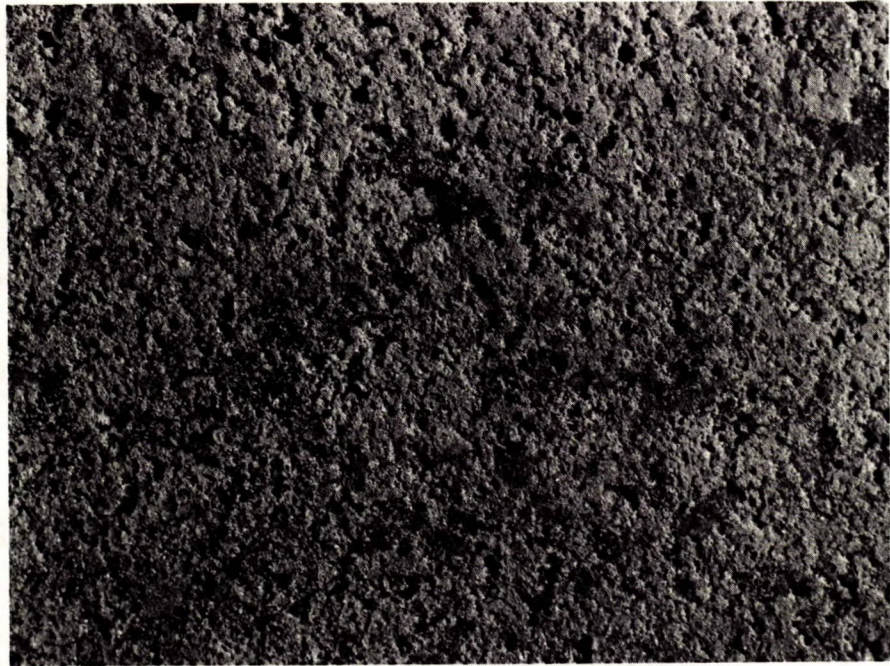
The convex surfaces of the pieces of blades were found to be generally rough, with numerous deep pits (Figure 2). The concave surfaces were found to be rough for the most part with numerous deep pits, but there were also some smooth areas (Figure 3). Most of the pits observed contained a black residue.

From the more severe corrosion of the convex surfaces of the pieces of fan blades, it was assumed that they had been so positioned that they had been subjected to impingement of abrasive particles carried in the exhausted air.

Figure 2 - Convex surface of fan blade after removal of adherent deposit.

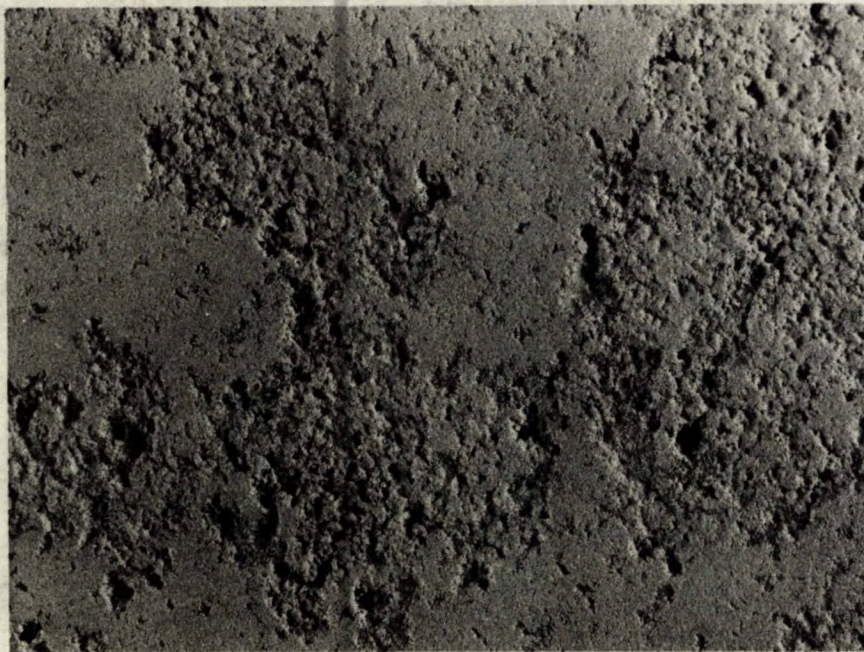
Figure 3 - Concave surface of fan blade after removal of adherent deposit.

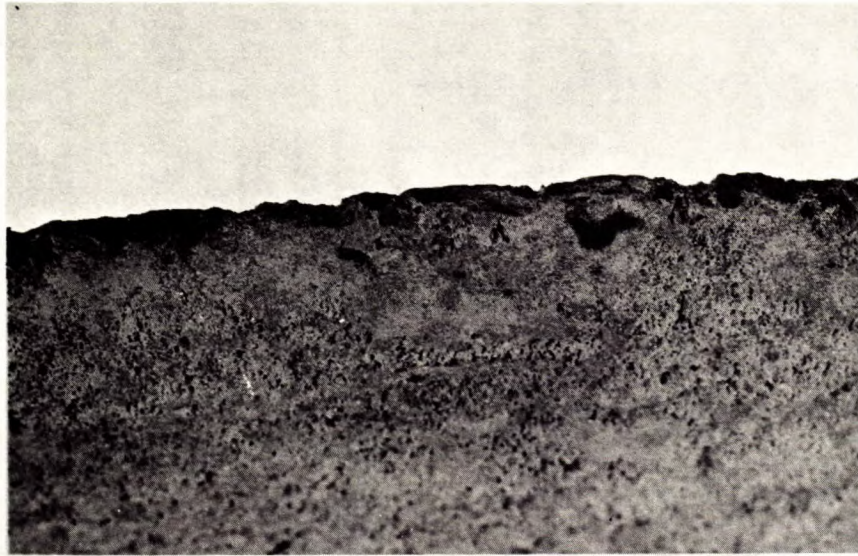
The thick, or leading edges, of the blades were severely roughened (Figure 4) while the thin, or trailing edges, were relatively smooth. This, again, was attributed to the impingement of abrasive particles upon the leading edges. Some cracks, such as the one illustrated in Figure 5, were observed at the leading edges of the blades.

Figure 4 - Leading edge of a typical fan blade showing deep indentations.

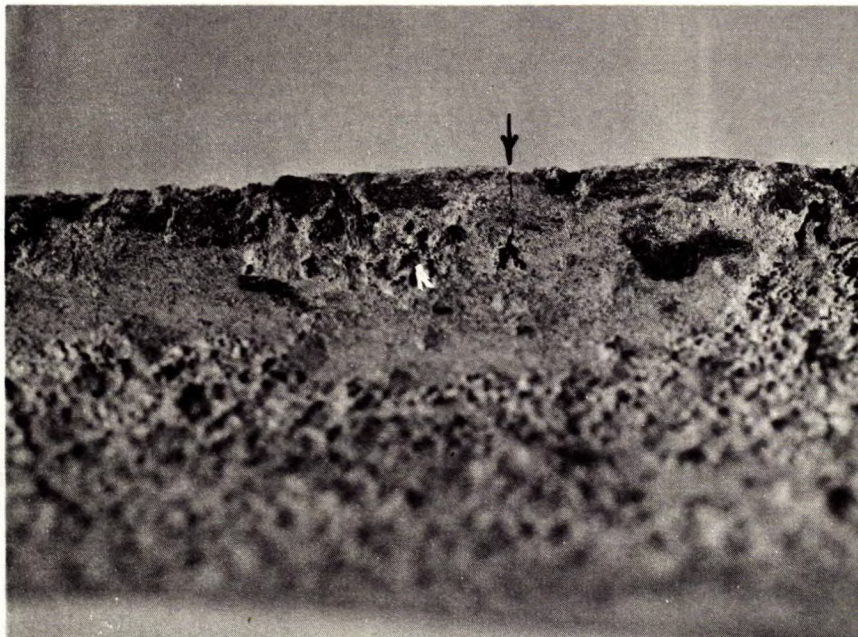
It was evident from the extreme surface roughening and pitting that the fans had been operating in an extremely corrosive environment. Failure appeared to have resulted from corrosion-fatigue, and some of the fractures showed evidence that the cracking had occurred in two stages. In the initial stage, cracking could be assumed to initiate at some particularly deep pit, in an area of high stress. A good example of this process is

illustrated in Figure 5. This initial cracking then propagated, accelerated by corrosion, until the uncracked metal remaining in the fan cross-section was insufficient to withstand operating stresses. The second stage, a rapid cracking, then occurred.

Figure 5 - Crack (arrow) on the leading edge of a fan blade.

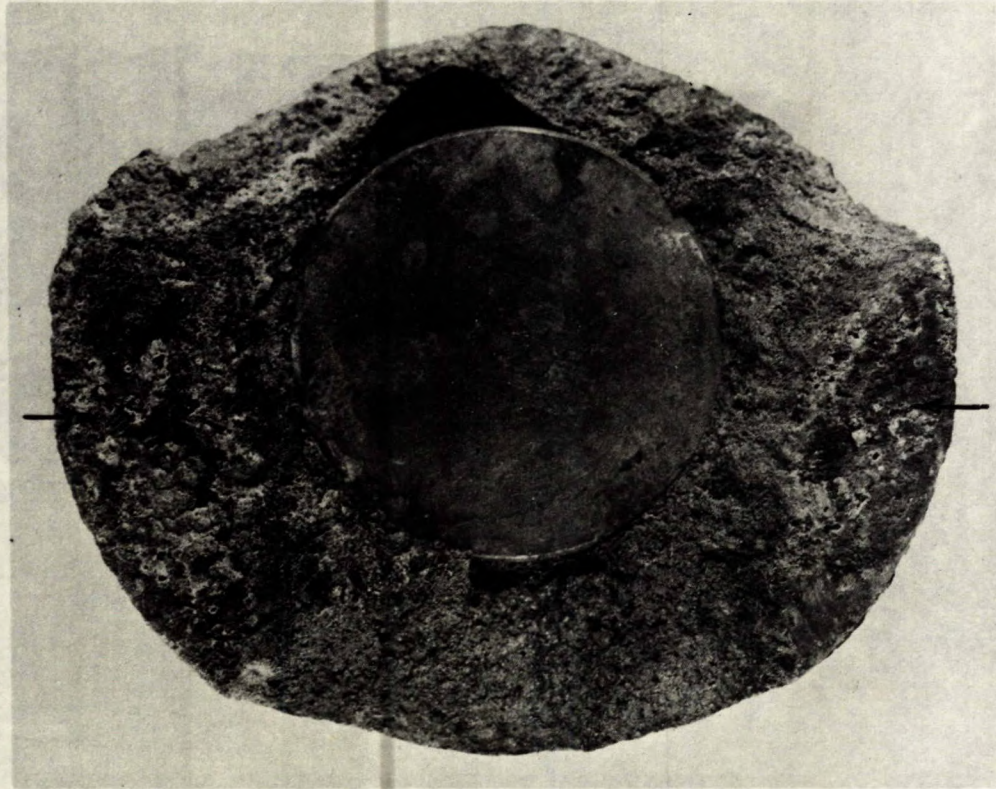
Examination of the fracture surface of Sample 1 (Figure 1) revealed that failure had occurred in two stages. From Figure 6 it may be seen that there were two relatively smooth semi-circular areas on the fracture surface. These smooth areas were covered with corrosion product. The remainder of the fracture was bright and quite rough, and seemed to represent an area of rapid fracture.

Figure 6 - Fracture surface of Sample No. 1 (Figure 1).
The corroded areas are indicated by arrows.

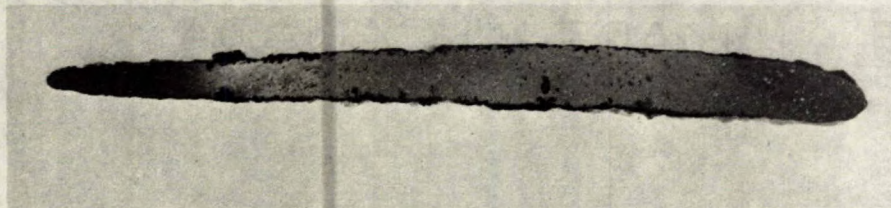
A transverse section of a fan blade was obtained from Sample 3 (Figure 1) and a macro-photograph was taken (Figure 7). This figure provides additional evidence that both surfaces of the blade were extensively pitted. It also demonstrates that the casting was very porous.

Though it appeared that the primary cause of the fan failure was the extremely corrosive operating conditions, the significant porosity of the casting, once the corrosion-fatigue cracking started, would be expected to shorten the service life of the fans.

Figure 7 - Transverse polished section of blade showing
pitting at surfaces and porosity. (Unetched)

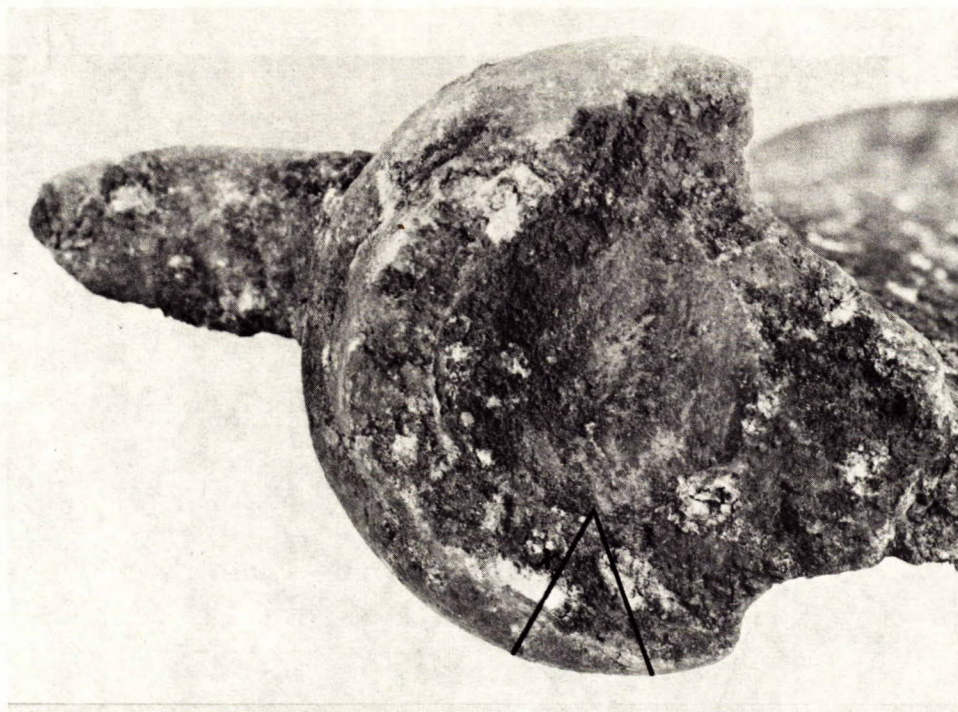
A micro-specimen was obtained from Sample 2 (Figure 1) transverse to the fracture, at the hub of the blade, as indicated in Figure 8. The structure of the unattacked alloy was seen to consist of aluminum dendrites surrounded by fine eutectic (Figure 9).

Figure 8 - Fracture surface at hub of Sample No. 2 (Figure 1). Area from which a micro-specimen was obtained is indicated by black lines. The surface examined is indicated by an (X).

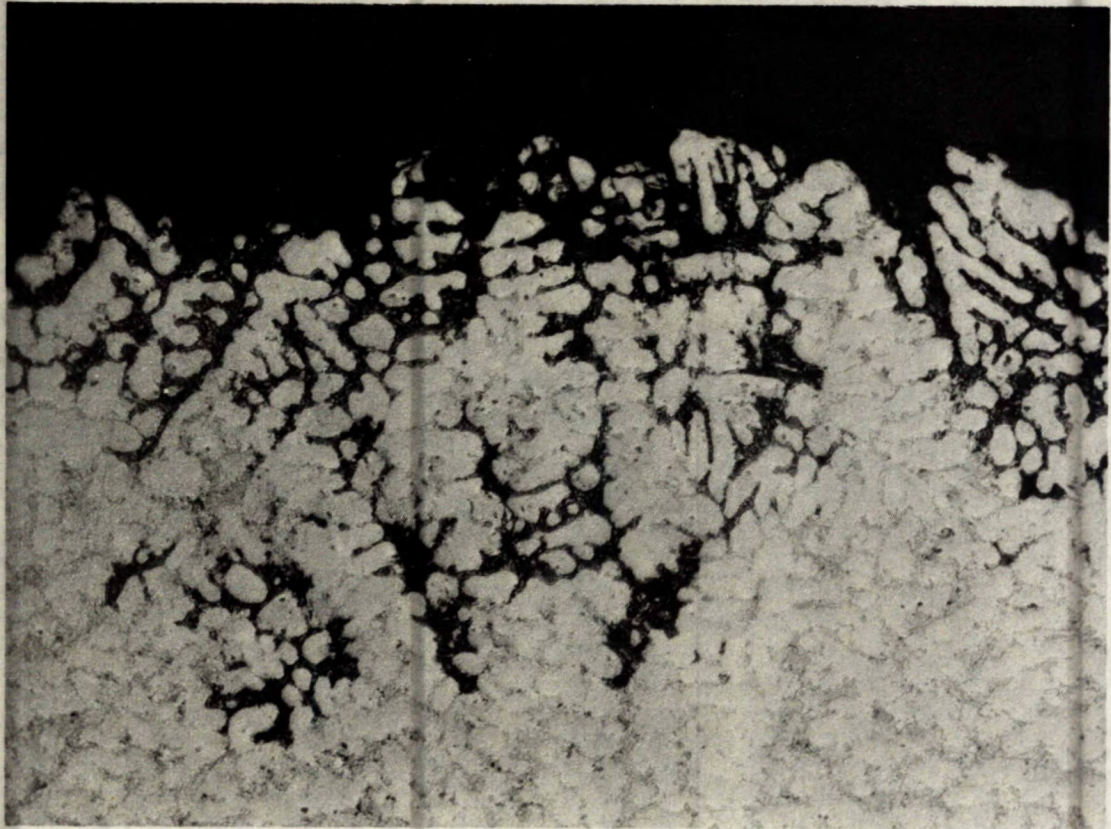
Figure 9 - Micro-photograph at failed surface of the fan blade (Sample 2) showing aluminum dendrites surrounded by fine eutectic. Preferential corrosion attack of the eutectic is also illustrated. (Unetched).

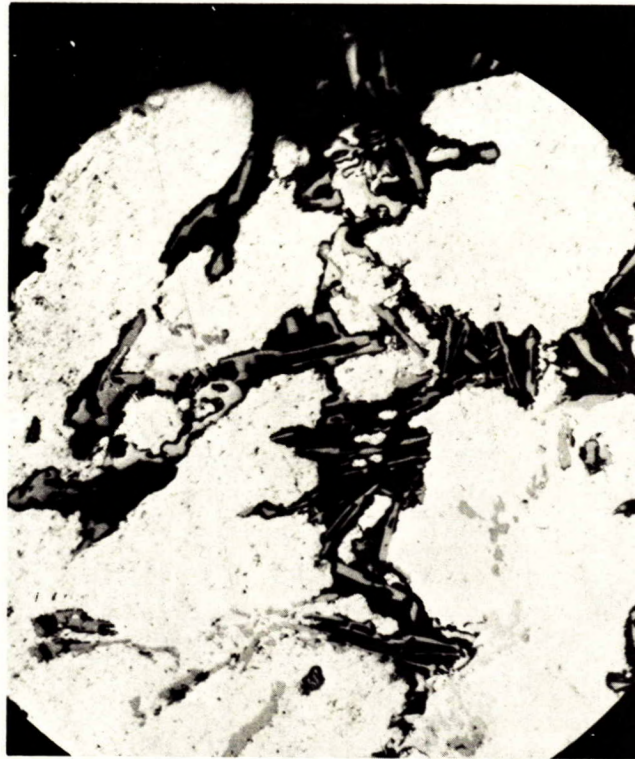
It was observed that the corrosion attack was concentrated on the aluminum phase of the eutectic (Figure 10).

Figure 10 - A portion of the area shown in Figure 9 at higher magnification, showing preferential corrosion attack on the aluminum phase of the eutectic. (Unetched)
