MINES BRANCH INVESTIGATION REPORT IR 65-26

**METALLURGICAL EXAMINATION OF
FAILED MANTLE HEAD NUT**

A portion of a failed mantle-retaining head nut from the crusher at Carol, Labrador, of the Iron Ore Company of Canada, was examined. The fracture had propagated principally in the brittle mode. The fracture origin was not detected on the sample. A considerable number of crack-like microshrinkage defects were present. Such defects can be expected to materially reduce resistance to crack propagation. Improper heat treatment had resulted in the presence of a considerable amount of lightly tempered martensite, which contributed to diminishing the notch toughness. As a first step to achieving a satisfactory nut it was suggested that metallurgically sound material with tensile properties equal to or somewhat higher than those determined for the sample be utilized. It was also suggested that investigation of any subsequent failures would require the full fracture as well as further information on the mechanical aspects of the application.

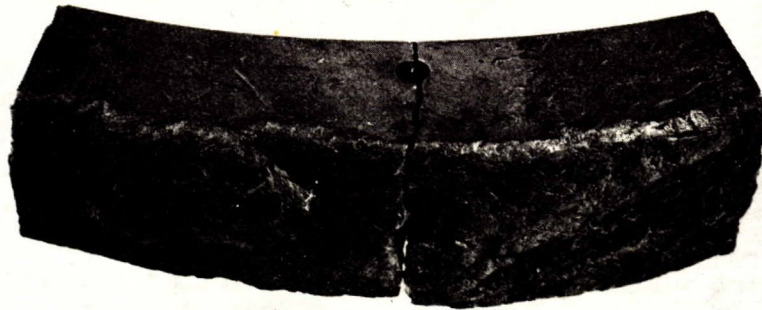
Figure 1(a) shows an over-all view of the sample submitted. The fracture is in the centre of the arc, the outside ends were flame cut. The nut threads are on the opposite side. The bottom surface was saw cut. The sample consisted of only half the height of the nut. The jogs in the line where the fracture plane intersects the top surface match perfectly. The general appearance of the fracture faces is shown in Figure 1(b). Although not visible in the illustration, there are many details in the fracture surfaces which also match perfectly. It is evident that these two sample pieces provide matching fracture faces, hence only half the fracture length is available for examination.

Figure 1. (a) General view of sample. Note matching of "steps" where the fracture intersects the top of the nut.

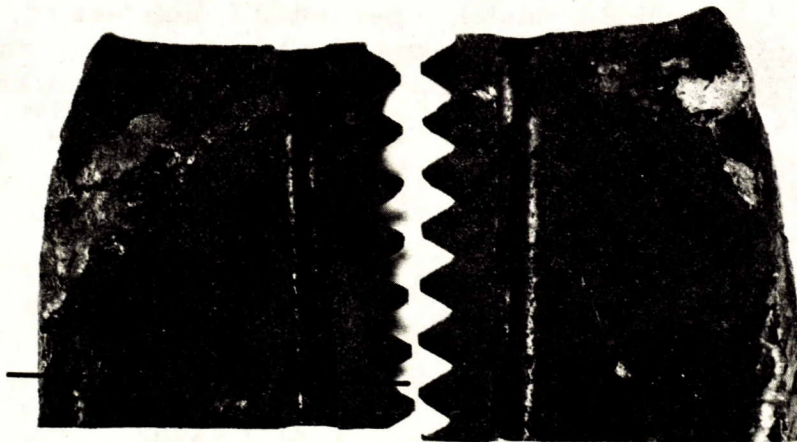
The samples show no gross deformation in fracturing but do show considerable deformation in service prior to fracture, notably that shown in Figure 1(b) where the side of the nut has flowed to a higher level than the top. The maximum wall thickness of the sample is only 2-1/2 inches, representing a decrease of almost 30% from the nominal value. It is not known whether this decrease represents wear or whether the nut failed to conform to the blueprint originally.

(b) Illustrating matching fracture faces. Ruled line in left hand piece indicates location of section for metallographic examination.

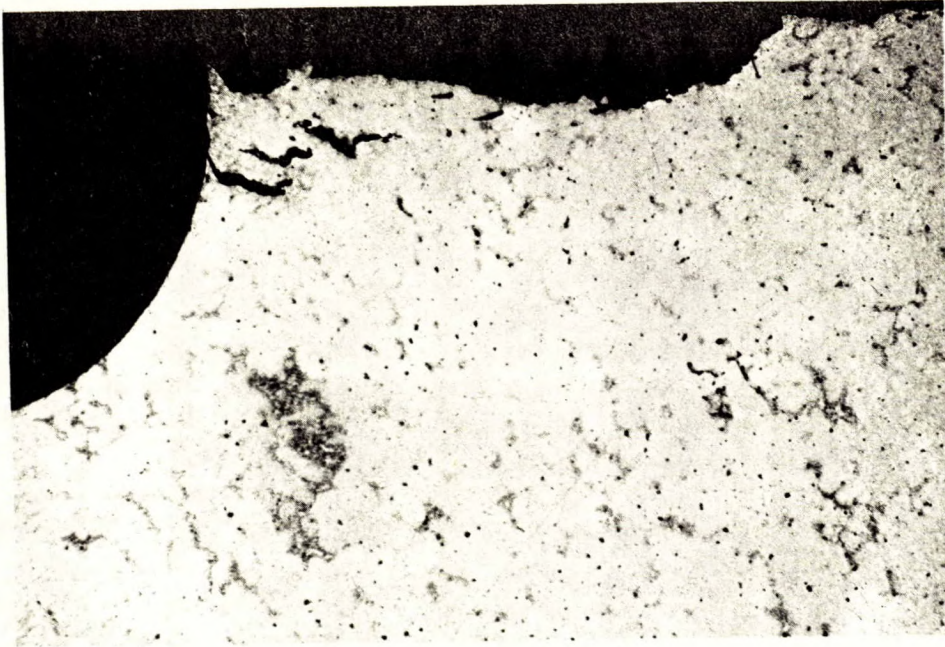
A section parallel to the top of the nut, intersecting the plane of fracture, as shown in Figure 1(b), was examined. The fracture mode was mixed, being principally intergranular and transgranular cleavage with minor amounts of shear. There was a considerable amount of microshrinkage, Figure 2. The microstructure was not uniform, there being a great many areas of mixed transformation products in a ferrite-pearlite matrix, Figures 2 and 3. These areas were very often, although not always, associated with microshrinkage, Figure 3. The mixed transformation products consisted principally of lightly tempered martensite with a small amount of bainite and some proeutectoid ferrite, Figures 4 and 5. The pearlite is principally lamellar with some divorced carbide, Figure 4. The configuration of the areas of mixed transformation products as well as their frequent association with microshrinkage, suggests compositional segregation, most probably of nickel, which has persisted from freezing. The modified picral etch specific to temper brittleness did not reveal this condition. This result could be anticipated as the plain nickel steel is not very susceptible to temper embrittlement.

Figure 2. Section through fracture (at top). Note segregation and microshrinkage.

The poor results of the Charpy impact tests after laboratory tempering are probably due in large part to the presence of the crack-like microshrinkage defects. There is little doubt that such defects lower resistance to crack propagation. Such defects are very difficult to eliminate in normal commercial casting practice, short of using vacuum degassed metal, and it would appear that use of forged steel is indicated as a means of improving metallurgical soundness. Although such material would probably be more expensive initially it is quite probable that increased service life would compensate.

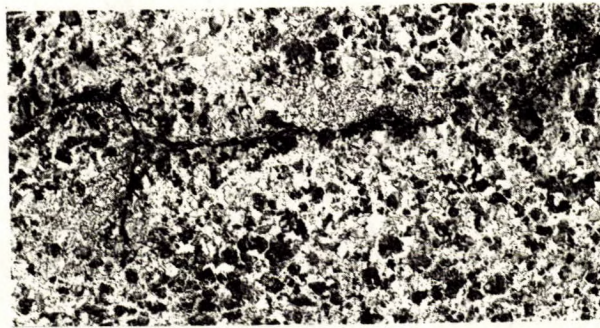
Figure 3. Illustrating general microstructure and microshrinkage.

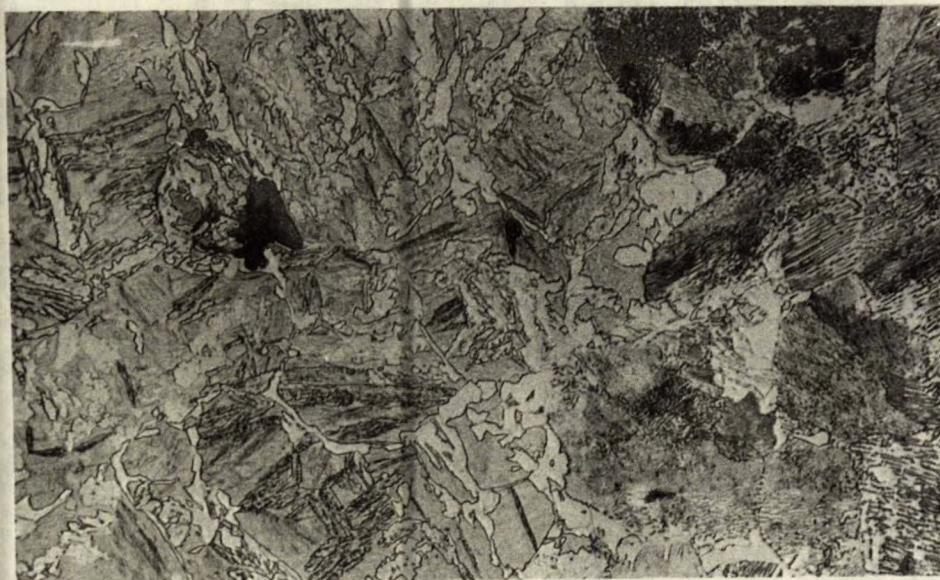
Figure 4. Illustrating the microstructure in the segregated area to consist of lightly tempered martensite with a small amount of bainite and some pro-eutectoid ferrite. Also showing the matrix pearlite to be predominantly lamellar with some divorced carbide.

From a comparison of the results of the Charpy tests on material before and after tempering in the laboratory, it is clear the presence of lightly tempered martensite contributed significantly to the susceptibility to brittle fracture. The presence of this brittle constituent is due to improper heat treatment. More than one sequence of heat treating could result in mixed microstructure and the actual heat treatment is unknown. It is, however, probable that the final tempering temperature was too high, leading to re-austenitization in the segregated areas with subsequent transformation to bainite and auto-tempered martensite on air cooling. Ideally, the as-cast alloy should receive a high-temperature homogenization treatment to reduce segregation. This alloy should be austenitized at 1450°F to 1550°F for normalizing or quenching. The tempering temperature should not exceed 1225°F maximum, and probably not 1200°F in commercial practice.

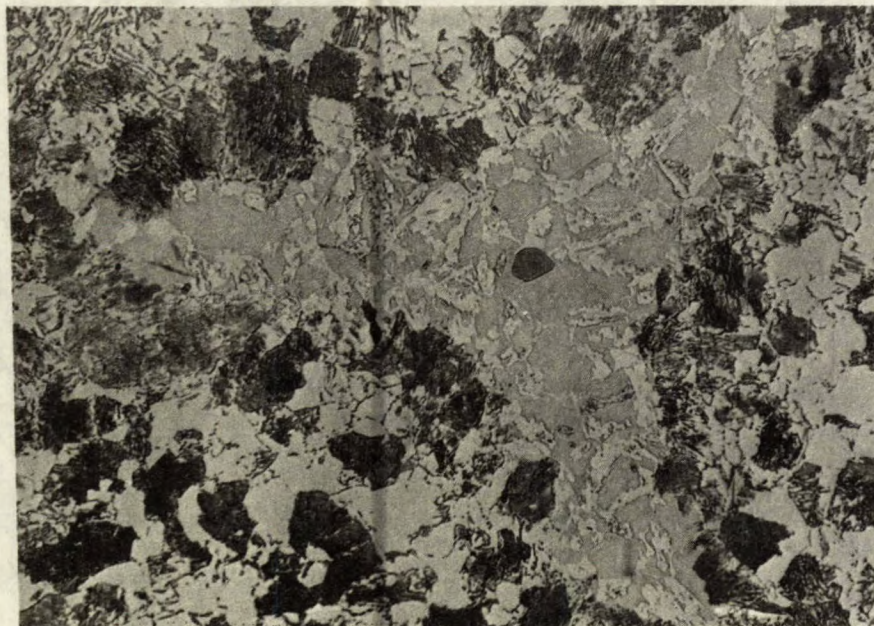
Figure 5. Illustrating segregation at a triple point, probably between dendrites of the original as-cast microstructure.
