MINES BRANCH INVESTIGATION REPORT IR 65-29

**EXAMINATION OF NOVA SCOTIA PULP
LIMITED RECOVERY BOILER TUBE SAMPLE**

D. E. PARSONS & D. A. MUNRO

MAY 12, 1965

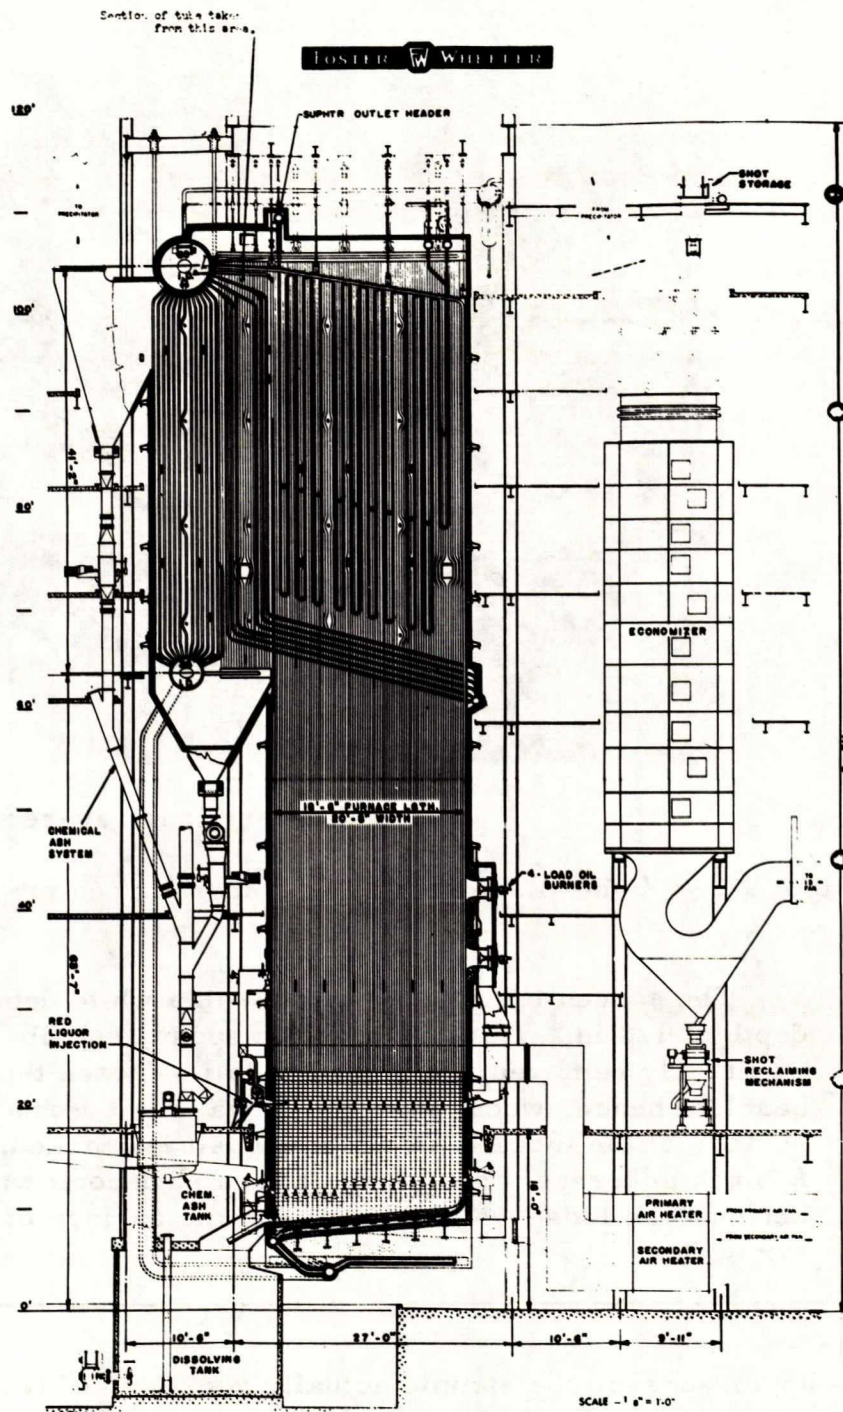
"I am enclosing a sketch of our unit on which we have marked in red pencil the areas of pronounced thinning.

Figure 1 - Chemical recovery boiler - design pressure 1040 psig. Final temperature 860°F - The location of the upper screen tube sample is shown. The U-bend sample was not identified as to exact location.

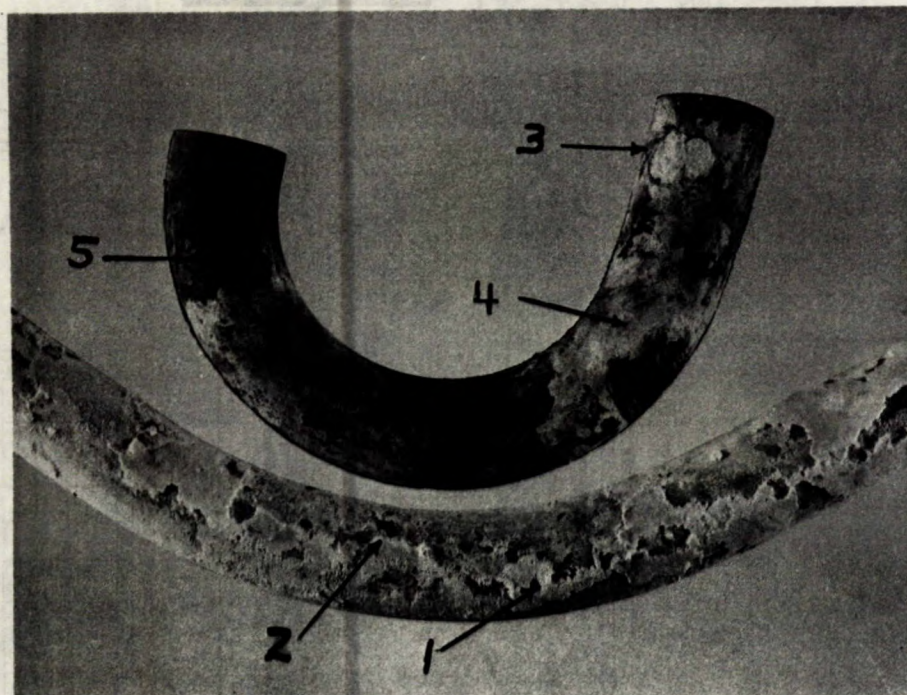
Figure 2 - U-bend sample, (top); Upper screen tube sample (bottom)

The screen tube* was coated with a white deposit having a depth of 1/8 in. This thick white deposit (soluble in hot water) was easily removed and tended to fall off when the sample was handled; hence, when received, it was not continuous on the surface of the tube. The white deposit is marked, arrow 1. A black adherent, non-magnetic (scale) deposit was observed between the loose white deposit and the surface of the metal, arrow 2.

The U-bend sample, when received, contained only one patch of thick white deposit, arrow 3, - the remainder of the U-bend surface was coated with areas of thin magnetic scale containing sufficient sulphate compound to vary in colour from black to white, arrow 4. This scale was not continuous and showed evidence of flaking and spalling, arrow 5.

Thinning of the tubes is apparent in samples taken at the outside bend surface. Thinning was due partly to the bending operation and partly to wastage of metal by formation of iron-rich scale between the white deposit and the metal surface.

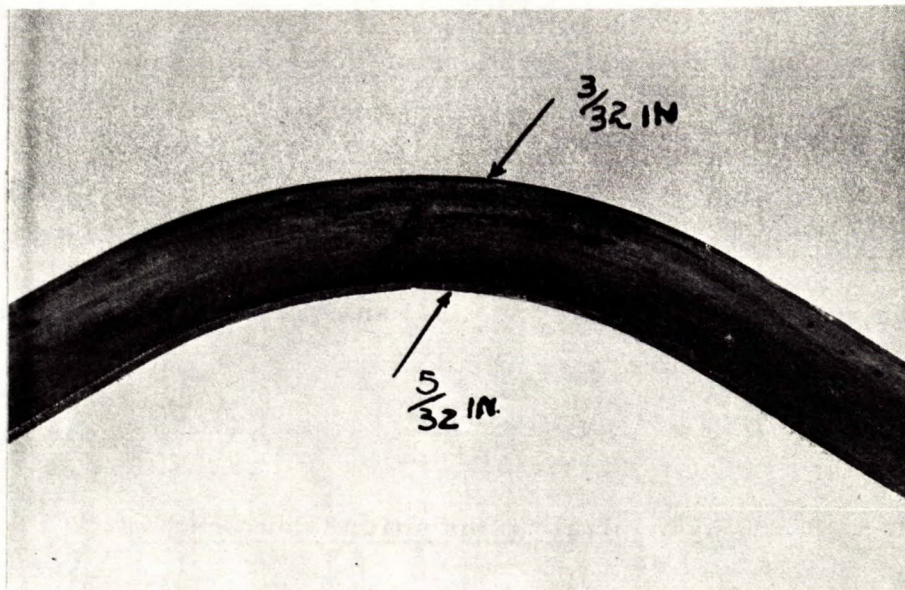
Figure 3 - Screen tube sample viewed from the inside surface.

The tube wall thickness is shown in inches at the inner and outer surfaces. The inside tube surface is comparatively free from pitting, is smooth and is coated with black, water-side deposit.

Measurement of the wall thickness (screen tube) showed that this dimension was about 1/8 in. (0.125 in.) on the inside of the bend radius and was about 3/32 in. (0.094 in.) on the outside of the bend. Some of the thinning observed at the outside radius of the bend was due to the hot bending operation, although thinning had apparently been increased by loss of metal due to slag action and oxidation. This relatively uniform thinning was observed at the bend and extending for about 1 ft in each tangent direction at the outside tube radius. The most serious and unpredictable type of thinning was observed in an area 13 in. from the bend where localized thinning of the tube wall (outer tangent surface) had reduced the wall thickness to 5/64 in. (0.078 in.). This serious localized attack appeared to be directly related to process operation, i.e., to slag action, acid attack, oxidation and erosion of the steel surface (4) and was not due to the tube bending operation. Attack or catalysis by vanadium pentoxide may have occurred but at the time of analysis the quantity of vanadium was 0.10% in a ground bulk sample including both the white and black, surface deposits.

Definite localized thinning was observed in an area (diameter 1-1/2 in.) about 13 in. from the bend in the screen tube where the wall thickness had been reduced from 0.125 in., nominal to 0.078 in. This thinning appeared to be due to progressive oxidation and slagging caused by reaction of sodium sulphate with iron oxide in an SO_2 atmosphere containing a low concentration of sulphur trioxide and with alkali metal deposits on the tubes catalyzing the reaction of SO_2 to form the corresponding sulphate⁽⁴⁾. The presence of any chloride ion would also have accelerated wastage of tubes.

More uniform thinning of the screen tube was also observed for a distance of about 1 ft on either side of the bend. This thinning was believed partly due to the original hot bending operation during fabrication of the boiler but was mainly attributed to FeSO_4 slagging. Thinning at the bends caused a total reduction (slagging and hot bending) from 0.125 in., nominal thickness, to 0.094 in. (The observed pitting, previously mentioned, resulted in wall thickness of 0.078 in., even in regions remote from the bend).

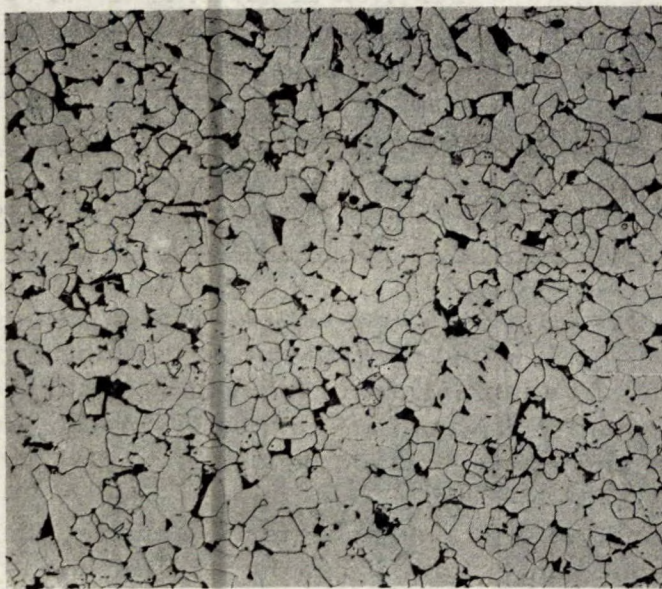
Figure 4. Transverse section through screen tube.

The microstructure consists of ferrite and lamellar pearlite. The grains are equiaxed and have a ferrite grain size of ASTM No. 6.

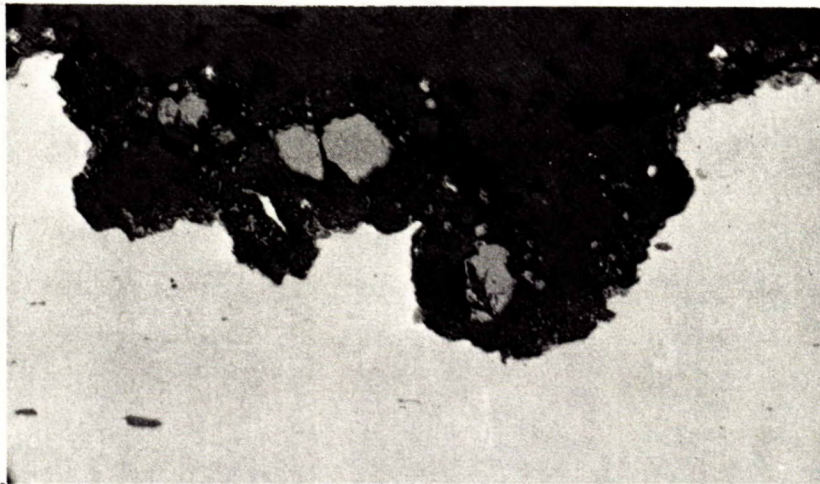
Figure 5 - Screen tube transverse section - inside water side of tube.

Minor pitting has occurred but the scale appears to have accumulated and to have remained in position. The original ferrite rim, visible at this surface, confirms that metal has not been lost from this surface.

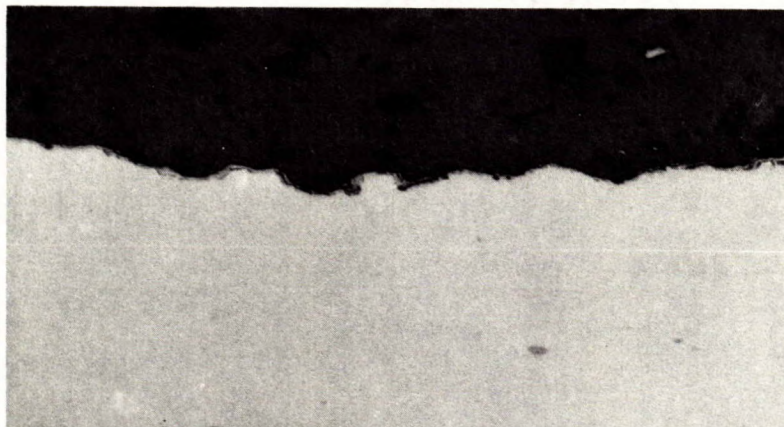
Figure 6 - Screen tube transverse section - outside (fire) side of tube.

The scale appears to have been removed continuously and progressively, leaving only the layer of subscale as illustrated.

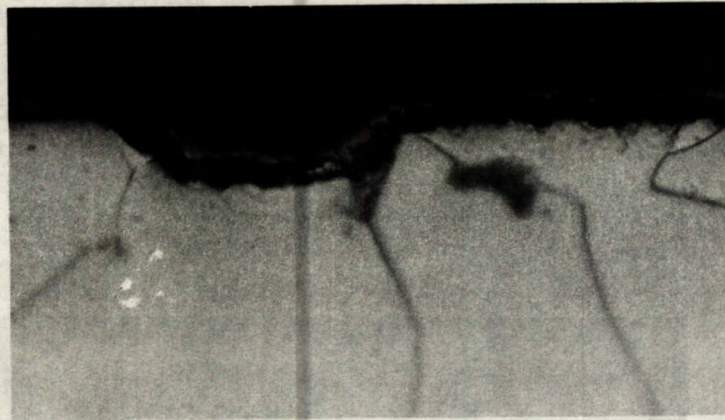
Figure 7 - Part of the same area as Figure 6 - outside (fire) side of screen tube.

Illustrates the residual scale and method by which wall thickness is reduced due to progressive oxidation and loss of scale (oxidation, slagging and erosion).

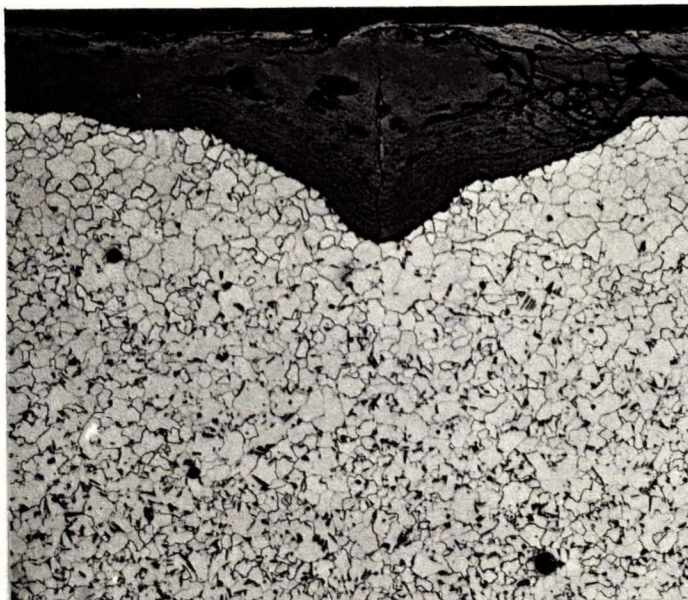
Figure 8 - Superheater U-sample. Transverse section of fire surface.

Progressive oxidation at the surface of the tube, accelerated by the formation of iron-sulphur compounds, is illustrated. The scale-metal interface is illustrated at higher magnification in Figure 9.

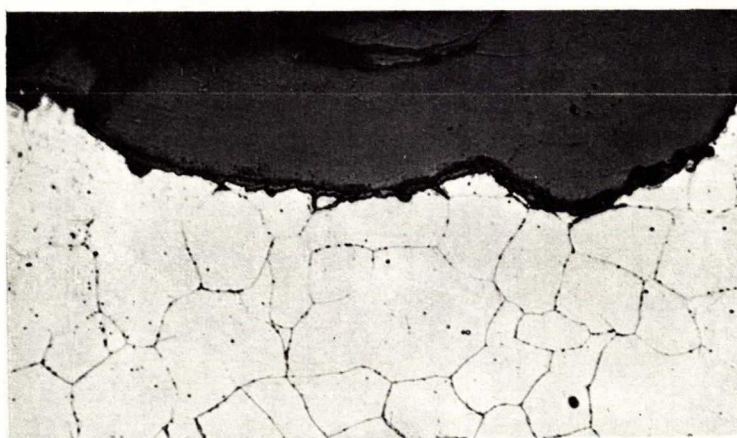
Figure 9 - Same area as Figure 8 at higher magnification.

The metal-scale interface is illustrated. Intergranular attack is also visible.

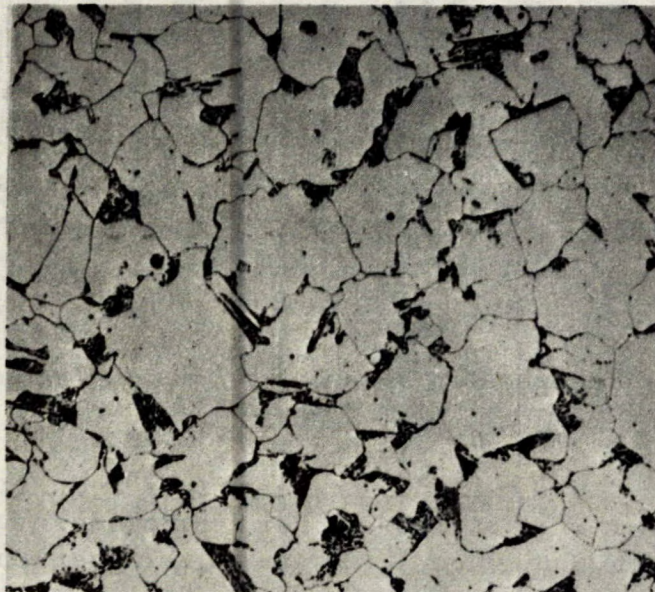
Figure 10 - Superheater U-sample. Transverse section.

The microstructure consists of fine-grained ferrite and slightly divorced pearlite, typical of hot formed seamless 1% Cr 1/2% Mo.
