MINES BRANCH INVESTIGATION REPORT IR 65-35

**EXAMINATION OF FAILED ALUMINUM
ALLOY AIRCRAFT COMPONENT**

W. A. POLLARD

APRIL 12, 1965

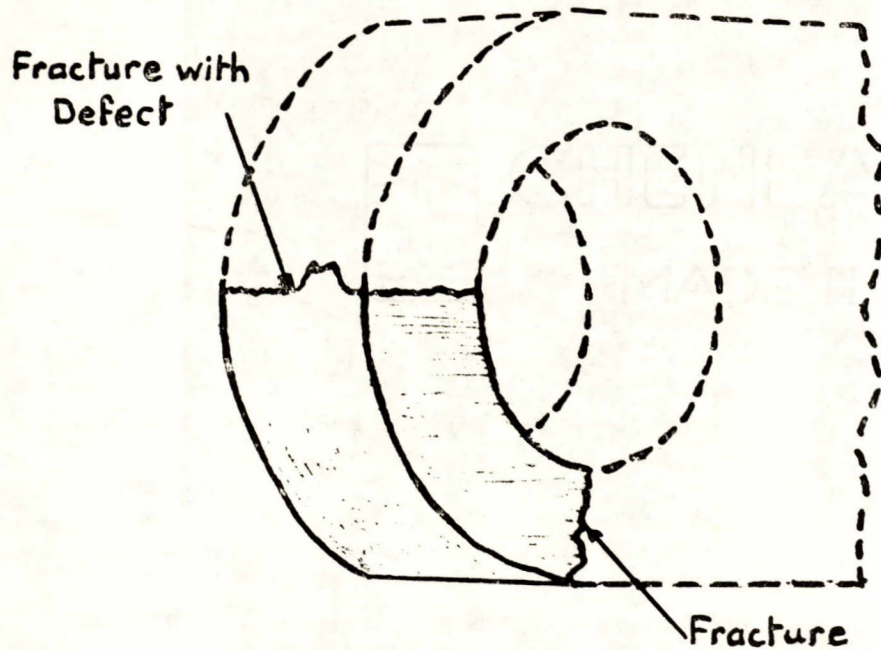
The aircraft concerned had crashed on landing and had been repaired by the replacement of broken parts. On its first flight after repair the aircraft again "cracked up" on landing. The samples supplied were parts of the "Cabin bottom" assembly to which undercarriage struts were attached. The components were made from aluminum alloy bar approximately 2 in. x 7/8 in. and the struts were attached to the ends of the bars by bolts or pins approximately 1-in. diameter. Failure had apparently occurred by one strut attachment being forced through the end of the bar causing two fractures, one at the extreme end and on the centre line of the bar, the other at the top (or bottom) of the hole roughly at right angles to the first fracture (see Figure 1).

Figure 1. Sketch showing position of fractured sample in end of component. The fracture shown at the bottom may have been at the top.

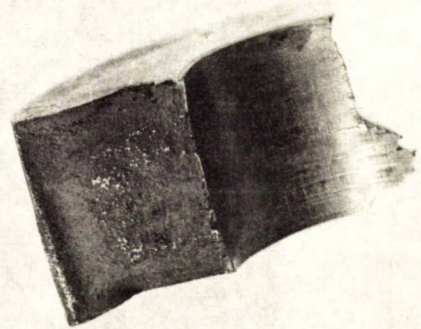
Figure 3.

Figures 2 and 3 are views of the fracture surfaces on the sample from the broken bar. From the direction of the extrusion marks on the unmachined surface of the piece it can be deduced that the fracture shown in Figure 2 occurred through the end of bar and the fracture shown in Figure 3 occurred at the top or bottom of the bar (see Figure 1).

Figure 2 shows the unusual nature of the "end" fracture. As shown in greater detail in Figures 4 and 5, part of the fracture was "fibrous" with marked alignment parallel to the axis of the bar and (in the original) had brown discolouration. The boundaries between the fibrous zone of the fracture and the remainder, which had a more normal appearance, were clearly marked and contained hairline cracks, one of which may be seen in Figure 4. The appearance of the other fracture surface was typical of a more ductile break through sound metal and is thought to have occurred by bending after the failure through the end of the bar.

Figure 2 and 3. Views of sample showing (Figure 2) end fracture with "fibrous" zone and (Figure 3) top (or bottom) fracture, probably caused by bending.

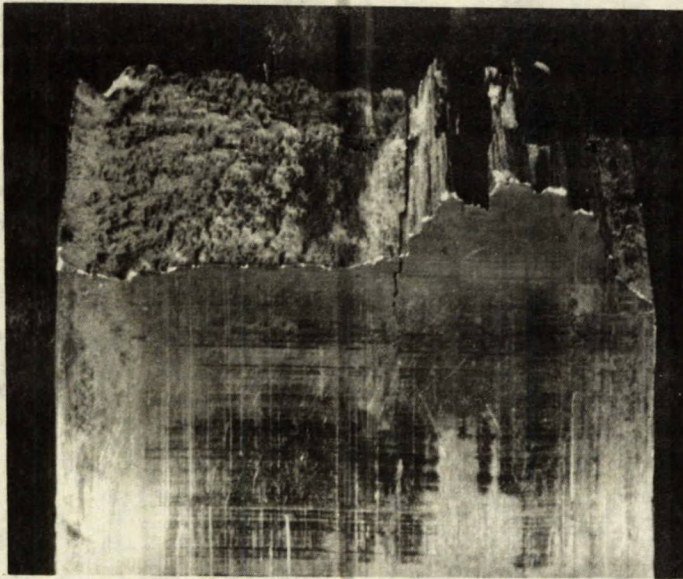
Figure 4. View of "end" fracture showing crack at boundary between "fibrous" and "normal" zones.

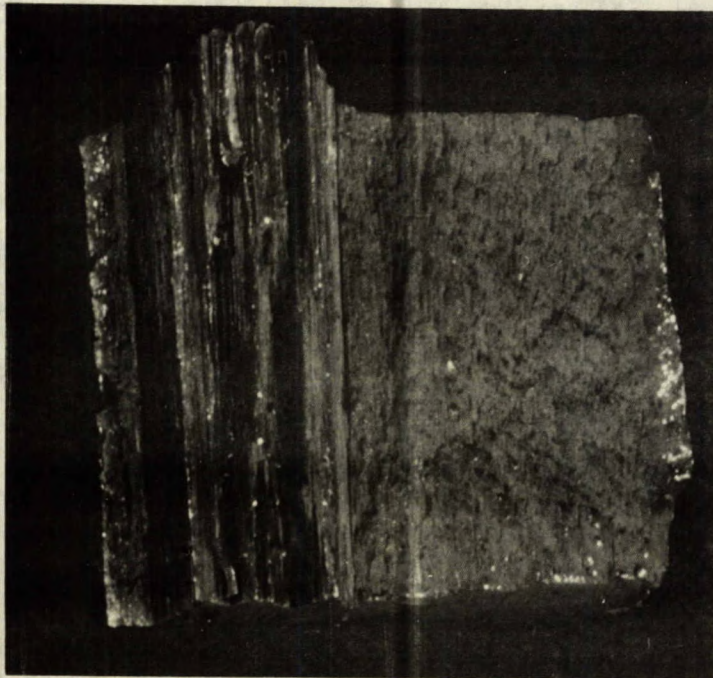
Figure 5. View of end fracture showing two zones.

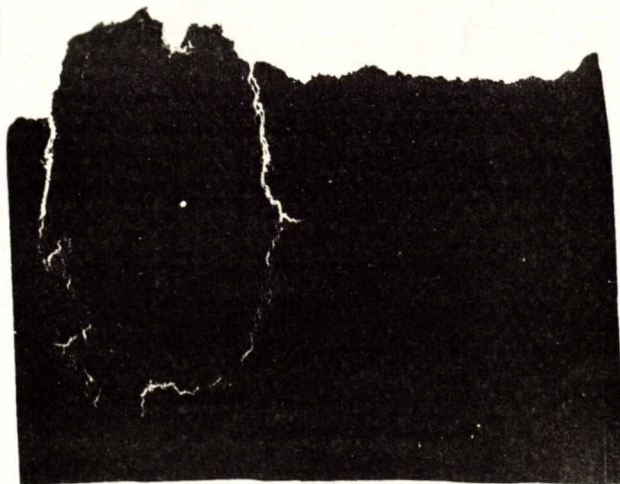
A cross section through the fracture containing the fibrous zone was polished for metallographic examination and Figure 6 shows part of this section under oblique lighting. The fibrous region is shown on the left side, the direction of the defect being perpendicular to the plane of the photograph. The cracks, which were visible at the boundary between the zones in the fracture surface (see Figure 4), appear in Figure 6 as white lines and it will be seen that a more or less continuous system of cracks and pores form a closed, roughly elliptical region in the section. A longitudinal section (see Figure 7), showed that this closed region extended roughly parallel to the axis of the bar. Examination at higher magnifications showed that the region of unsoundness consisted of pores and strings of unidentified, non-metallic foreign material (see Figures 8 and 9).

Figure 6. Transverse section through "end" fracture showing tubular nature of defect. The white lines indicate cracks and voids. (Oblique illumination, unetched).

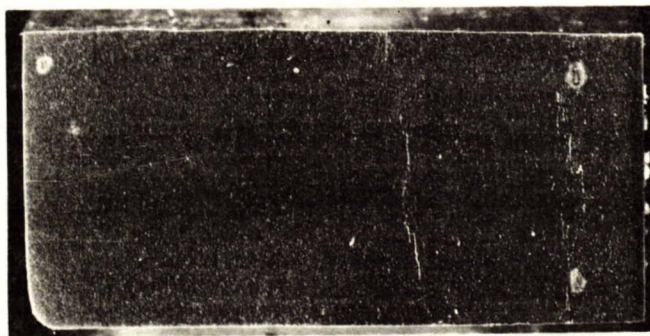
Figure 7. Longitudinal section through defect showing elongation roughly parallel to bar axis.

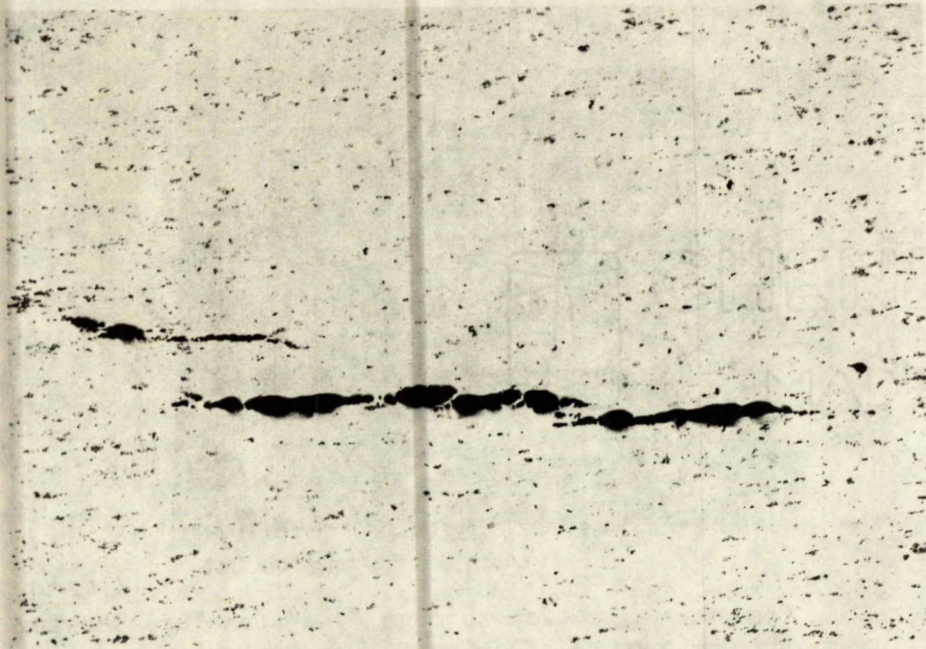
Figure 8. Longitudinal section through defect showing stringers of voids and inclusions.

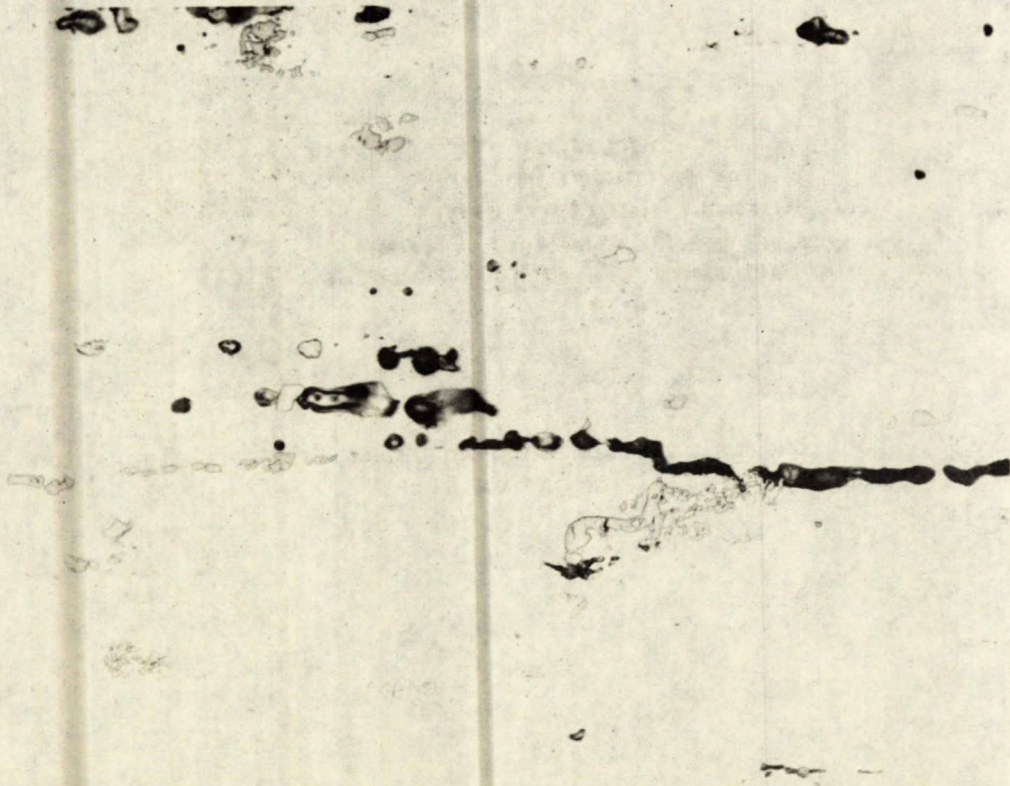
Figure 9. As Figure 8 at higher magnification, showing stringers of voids and inclusions in defect.
