MINES BRANCH INVESTIGATION REPORT IR 65-41

**EXAMINATION OF FRACTURED
REINFORCING RODS FROM MATSQUI
INSTITUTION DRUG CENTRE,
BRITISH COLUMBIA**

W. M. CRAWFORD

MAY 4, 1965

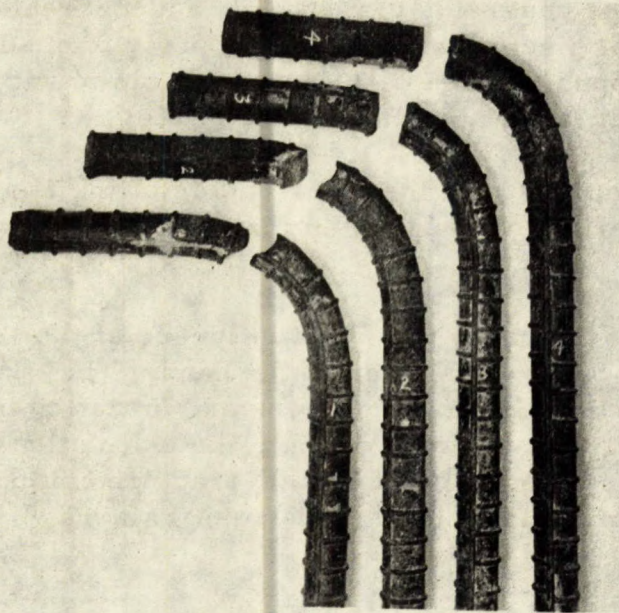
- (a) The general location of fracture was the same in each case and occurred at the start of the bend, on the side which was not embedded in the concrete (see Figure 1).
- (b) Each fracture was of the same completely brittle appearance (see Figure 2) and the markings showed that it originated on the underside of the bend, at the root of one of the transverse deformations. It was noted that at this point of origin, the deformation had been flattened, presumably during the bending operation.

Figure 1. Photograph (approximately 1/6 actual size) of No. 11 reinforcing rod as-received. Note location of each fracture at the bend.

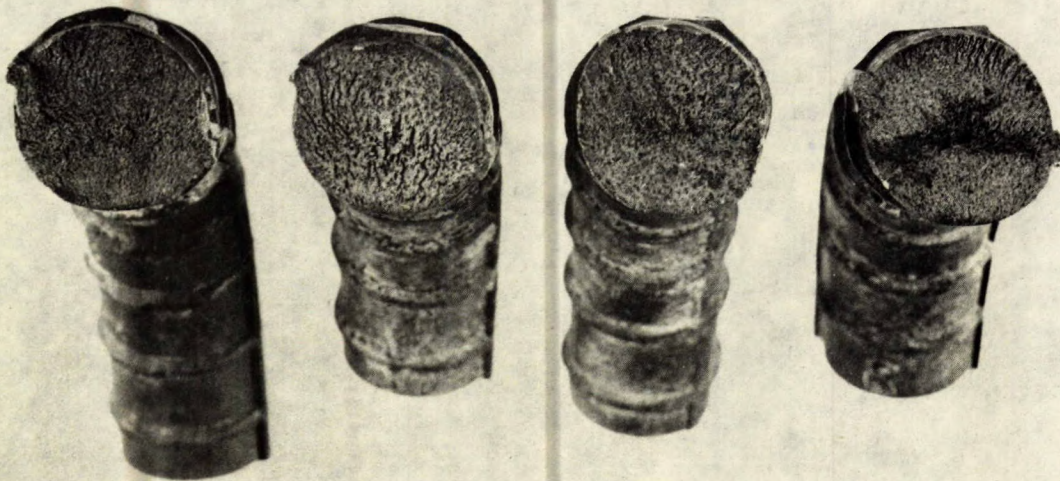
Figure 2. Photograph showing fractured surface of each rod. (approximately full size).

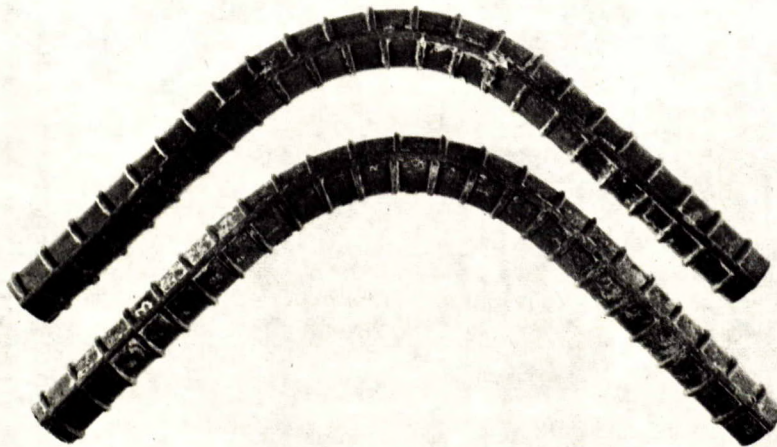
The specification bend test for deformed bars, intermediate grade, required that they be bent at 90 degrees around a pin of 8-1/2 in. diameter, without cracking. This was performed successfully with no sign of cracks on the outside portion of each bar. A photograph of the test bars is shown in Figure 3.

bend and it is felt that such improper bending was the cause of failure of the four rods. The fact that the origin of each fracture was observed at the same location, on the underside of the bend, supports this assessment. Also, the two bend test pieces, which were properly formed according to that prescribed in CSA Specification G-30.1, were able to withstand repeated impact blows without failure, while held in a vice.

Figure 3. Photograph (approximately 1/5 actual size), showing results of bend tests.

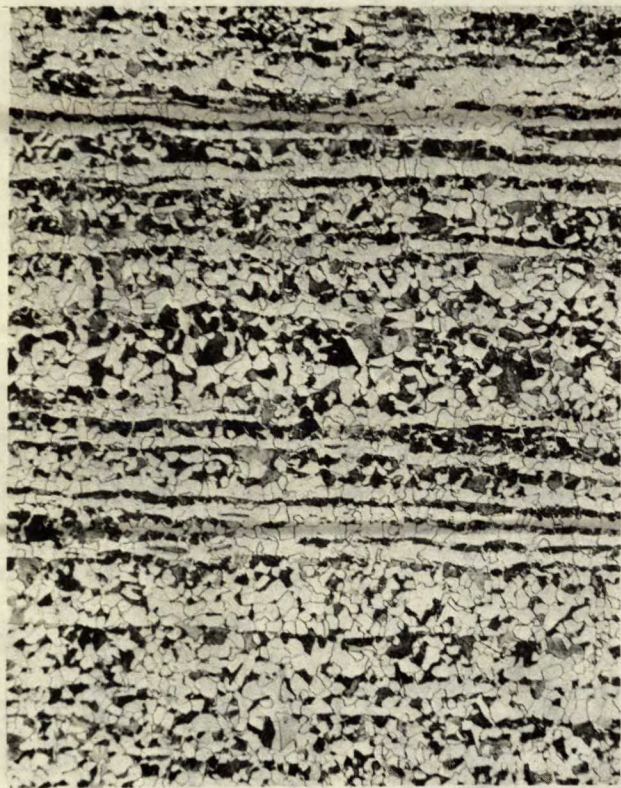
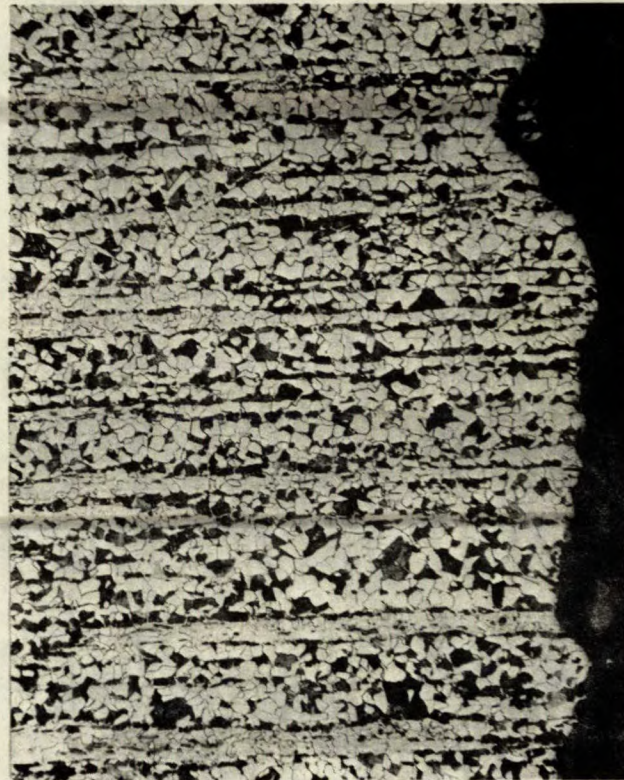
Longitudinal microspecimens were cut from rod No. 3 at the fracture and also at the extremity of the long piece, farthest from the fracture. The two specimens were examined in order to compare microstructure and so determine whether the fracture zone had been subjected to any localized treatment. As shown in Figure 4(a) and (b), both regions exhibited the same ferrite-pearlite structure and one which is considered normal for this composition of steel. Close examination of the edge of the fracture indicated that it was of a transgranular nature.

(a) At end farthest from fracture

(b) At fracture

Figure 4. Photomicrographs showing same ferrite-pearlite microstructure at the fractured zone and at the end of rod No. 3 (longitudinal sections).

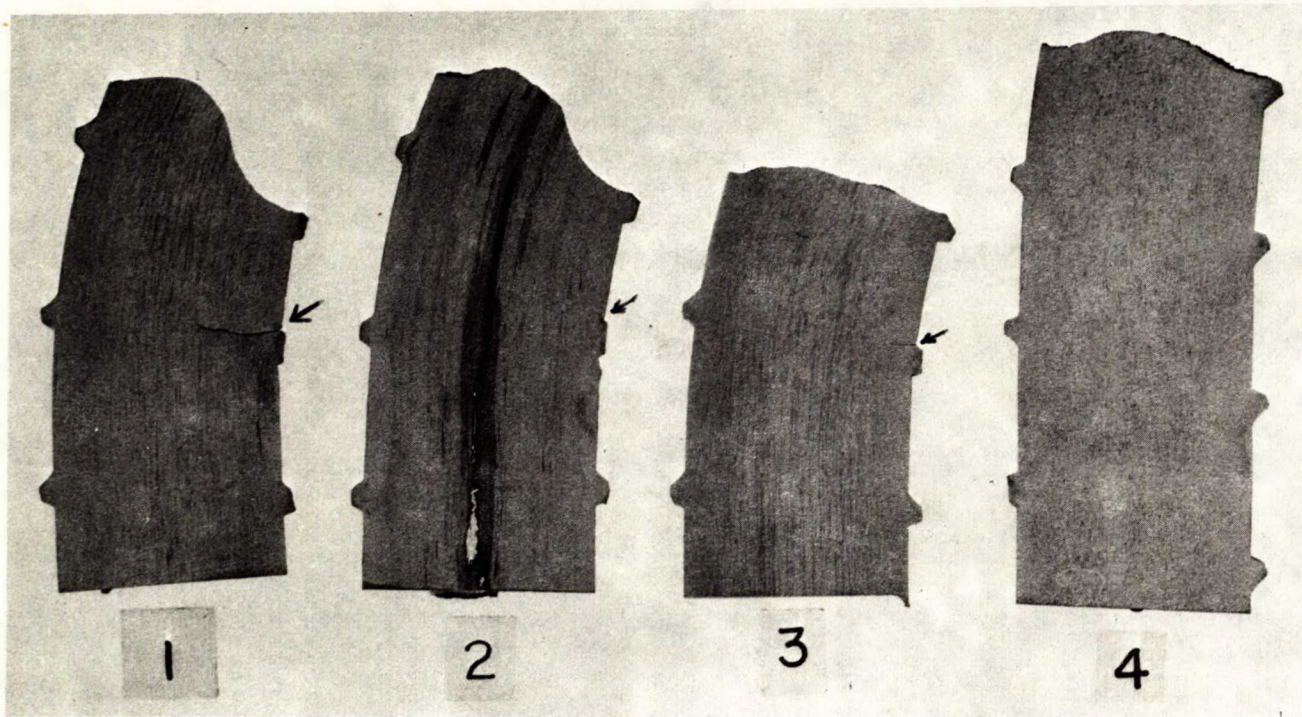
Longitudinal sections through the centre of the fracture at the point of origin were cut from the small half-fractures, and deep-etched for macroexamination. The photographs of these sections, (Figure 5), illustrate the start of each fracture at the root of a deformation. (It would also appear that rod No. 2 was rolled from a billet possibly containing part of the ingot pipe.) The most significant observation, however, is that in three cases (No. 1, 2 and 3), a crack was present at the root of the next deformation down from the fracture, and on the same underside of the bend. It was noted that these deformations had been considerably flattened. Macroexamination revealed that these cracks propagated from a lap at the root of the deformation; as an example, that occurring in rod No. 3 is shown in Figure 6. Here, the directionality of the ferrite and pearlite grains clearly shows how the surface was 'lapped' into the rod, leaving the oxide-filled fissure from which a crack would start.

"Laps" were discovered in the rods, but such defects need not necessarily be regarded as injurious if the material has sufficient ductility. From the evidence shown in Figures 5 and 6, it appeared very likely that they contributed to failure by acting as initiation points, but the material must first of all have been in a brittle condition. The successful bend tests indicated that no serious surface defects were present in the straight part of the rods and, therefore, suggested that perhaps the laps were a feature of the bend portion. In actual fact, each point of fracture, and the cracks shown in Figure 5, were observed at the root of a deformation that had been flattened. The flattening obviously occurred during the bending operation; therefore, it is very probable that the laps occurred as a result of this operation.

Figure 5. Photograph (approximately full size) of macroetched longitudinal sections through fractures. Note cracks at root of deformations.

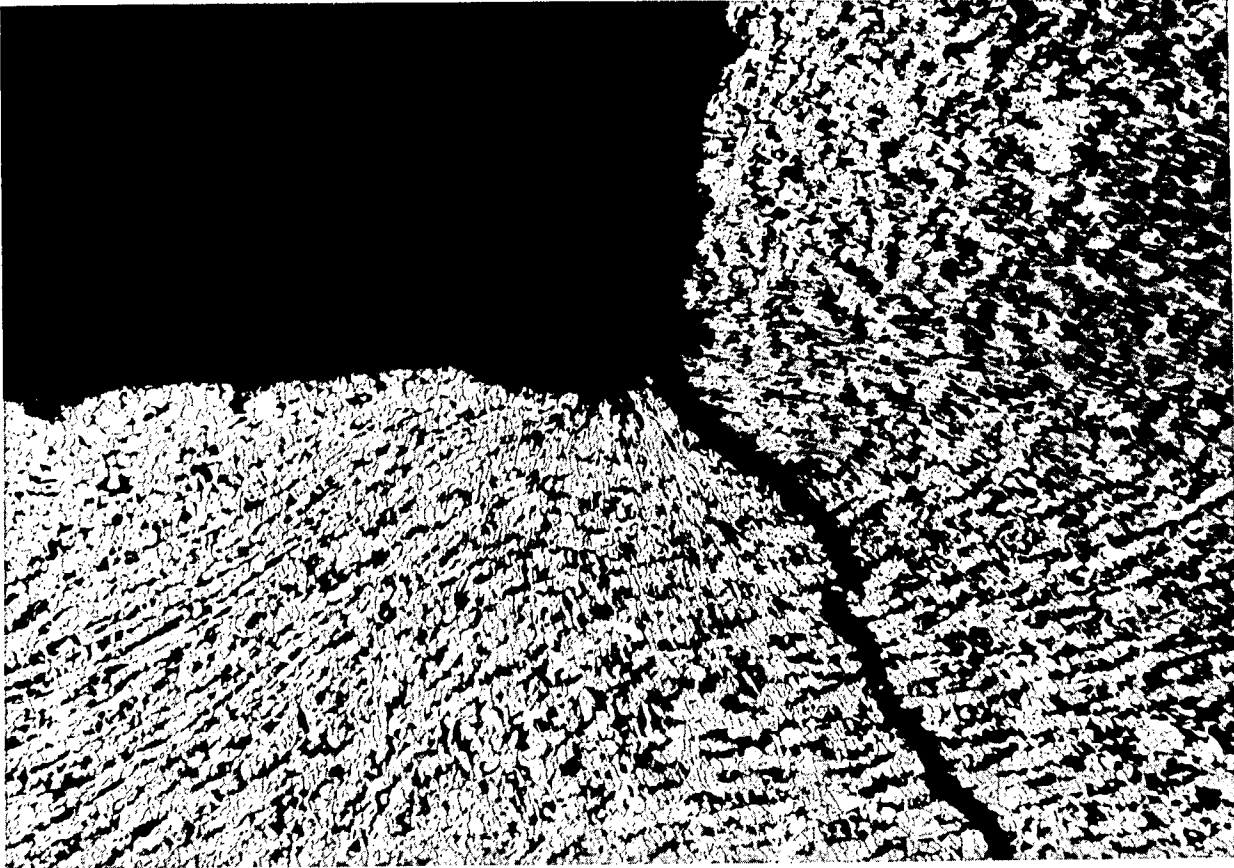
It is difficult to assess the exact influence of the 'laps' at the roots of the deformations on the underside of the bend. They undoubtedly contribute to failure by acting as stress-raisers and initiation points, but it is also quite probable that even when absent, the exhaustion of ductility of the material due to the prestrain is such, that fracture could occur with only the roots of the deformations acting as stress-raisers.

Figure 6. Photomicrograph showing crack emanating from a lap at the root of a deformation (rod No. 3).
