MINES BRANCH INVESTIGATION REPORT IR 65-42

EXAMINATION OF FAILED EXHAUST MANIFOLD FROM A HELICOPTER

W. P. CAMPBELL & R. D. McDONALD

MAY 5, 1965

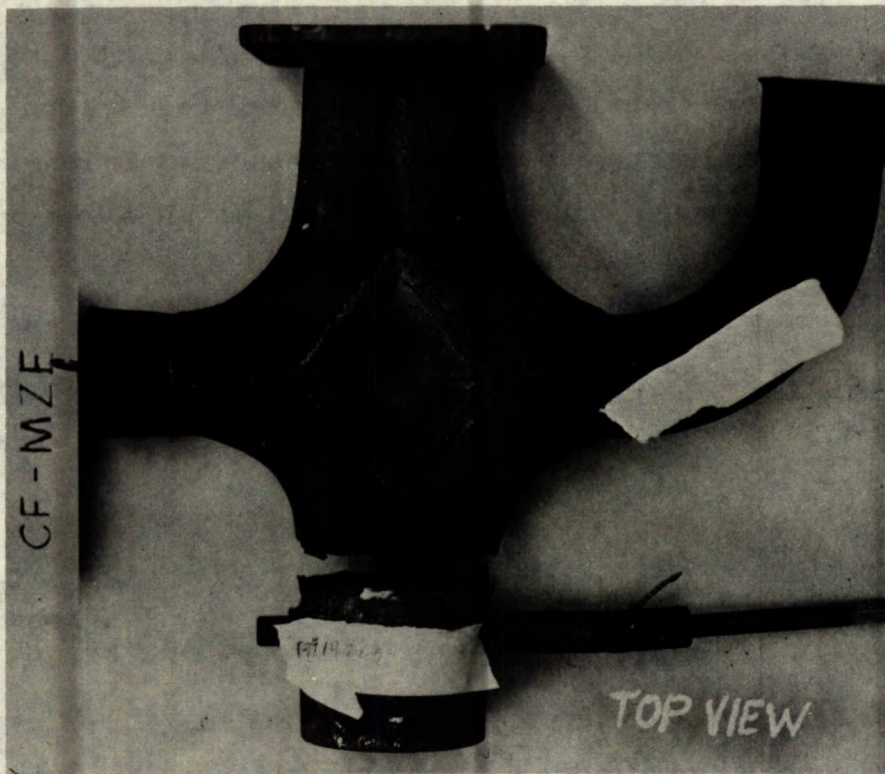
Figure 1 and 2 show the submitted samples. The lines marked adjacent to the welds indicate the extent of cracking that was apparent by visual examination at or close to the junction of the welds with the collector.

Figure 1 - Top view of part when installed.

A crack, at least one inch in length, was found in the collector adjacent to the junction of the butt weld attaching the bell-mouth pipe seen at the left side of Figure 1.

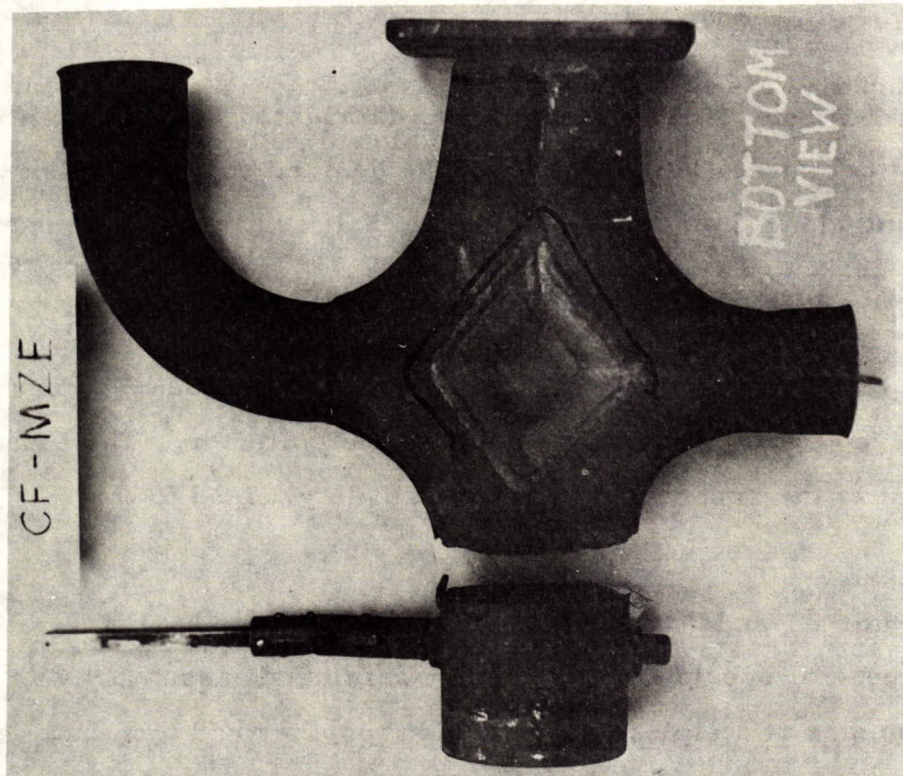
Figure 2 - Bottom view of part when installed.

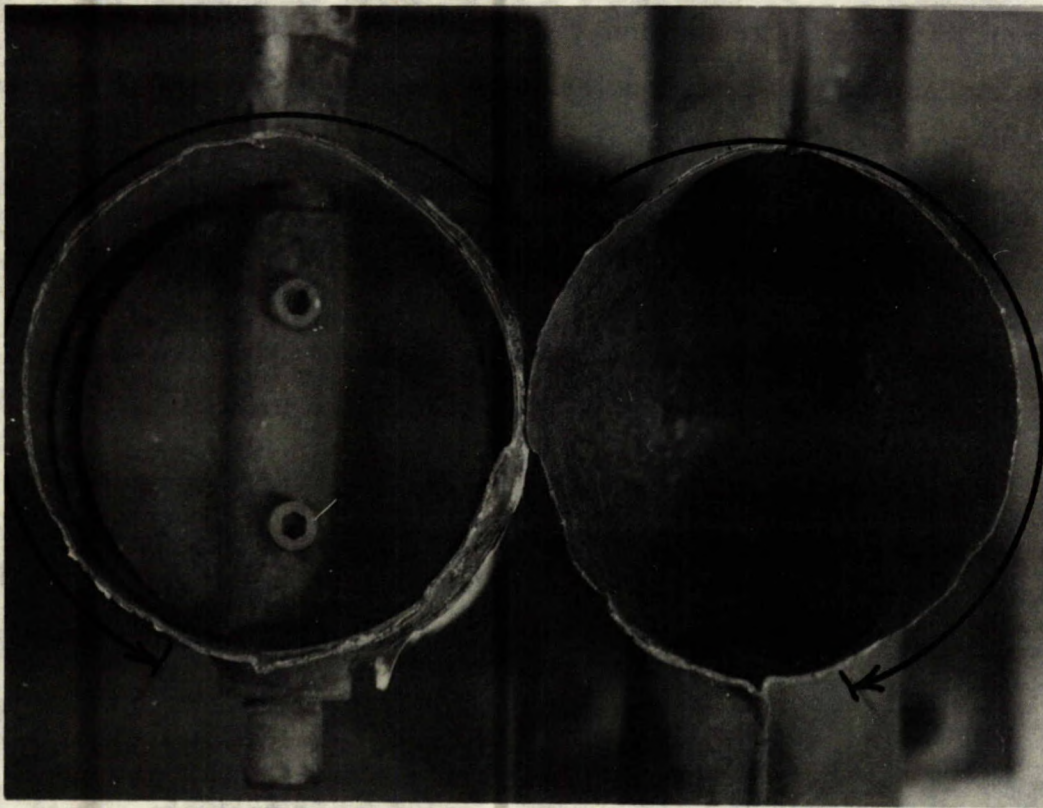
In the portion of the circumference of the fracture indicated in Figure 3, oxidation colours ranging from pink to deep purple were observed, usually in the central part of the collector wall. These colours were not found on the remaining portion of the circumference. Instead, black oxides that had formed at higher temperatures were detected at some locations on the fracture face. The texture of the fracture was less distinct at these locations.

Figure 3 - Showing end view of main fracture. The valve portion is at left and the collector at the right. The arrow indicates the part of the fracture surface which showed low temperature oxidation colours.

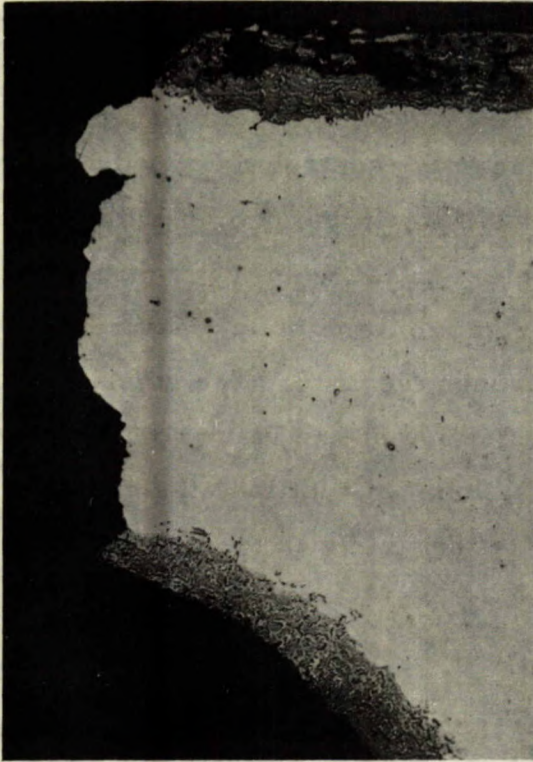
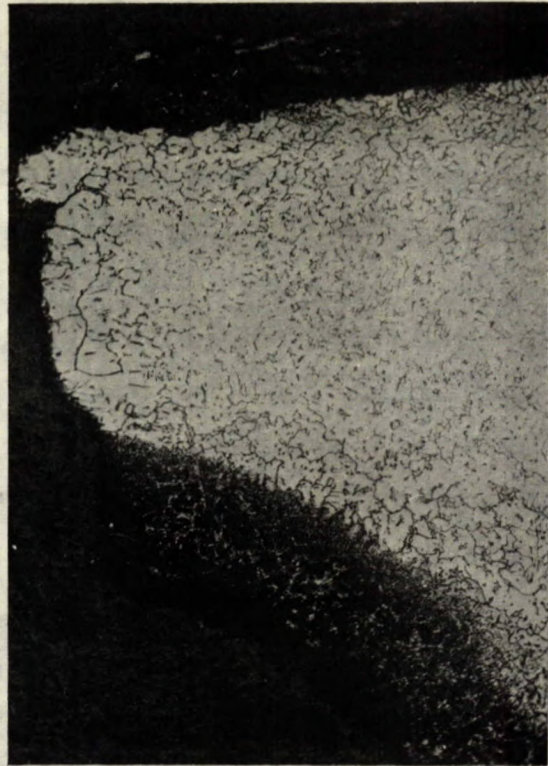
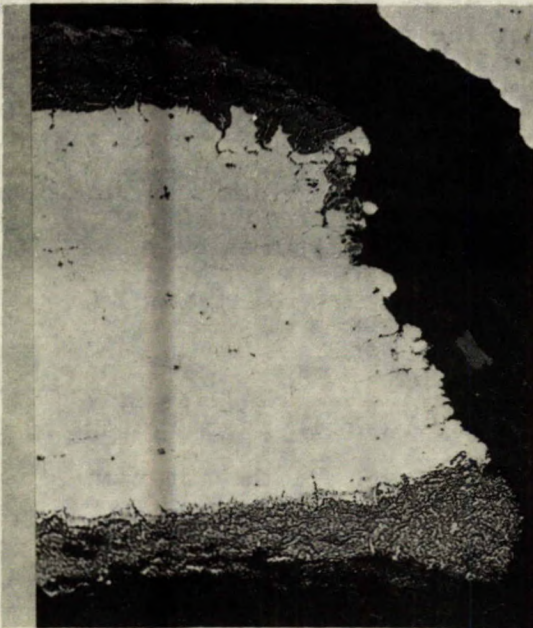
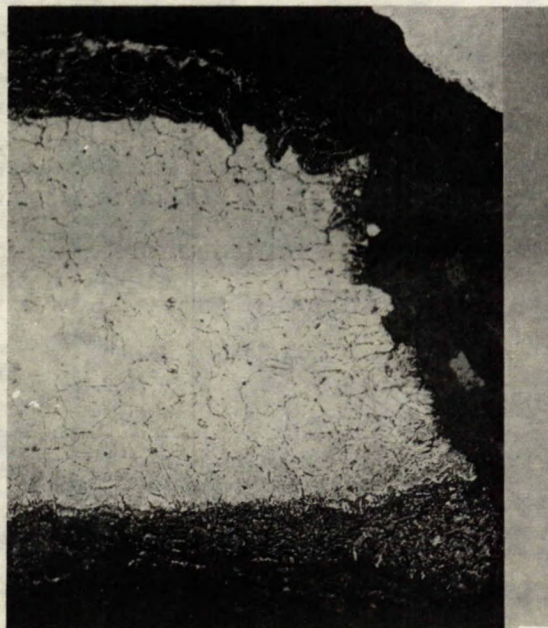
The section illustrated in Figures 4A and 4B has a fracture path that appears to be mainly transgranular except for the outer one-third which has a tendency to be intergranular. The fracture path is in the coarse-grained heat affected zone close to the weld fusion line. A "lip" of scale, such as was observed during low-power examination of the fracture face, is evident in Figure 4A. In this unetched view, high temperature oxidation products are apparent on both inner and outer surfaces, but no oxidation is evident on the fracture face. The appearance of this section is reasonably representative also of other sections from the part

Figures 4A-4D - Showing sections through the main fracture which caused separation of the valve portion. In each figure, the weld is to the right of the fracture and the inner surface of the collector is at the bottom of the picture.

The fracture path of the section illustrated in Figures 4C, 4D, 5A and 5B is entirely or mainly intergranular. This fracture path was also in the heat-affected zone in the collector but slightly farther from the weld fusion line than in the section shown in Figures 4A and 4B. In addition to the high-temperature oxidation products on the inner and outer surfaces of the collector, a similar product is associated with the fracture face. The low-power microscopic examination indicated more scale on the surface of this fracture than is apparent in the photomicrographs. However, it is believed that some high-temperature scale was lost from the fracture face of the sample shown in Figure 4A during sample preparation. In Figures 5A and 5B, traces of gray to black oxide can be seen extending along grain boundaries inward from the fracture face. These grain boundaries contain precipitated chromium carbides as shown by electrolytic etching in a sodium cyanide solution. Thus it is concluded that the failure at this location was by progressive cracking and oxidation along grain boundaries containing chromium carbide precipitates.

The etched sections shown in Figures 4B and 4D illustrate that there was a significant increase in carbide precipitation towards the inner surfaces of the collector. A similar increase was noted in other sections from the valve portion and from the collector remote from the weld. Figure 5B exhibits more clearly the large amount of carbide particles within the grains and at grain boundaries. The irregular lines, which do not correspond to grain boundary carbide precipitation, are believed to be due to carbide precipitation along slip bands resulting from deformation during manufacture of the collector. Similar irregular lines containing carbides were found in an area including about the inner one-third of the wall in all sections taken from the collector. Except for these slip bands which were not confined to the fracture area, there was little or no evidence of plastic deformation of the fracture surfaces.

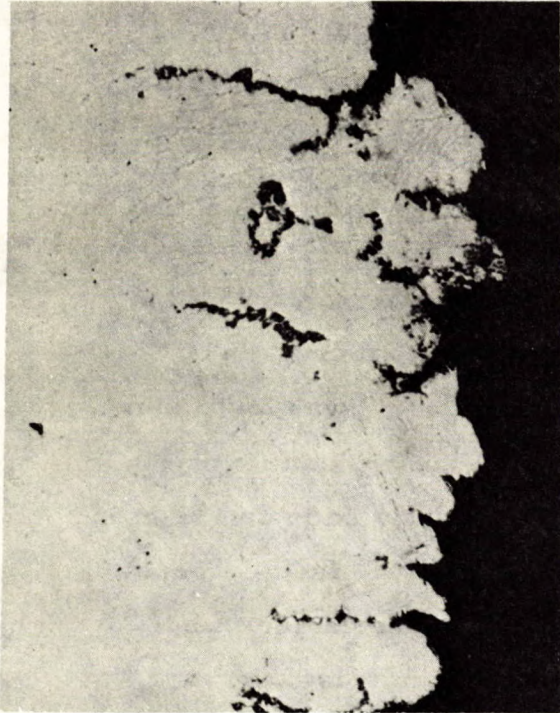
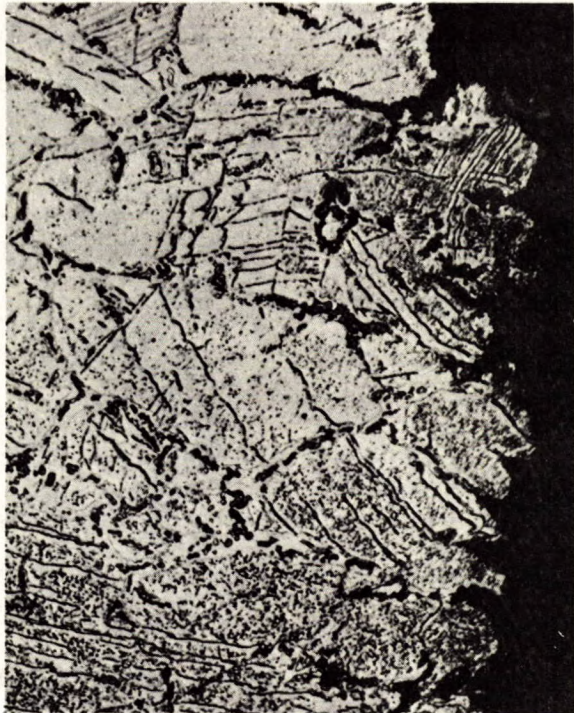
Figures 5A and 5B - Showing a portion of the fracture illustrated in Figures 4C and 4D.

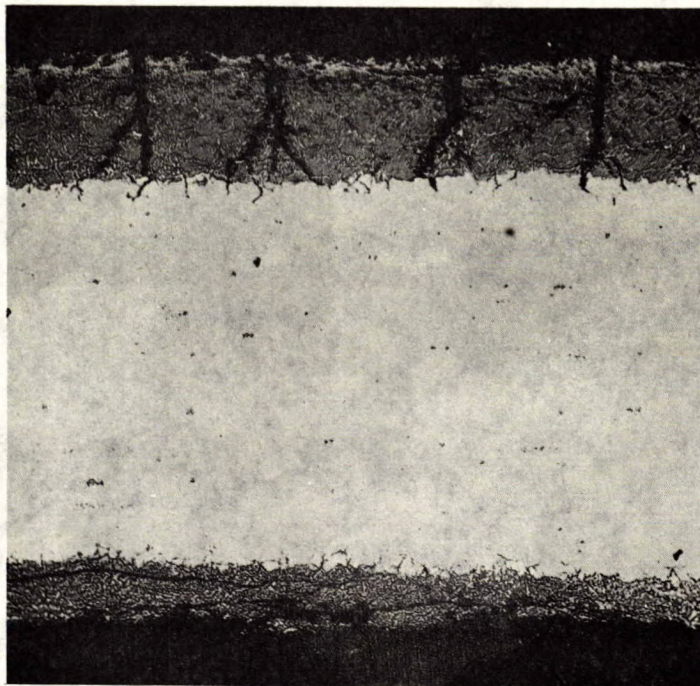
Figure 6 shows a section from the collector, taken about 1/2 in. from the severed joint. The heavy coatings on the inner and

Figure 6 - Showing a section through the collector sheet. The inner surface is at the bottom of the picture.

outer surfaces consist chiefly of high-temperature oxide, but contain also smaller amounts of carbides and base metal. In this particular section, several cracks were found which extended through the scale on the outer surface and into the underlying metal. Similar cracking was found at the inner surface in other sections. As shown by Figure 7, the cracks in the underlying metal follow grain boundaries containing precipitated carbides. The cracking is associated with progressive oxidation along these boundaries. Numerous cracks of this nature were found in all sections examined.

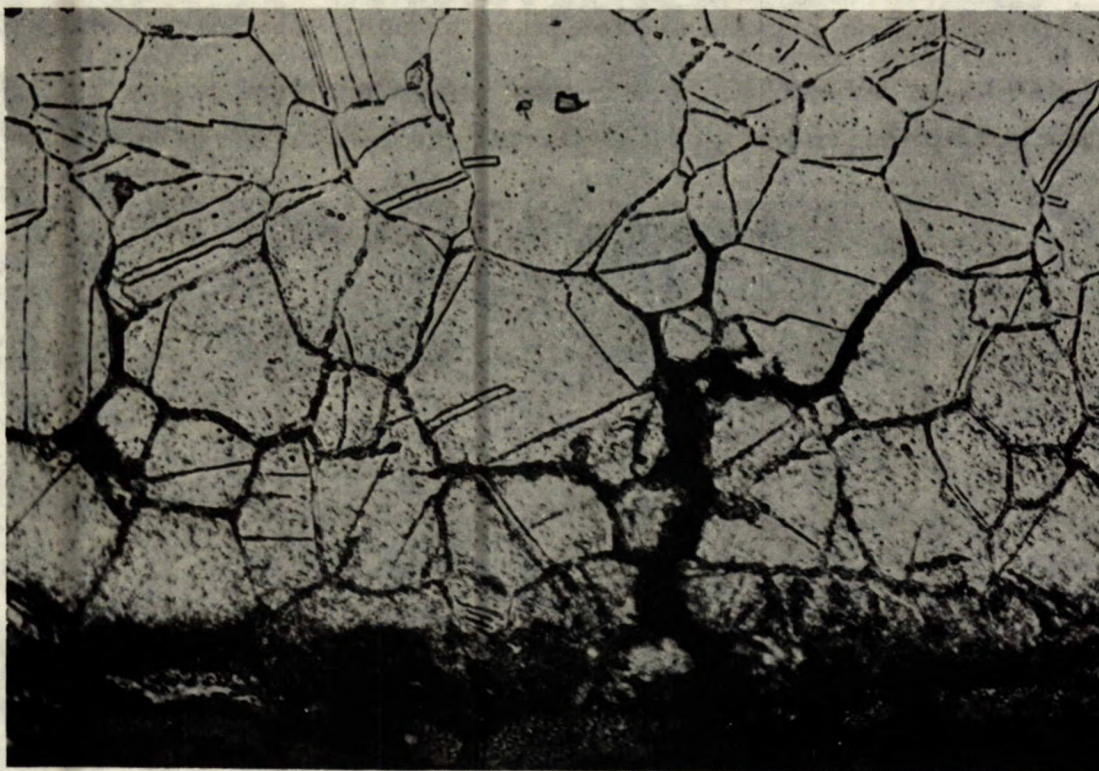
Figure 7 - Typical appearance at the inner surface of the collector, at the junction of the surface scale with the underlying metal. This sample is remote from the weld.
