MINES BRANCH INVESTIGATION REPORT IR 65-53

**METALLURGICAL EXAMINATION
OF COINING DIES**

Mines Branch Investigation Report IR 65- 53

METALLURGICAL EXAMINATION OF COINING DIES

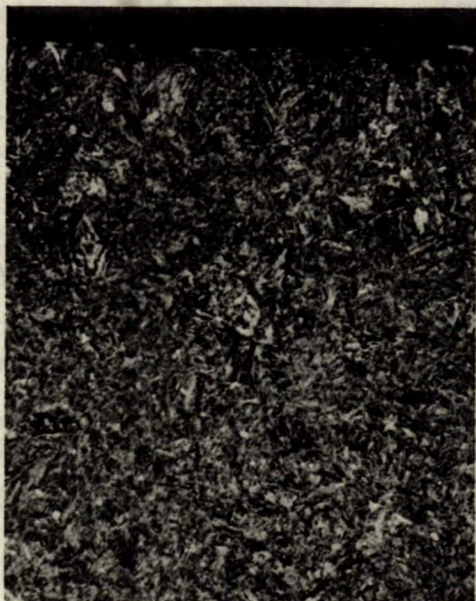
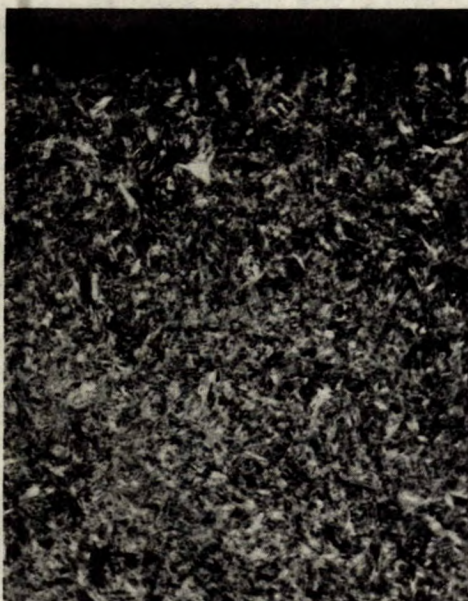
Samples "F" (W-2 type tool steel) and "G" (W-1 type) were submitted as representative of dies produced using the gas-atmosphere process. Such dies reportedly give satisfactory service life, although no figures for die life were available for these particular samples. The microstructures (Figure 1) and hardness level (Rc 57) were consistent with the hardening treatment reported. This consisted of holding at 1500°F for two hours, quenching in brine (6% NaCl at 68°F), and tempering at 500°F for four hours. (The suitability of this treatment will be commented upon in a later section).

Die "F" - W-2 Type

Die "G" - W-1 Type

Figure 1. Microstructure at the surface of die samples austenitized for hardening in a gas atmosphere, brine quenched, and tempered at 500°F. Both samples gave Rc 57 hardness values.

The tempering temperature of 500°F would seem to be an unfortunate choice since this is the temperature corresponding to the greatest degree of tempered martensite brittleness. One would expect equal or better ductility and superior hardness on a draw at a lower temperature.

7. Temper in oven at 300°F or in salt at approximately 350°F. Holding times are 60 minutes per inch of section in the oven and 30 minutes per inch of section in salt.

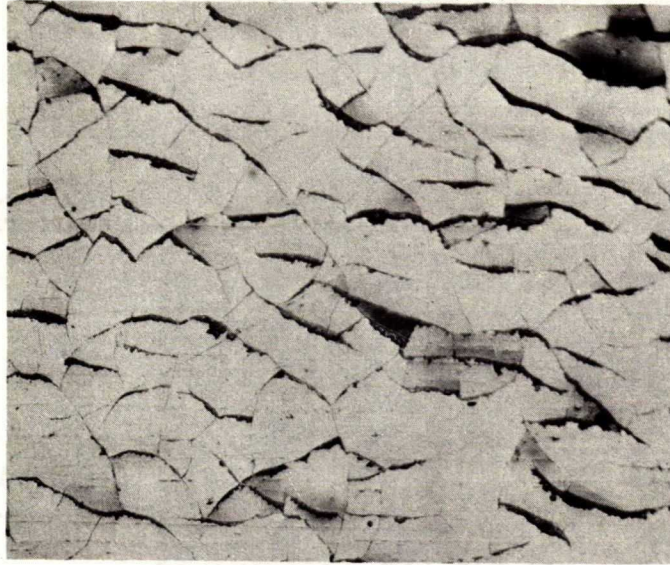
Sample 20 x 2N had been treated in the salt bath with the negligible quantity of 0.05% CN present, and after it had struck only ten pieces of coinage the flaw referred to as "matting" appeared and the die was withdrawn from service. A magnified view of the "matting" shows it to be extensive cracking of the chromium plating.

Figure 2. Magnified view of "matting" at the striking face of Die 20 X 2N.

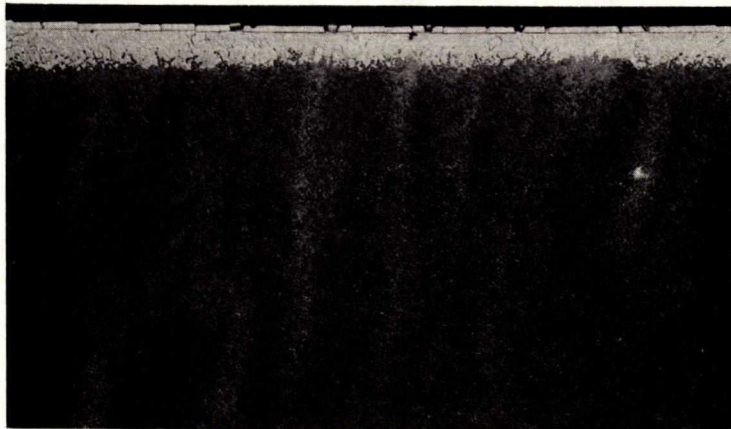
Figures 3 and 4 show the microstructure of a section taken through the "matted" area, illustrating the cracked layer of chromium and deep decarburized layer observed.

Figure 3. Microstructure through "matting" defect, illustrating layers of cracked chromium plating and of ferrite formed by decarburization.

The extreme softness of the decarburized layer makes it obvious why the heavy cracking of the chromium plating occurs, and why, when this condition exists, the dies ultimately fail by "sinking" of the crown, that is, by collapse and outward flow of the soft material under pressure.

1. In the high temperature furnaces use a ternary neutral hardening salt such as the barium-base K3 salt, or 1145 salt. These salts must be kept rectified by constant contact with a graphite rod and the regular addition of perliton.
2. The neutrality of the bath can be checked by the rapid treatment of high carbon strips (such as razor blades). The quenched strip should snap; if it bends the bath is decarburizing.
3. Temperature control should be checked regularly.
4. Hardness testing with the Rockwell Superficial Hardness Tester should be carried out after quenching as a further check for decarburization.
5. Treat the dies in batches of from five to ten only to minimize temperature fluctuations and to give more satisfactory hardening.

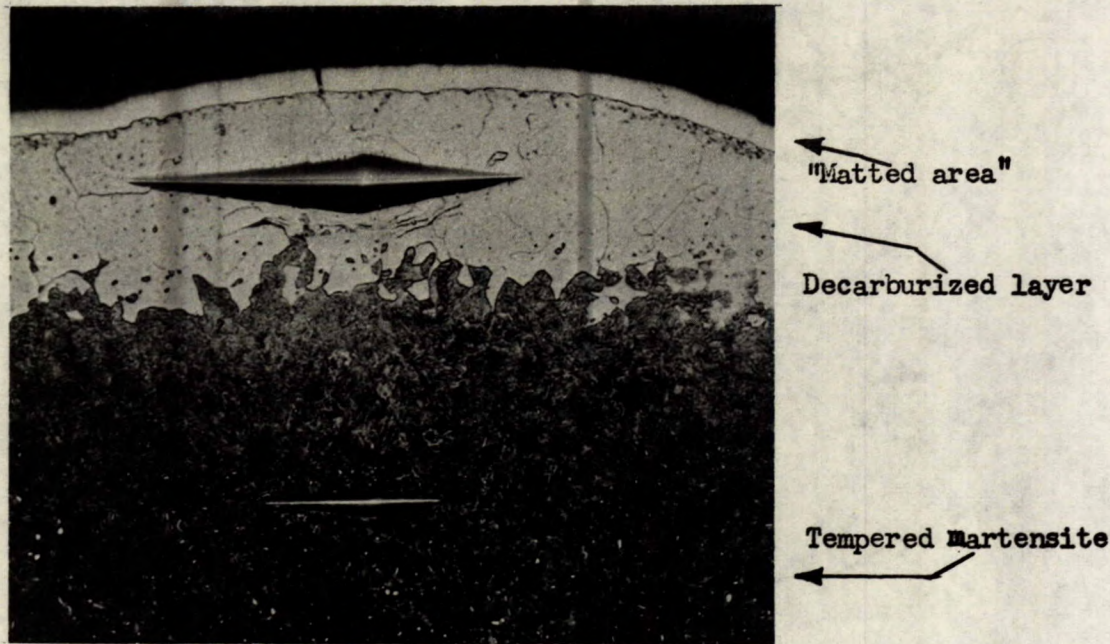
Figure 4. Shows a field similar to Figure 3. but at higher magnification. The difference in hardness between the decarburized layer (Rb 61) and the tempered martensite core (Rc 59) is readily seen.

6. Dry and check hardness with Superficial Hardness Tester. A number of readings which do not convert to approximately Rc 67, are indicative of decarburization.

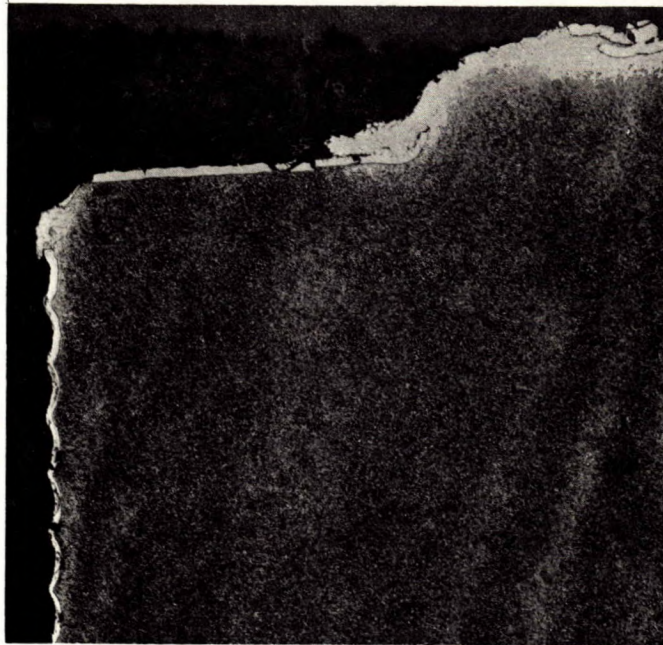
Hardness testing of the heat treated die should have made it clear that such a condition existed and that the use of this die in service would be nonproductive. Removal of the decarburized layer at the collar before chromium plating (see Figure 5) will not in any way improve conditions at the die face.

Figure 5. Shows where decarburized metal has been removed on the collar, but remains at the face.

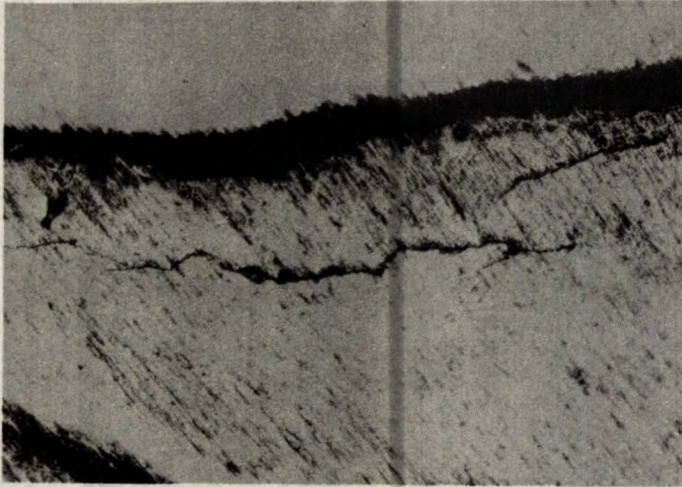
Sample CVX 10-2C was one of three experimental dies that had been treated immediately after addition of 1.75% CN to the salt. These dies were immersed at 1500°F for periods of 5, 10 and 15 minutes, respectively, before quenching, and the die lives were 102,000, 137,000 and 186,000 pieces. Sample CVX 10-2C was the experimental die exhibiting the longest service life.

Figure 6. Magnified view of crack at the striking face of Die CVX.10-2C.

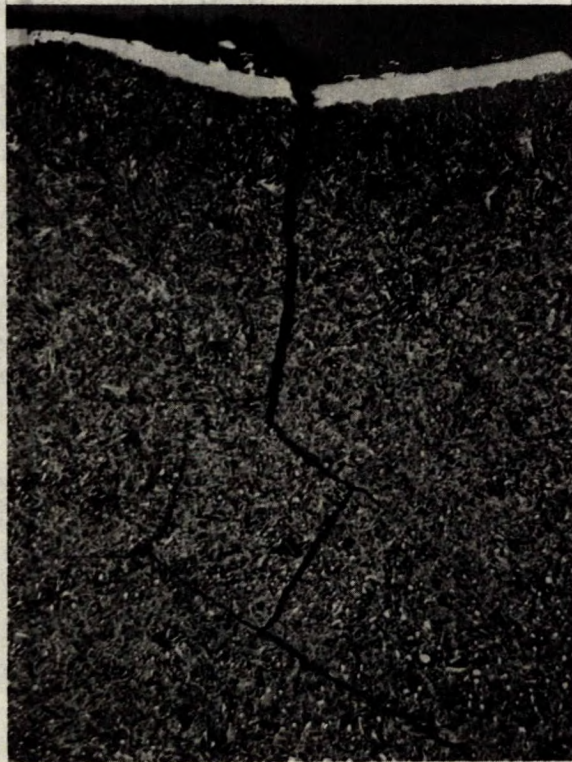
Figure 6 shows a view of the crack, which resulted in rejection of the die, and Figure 7 shows sections through the crack. No decarburization is evident. Figure 8 shows another crack that occurred between the neck and collar of the die.

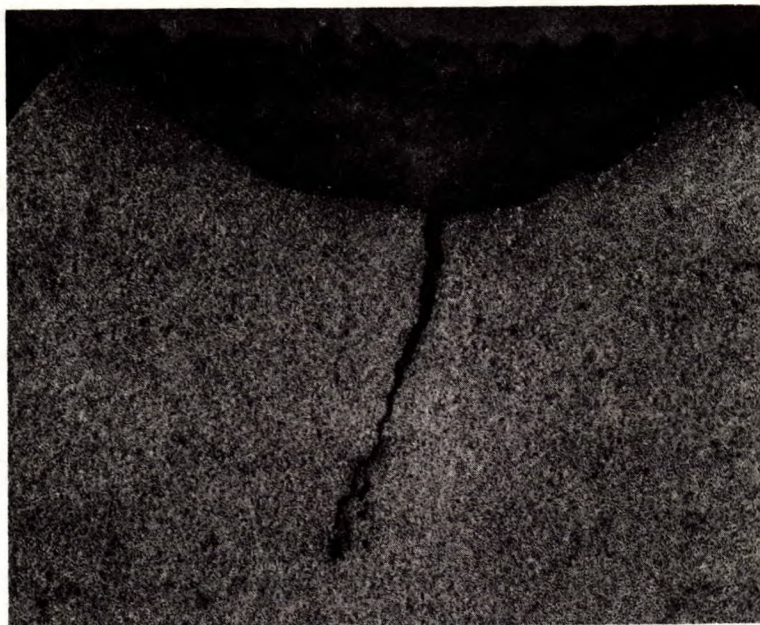
Figure 8. Shows crack at relatively sharp angle between the neck and collar of Die CWX. 10-2C
