MINES BRANCH INVESTIGATION REPORT IR 65-59

**FRACTURED ALUMINUM ALLOY
PRESSURE COOKER COVER**

JULY 30, 1965

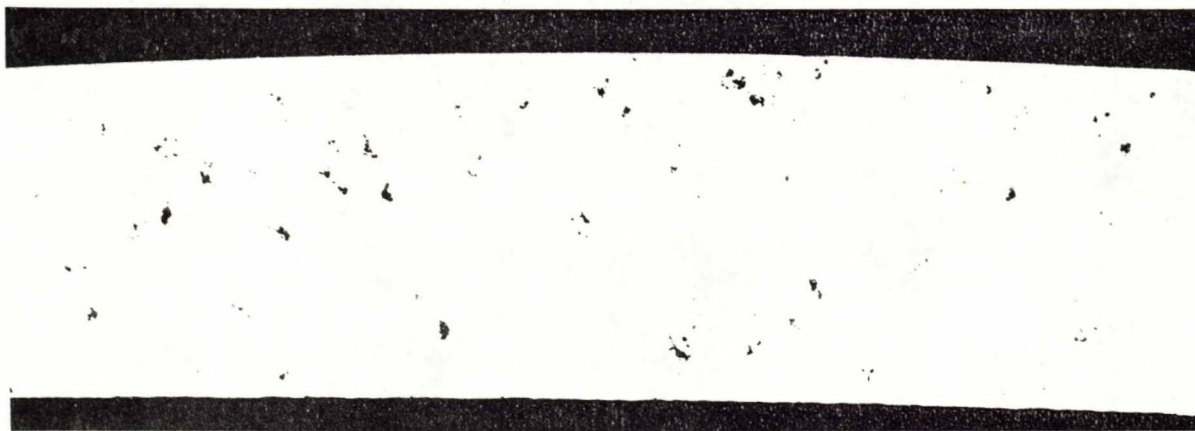
A section was taken from the thin (5/32 in.) part of the cover near the radius joining the main centre section to the rim, and polished for metallographic examination. At low magnification considerable micro-porosity was observed (See Figure 1). At high magnifications the structure was seen to consist of silicon (Si), aluminum-magnesium silicide-silicon (Al-Mg₂Si-Si) eutectic and several minor constituents, probably containing iron (Fe), in the aluminum solid solution matrix. The relatively large amount of magnesium silicide (Mg₂Si) present would be expected to make the alloy brittle.

Examination of the cover has shown that the material was cast (probably permanent mould) aluminum alloy of an unusual type whose properties are not published. However, from the structure it would be expected to be relatively brittle. Both radiographic and metallographic examination showed considerable microporosity but this would not be regarded as unusual in this type of casting.

Figure 1 - Section through cover showing micro-
porosity. (Unetched).
