MINES BRANCH INVESTIGATION REPORT IR 65-60

**METALLURGICAL EXAMINATION OF
BURST BOILER TUBE FROM ELECTRIC
REDUCTION COMPANY OF CANADA, LTD.**

AUGUST 5, 1965

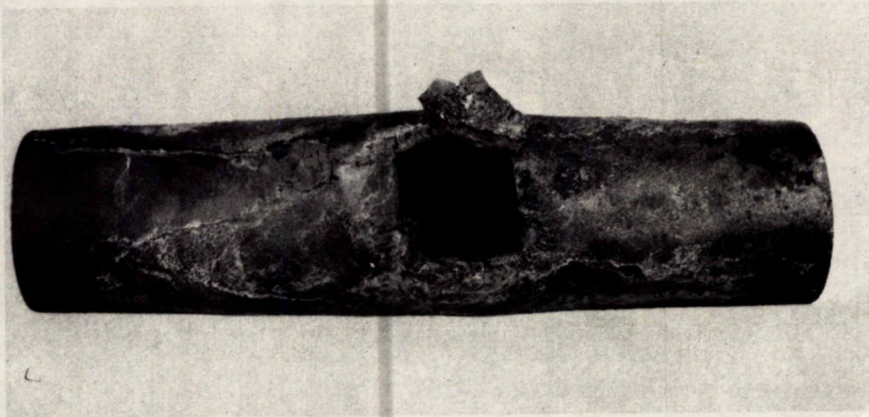
Figure 1 illustrates the failed tube in the as-received condition. Figure 2 shows the presence of both a thick (water-side) inside scale and a thick (fire-side) outer scale.

Figure 1 - Failed section of tube in the as-received condition.

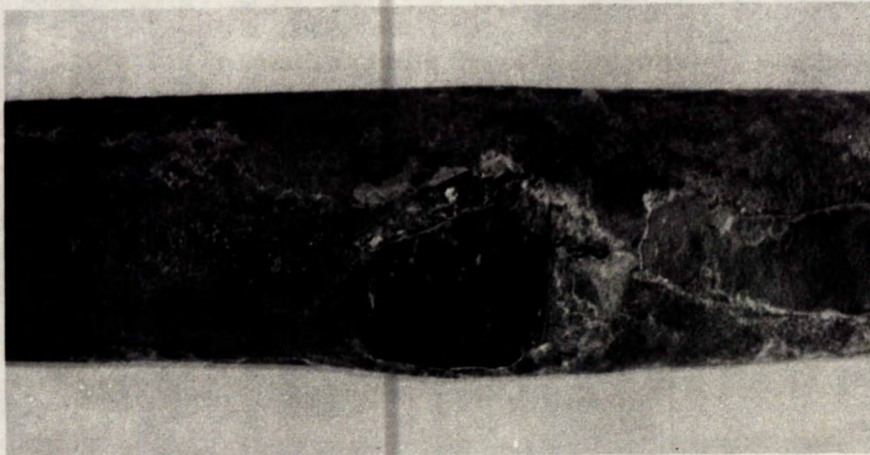
A heavy water-side scale was observed. This scale by its insulating action may have contributed to overheating.

Figure 2 - Heavy scale deposits on the outside (fire-side) and heavy white scale on the inside (water-side) of the tube.

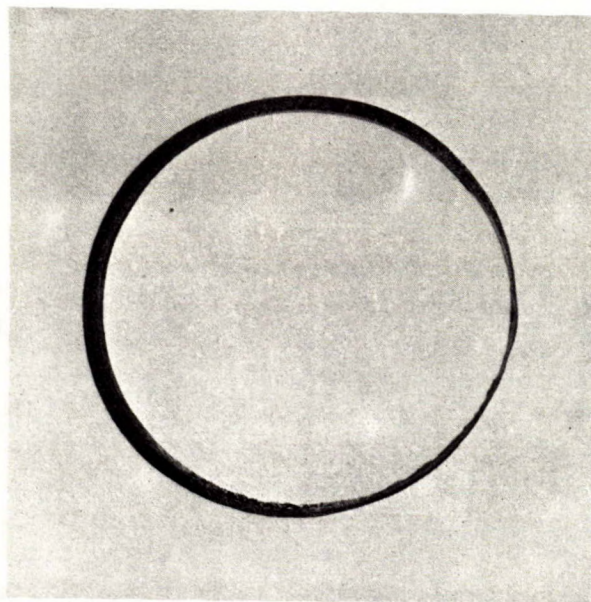
Examination of a burst boiler water tube submitted by Electric Reduction Company Limited, Buckingham, Quebec, showed that rupture was due to extreme thinning of the tube wall. Thinning was apparent on half the circumference of the pipe and for the full length of the sample. The wall thickness in the thinned region was of the order of 0.006 inches.

Measurements of the wall thickness of the tube were made to determine the amount of reduction that had taken place in this section of tube. The thickest wall section measured was 0.125 inches thick and had a Rockwell B hardness of 69. The wall thickness of the tube at the thinned, burst section was 0.006 inches. This transverse section had a hardness of Rockwell B 50.

Figure 3 - Etched in boiling 1:1, HCl:H₂O solution to remove scale. The picture illustrates thinning of the pipe wall section.

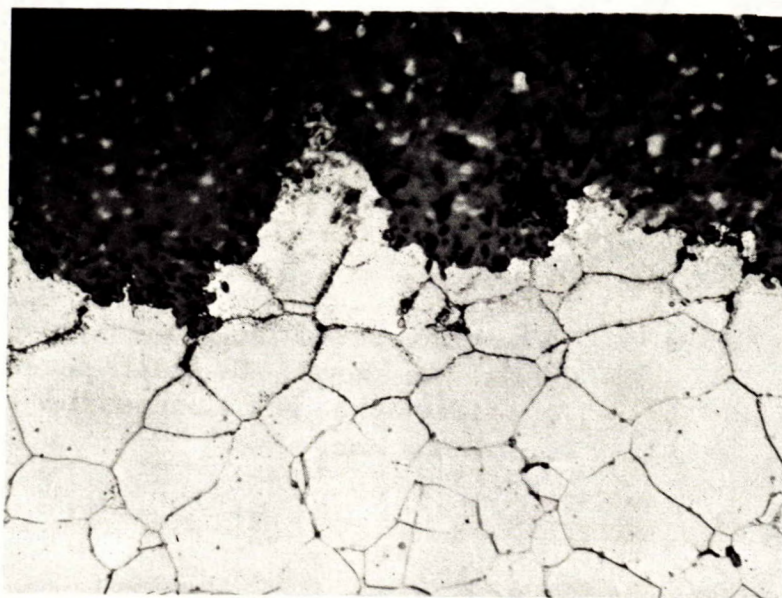
Metallographic samples were cut from the tube, mounted in bakelite and were polished for microscopic examination. Figure 3 shows the amount of reduction that has taken place in the wall of the tube. Figure 4 shows the penetration of oxides along the grain boundaries of the tube on the outer surface (fire-side) associated with the thick outer scale. Figure 5 also illustrates the amount of reduction in the tube and shows a 0.006 in cross section of the tube at a magnification of 500 diameters. Grain boundary oxides have completely penetrated the wall of the tube in this section. Figure 6 shows the microstructure of the tube approximately six inches from the failure. Complete spheroidization and coalescence of the carbide (Fe_3C) has taken place in this region. Figure 7 shows the microstructure near the thin section (approximately 0.006 inches). Sub-critical grain growth has occurred in this region. Grain coarsening and oxide penetration indicate temperatures in excess of those allowed for carbon steel pipe.

Figure 4 - Grain boundary penetration of oxides and the presence of heavy scale on the fire-side of the tube is illustrated.

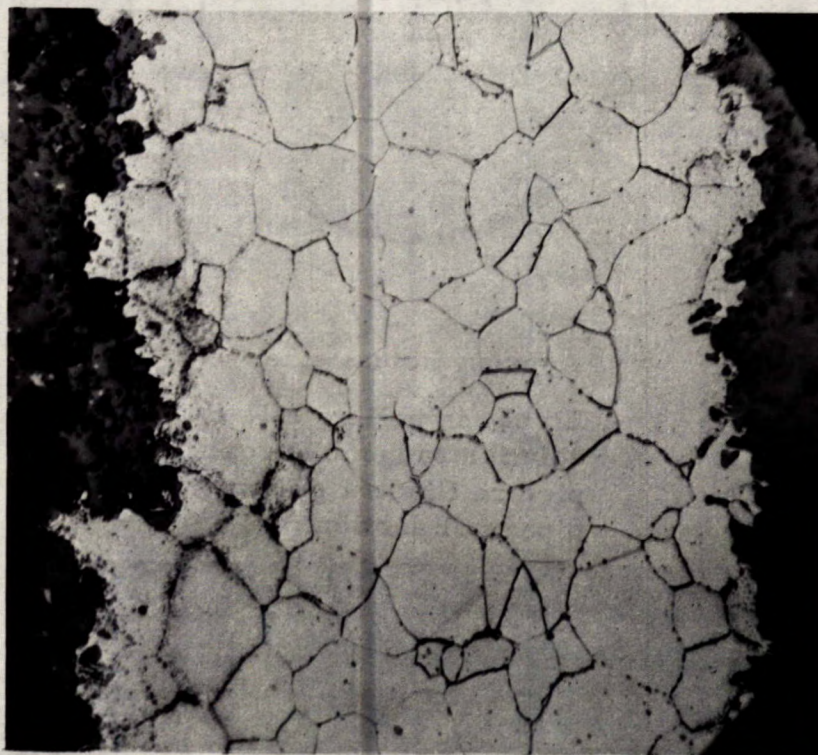
Overheating and severe thinning of the tube wall section by progressive oxidation caused weakening of the wall section prior to rupture. In fact, the tube wall thickness for part of the circumference and the length of the sample was reduced to 0.006 in. The temperature of the tube in service has been of the order of 1100°F. Possibly the presence of a heavy water-side scale or

Figure 5 - The thinnest section of the pipe near the failure is shown. Complete penetration of oxides at the grain boundaries is visible in this section.

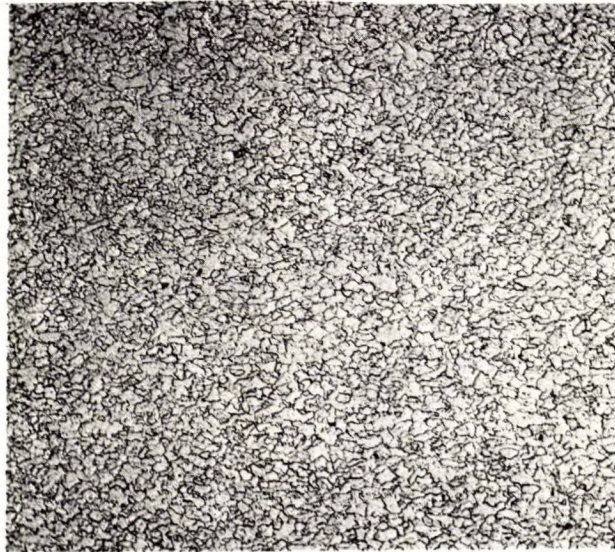
In service, the pipe had been heated to temperatures considerably higher than 850°F (approximate) allowed for carbon steel. Sub-critical grain coarsening and grain boundary oxidation were observed, and indicated that excessive temperatures of the order of 1100°F were attained.

Figure 6 - Spheroidization and coalescence of carbide (Fe_3C) in this section of the tube remote from the failure, indicates high operating temperatures. Hardness - R_b 69 in this section.

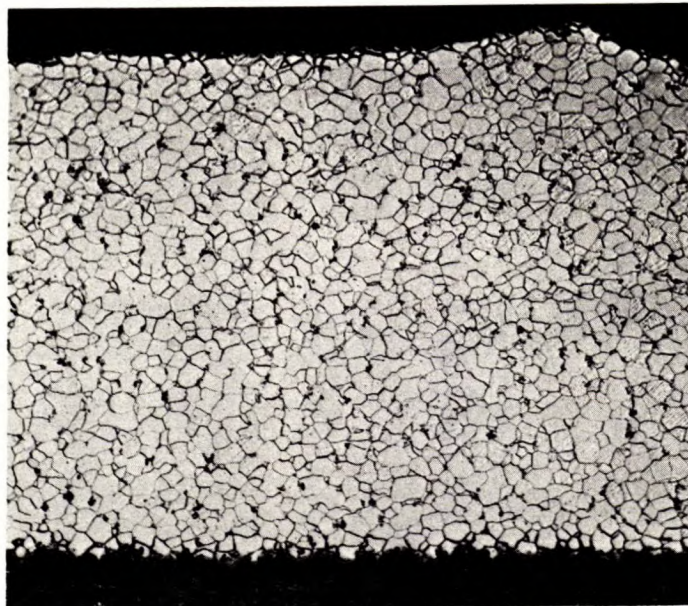
Figure 7 - Microstructure of the pipe adjacent to the rupture. Decarburization and grain coarsening are visible. Hardness - R_b 50 in this section.
