MINES BRANCH INVESTIGATION REPORT IR 65-84

**EXAMINATION OF 33S ALUMINUM ALLOY
EXTRUSION BILLET SAMPLES**

OCTOBER 22, 1965

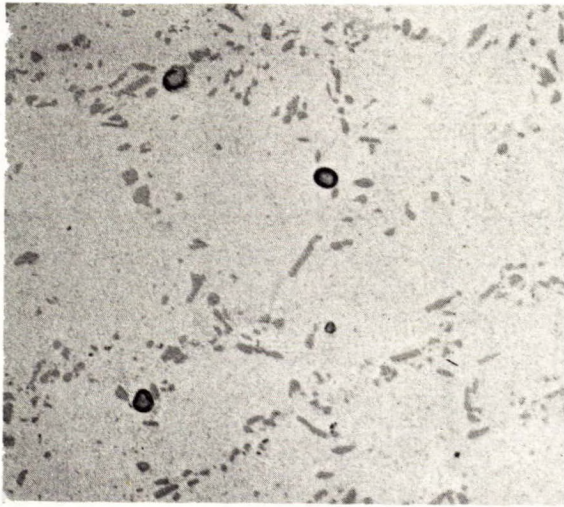
In most sections of both billets small particles of a very hard substance were observed. However, these were very numerous in two sections from the "poor" billet and were much less widely observed in the "good" billet. Typical micrographs showing inclusions are given in Figures 1 and 3.

Metallographic examination of the two billet sections has shown that the most likely cause of the poor extrusion behaviour of the first billet was the presence of high concentrations of hard particles. The appearance of the particles suggests that they consist of "gamma alumina". In a previous study it was shown that such inclusions were the most probable cause of poor machinability in aluminum alloy die castings. In the periodical "Foseco Foundry Practice" for February 1961 published by Foundry Services, (Canada) Ltd., an article entitled "Hard Spots in Aluminum Castings" describes these inclusions and states that although the nature and mode of formation of gamma alumina is not completely understood, many investigators "have established that excessive disturbance of the molten metal, incorrect fluxing practice, the melting of oxidized scrap material and failure to clean out furnaces regularly are all contributory causes".

Figure 1. Section from "poor" billet showing general structure and several hard particles. (Unetched)

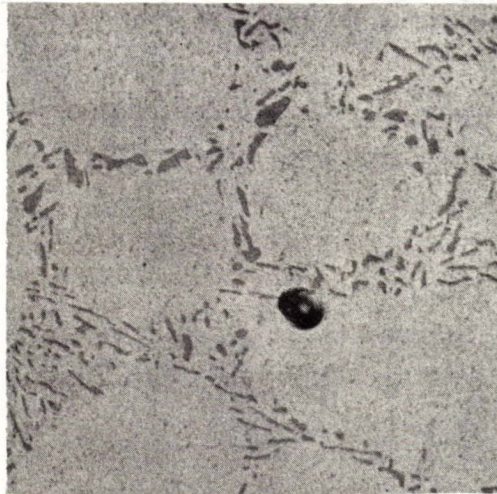
Figure 2. Section from good billet showing general structure. Note eutectic particles are less rounded than in Figure 1. One hard particle is also shown. (Unetched)

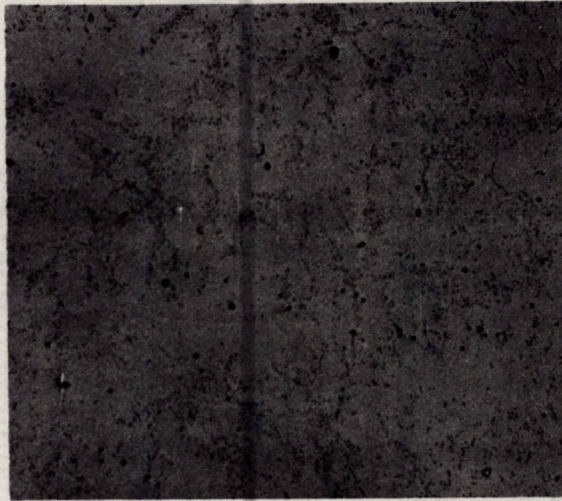
Figure 3. Section from "poor" billet showing dense concentration of hard particles.
