MINES BRANCH INVESTIGATION REPORT IR 65-106

**EXAMINATION OF RIVETS FROM
S.S. "MIDLAND PRINCE" BOILER**

D. E. PARSONS & D. A. MUNRO

JANUARY 11, 1966

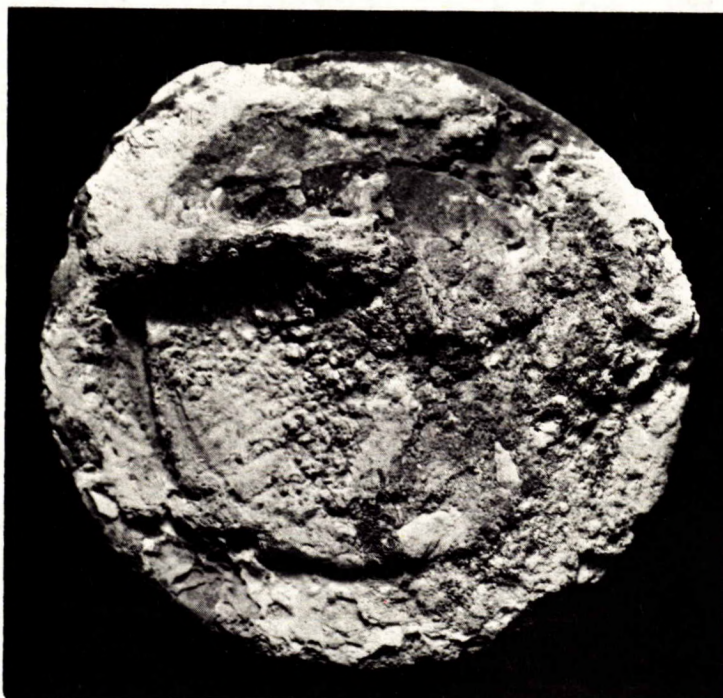
Figure 1. Head and Fracture Surface, Rivet Sample No. 1.
This rivet head and fracture surface were coated
with white deposit.

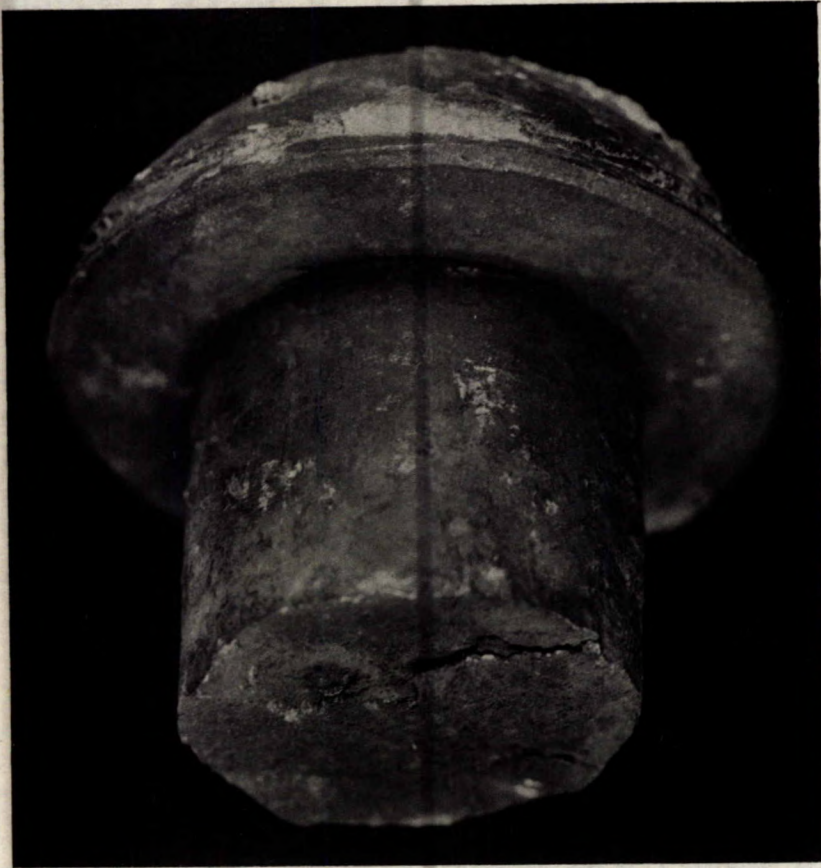
Figure 2. Illustrates Head and Shank, Rivet Sample No. 2.
In addition to the fracture a deep circumferential
crack is present in the fillet between the shank
and the head.

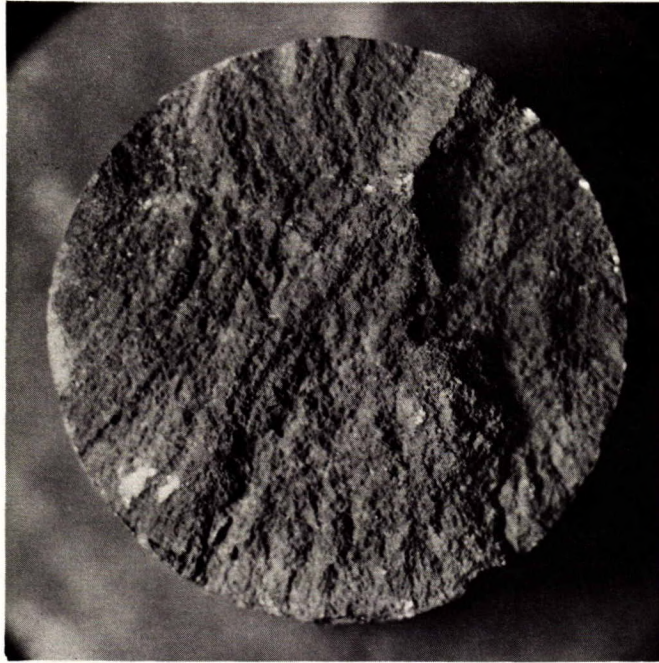
Figure 3. Illustrates Fracture Surface, Rivet No. 2,
same as Figure 2.

Fracture of this rivet shows no evidence of deformation and appears to be irregular or intergranular and has the appearance of having occurred in a relatively brittle manner.

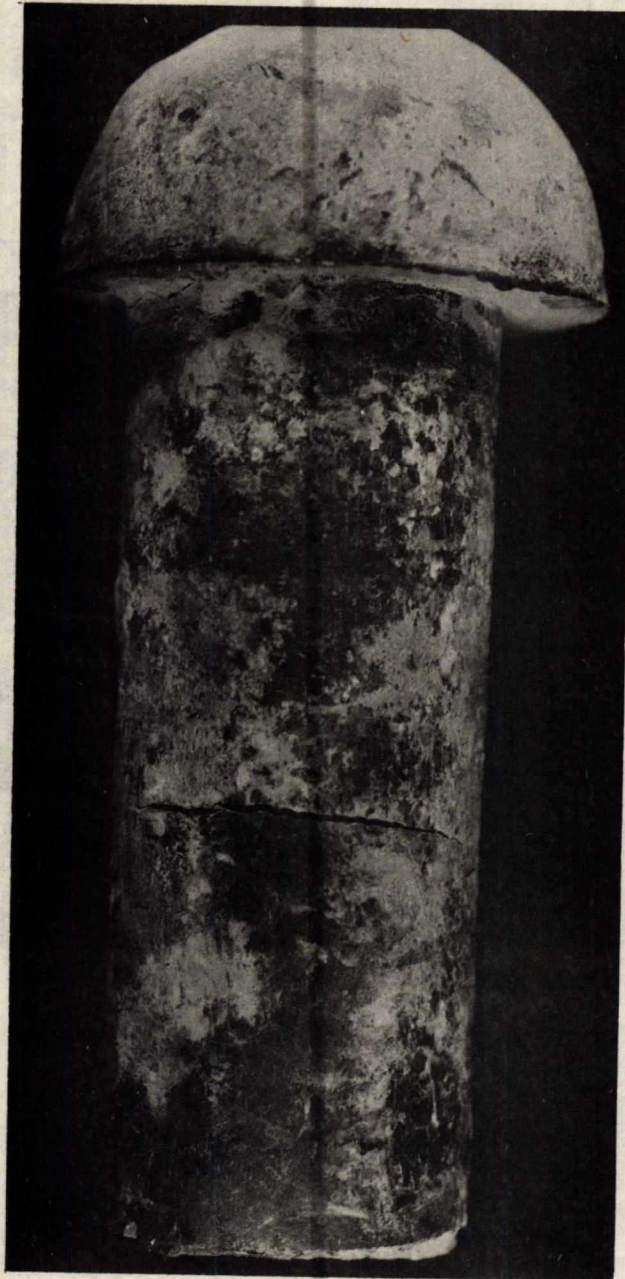
Figure 4. Illustrates the Appearance of Cracked Rivet No. 3.
In addition to the large crack, smaller circumferential cracks are present at the head shank fillet.

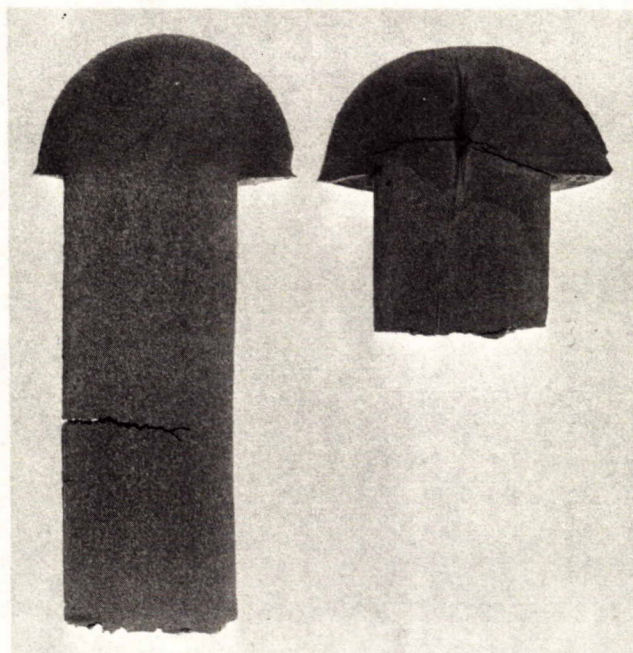
The appearance of deep-etched sections is illustrated in Figure 5. Sulphur prints taken on the same rivets are illustrated in Figure 6.

Figure 5. Deep-Etched Sections,
Rivet No. 3 (left),
Rivet No. 2 (right).

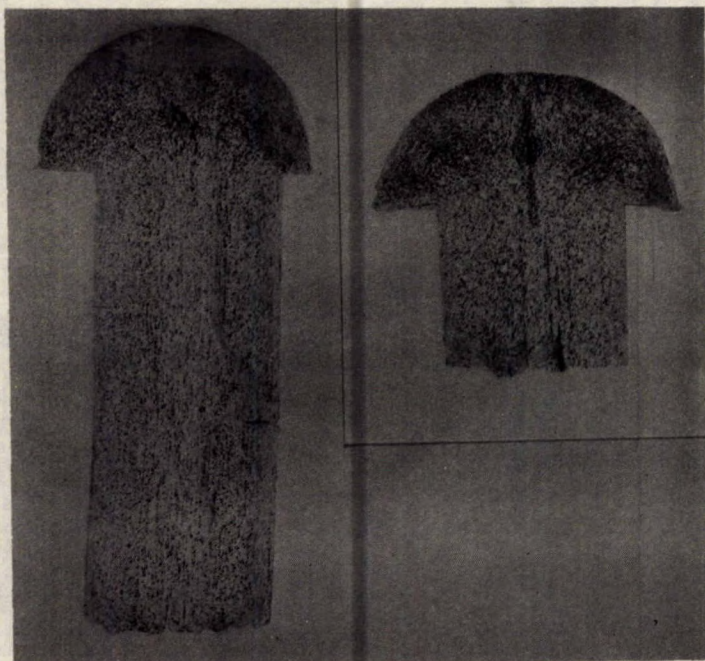
Figure 6. Sulphur Prints,
Rivet No. 3 (left),
Rivet No. 2 (right).

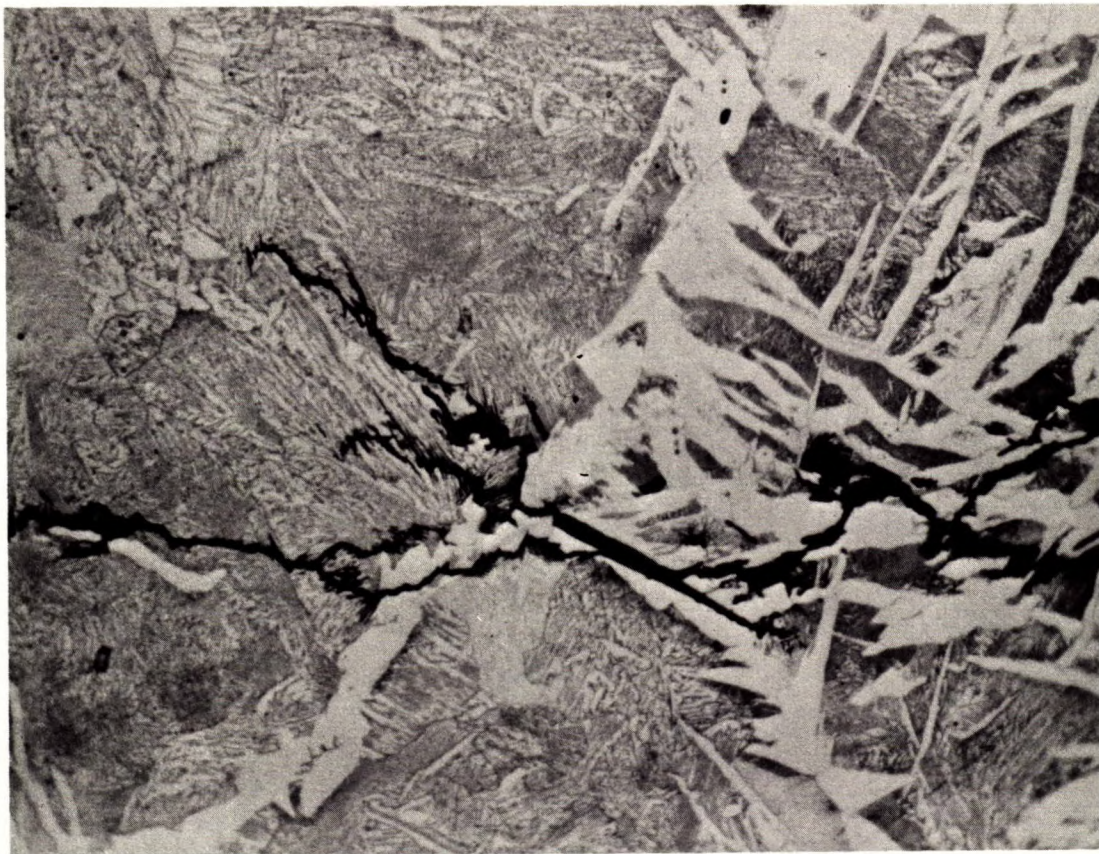
The appearance of the cracks taken at the tip of the circumferential fillet crack of rivet No. 2 is illustrated in Figures 7, 8 and 9. There is an intercrystalline network of cracks showing evidence of preferential attack of carbide lamellae in the pearlite areas. This type of attack has been reported to be due to the reaction between hot concentrated NaOH and the Fe₃C carbide and is stated(1)(2), to indicate that caustic embrittlement (intercrystalline stress corrosion cracking) may have occurred. Evidence of cracking in the boiler shell plate tends to confirm this observation.

Figure 7. Part of Circumferential Crack, Head of No. 2 Rivet. This crack is not completely intercrystalline but does have numerous branches, suggesting that it may have started as a fatigue crack in the fillet (due to strain-aging) but that caustic attack occurred subsequently.

1. The remainder of the boiler should receive thorough inspection for evidence of cracking in boiler shell plates and straps.

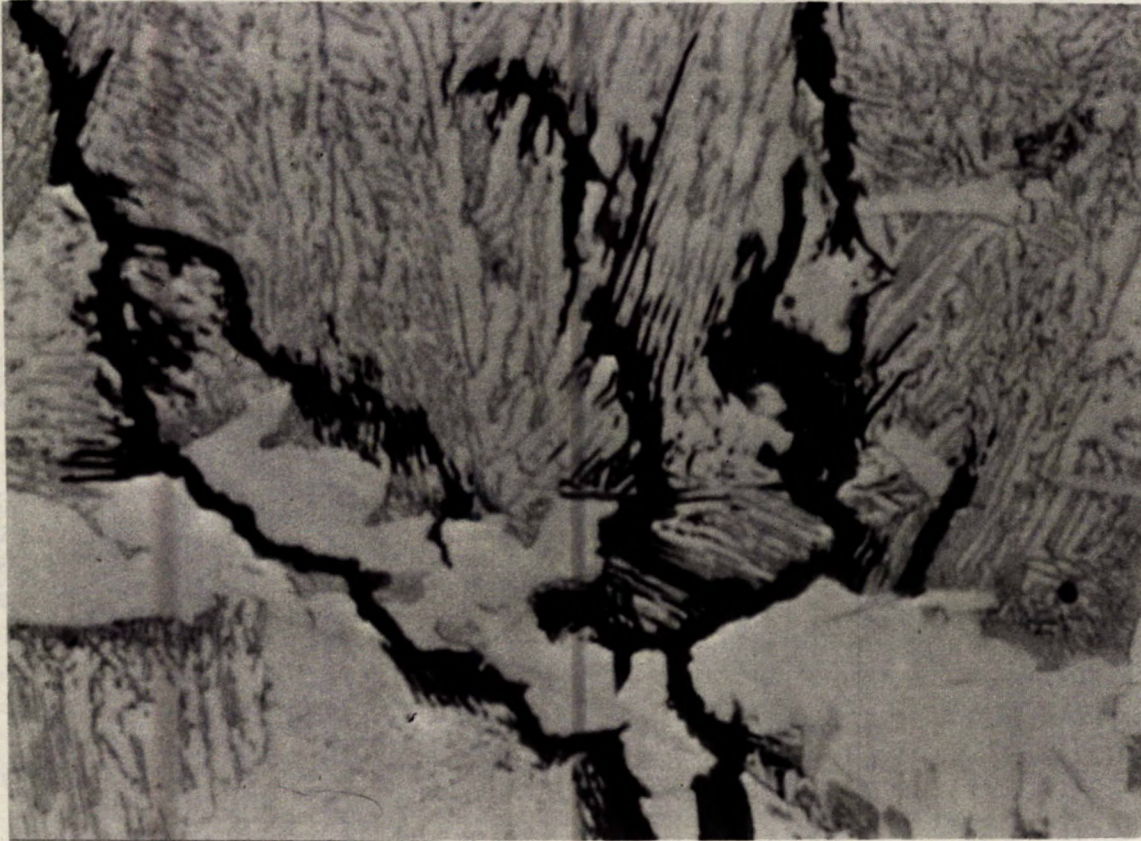
The evidence of caustic attack is illustrated in Figures 8 and 9, and in this sense appears to be identical to the condition previously observed in 1960 and described in Mines Branch Investigation Report IR 60-37.

Figure 8. Appearance of Crack Network and Attack of Fe_3C Lamellae in the Head of Rivet Sample No. 2.

Attack and oxidation of carbide lamellae is visible. This effect has only been reported due to the action of hot concentrated NaOH.

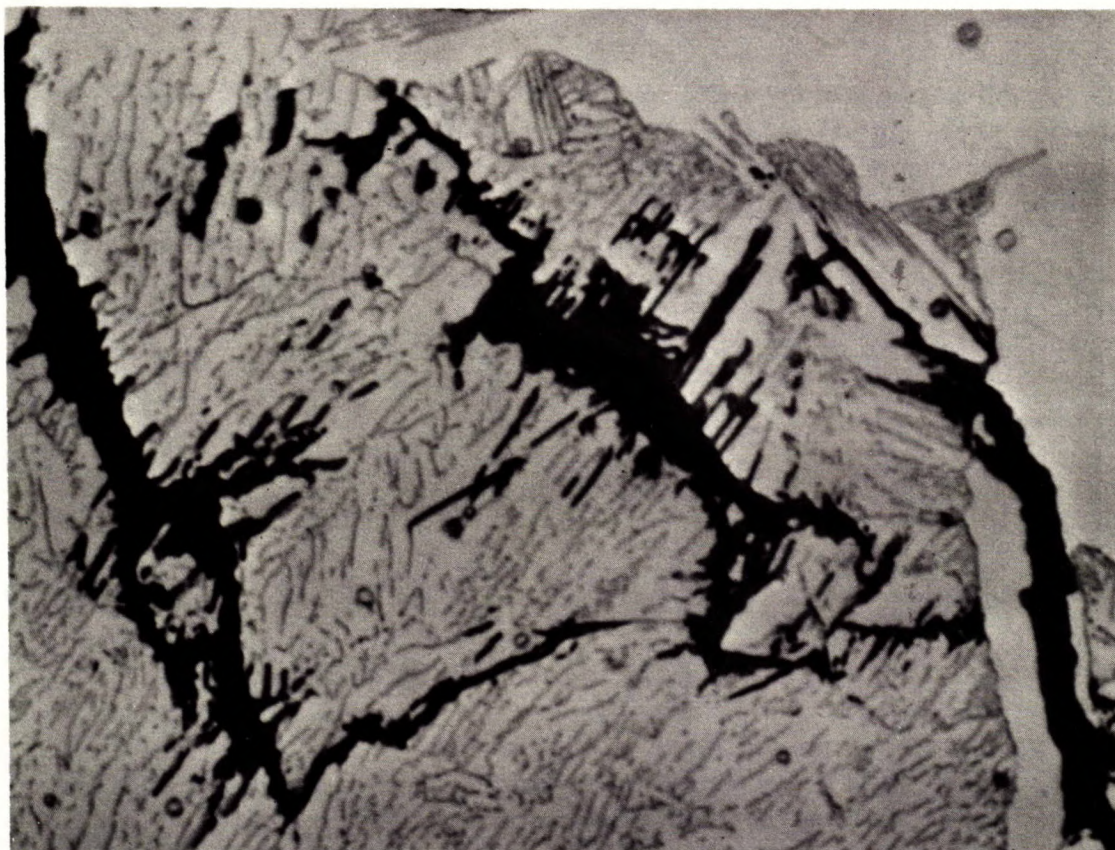
Figure 9. Rivet Sample No. 2. Crack Network and Evidence of Caustic Attack.
