MINES BRANCH INVESTIGATION REPORT IR 65-107

DECEMBER 21, 1965

EXAMINATION OF A FRACTURED
GREY CAST IRON SUPPORT RING

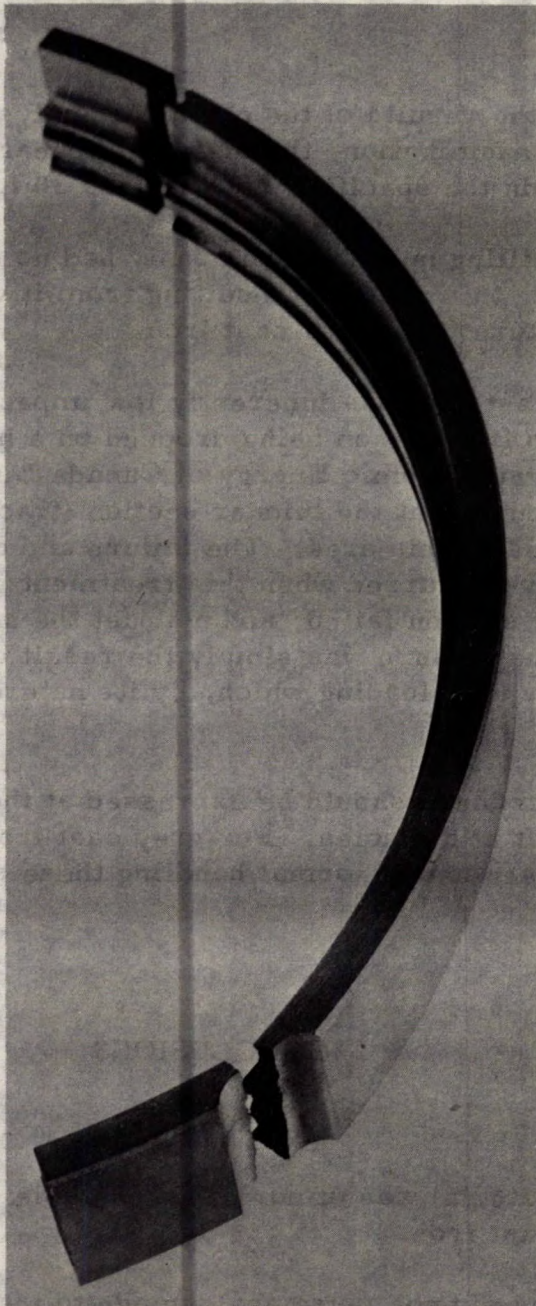
The section of ring was received as three pieces (see Figure 1) which, when fitted together, had a peripheral length of about 12 inches. It was, approximately, 1 1/4 in. high with a section thickness of 5/16 in. at the top and 1/2 in. at the bottom. Fracture had occurred on one end at a reduced section and on the other, at a drilled hole. These fractures are shown in Figure 2 and they appeared to be normal fractures, typical of grey cast iron. Figure 2(b) shows clearly the section of the stepped drill-hole and the surface discolouration previously mentioned. Note the very thin section at the top and bottom of the hole. This was measured and found to be in the region of 0.030/0.035 inches thick.

Figure 1. Photograph (approximately half size) showing fractured support ring as-received.

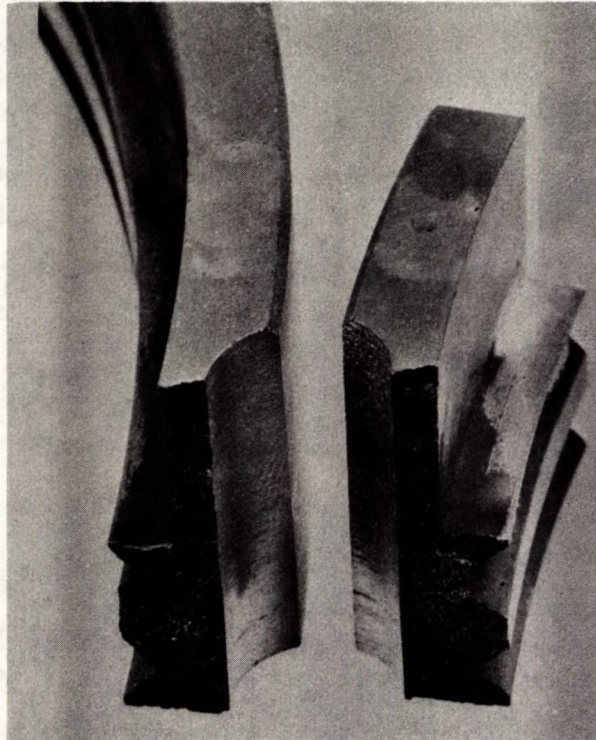
(a)

Grey cast iron has inherently low impact strength and it is not unusual for it to fracture on being dropped on a hard surface. Verbal communication with Atomic Energy of Canada Limited revealed that failure first occurred at the thicker section (fracture 4). Probably the ring was dropped on this area. The failure and cracks at the drilled holes were said to have occurred when this treatment was repeated. The fact that the heavier section failed, and not just the section at the drilled holes, demonstrates that failure was simply the result of the material having been subjected to a type of loading which, by its nature, it was unable to withstand.

Figure 2. Photographs (slightly enlarged) showing fractures. (For reference, fracture of Figure 2(a) is designated A, and that of Figure 2(b) - B).

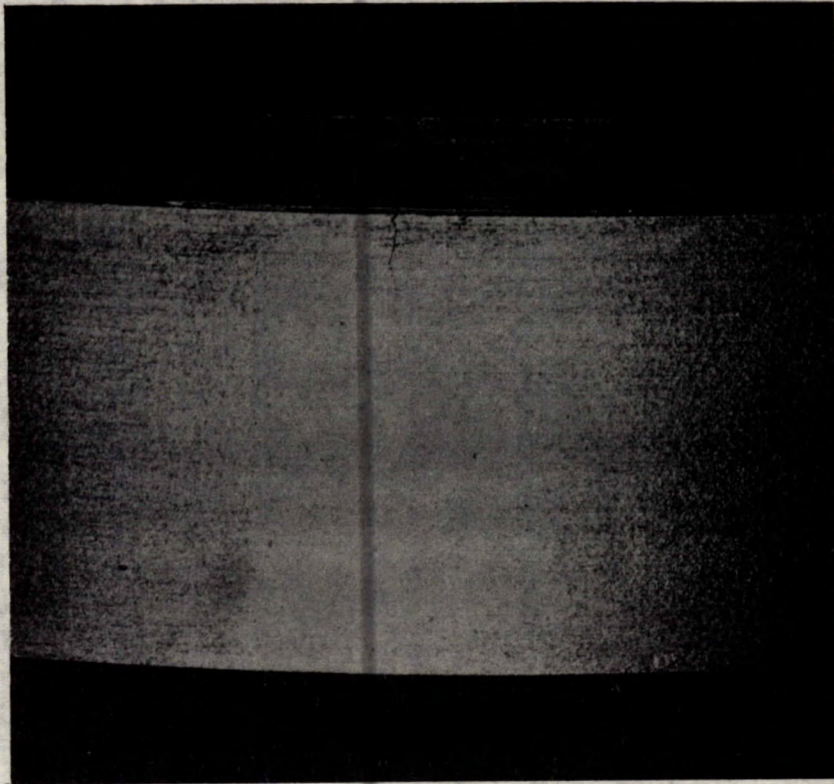
Another similar drilled hole was located on the ring between the two fractures. Close examination of this revealed two cracks, each running the length of the thin sections. That occurring at the larger diameter end of the hole is shown in Figure 3.

Some concern should be expressed at the presence of the very thin sections left at the holes. For grey cast iron such design should be avoided since even under normal handling these sections could quite easily break.

Figure 3. Photograph (approx. X2) showing crack at drilled hole.

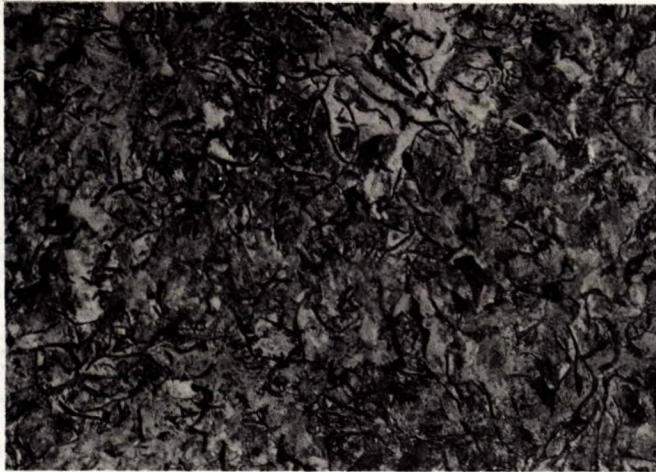
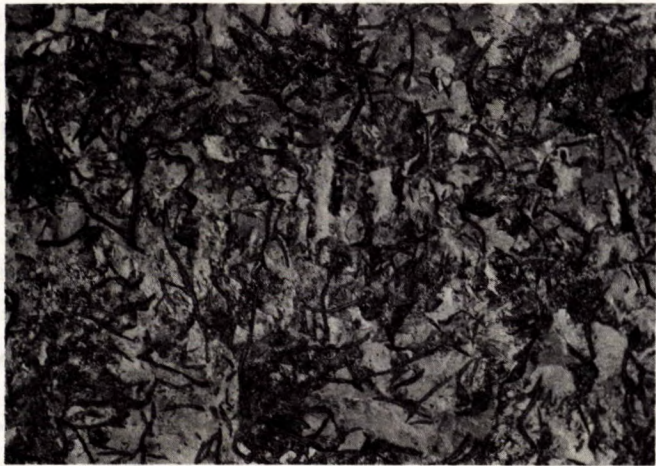
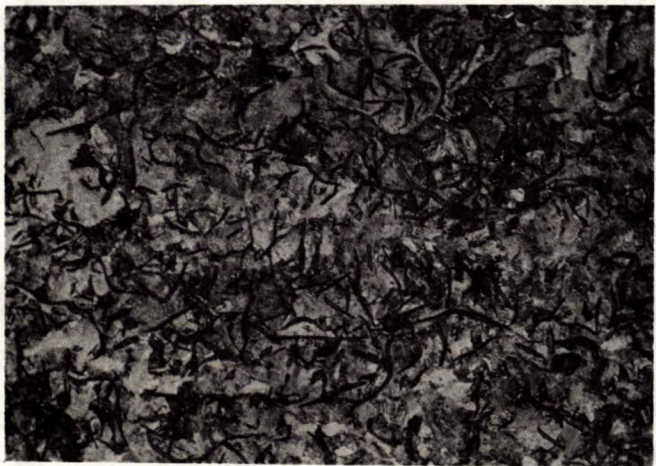
The same general microstructure, typical of this class of grey cast iron, was observed in each case, i.e. a uniform distribution of type A graphite flakes randomly orientated in a pearlitic matrix (see Figure 4). The structure at the fractures was completely normal and gave no indication of anything deleterious that might have caused premature failure. The surface discolouration of fracture B was harmless; the drilling operation had not affected the microstructure.

A - Adjacent to fracture A

B - Adjacent to fracture B

C - Away from fractures

Figure 4. Photomicrographs (X100) of typical microstructures at three locations on the support ring.
