MINES BRANCH INVESTIGATION REPORT IR 65-108

EXAMINATION OF 155 MM HOWITZER DRIVER CASTING

D. E. PARSONS AND D. A. MUNRO

JANUARY 19, 1966

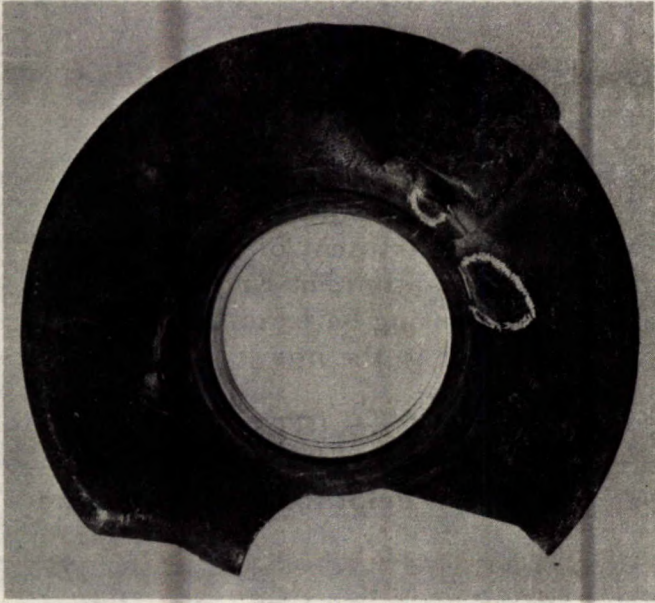
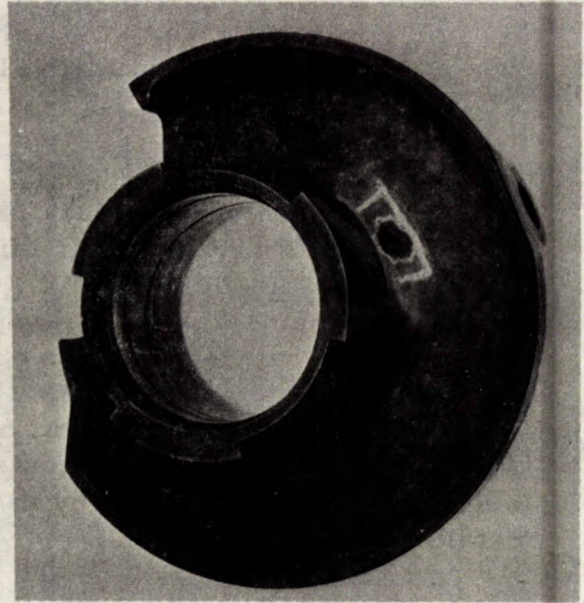
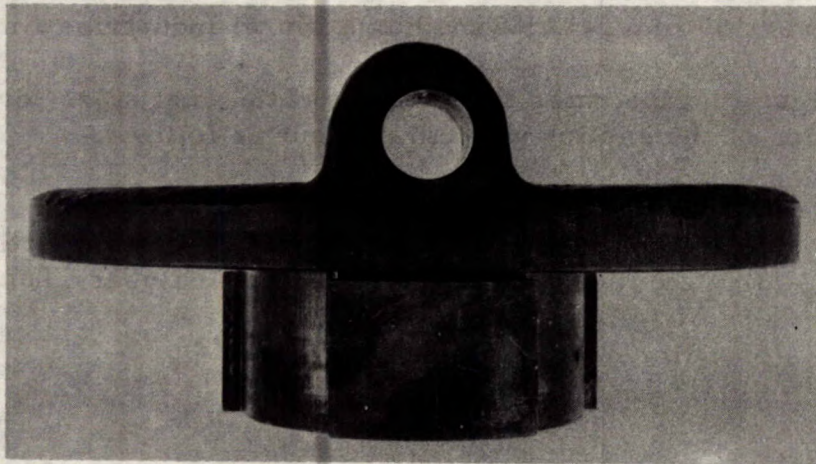
Figure 1. Illustrates View of Driver Casting.

Visual examination showed that the hole present in the boss was off-centre, suggesting an error in boring or misalignment of a core during casting.

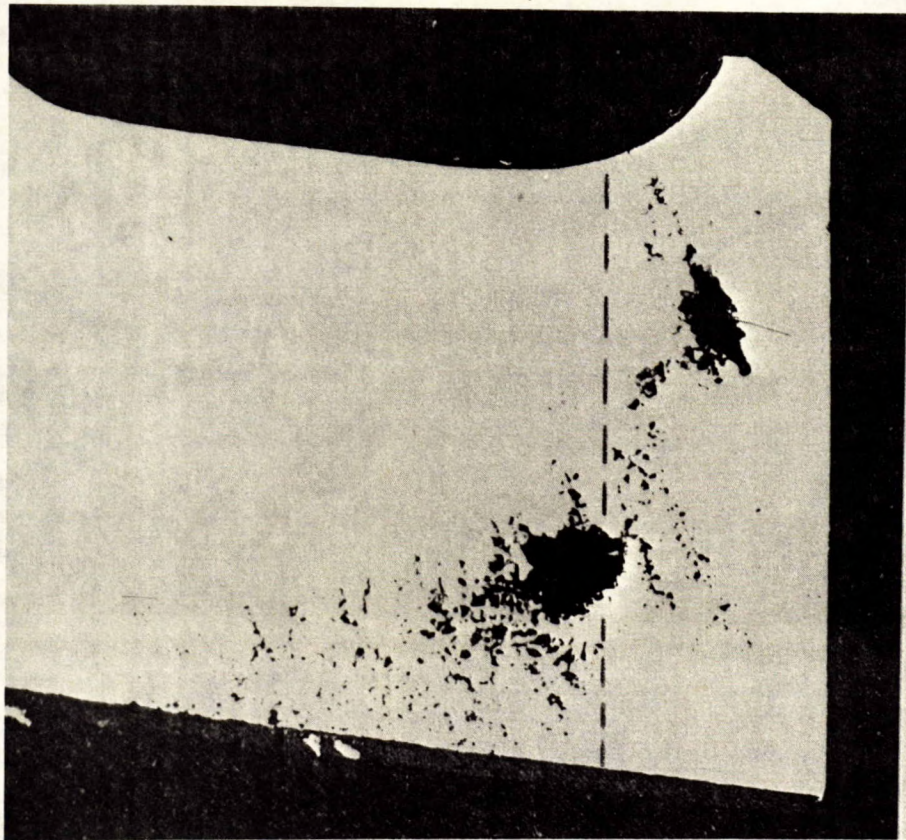
Figure 3. Radial Section Illustrating Shrinkage Area Adjacent to the Boss.

The plane of the circumferential crack having a length of approximately $3/8$ in. is illustrated by the dashed line.

The shrinkage illustrated, while present for a distance of approximately 1/4 in., would offer a plane of weakness and could explain the rapid initiation of the circumferential crack adjacent to the boss.

- (1) Shrinkage was present adjacent to the boss and may have contributed to formation of a circumferential crack in this region.
- (2) The casting was in the annealed condition and met the yield strength requirement of the specification - Class 80-50, but gave a per cent RA value of only 12%.
- (3) The hole was off-centre in the boss.
- (4) Superficial damage had been done to the casting surface by accidental contact with a cutting torch.

- (1) Consider whether this casting should be purchased in a quenched and tempered condition to a high strength and inspection standard.

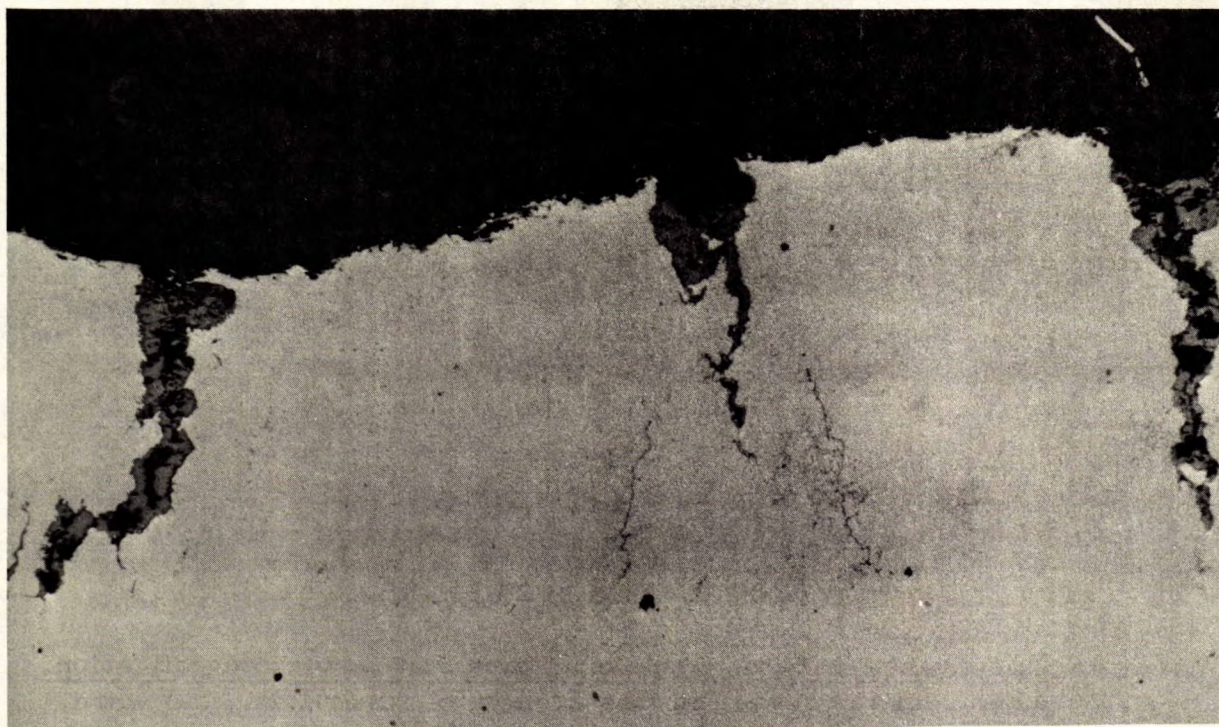
Figure 5 illustrates the appearance of a transverse (radial section) through the groove which appeared to have been produced by an accidental strike from the cutting torch. The surface metal in this zone is decarburized and contains shallow "burn" cracks.

Figure 5. Section Through Groove Observed on Surface of Casting.
The metal is decarburized and appears to have been
burned.

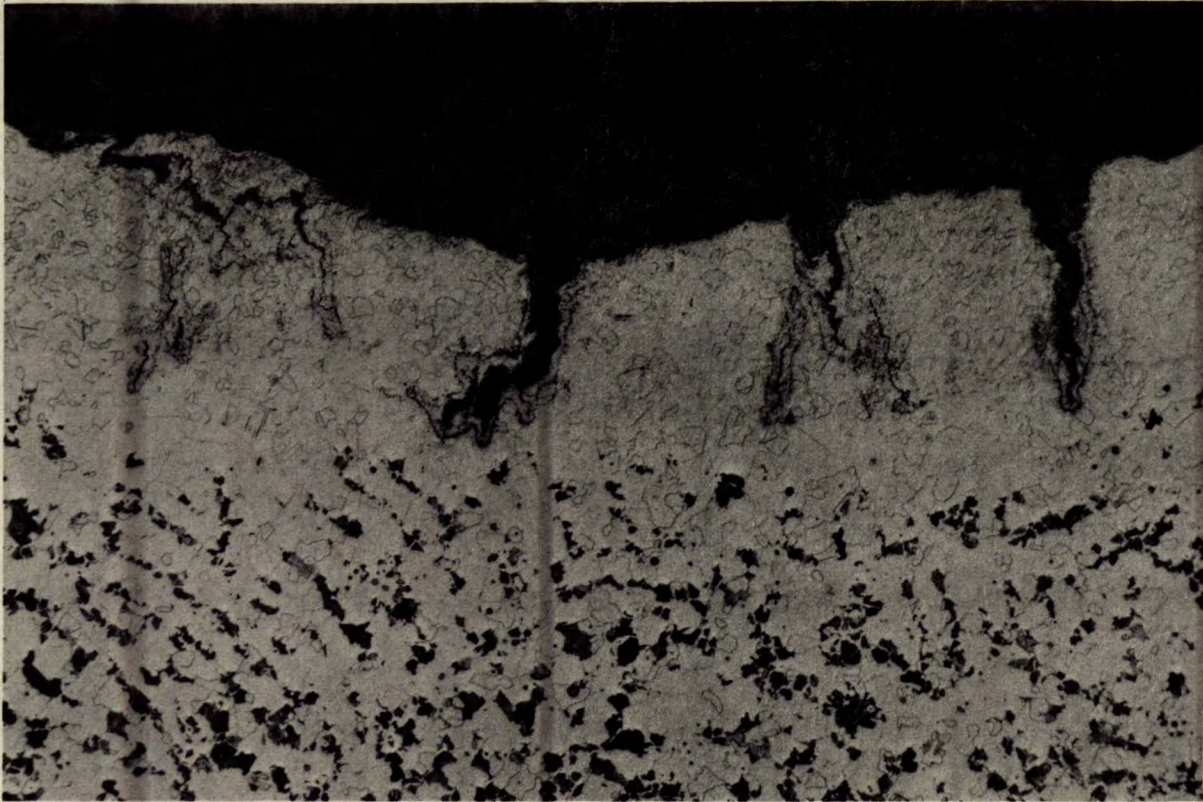
Figure 6. Appearance of Same Area as Figure 5 at Lower Magnification. The cracks observed in this area were superficial, but were apparently of accidental origin due to gouging by the flame of the cutting torch used to remove the gates and risers. The affected depth is approximately 1/64 in.
