**MINES BRANCH INVESTIGATION REPORT IR 66-4**

**METALLURGICAL EXAMINATION  
OF GALVANIZED TUBING**

Mines Branch Investigation Report IR 66-4

METALLURGICAL EXAMINATION OF GALVANIZED TUBING

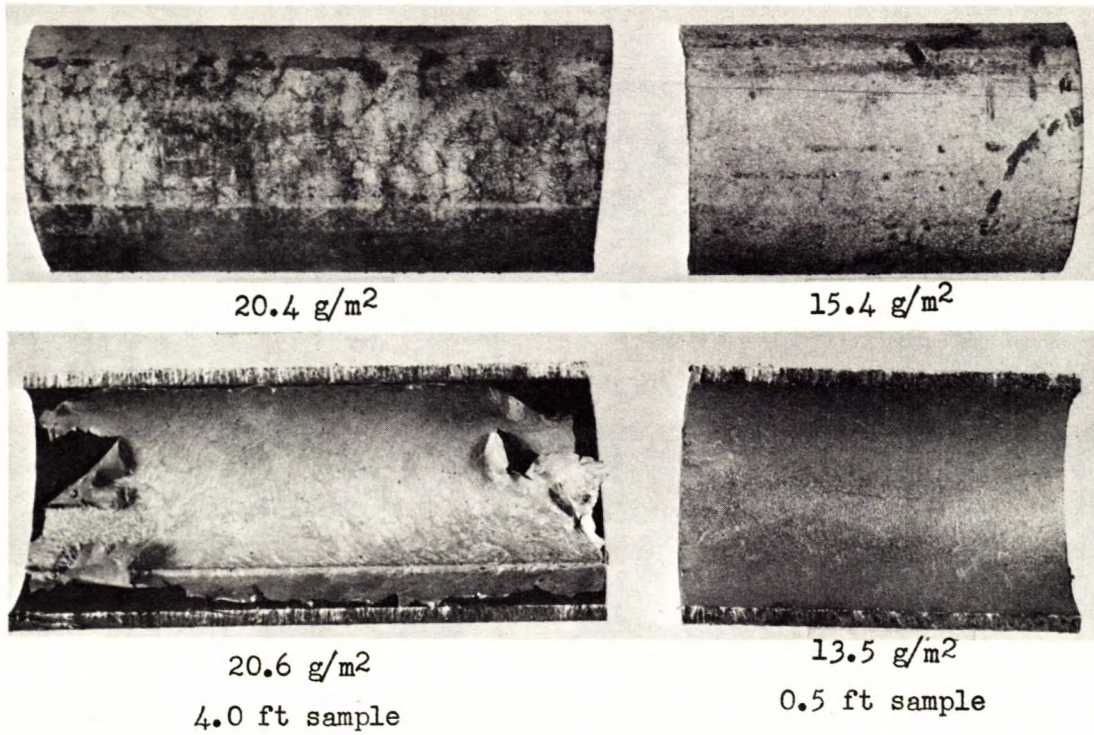
A photograph of the samples provided after sectioning longitudinally to show inside and outside surfaces is given in Figure 1. Although not stated, these were presumably taken from a tube which was positioned at or near the centre of a racked bundle. The sample 0.5 ft from the tube end, as shown on the right of Figure 1, had a bright metallic finish on the inside and a whitish-grey crystalline deposit (not identified) on the exterior surface. There was no evidence of separation of the zinc layer on either surface, even by vigorous scratching with a scribe. In contrast, bonding of the bright zinc layer on the interior of the 4 ft sample was completely destroyed and the thick layer present could be readily peeled away as shown on the left of Figure 1. The exterior coating on the same sample had a discoloured appearance varying from patches and bands with a black finish to brighter areas broken up by a black network pattern.

but may retain sufficient point contact that it eventually disappears by continued reaction to form more of the underlying zeta iron-zinc phase. The black oxidized surface of this phase can be seen in Figure 1. The exterior coating on the 4 ft sample represented an apparently advanced stage in this sequence, principally because the zinc layer was initially thin as a result of wiping. The black network pattern on this surface corresponds to zinc grain boundaries and is explained by the inherently higher diffusion rate, and thus earlier depletion of zinc, in such areas. Similar zinc diffusion effects were not evident on the peeled interior coating of this sample because of the much heavier zinc deposit, which appeared to have separated from the base metal more completely when the interface bond was broken.

Duplicate determinations of the iron content of the coatings were made and the results are given in Figure 1. These substantiate the metallographic effects noted and confirm the higher reaction activity on the 4 ft sample, as

Figure 1 - Exterior and interior views of tubing samples with iron content of coating indicated in each case. X1

It is suggested that peeling and other deterioration of the coating on the samples of galvanized tubing submitted was primarily caused by inadequate cooling after galvanizing and before racking of the tubes into bundles. Standard practice to avoid such deterioration, particularly with heavy-wall products, is to water quench. However, when air cooling is used, any stacking or bundling of the products should be delayed until a temperature considerably below the galvanizing temperature, and preferably approaching ambient conditions, is reached. Close proximity contact as would occur with tubing on a run-out table should not be harmful during this cooling period.

Alternatively, if space considerations preclude extensive air cooling racks, some other form of forced cooling of the bundles could be adopted provided this was done soon enough, and was effective in rapidly reducing the temperature at all points in the stack.

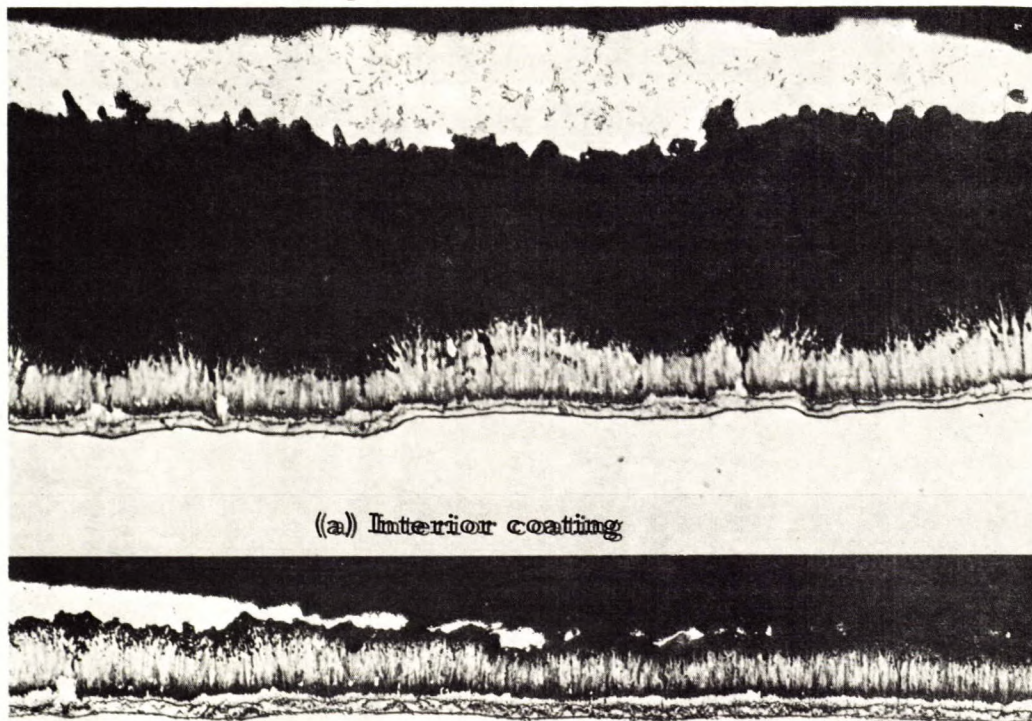
Complete separation of the thick zinc layer from the interior coating of the 4 ft sample is illustrated in Figure 2(a). The degree of separation apparent was unavoidably exaggerated since the zinc layer pulled free on cutting of the specimen and had to be cemented in place. This accounts also for its lack of register with the adjacent alloy phase. In Figure 2(b) it can be seen that much of the initially thin zinc layer in the outer coating has disappeared locally, having reacted to form iron-zinc alloy. Patches of zinc remaining were apparently unbonded but presumably retained some adherence because of mechanical keying along the irregular interface. These patches correspond to the brighter surface areas of the exterior coating in Figure 1.

Figure 2 - Microstructures of coatings on 4 ft sample. X300

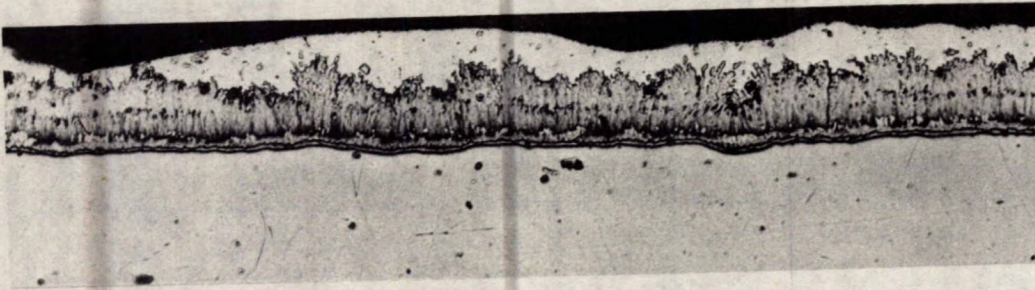
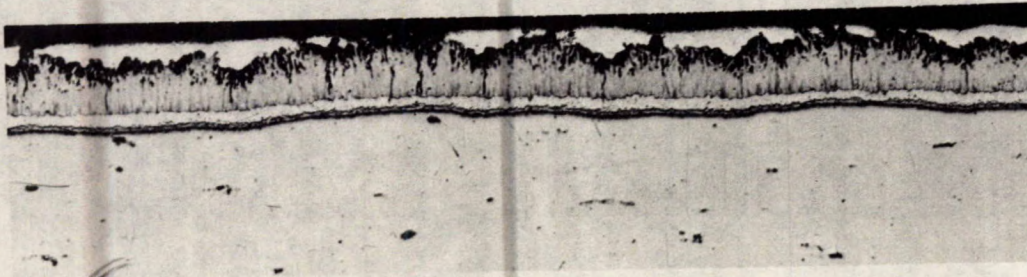
Figure 3 - Microstructures of coatings on 0.5 ft sample. X300

As noted earlier, neither of the zinc layers on the 0.5 ft sample could be induced to peel. However, Figure 3 confirms that here also some destruction of the zinc-zeta interface bond had taken place, particularly in the exterior coating. Separation in this case was almost continuous in the area examined as shown in Figure 3(b) but, again, the good adherence would presumably be accounted for by interface keying. Minimal bond failure was evident on the interior coating of the 0.5 ft sample and local areas only were affected as shown in Figure 3(a).
